# Feasibility Study

Client: Knowsley Council

Project: New Hutte Neighbourhood Centre

Location: Halewood, Liverpool

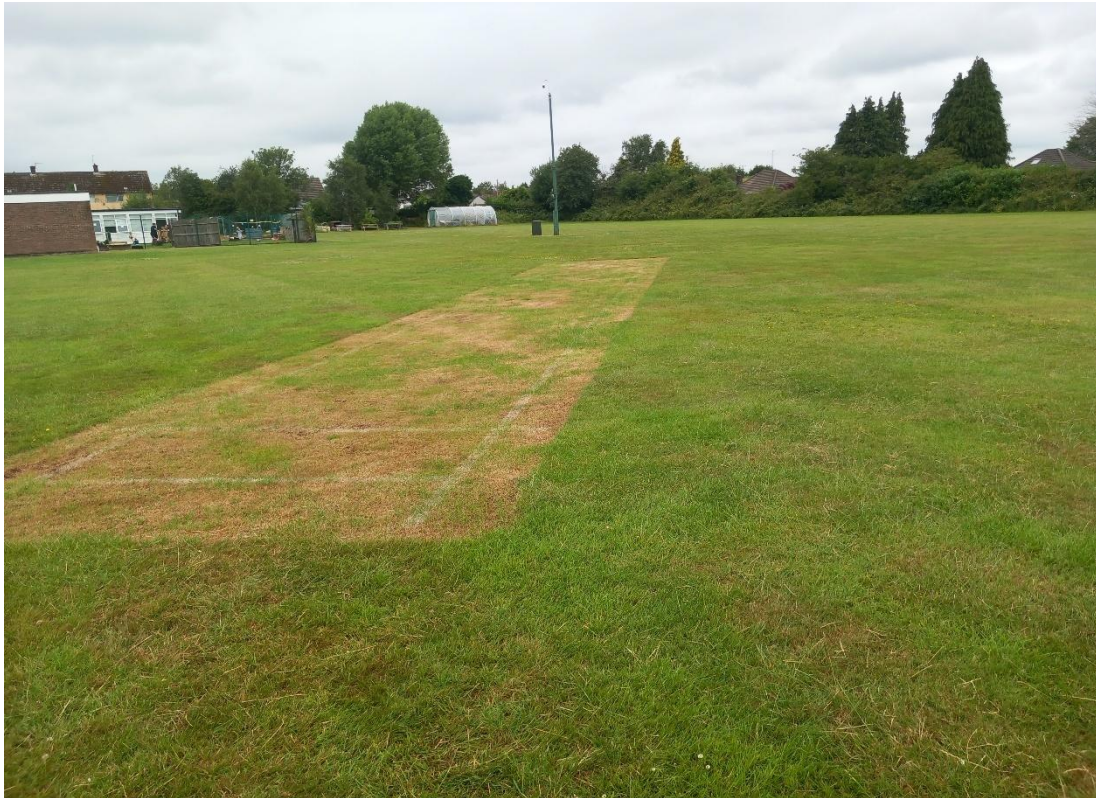
| Existing sports facilities : | No winter sports pitches were marked out at the time of the visit however an informal Cricket pitch was marked out at the time of the visit. No formally constructed square or artificial surface was observed. | |

Photo 7: Mown out Cricket wicket
