# Equivalent Quality Assessment

Client: Knowsley Council

Project: Grace Park and New Hutte Neighbourhood Centre

Location: Halewood, Liverpool

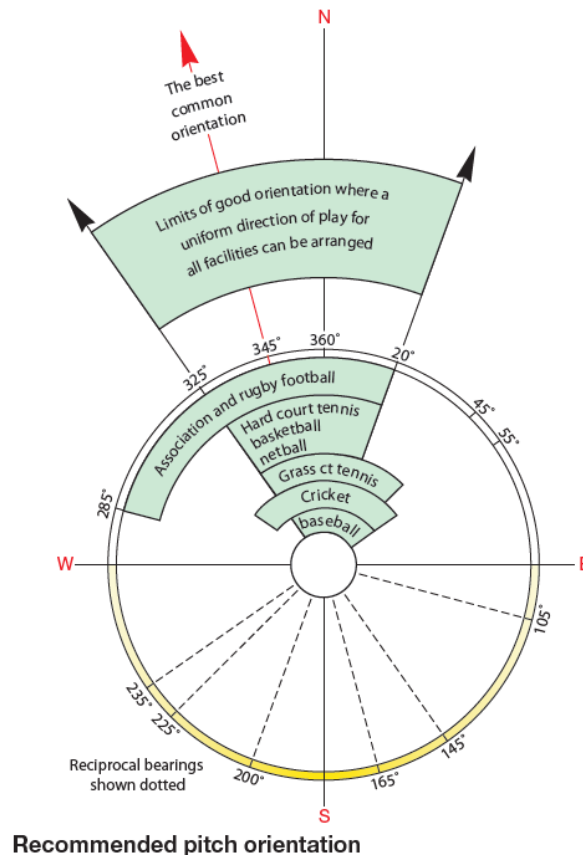
**Figure 4: Recommended orientation**

- 2.16 With respect to pitch orientation, Sport England has published guidance on optimum pitch orientations for a range of sports to minimise the impact of glare from the sun. For winter sports pitches, the limits of orientation are 285° and 20°.
- 2.17 Analysis of Google Earth imagery indicates that pitch orientation varies depending on the requirements of the junior football club; therefore, no single statutory layout was consistently observed across the available historical imagery.

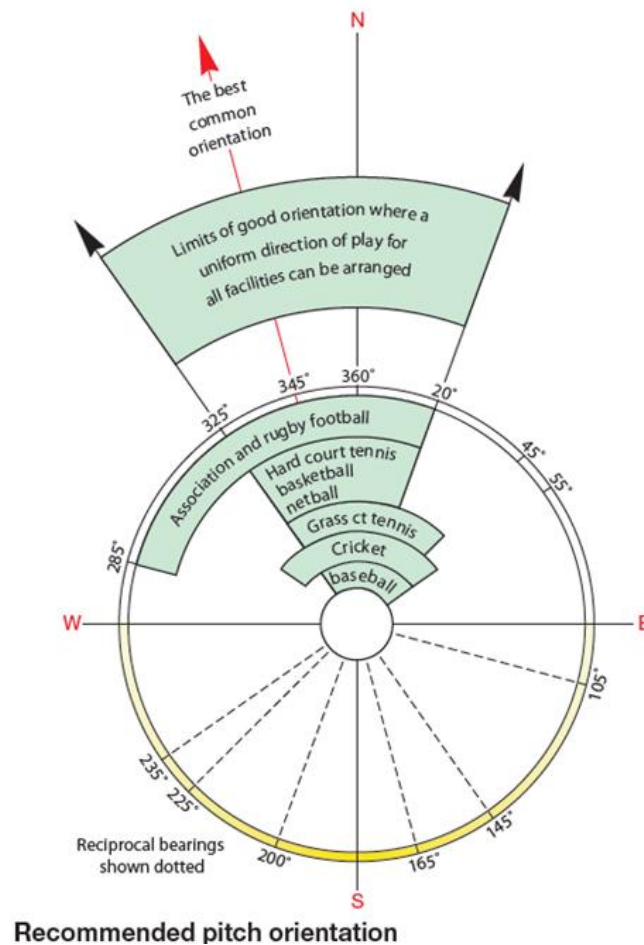
**Figure 10: Recommended Orientation**

- 3.22 Below is the recommended Sport England guidance for pitch orientation which would need to be considered for the proposed winter sports surfaces at New Hutte.
