# **Molyneux House 21 High Street Prescot**

**Plastering Schedule For  
Proposed Conversion Of Ground  
Floor Into 2 x Apartments**

**BPS  
DEVELOPMENTS LTD**

**September 2026**

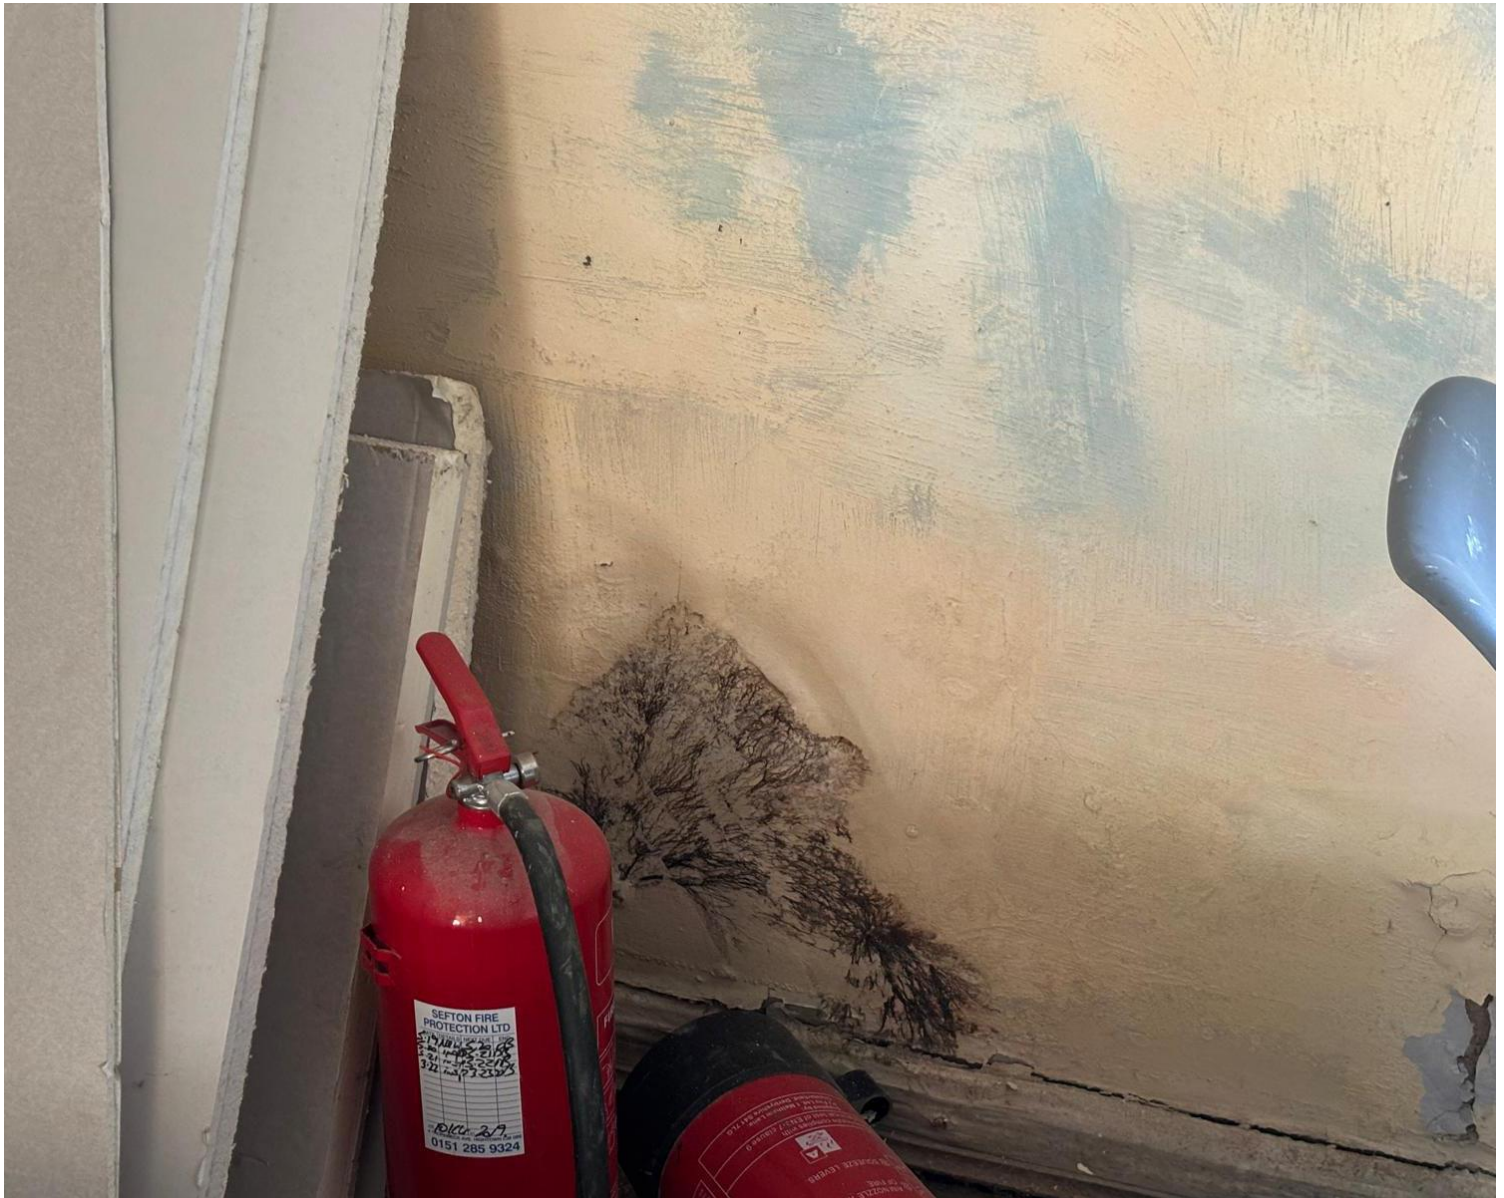
## Flat 2 Bedroom / Rear Wall

The rear elevation is in sand/cement & is in a poor condition, showing signs of damp in areas.

A 1m band needs to be removed to check for dry rot, so it is felt that so much is proposed to be removed that this should be removed fully.

Consequently renewal will be in a lime based system
