## Tree Survey, Arboricultural Impact Assessment, and Arboricultural Method Statement

A report to accompany a planning application for the proposed development of a new lambing shed on an existing foundation

**Site Address: Knowsley Hall, Merseyside, Prescot L34 4AJ**

| Reference: | RA.BS5837.037 |

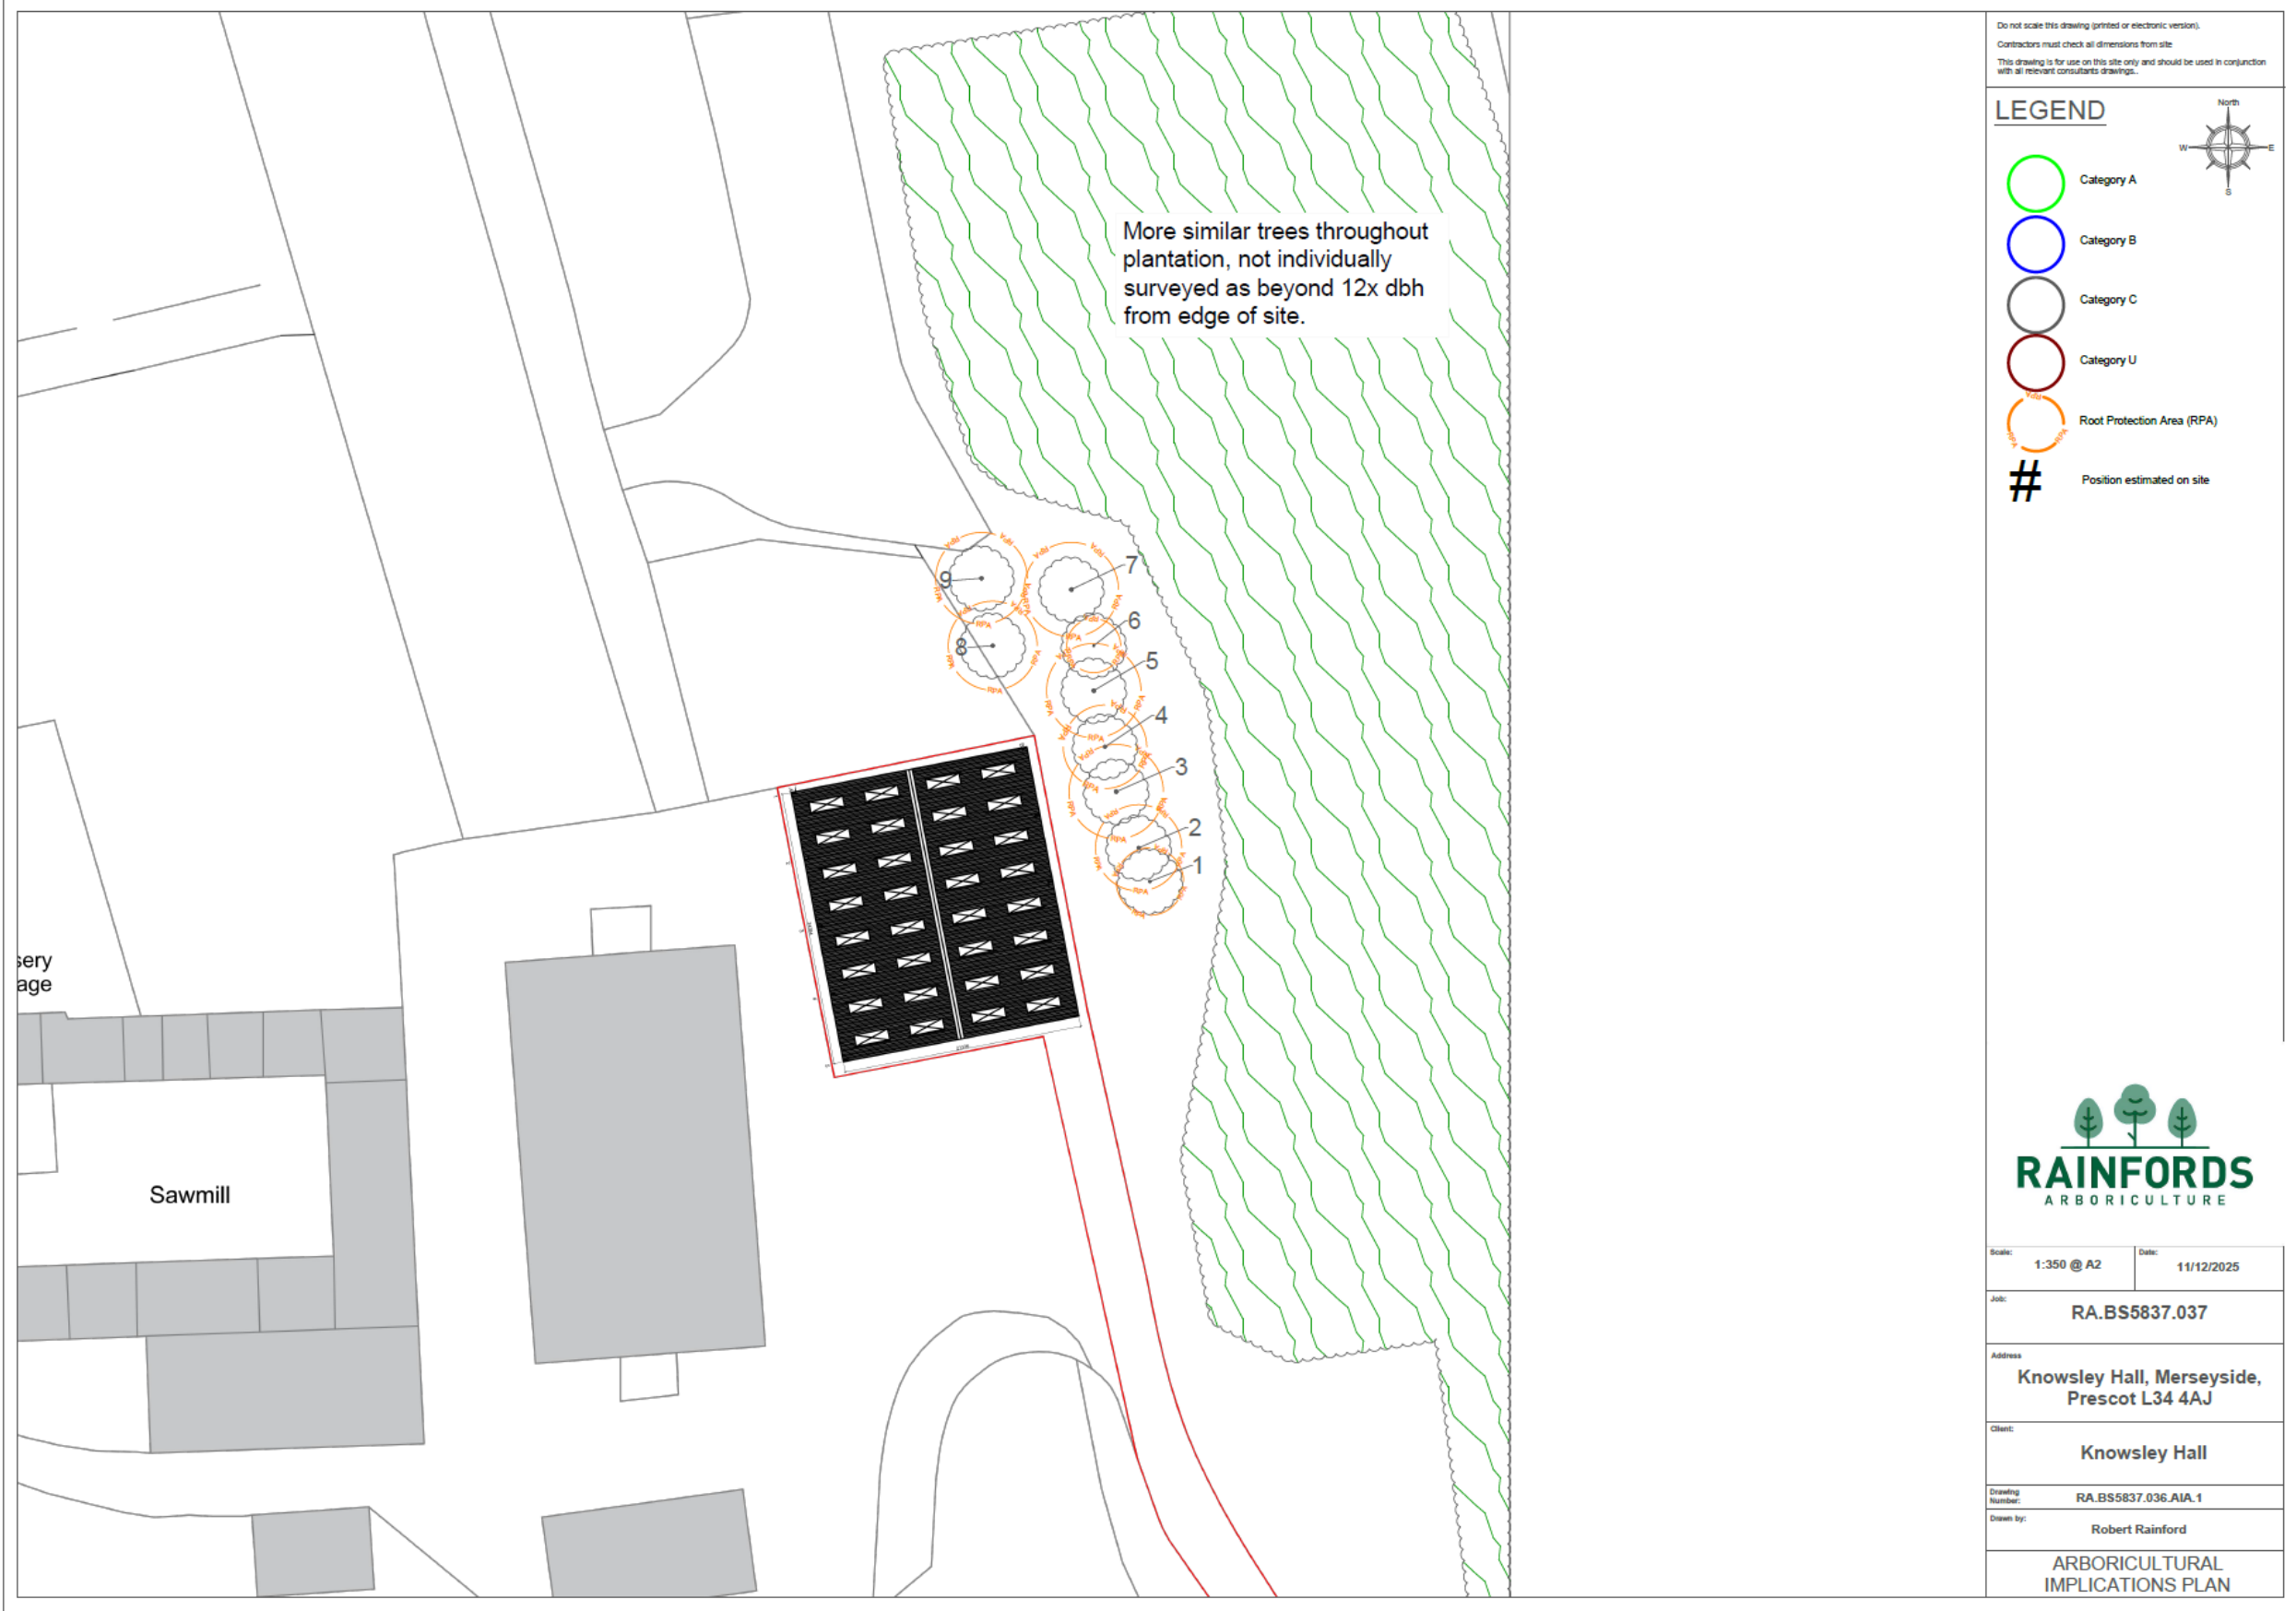
9 APPENDIX C - Arboricultural Implications Plan

The proposed lambing shed will be constructed on an existing concrete foundation. The Root Protection Areas (RPAs) of T1–T9 do not extend to the edge of this concrete pad, so there is no direct RPA incursion. A low soil mound of approximately 1 m height lies between the trees and the pad and is proposed to be pushed back.

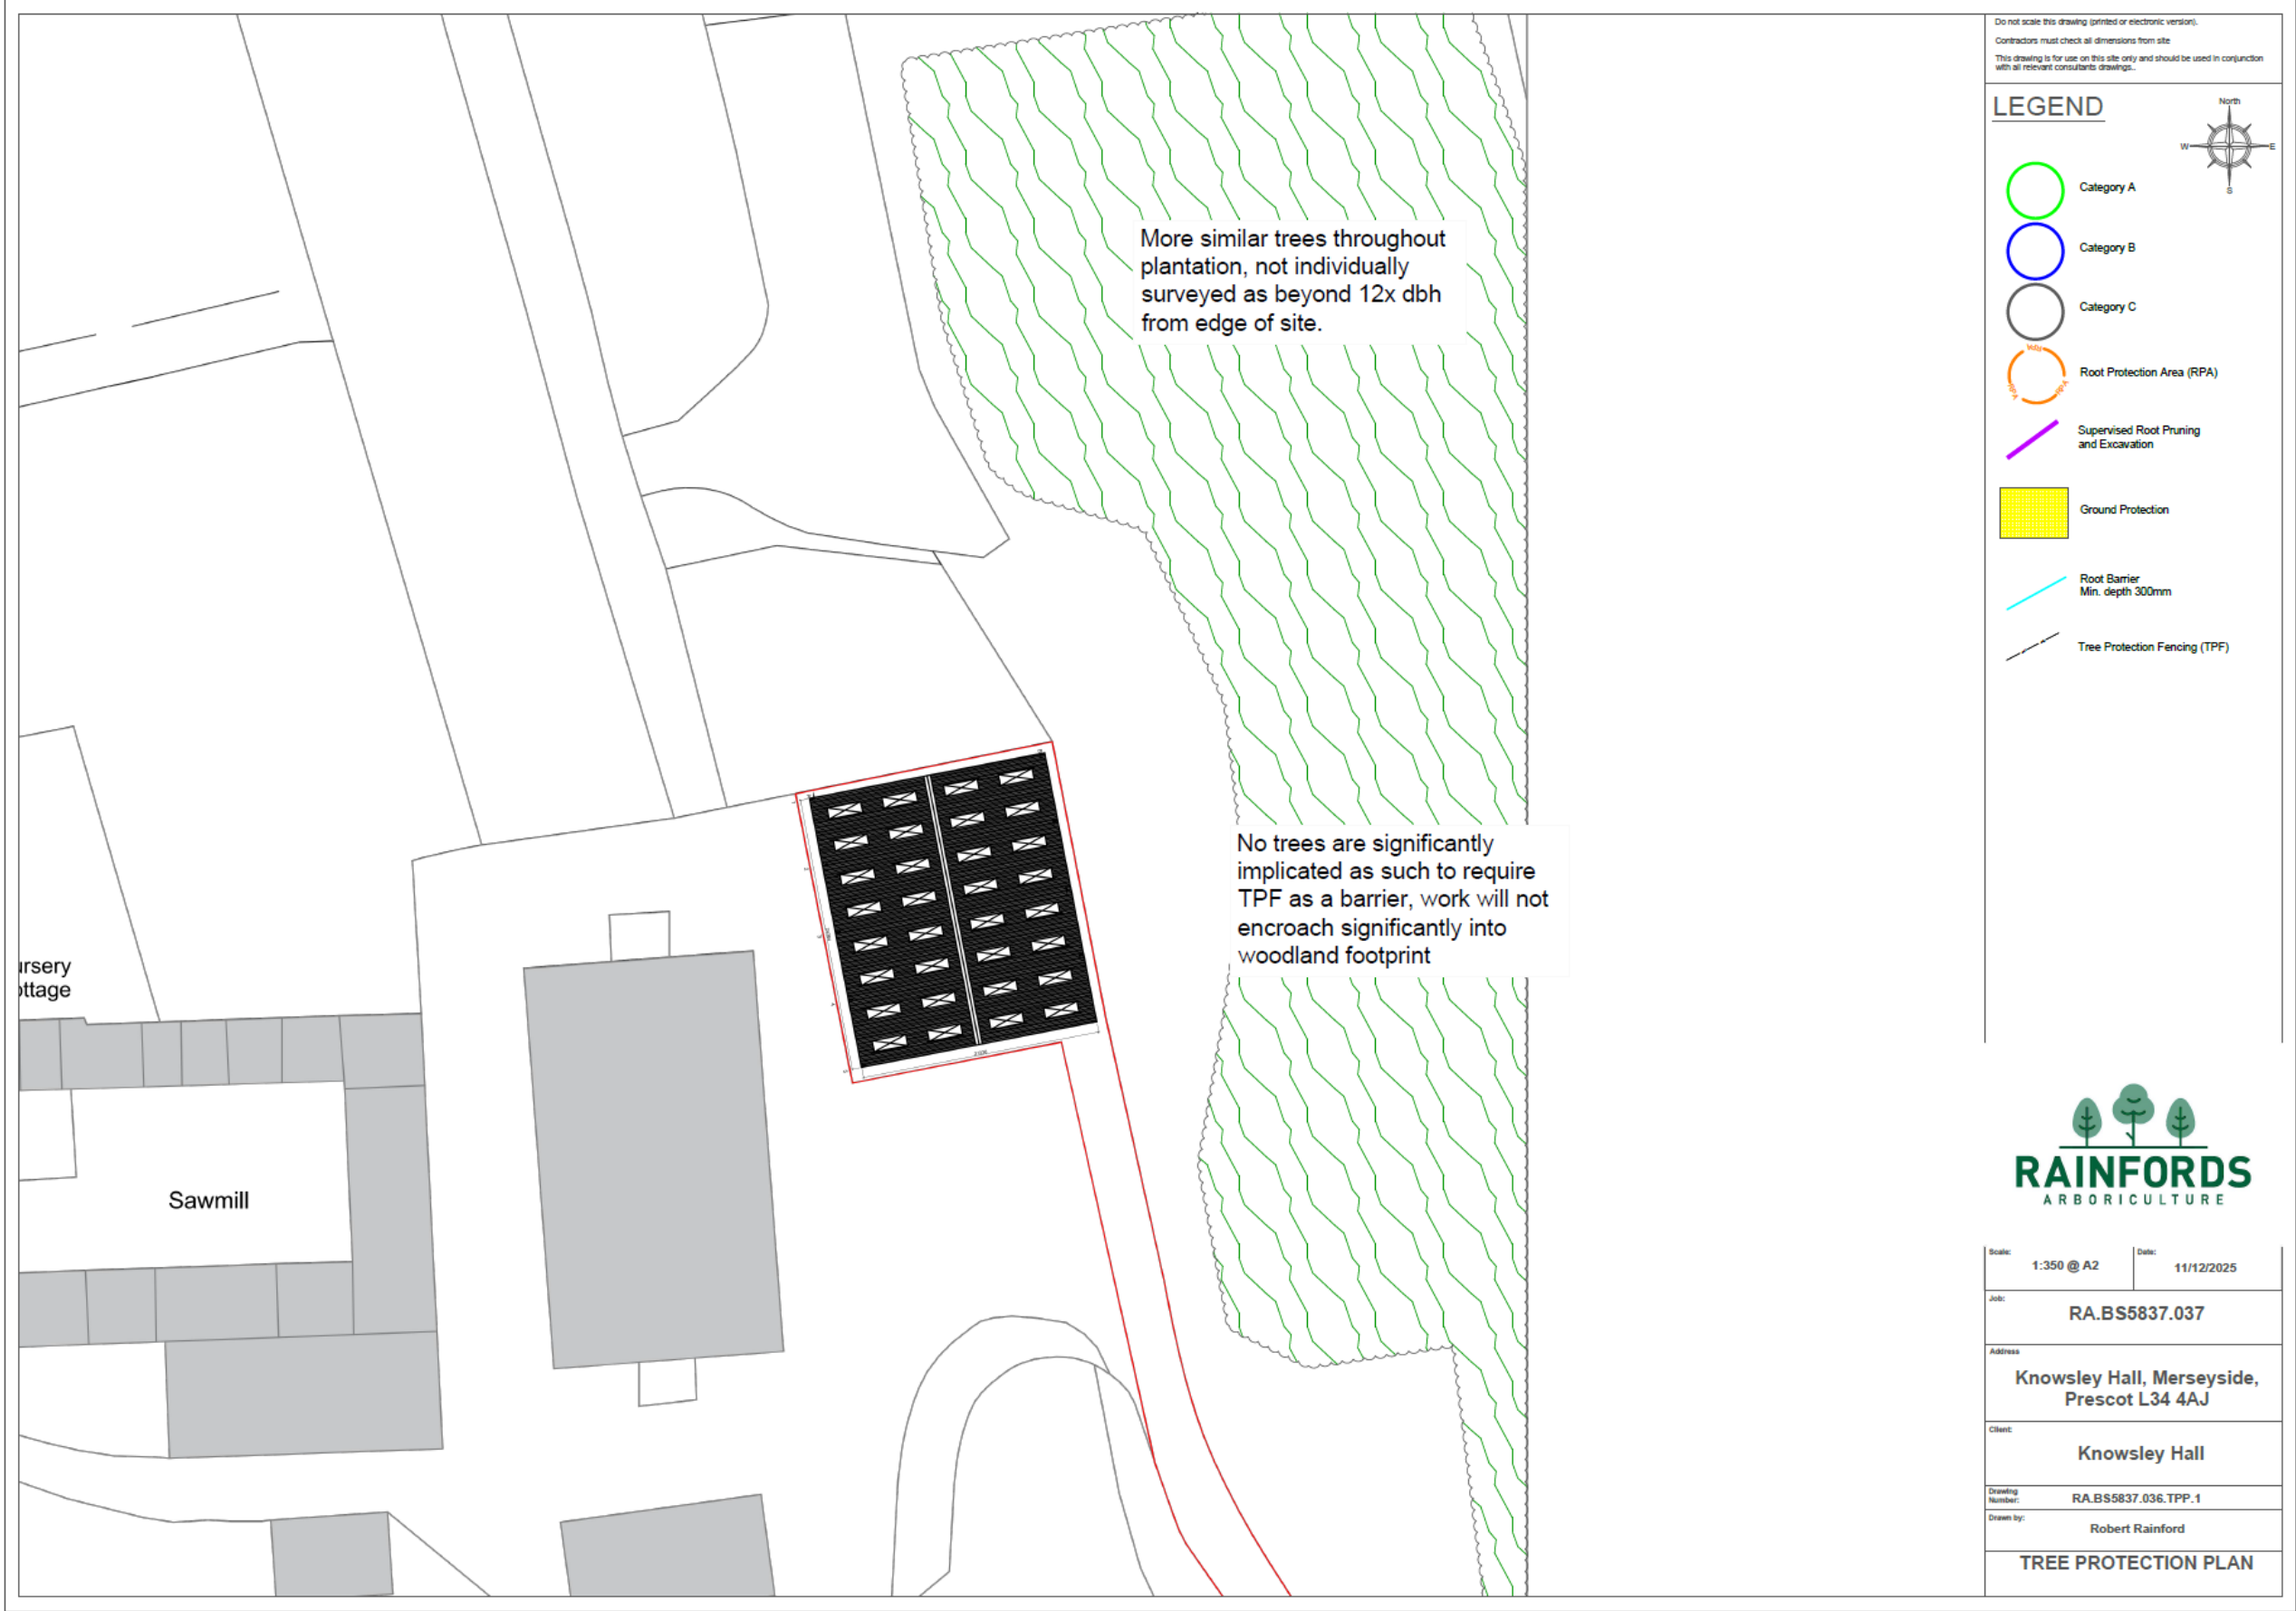
11 APPENDIX E - Tree Protection Plan

As the development relies on an existing hardstanding and there are no retained trees in proximity, the risk of construction-related damage to remaining tree stock is negligible.
