65215060  
INDURENT PARK, MOORGATE POINT,  
ALCHEMY BUSINESS PARK, KNOWSLEY  
STAGE 1 ROAD SAFETY AUDIT

65215060-SWE-GEN-ZZ-AS-PC-00001

12 November 2025

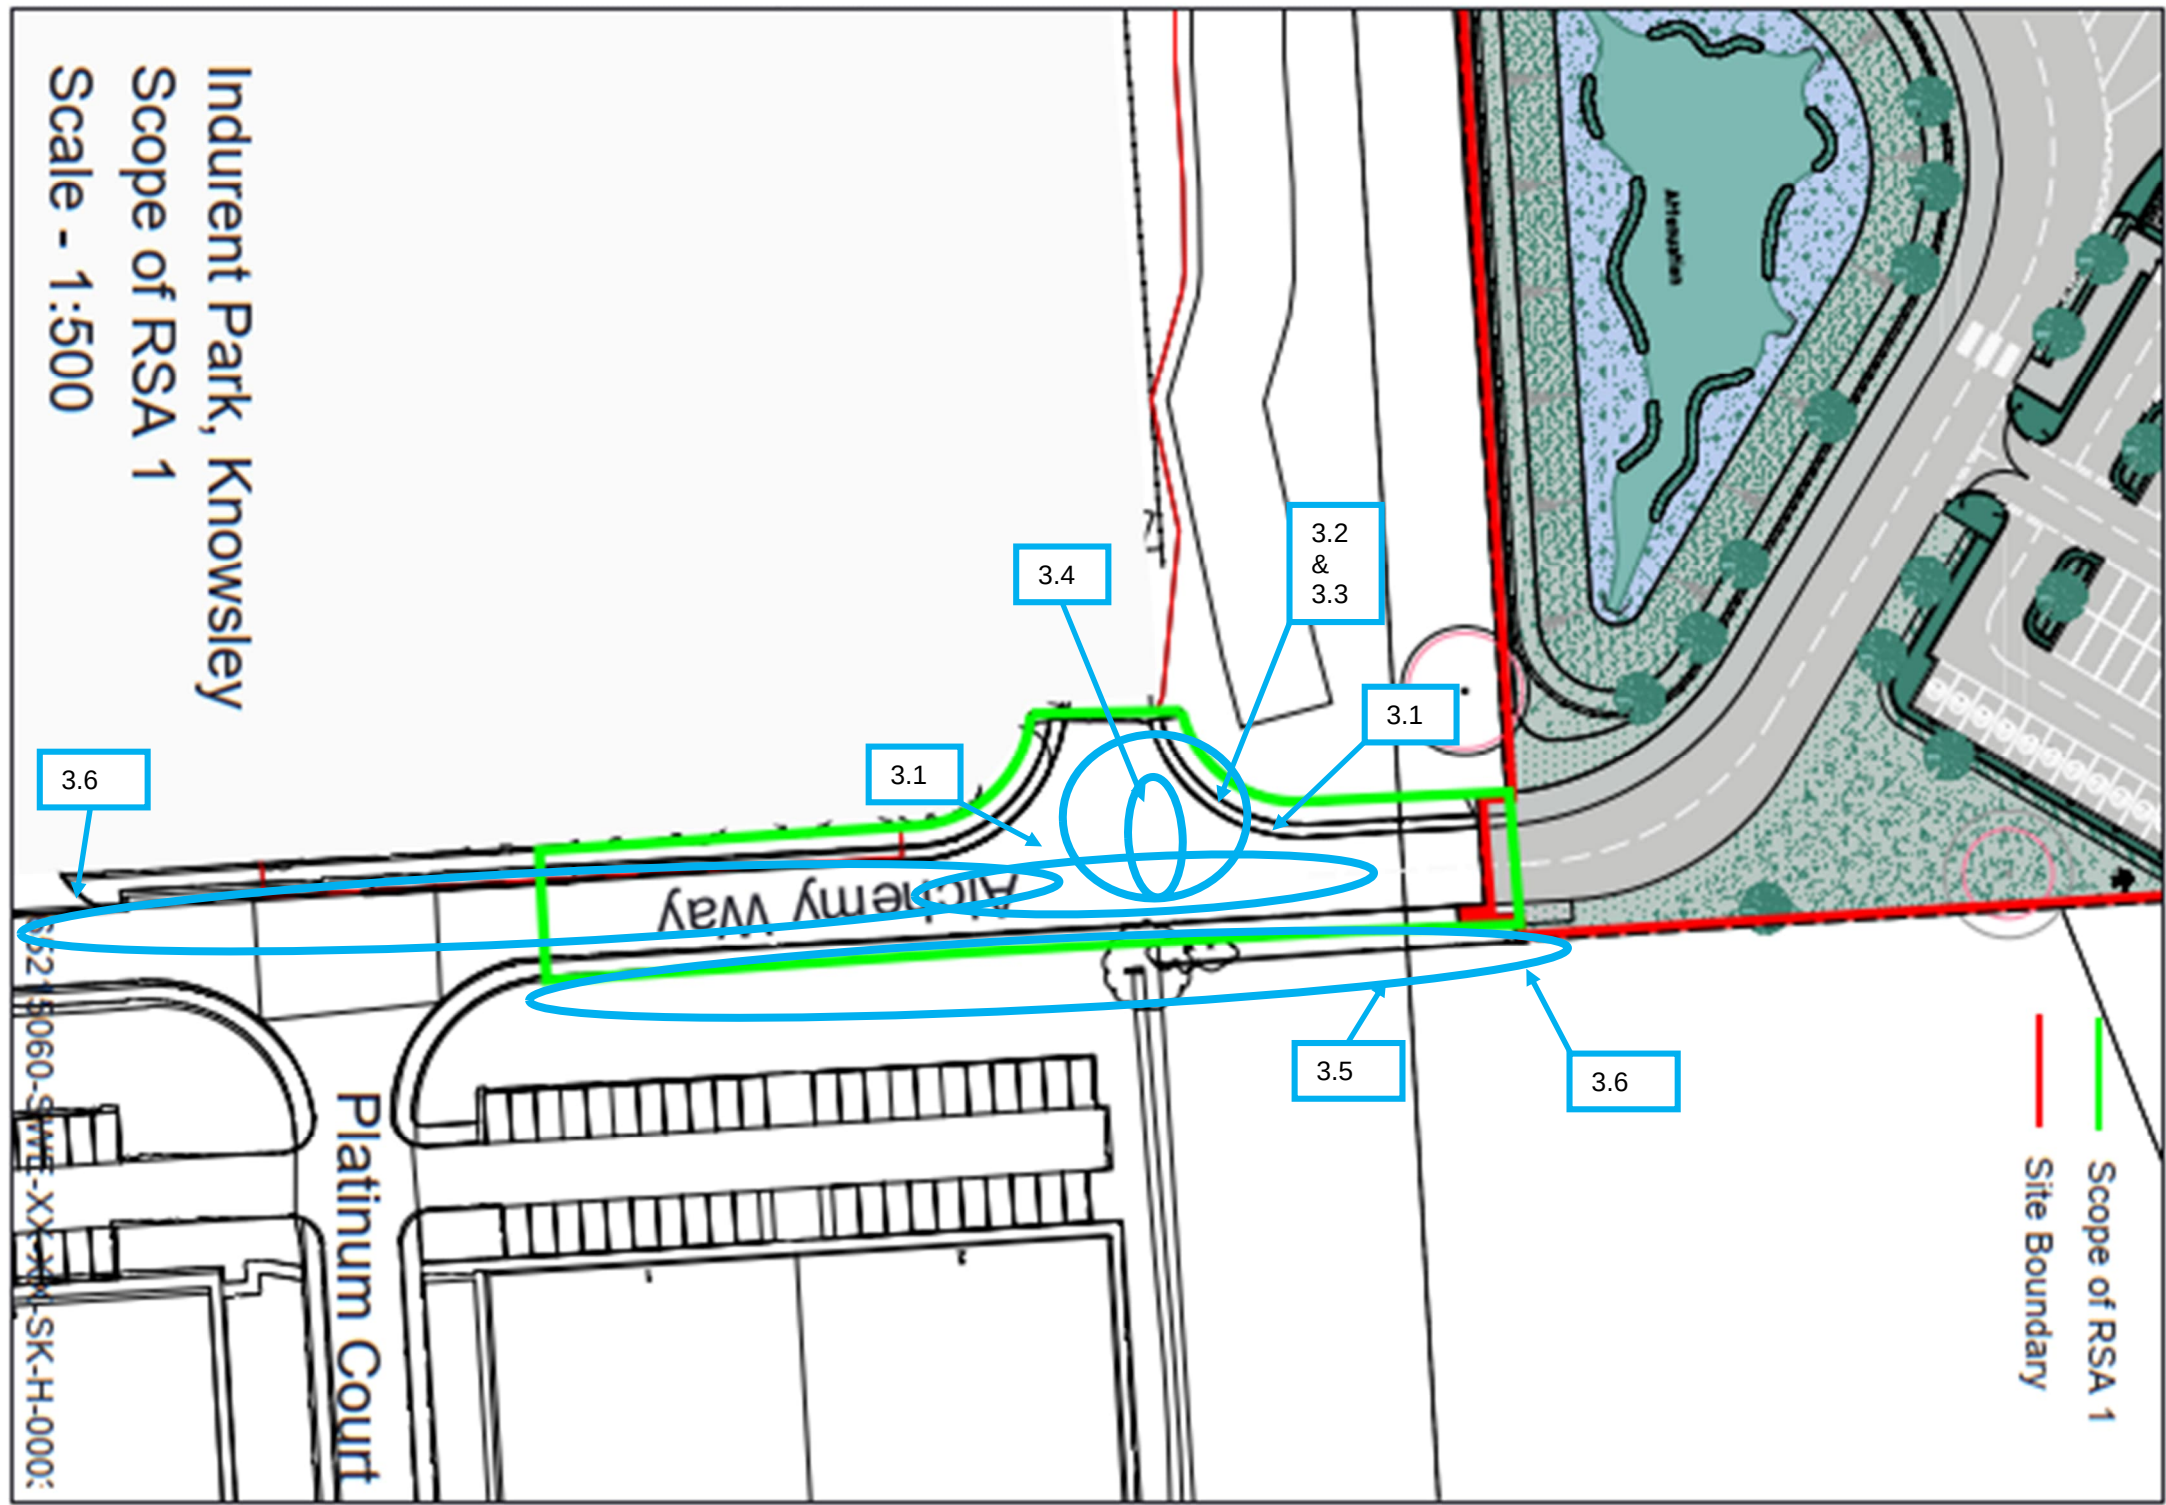
## Appendix B – Annotated scheme drawing

All comments and recommendations are referenced to the design drawings, and the locations have been indicated on the plan supplied with the Road Safety Audit Brief in Appendix B.
