## GAS MEMBRANE VALIDATION

| <b>Site Name:</b> Parcel C, Prescott | <b>Project Number:</b> 15-292 |
| Company: Miller Homes | Date: 19-05-2023 |

### Overview:

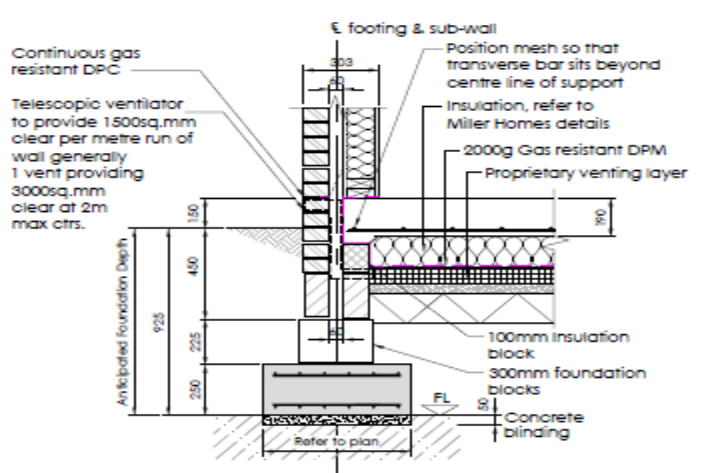
| <p><b>Overview:</b></p> <p>The membrane comprised a JUTA GP1 (Black) and visqueen membrane (Blue) resistant to radon, carbon dioxide and low levels of methane. E3P can confirm there were no holes or rips at the time of inspection. Upon being laid the membrane is to be covered with a Celotex (closed Cell) floor insulation material which is considered to provide a high degree of protection.</p> <p>Each unit has a service duct located to the front and outer edge of the property. E3P inspected each one and can confirm that the top-hats have been adequately sealed against the membrane.</p> <p>Based on the information provided within this report, the site inspections and validation checklists, E3P can confirm that <b>Plots 38-43</b> have been installed with gas protection measures in accordance with Characteristic Situation 2 to an acceptable level of workmanship.</p> | |
