**Appendix B**

### Photographic Record BH105 Trial Trench

### Photographic Record Cell One

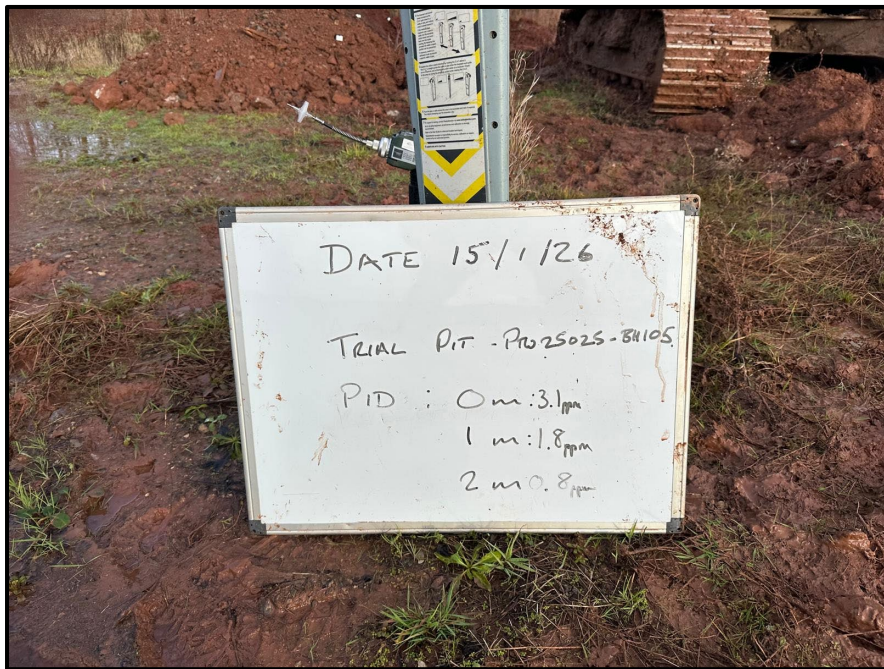
During the trial trenching a PID was used and the results were recorded on the site referencing board used for each trial pit. Also, prior to breaking ground a CAT scan was used to prevent encountering live services.

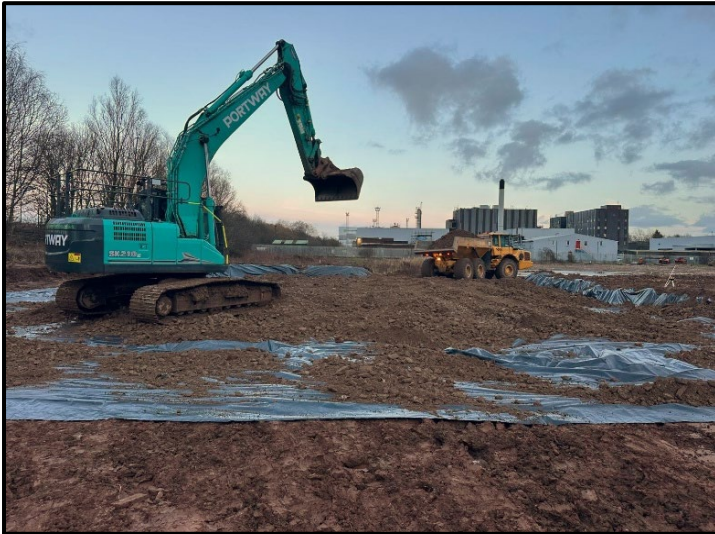
An area of the site that did not detect contamination was levelled and then a membrane was installed to prevent cross contamination. The membrane is held in place and protected with a layer of crushed material.

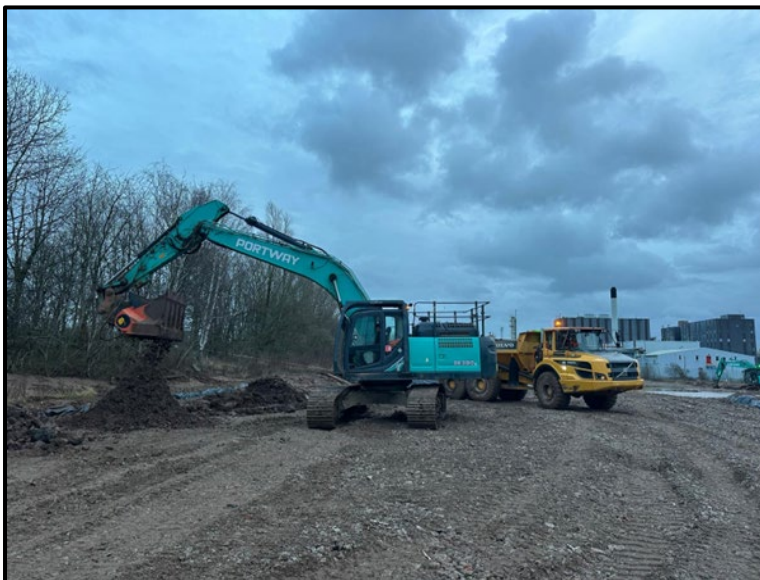
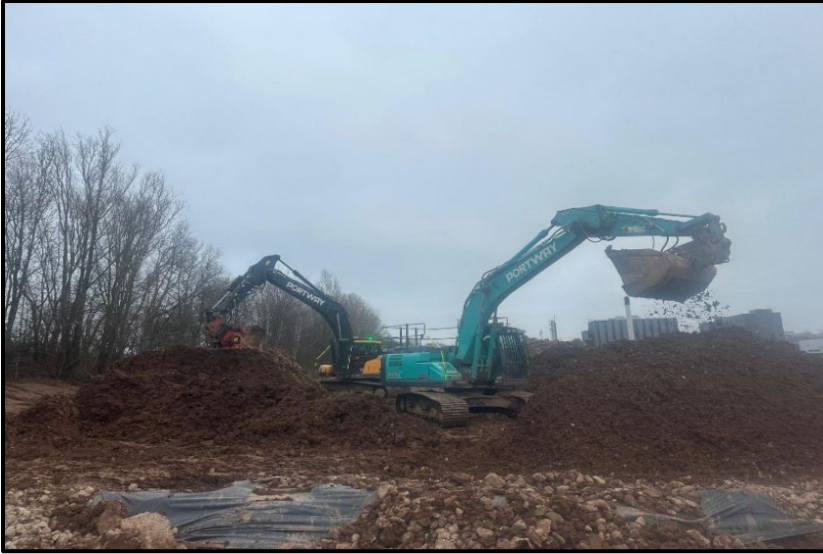
After setting up the treatment area impacted soils were transported on to treatment pad. Each cell excavated was placed to form a biopile to enable treatment and monitor testing for validation purposes.

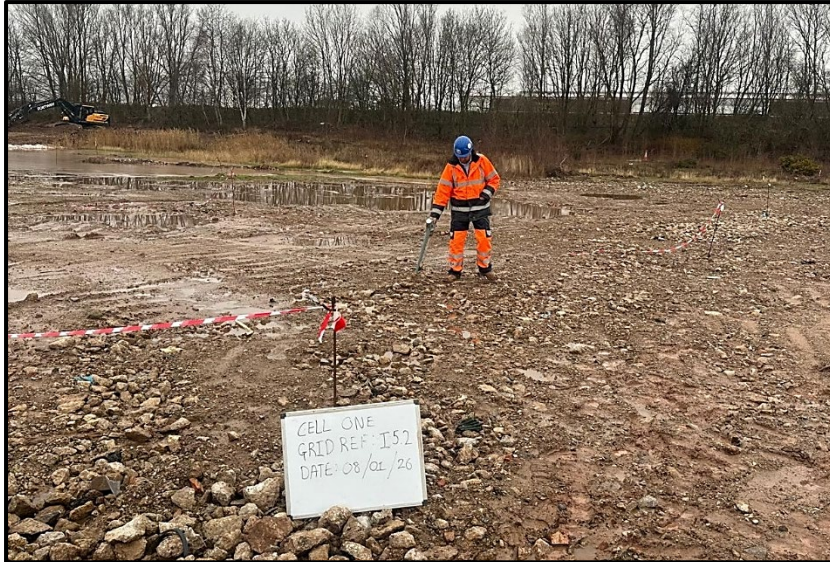
Prior to the commencement of excavating the ground, each area was subject to a CAT scan to check for underground services.

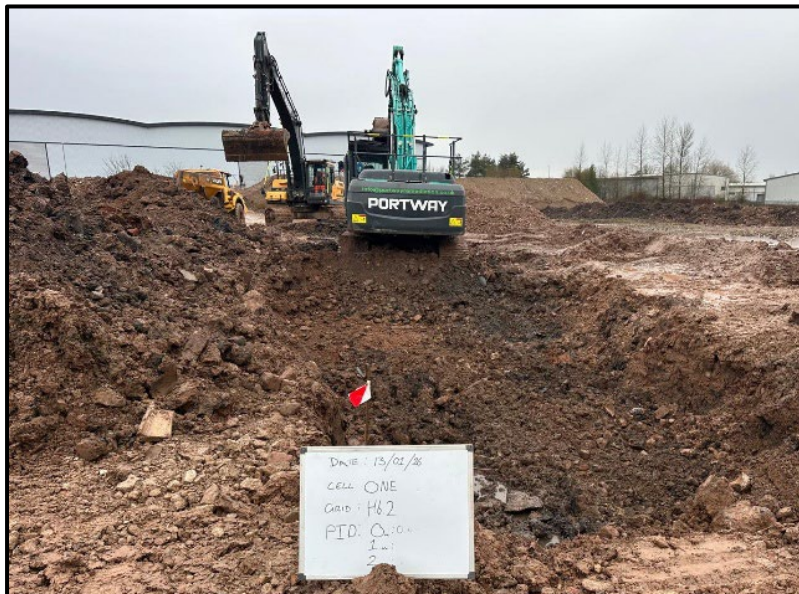
This image shows the start of the excavation process as the impacted material was carefully removed from each identified impacted grid square.

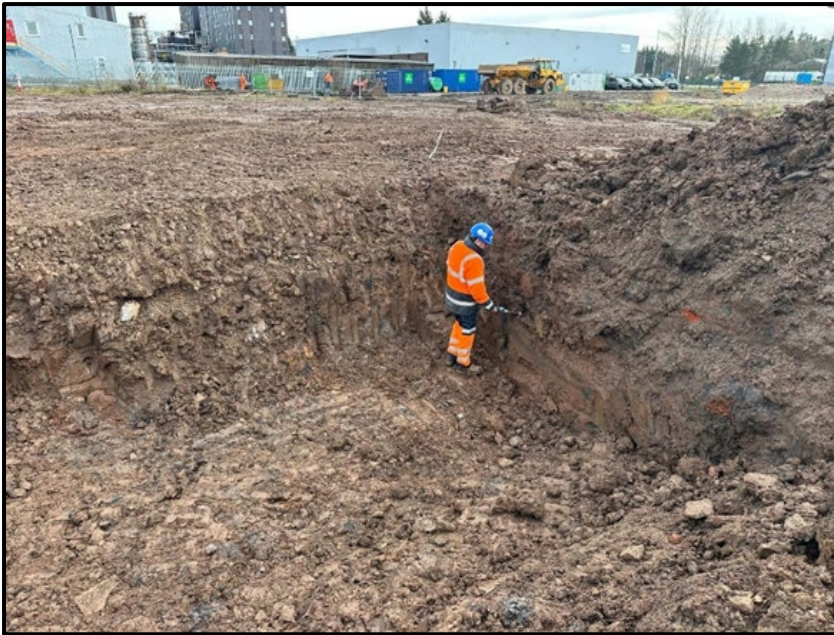
During the excavation process a PID meter was used to help in identifying the differing concentrations of contamination. This also assisted in tracking the suspected contaminated ground.

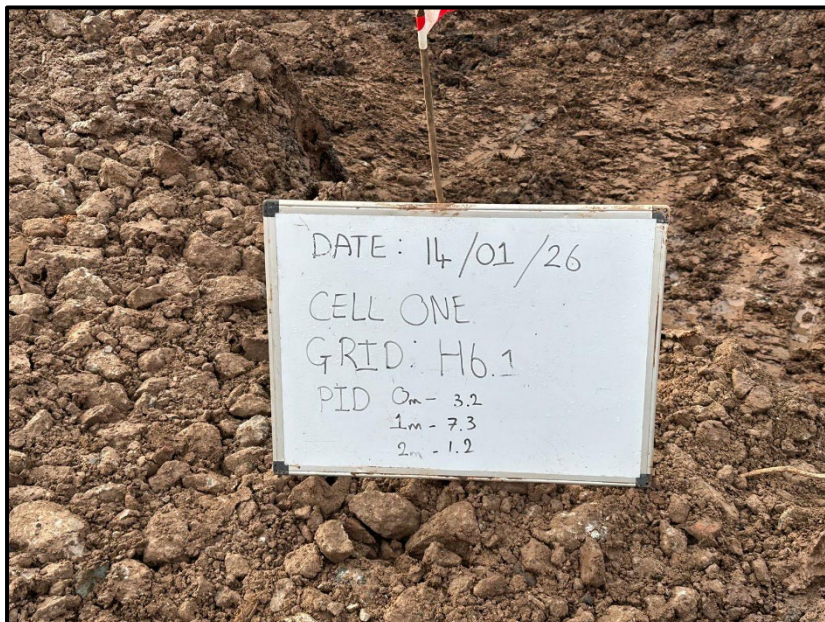
Each grid section within the cell was recorded on a white board denoting the PID readings and depth, while chasing the impacted ground during the excavation process.

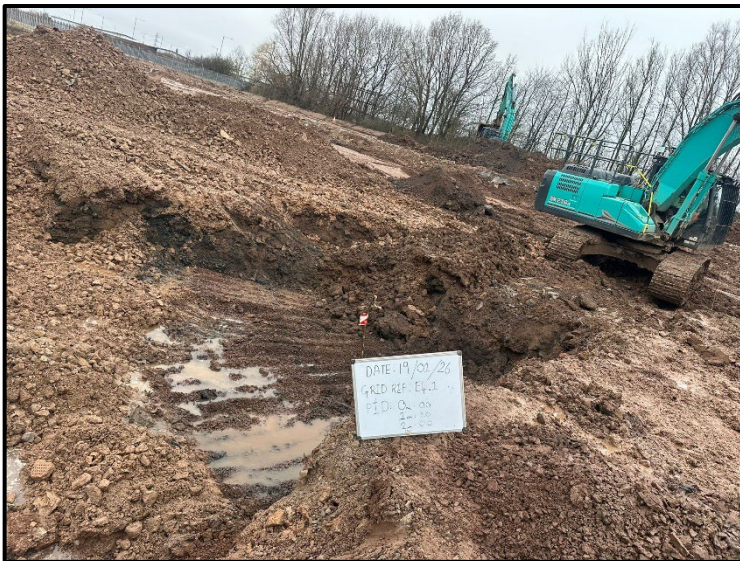
This image shows the excavation process as the area within cell two was reduced down recovering the impacted material.

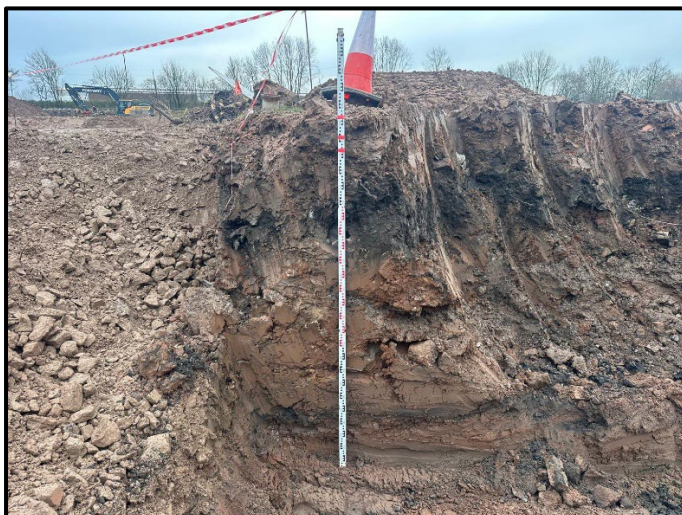
A measuring staff has been used to confirm the depth and contrast against the darker impacted ground and deeper clay strata.

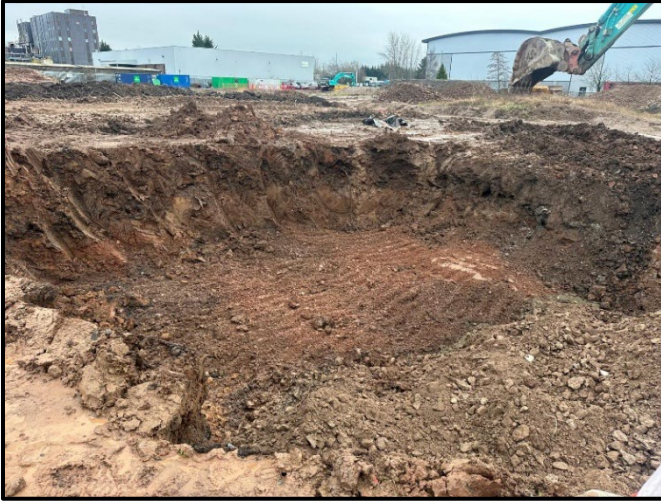
After collecting validation samples from the sidewalls and base of the excavation, the void was dished to make it safe.

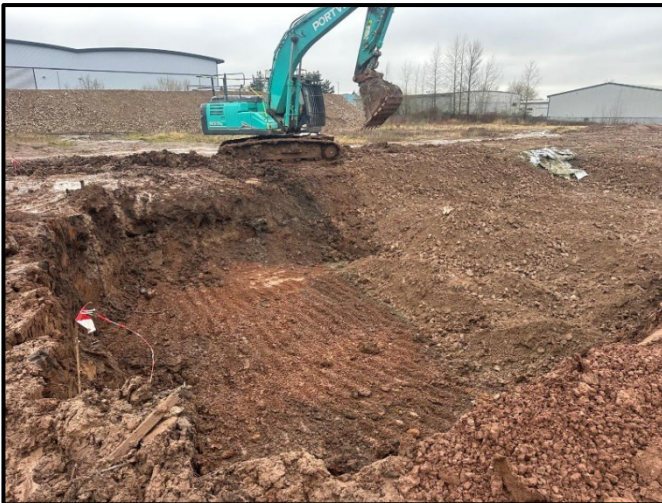
A limited amount of site available material was used to dish the void and lift the bottom of void above the groundwater table.

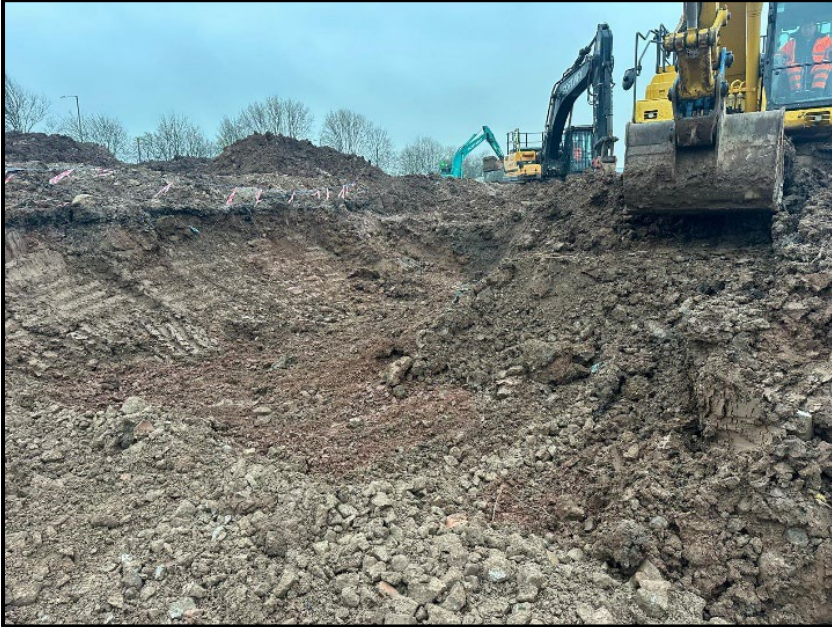
Material from cell three that was identified within the trial pit stage, prior to being removed and placed in the treatment zone.

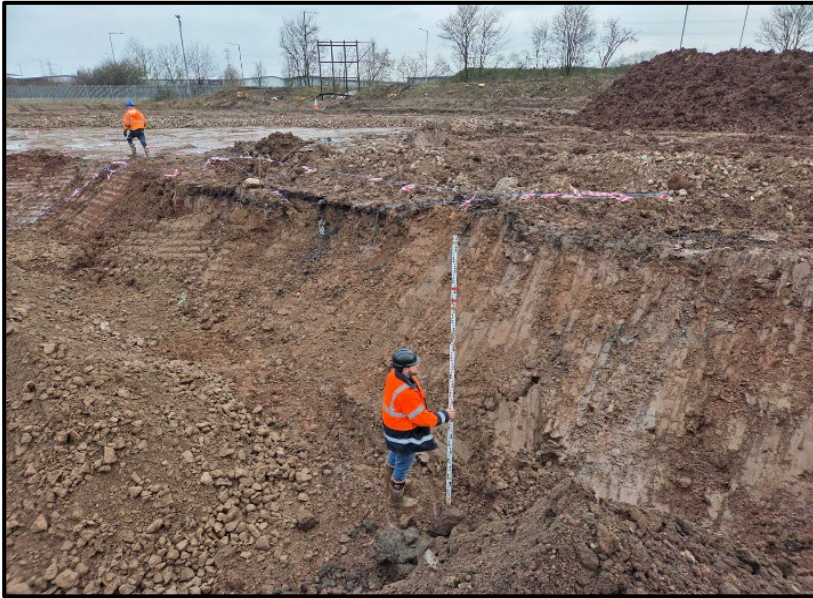
Image shows the depth of the excavation and partly graded sidewalls prior to validation samples being obtained.

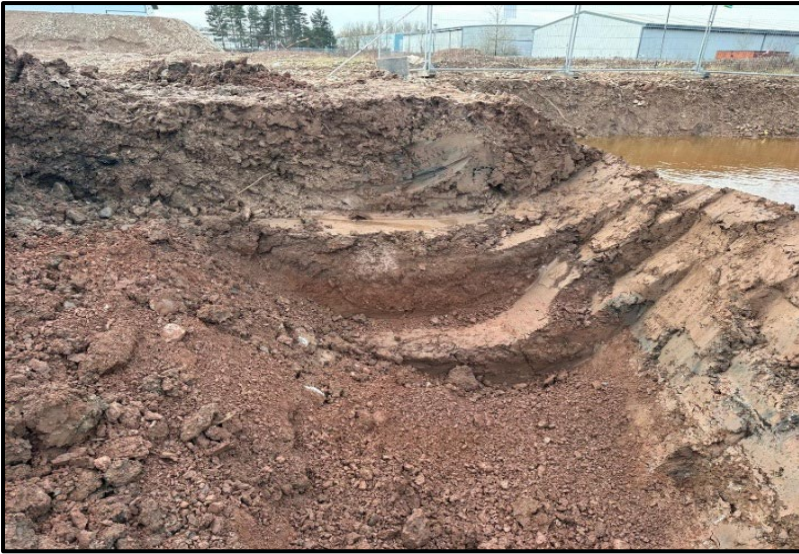
Further testing was carried out in the extension of cell three, with further testing for faces and bases completed.

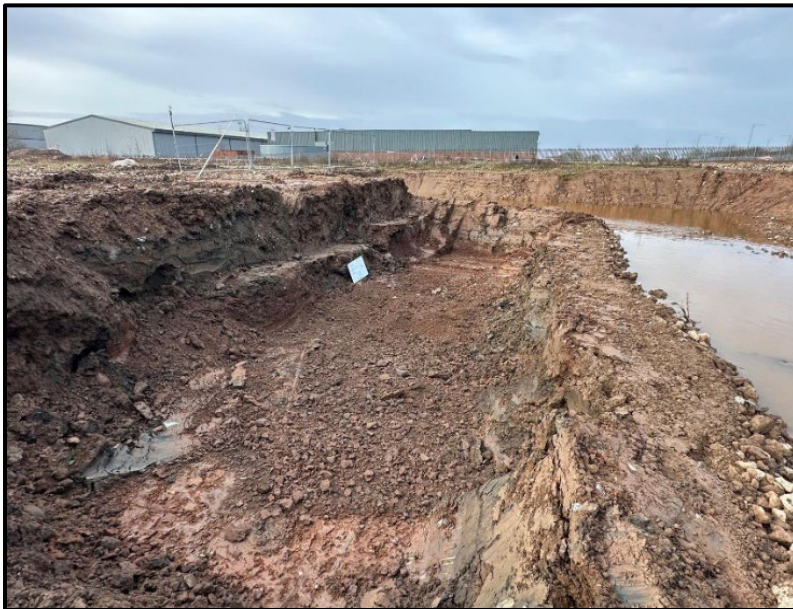
Finally the earth bund was removed after obtaining the validation results. The bund material was then placed into the treatment area.

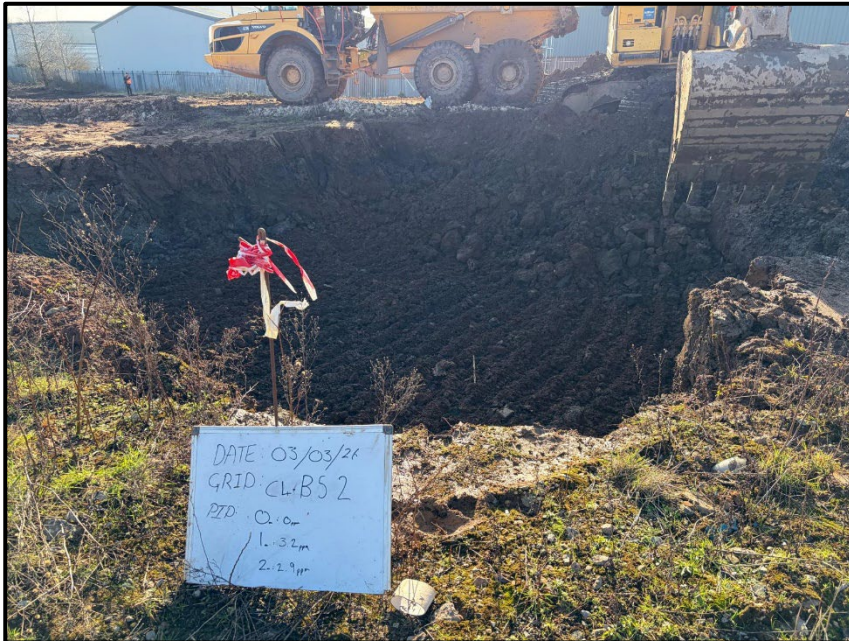
The first image is of the start of the excavation in cell 4, with on going PID monitoring to assist in finding the depth of the contamination.

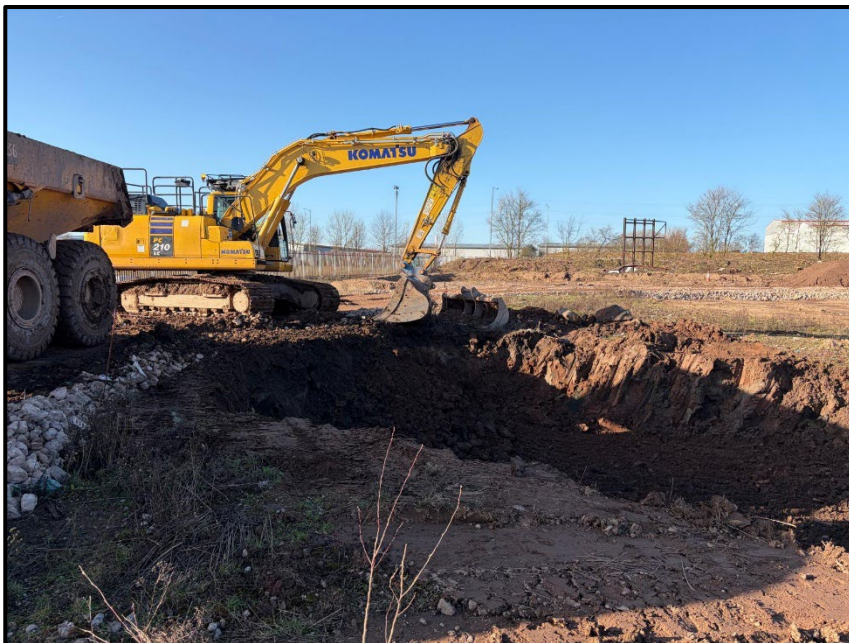
This is the same void in cell4 from a different angle.

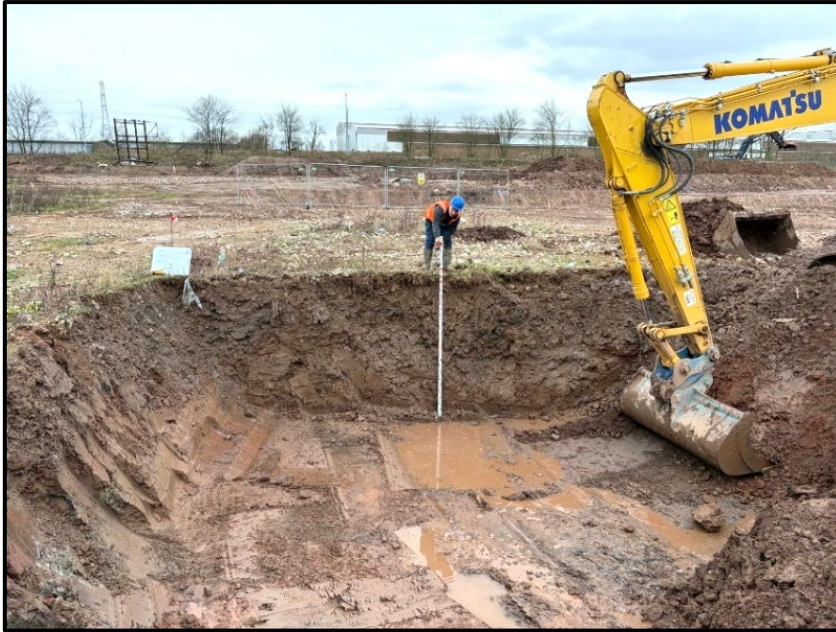
Cell four was excavated down to clean material as determined by the PID meter and visual factors. Chemical testing also verified the chemical makeup of the material to be below RTV's.

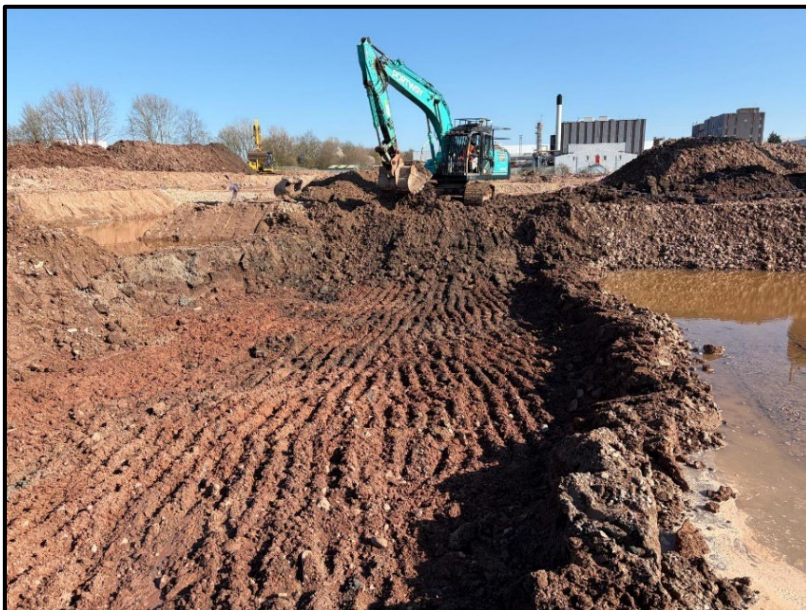
This image shows the control of water when extending cell four with the earth bund limiting the ingress of water as the recovery of impacted material is excavated for treatment. Validation samples were taken from the base and sidewalls. Finally the earth bund is removed to the treatment area and the water is released into the void

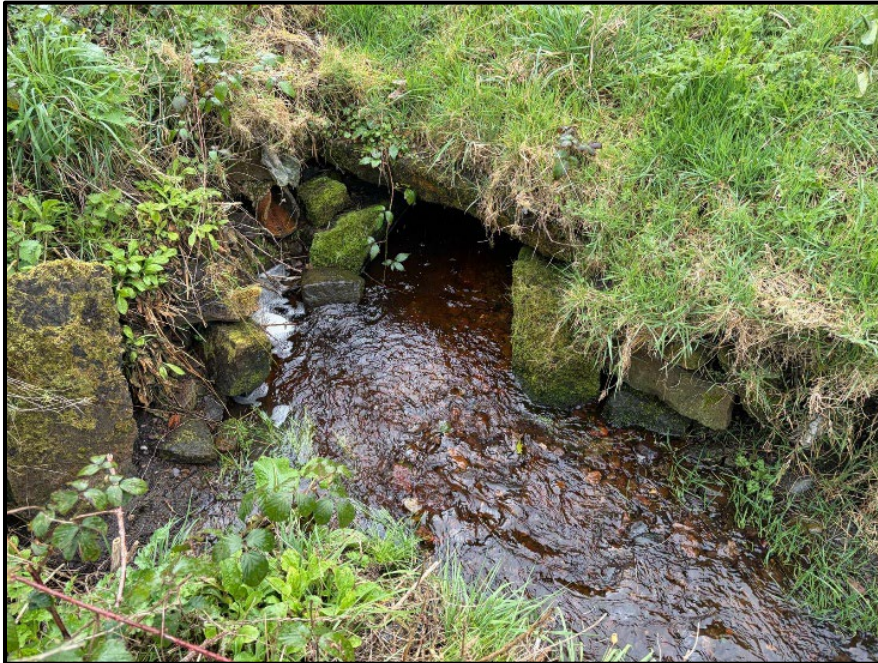
Portway tested Knowsley brook following the completion of the remediation process. To ensure that the watercourse was unaffected by works undertaken, samples were taken from the nearest open source for the brook, both up and down stream. This is the **up-stream** location.

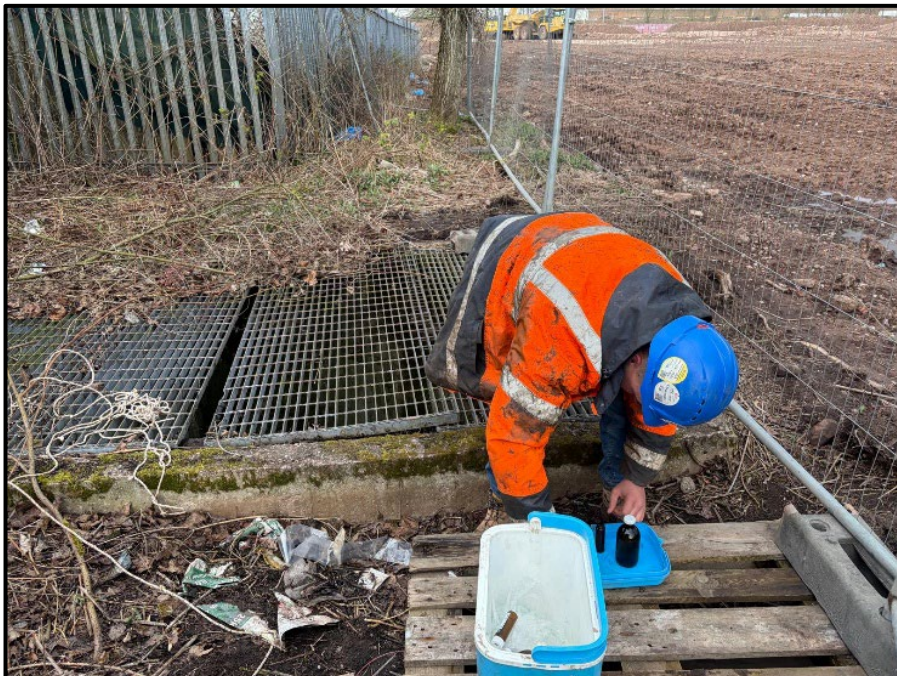
The **downstream** sample location was via the culvert, located on the south western side of the site and is that last location before the culvert exits off site. The test result mirrored the upstream result showing that the brook continues to be unaffected.

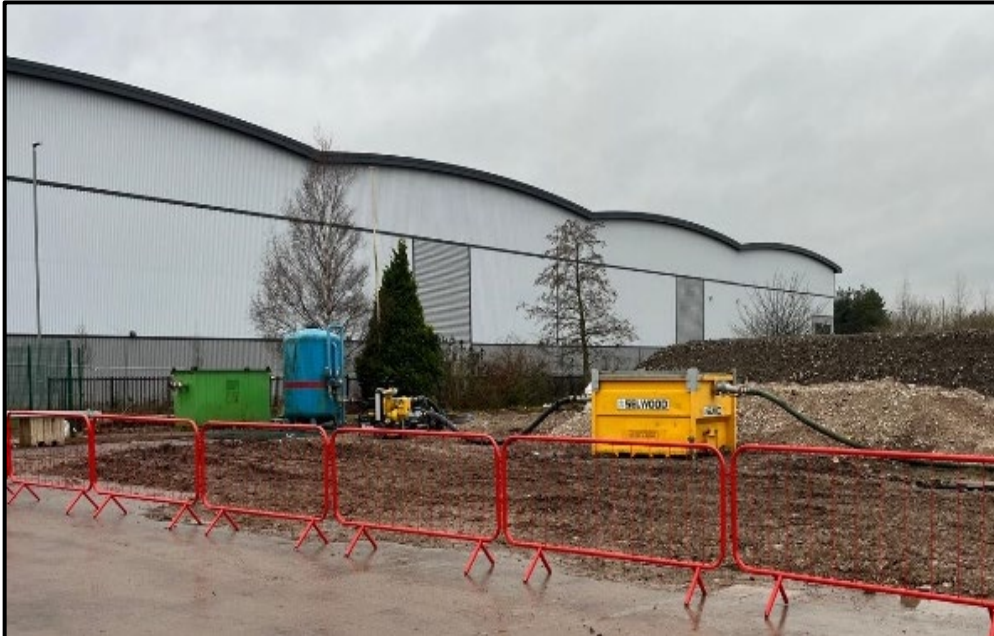
This shows the treatment system we used before the water was discharged under a permit to the foul sewage.

The system includes a silt buster to remove any suspended solids and a pressurised carbon filter to remove any free and dissolved phase before discharge.

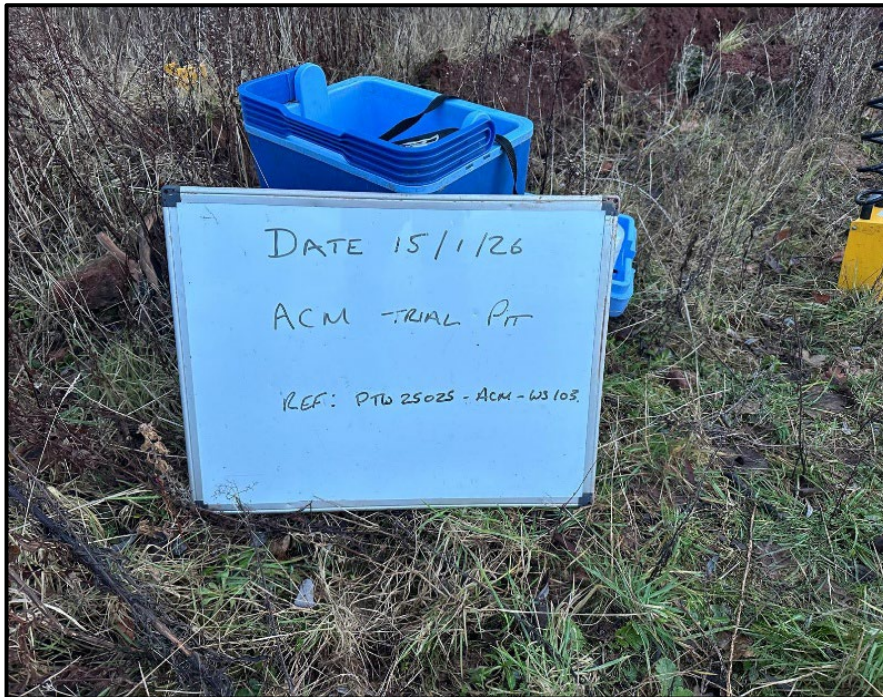
As a detection of asbestos had been noted within a previous site investigation report, further detailed analysis was undertaken on site. The yellow box on the righthand side of this image is part of the background air monitoring device for asbestos fibres.
