# Drainage Report

**Jubilee Park**  
**Jubilee Park, Dinas Lane**  
**Liverpool**  
**L36 2NW**

## 102678 Jubilee Park - CCTV Survey Report : 09/11/23

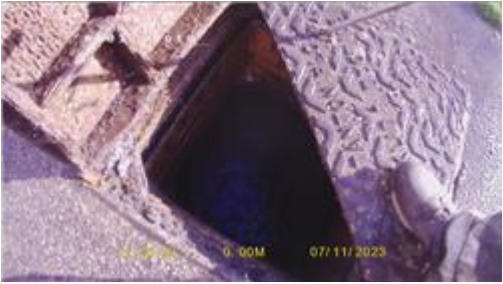
| Pos | Video Ref | Code | Cont. | Description | Image |
|---|---|---|---|---|---|
| 00.0m | 0:00:00 | MH | | Start node type, manhole, reference mh01 photo<br>mh01 photo | Image Provided - Ref: 0_0<br> |

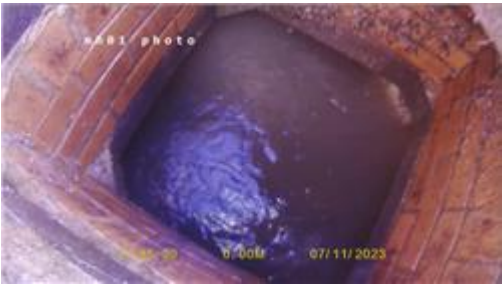
| Pos | Video Ref | Code | Cont. | Description | Image |
|---|---|---|---|---|---|
| 00.0m | | MHF | | Finish node type, manhole, reference mh01 photo<br>mh01 photo | Image Provided - Ref: 0_9999<br> |

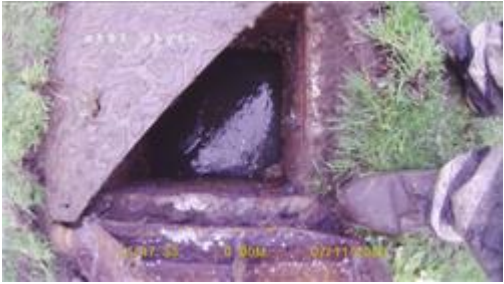
| Pos | Video Ref | Code | Cont. | Description | Image |
|---|---|---|---|---|---|
| 00.0m | 0:00:00 | MH | | Start node type, manhole, reference mh02 photo<br>mh02 photo | Image Provided - Ref: 1_0<br> |

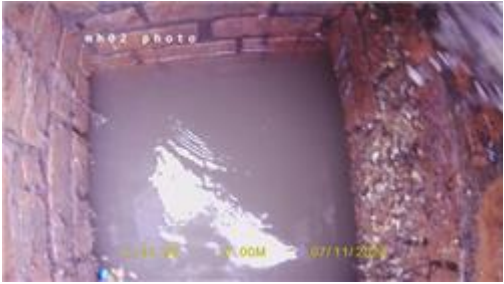
| Pos | Video Ref | Code | Cont. | Description | Image |
|---|---|---|---|---|---|
| 00.0m | | MHF | | Finish node type, manhole, reference mh02 photo<br>mh02 photo | Image Provided - Ref: 1_9999<br> |

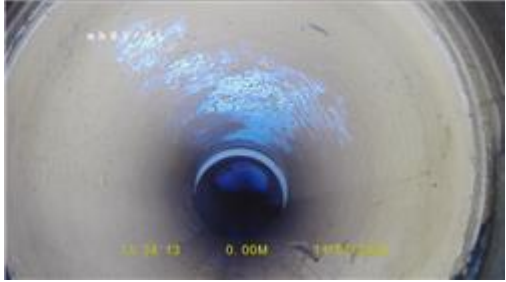
| Pos | Video Ref | Code | Cont. | Description | Image |
|---|---|---|---|---|---|
| 00.0m | 0:00:00 | MH | | Start node type, manhole, reference mh03 ds | Image Provided - Ref: 2_0<br> |

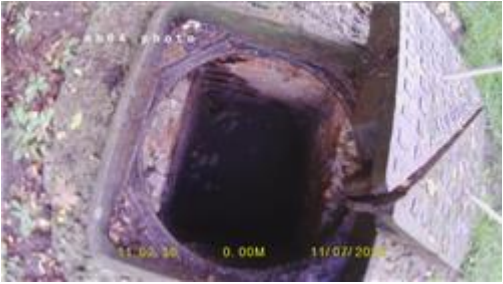
| Pos | Video Ref | Code | Cont. | Description | Image |
|---|---|---|---|---|---|
| 00.0m | 0:00:00 | MH | | Start node type, manhole, reference mh04 photo<br>mh04 photo | Image Provided - Ref: 3_0<br> |

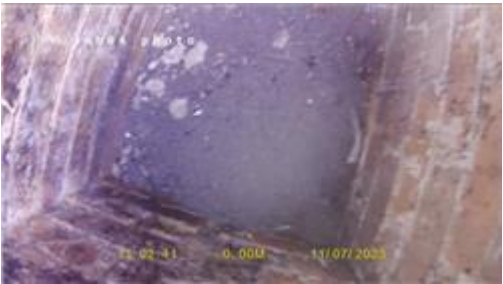
| Pos | Video Ref | Code | Cont. | Description | Image |
|---|---|---|---|---|---|
| 00.0m | | MHF | | Finish node type, manhole, reference mh04 photo<br>mh04 photo | Image Provided - Ref: 3_9999<br> |

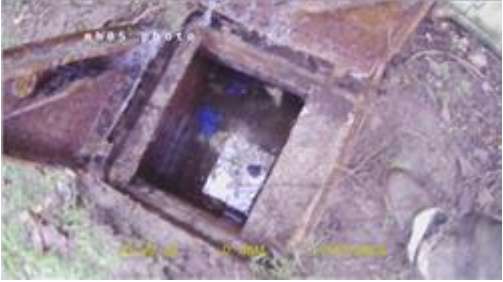
| Pos | Video Ref | Code | Cont. | Description | Image |
|---|---|---|---|---|---|
| 00.0m | 0:00:00 | MH | | Start node type, manhole, reference mh05 photo<br>mh05 photo | Image Provided - Ref: 4_0<br> |

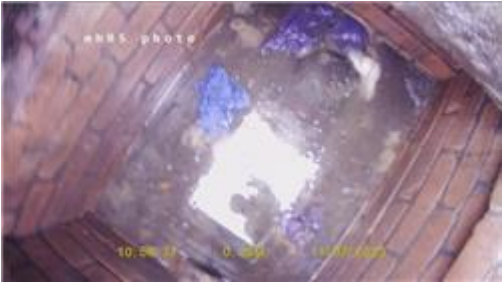
| Pos | Video Ref | Code | Cont. | Description | Image |
|---|---|---|---|---|---|
| 00.0m | | MHF | | Finish node type, manhole, reference mh05 photo<br>mh05 photo | Image Provided - Ref: 4_9999<br> |

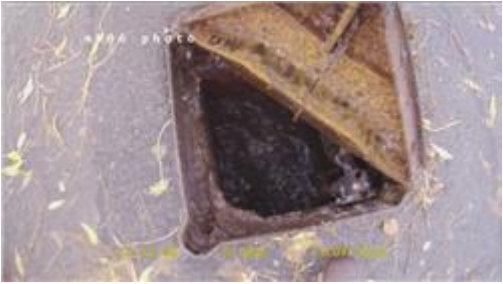
| Pos | Video Ref | Code | Cont. | Description | Image |
|---|---|---|---|---|---|
| 00.0m | 0:00:00 | MH | | Start node type, manhole,<br>reference mh06 photo<br>mh06 photo | Image Provided - Ref: 5_0<br> |

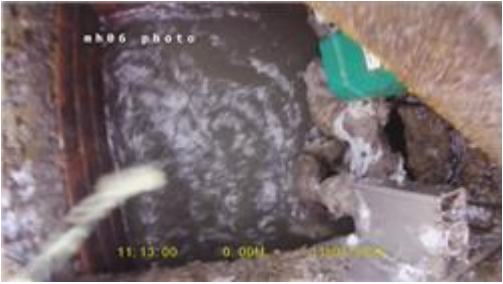
| Pos | Video Ref | Code | Cont. | Description | Image |
|---|---|---|---|---|---|
| 00.0m | | MHF | | Finish node type, manhole,<br>reference mh06 photo<br>mh06 photo | Image Provided - Ref: 5_9999<br> |

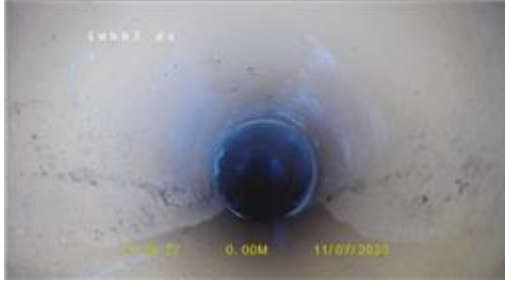
| Pos | Video Ref | Code | Cont. | Description | Image |
|---|---|---|---|---|---|
| 00.0m | 0:00:00 | MH | | Start node type, manhole, reference imh02 ds imh02 ds | Image Provided - Ref: 7_0<br> |

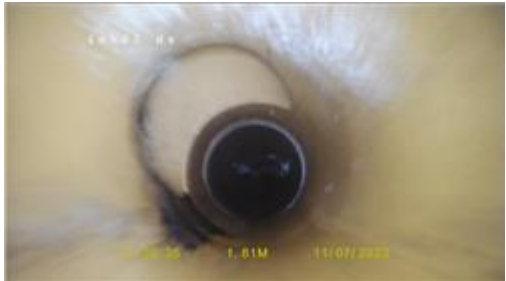
| Pos | Video Ref | Code | Cont. | Description | Image |
|---|---|---|---|---|---|
| 01.9m | 0:00:08 | JN | | Junction at 10 o'clock: 100mm Diameter | Image Provided - Ref: 7_3<br> |

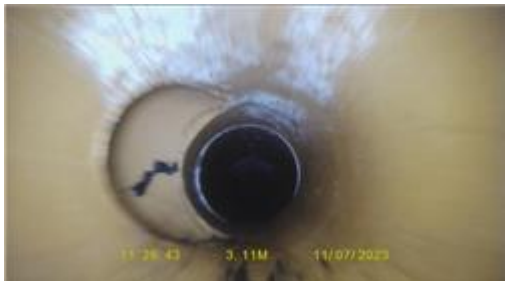
| Pos | Video Ref | Code | Cont. | Description | Image |
|---|---|---|---|---|---|
| 03.4m | 0:00:15 | JN | | Junction at 09 o'clock: 100mm Diameter | Image Provided - Ref: 7_4<br> |

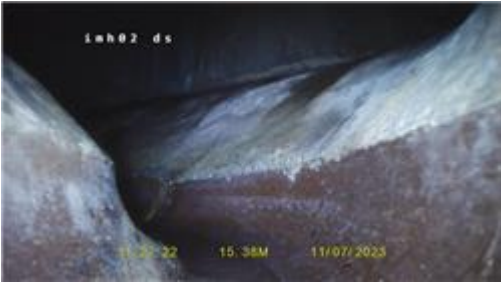
| Pos | Video Ref | Code | Cont. | Description | Image |
|---|---|---|---|---|---|
| 15.4m | | MHF | | Finish node type, manhole, reference mh03 | <div>Image Provided - Ref: 7_9999</div> |

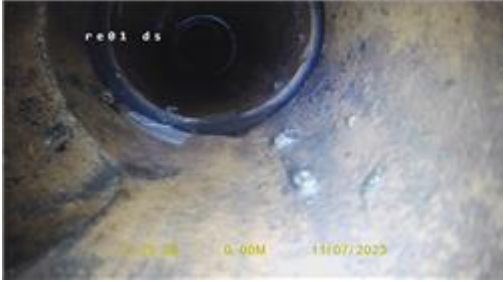
| Pos | Video Ref | Code | Cont. | Description | Image |
|---|---|---|---|---|---|
| 00.0m | 0:00:00 | RE | | Start node type, rodding eye, reference re01 ds | Image Provided - Ref: 8_0<br> |

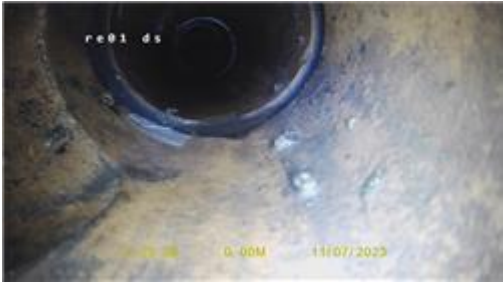
| Pos | Video Ref | Code | Cont. | Description | Image |
|---|---|---|---|---|---|
| 00.1m | 0:00:00 | JN | | Junction at 09 o'clock: 100mm Diameter | Image Provided - Ref: 8_1<br> |

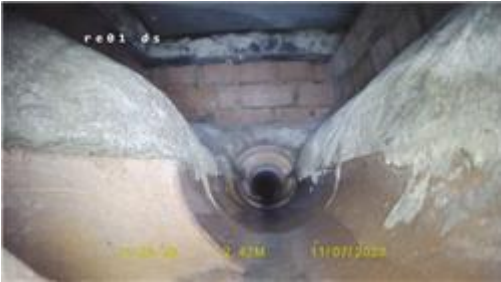
| Pos | Video Ref | Code | Cont. | Description | Image |
|---|---|---|---|---|---|
| 02.3m | | MHF | | Finish node type, manhole, reference imh01 imh01 | Image Provided - Ref: 8_9999<br> |

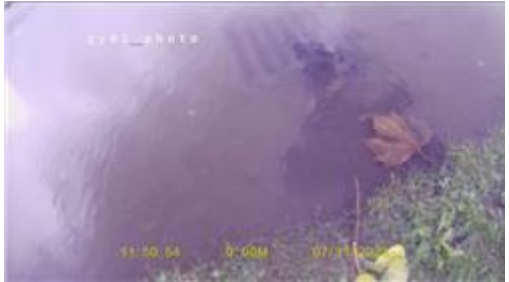
| Pos | Video Ref | Code | Cont. | Description | Image |
|---|---|---|---|---|---|
| 00.0m | 0:00:00 | GY | | Start node type Gully, reference gy01 photo<br>gy01 photo | Image Provided - Ref: 9_0<br> |

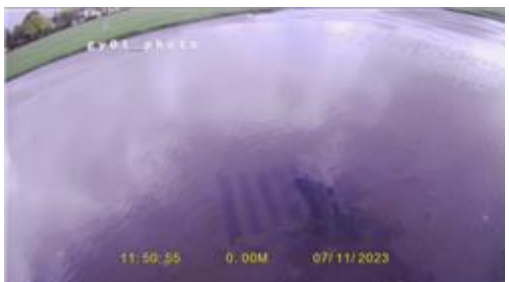
| Pos | Video Ref | Code | Cont. | Description | Image |
|---|---|---|---|---|---|
| 00.0m | | GYF | | Finish node type Gully, reference gy01 photo<br>gy01 photo | Image Provided - Ref: 9_9999<br> |
