# ARBORICULTURAL IMPACT ASSESSMENT (AIA)

**PROPOSED DEVELOPMENT AT**

**LYNEHAM,**

**PLA/0422/L35**

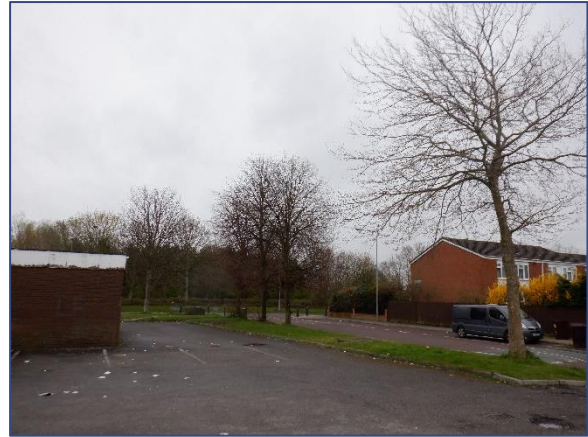
Cherries (T1 – T5) and Sycamore (T19)

| Ref | Species | Height<br>(m) | Stem<br>Diam<br>(mm) | Radial<br>Crown<br>Spread<br>(m) | | Crown<br>Height<br>(m) | Age | Comments | Recommendations | ERC | Cat | RPA<br>Radius<br>(m) | RPA<br>Area<br>(m <sup>2</sup> ) |
|---|---|---|---|---|---|---|---|---|---|---|---|---|---|
| T1 | Cherry<br>( <i>Prunus spp.</i> ) | 13.8 | 335 | N | 3.4 | 2.0 | EM | High pruned (alongside road and pavement). Multiple pruning wound encircling the stem at approximately 2m. Pruning wounds partially occluded although there is some evidence of stem swelling (thickening) in the area probably caused by the deposition of wound wood surrounding the coalescing decay pockets caused by the multiple pruning wounds. | Remove to facilitate development | 20-40 | B2 | 4.0 | 51 |
| T2 | Cherry<br>( <i>Prunus spp.</i> ) | 12.5 | 335 | N | 3.2 | 4.0 | EM | High pruned (alongside road and pavement). Multiple pruning wound encircling the stem at approximately 2m. Pruning wounds partially occluded although there is some evidence of stem swelling (thickening) in the area probably caused by the deposition of wound wood surrounding the coalescing decay pockets caused by the multiple pruning wounds. | Remove to facilitate development | 20-40 | B2 | 4.0 | 51 |
| T3 | Cherry<br>( <i>Prunus spp.</i> ) | 12.0 | 345 | N | 3.0 | 2.0 | EM | High pruned (alongside road and pavement). Multiple pruning wound encircling the stem at approximately 2m. Some epicormic growth surrounding the pruning points which creates a lower crown clearance. Pruning wounds partially occluded although there is some evidence of stem swelling (thickening) in the area probably caused by the deposition of wound wood surrounding the coalescing decay pockets caused by the multiple pruning wounds. | Remove to facilitate development | 20-40 | B2 | 4.1 | 54 |
| T4 | Cherry<br>( <i>Prunus spp.</i> ) | 13.4 | 330 | N | 2.45 | 3.5 | EM | High pruned (alongside road and pavement). Multiple pruning wound encircling the stem at approximately 2m. Pruning wounds partially occluded although there is some evidence of stem swelling (thickening) in the area probably caused by the deposition of wound wood surrounding the coalescing decay pockets caused by the multiple pruning wounds. | Remove to facilitate development | 20-40 | B2 | 4.0 | 49 |

| Ref | Species | Height<br>(m) | Stem<br>Diam<br>(mm) | Radial<br>Crown<br>Spread<br>(m) | | Crown<br>Height<br>(m) | Age | Comments | Recommendations | ERC | Cat | RPA<br>Radius<br>(m) | RPA<br>Area<br>(m <sup>2</sup> ) |
|---|---|---|---|---|---|---|---|---|---|---|---|---|---|
| T5 | Cherry<br>( <i>Prunus spp.</i> ) | 12.7 | 400 | N | 2.7 | 2.5 | EM | High pruned (alongside road and pavement). Multiple pruning wound encircling the stem at approximately 2m. Some epicormic growth surrounding the pruning points which creates a lower crown clearance. Pruning wounds partially occluded although there is some evidence of stem swelling (thickening) in the area probably caused by the deposition of wound wood surrounding the coalescing decay pockets caused by the multiple pruning wounds. | Remove to facilitate development | 20-40 | B2 | 4.8 | 72 |
