**WJ SHIRLEY**

Mon 25th, Tues  
26th & Wed 27th  
February  
2019

# DRAINAGE REPORT

**UNIT 6, WILSON ROAD  
HUYTON BUSINESS PARK  
LIVERPOOL  
L36 6JF**

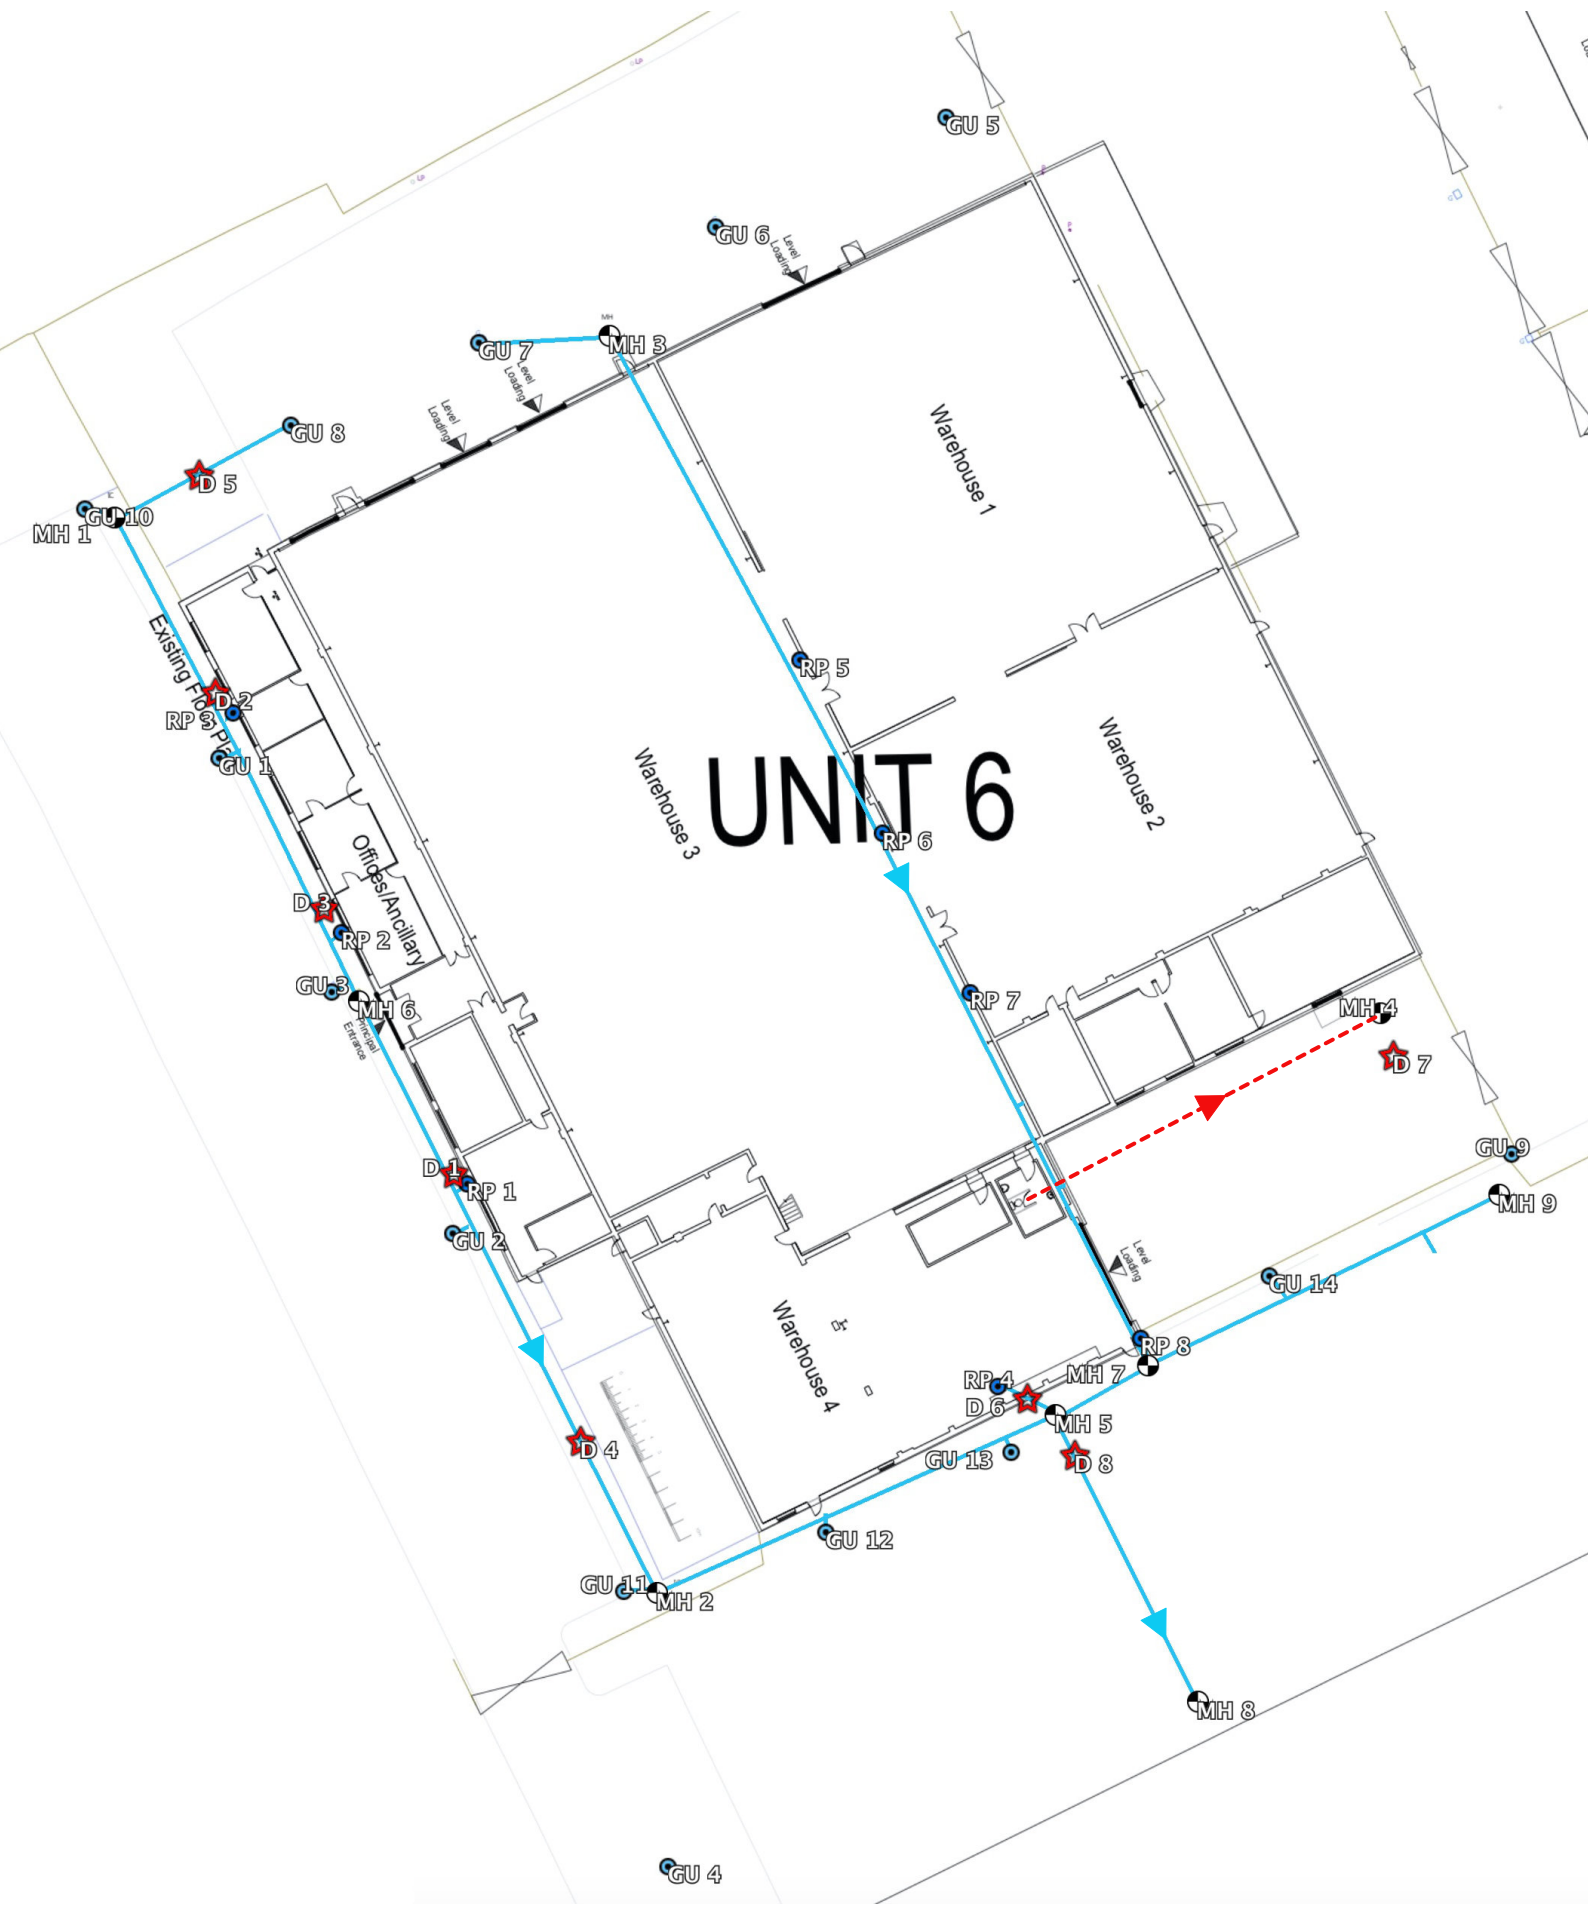
Surface-water drain

We noted a crack in a section of below-ground surface-water drain at MH2. We recommend this is repaired to prevent further deterioration and possible collapse. This can currently be repaired in-situ by patch lining.
