Mon 25th, Tues  
26th & Wed 27th  
February  
2019

# DRAINAGE REPORT

**UNIT 1, WILSON ROAD  
HUYTON BUSINESS PARK  
LIVERPOOL**

**L36 6JF**

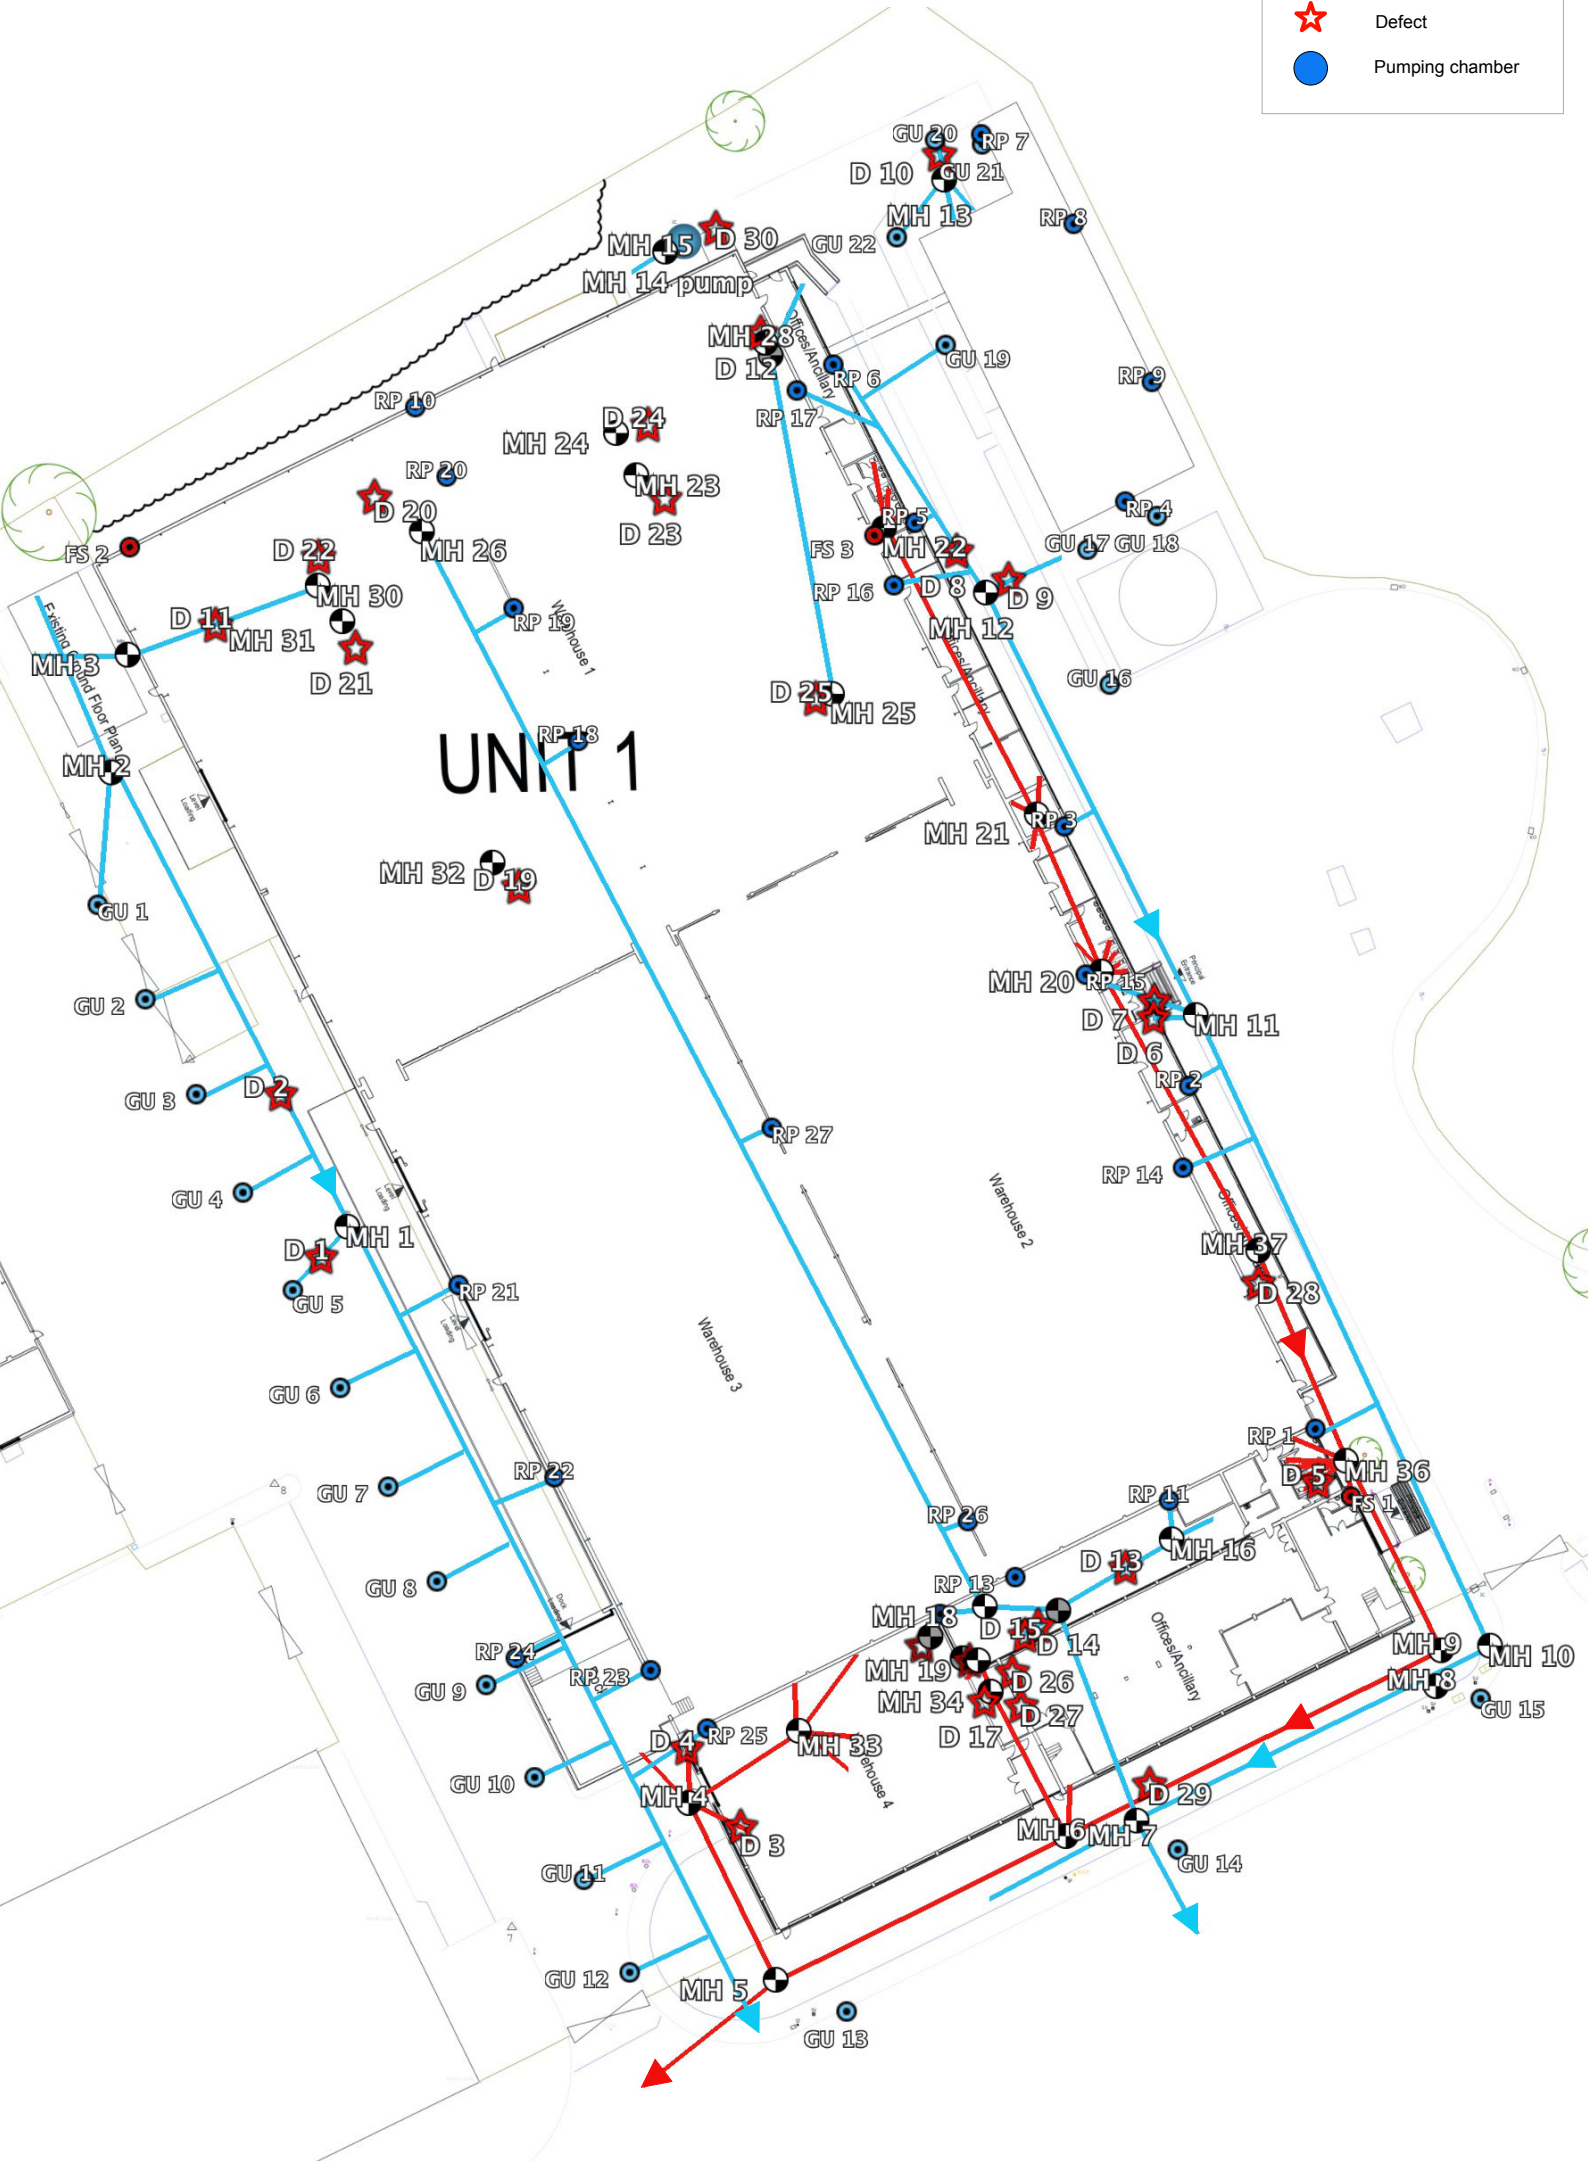
Pumping chamber

There is a surface-water pumping chamber at the north end of the site (MH14). If there is no evidence of regular maintenance we recommend a service/ overhaul is carried out by a specialist drainage pump engineer. We have allowed a provisional sum for this in the budget costs.

Defect
