# CCTV Drainage Inspection Report.

Produced on behalf of - McCarthy and Stone

Site location - Huyton Liverpool

Survey reference – **108648**

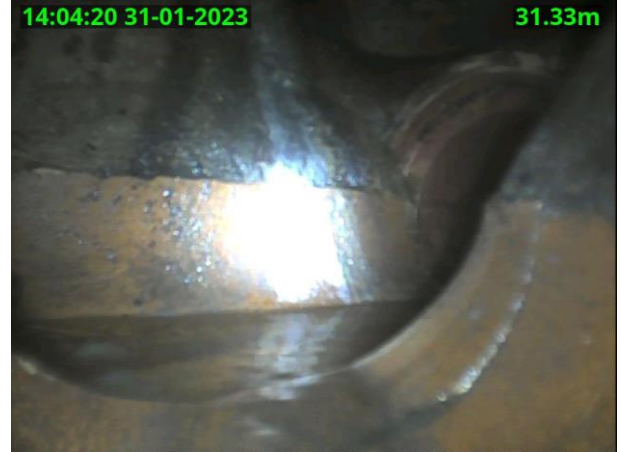
(ELJ) Encrustation light from ... to ... o'clock at /MH00001-Pipe-X/MH00001-Pipe- (MH) Manhole/node /MH00001-Pipe-X/MH00001-Pipe-X\_2023\_01\_31-

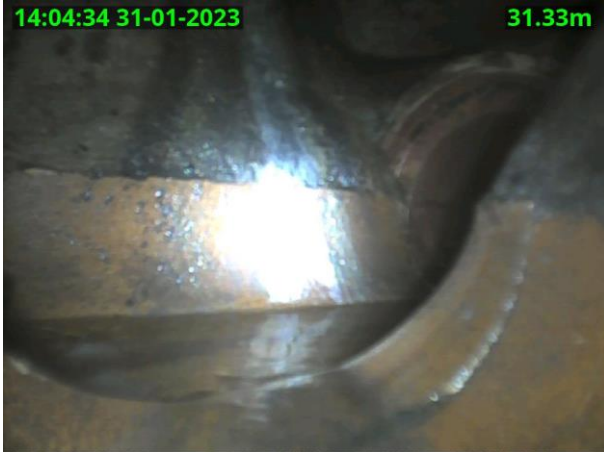
./MH00001-Pipe-X/MH00001-Pipe-

(FH) Finish survey
