# Urban Regen

## Asbestos Solutions

### PLAN OF WORKS NON-NOTIFIABLE RISK ASSESSMENT & METHOD STATEMENT

| <b>Site Address:</b> | Glen Dimplex Stoney Lane Prescott<br>Merseyside Liverpool L35 2XW |

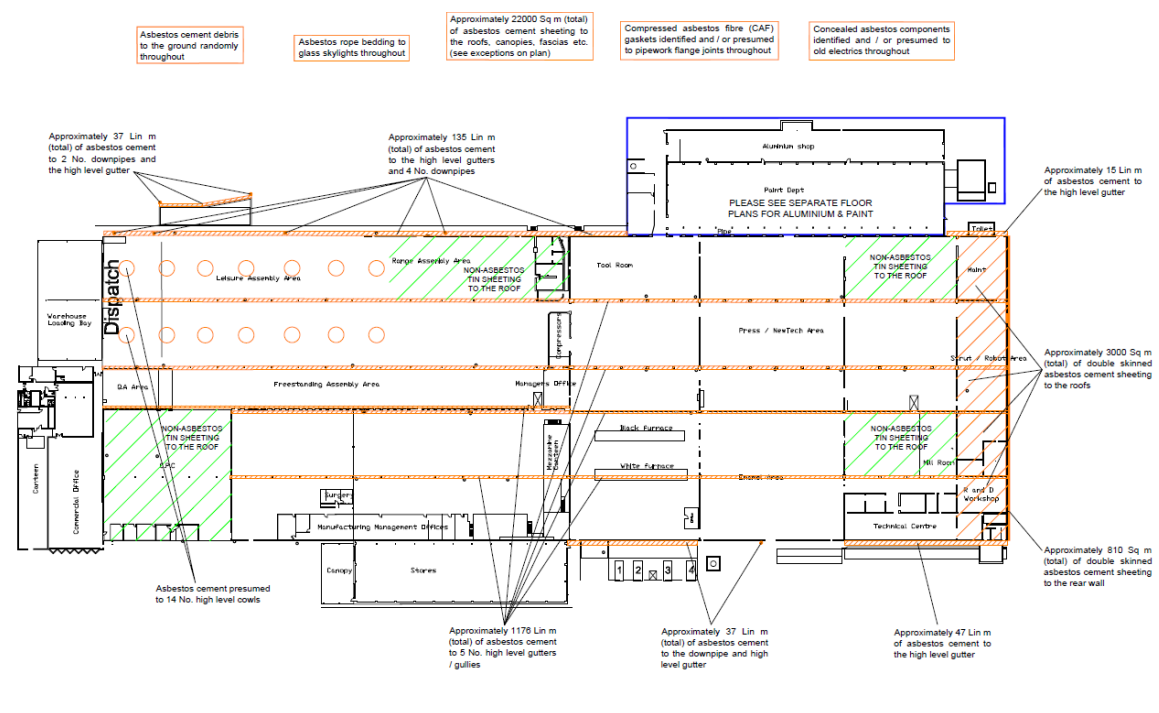
## Main Building

### Removal of approx 7,346,491 m2 asbestos cement sheets

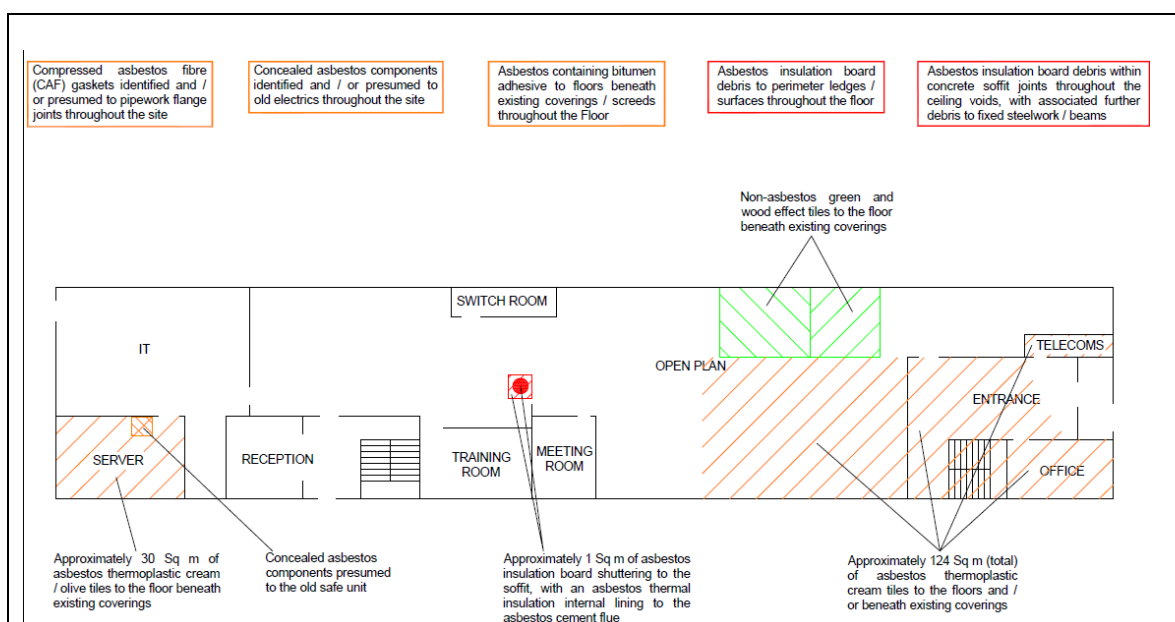
### Office Block – Ground

- Approximately 154 Sq m (total) of asbestos thermoplastic cream and beige tiles were identified to the floors and / or beneath existing floor coverings within the Entrance / Staircase Lobby, Office, Telecoms, part of the Open Plan Office and to the Server Room.
- A small section of asbestos cement flue, with an internal asbestos thermal insulation lining, was identified protruding through the above mentioned asbestos insulation board shuttering.
- Concealed asbestos components were presumed to the old safe unit within the Server Room. The safe unit should be removed and disposed of as asbestos waste prior to the demolition works commencing.

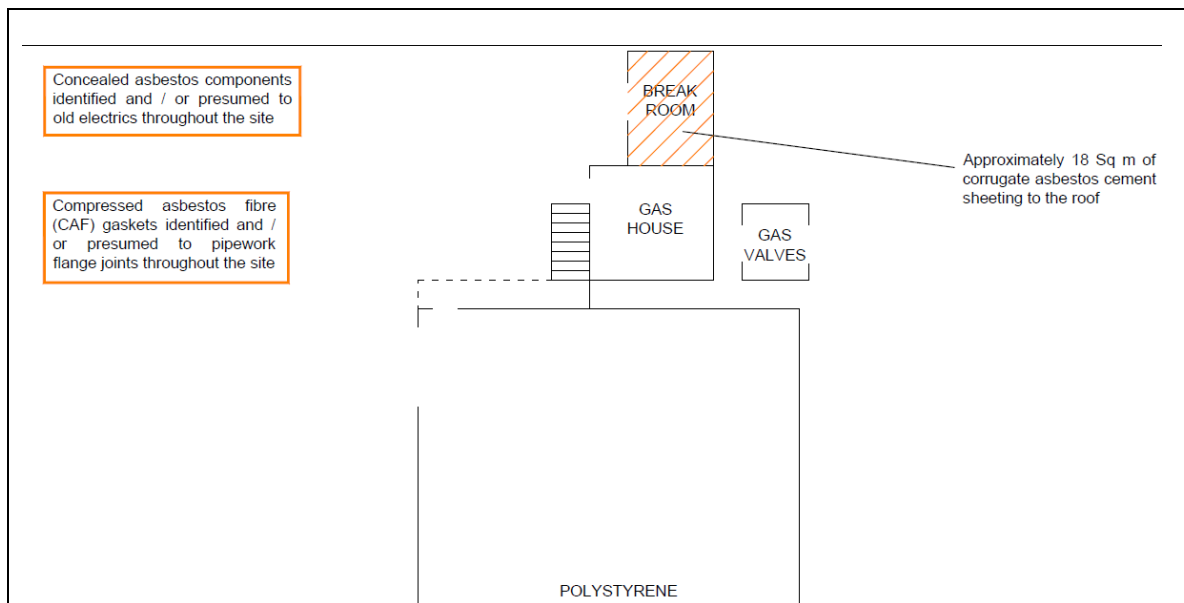
### Polystyrene & Gas House

- Approximately 18 Lin m of corrugate asbestos cement sheeting was identified to the Break Room roof.
- Old electrics throughout the site, including stored / redundant items, were seen and / or presumed to contain asbestos components such as flash pads, cement separators etc.
- Compressed asbestos fibre (CAF) gaskets were identified to pipework flange joints within the Gas House.

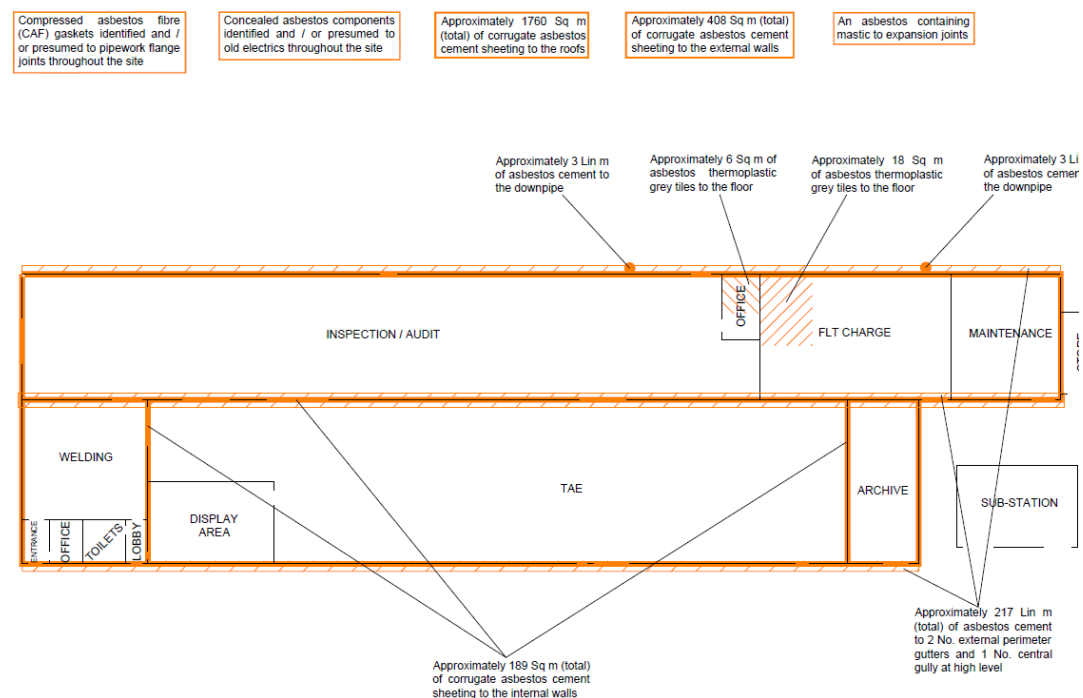
### Welding Building

- Approximately 6 Sq m of asbestos thermoplastic grey tiles were identified to the Inspection / Audit Office floor. The material was sampled and found to contain asbestos.

- Approximately 18 Sq m of asbestos thermoplastic grey tiles were identified to part of the FLT Charge floor.

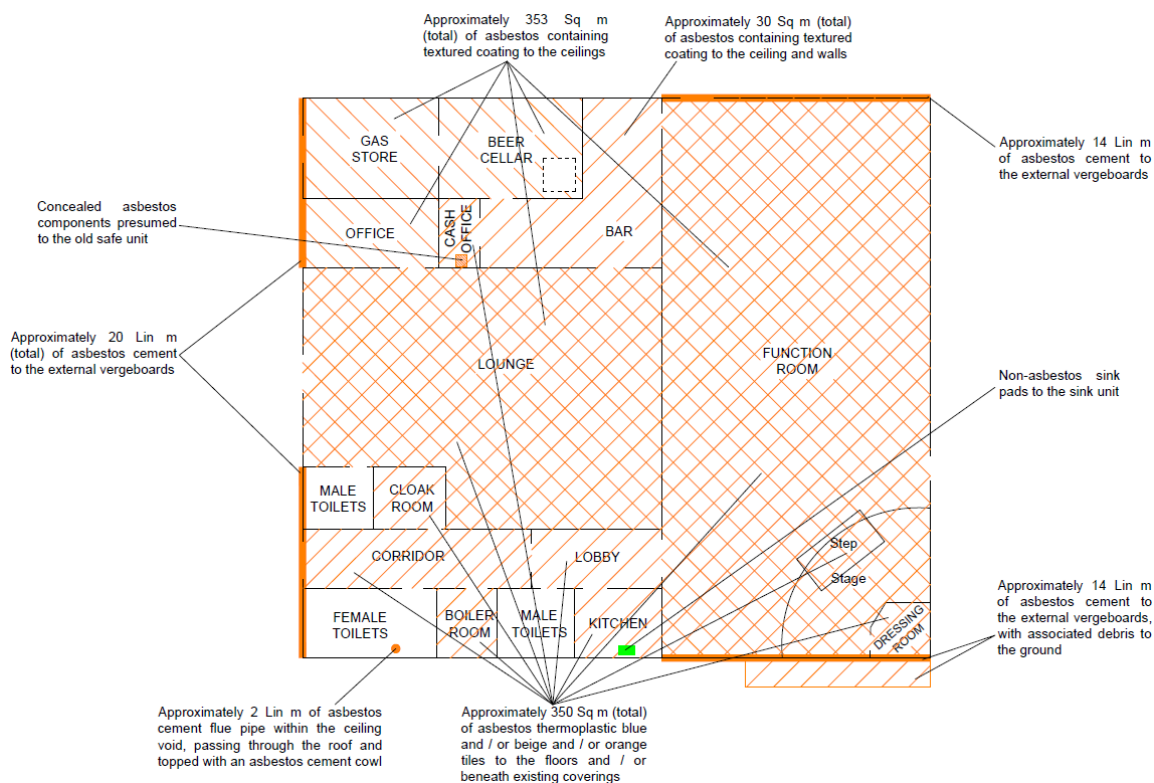
### Club House

- Approximately 48 Lin m (total) of asbestos cement was identified to the external gable ends vergeboards.
- We found the following asbestos containing materials to the inside of the building: -

- Approximately 353 Sq m (total) of asbestos containing textured coating was identified to the ceilings throughout the Lounge, Office, Beer Cellar, Gas Store and Function Room. The material was sampled and found to contain asbestos.

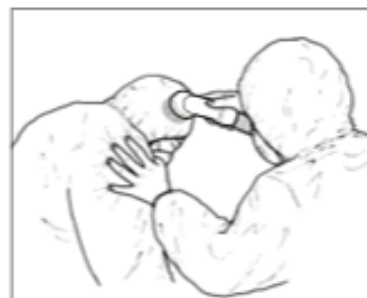
- Clean your boots with damp rags – see sheet em7.
- Where available, clean your overalls with the brush attachment on a Class H vacuum cleaner. Vacuum off the brush.
- Otherwise, use damp rags in a gentle 'patting' action. Rubbing can disturb fibres.
- Where there are two workers, they can help to clean each other.
- Peel off disposable overalls. They should be inside out when they have been removed. Put them in a suitable asbestos waste bag.
- Bag up reusable overalls for a specialist laundry.
- Finally, remove your respiratory protective equipment (RPE) in accordance with em6.
- Tape the bag closed.

'Buddy' cleaning using a Class H vacuum cleaner
