# Urban Regen

### PLAN OF WORKS NON-NOTIFIABLE RISK ASSESSMENT & METHOD STATEMENT

| <b>Site Address:</b> | Glen Dimplex Stoney Lane Prescott<br>Merseyside Liverpool L35 2XW |

### Removal of approx 7,346,491 m2 asbestos cement sheets

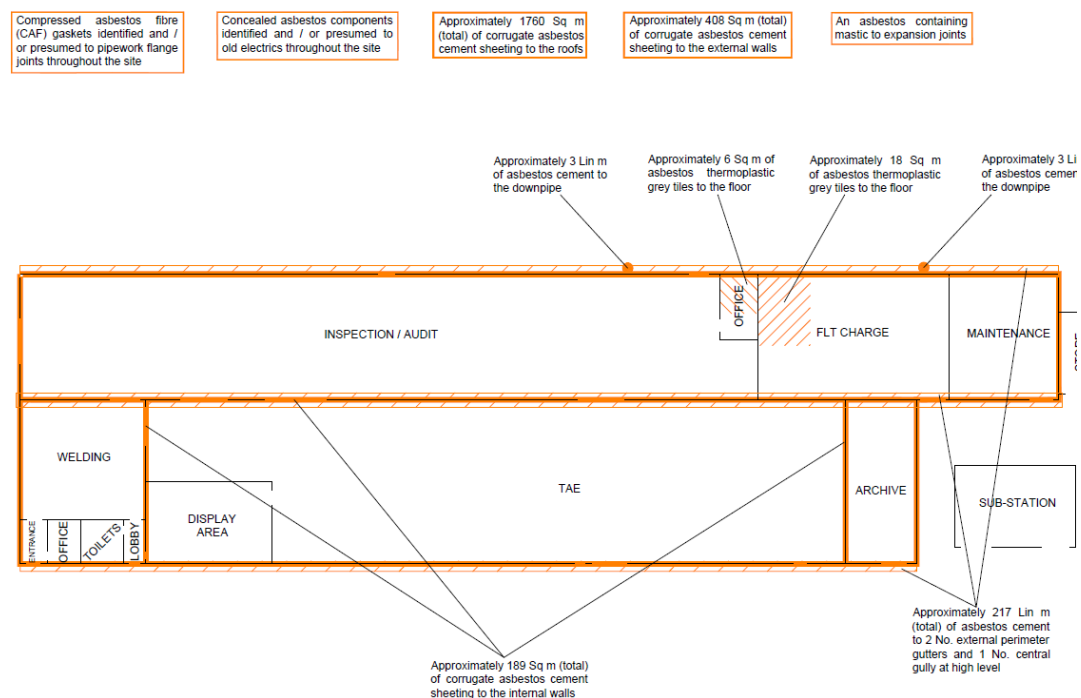
### Welding Building

- Approximately 6 Sq m of asbestos thermoplastic grey tiles were identified to the Inspection / Audit Office floor. The material was sampled and found to contain asbestos.

- Approximately 18 Sq m of asbestos thermoplastic grey tiles were identified to part of the FLT Charge floor.

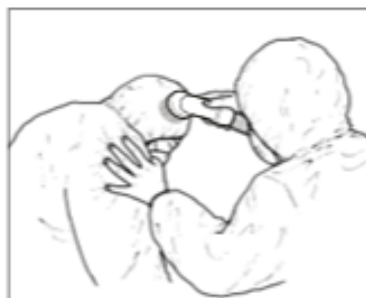
'Buddy' cleaning using a Class H vacuum cleaner

- Clean your boots with damp rags – see sheet em7.
- Where available, clean your overalls with the brush attachment on a Class H vacuum cleaner. Vacuum off the brush.
- Otherwise, use damp rags in a gentle 'patting' action. Rubbing can disturb fibres.
- Where there are two workers, they can help to clean each other.
- Peel off disposable overalls. They should be inside out when they have been removed. Put them in a suitable asbestos waste bag.
- Bag up reusable overalls for a specialist laundry.
- Finally, remove your respiratory protective equipment (RPE) in accordance with em6.
- Tape the bag closed.
