# **BEAM & BLOCK - TYPICAL CS-3 GAS PROTECTION DETAILS**

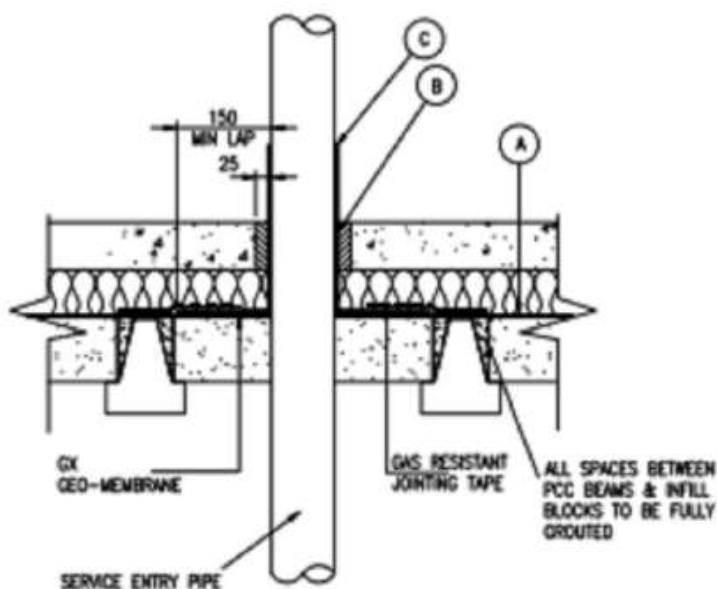
- (A) VISQUEEN GX GEO-MEMBRANE.
- (B) FACTORY FORMED TOP HAT DETAIL FIXED TO MEMBRANE AND TO EXTERNAL FACE OF PIPE USING PROPRIETARY DOUBLE SIDED GAS RESISTANT TAPE.
- (C) SERVICE PENETRATION THROUGH THE SLAB IS TO BE SEALED WITH APPROPRIATE SEALANT IN ACCORDANCE WITH MANUFACTURERS DETAILS.

**TYPICAL DETAIL AT SERVICE PIPE  
PENETRATING SLAB  
(ISOLATED LOCATIONS)**

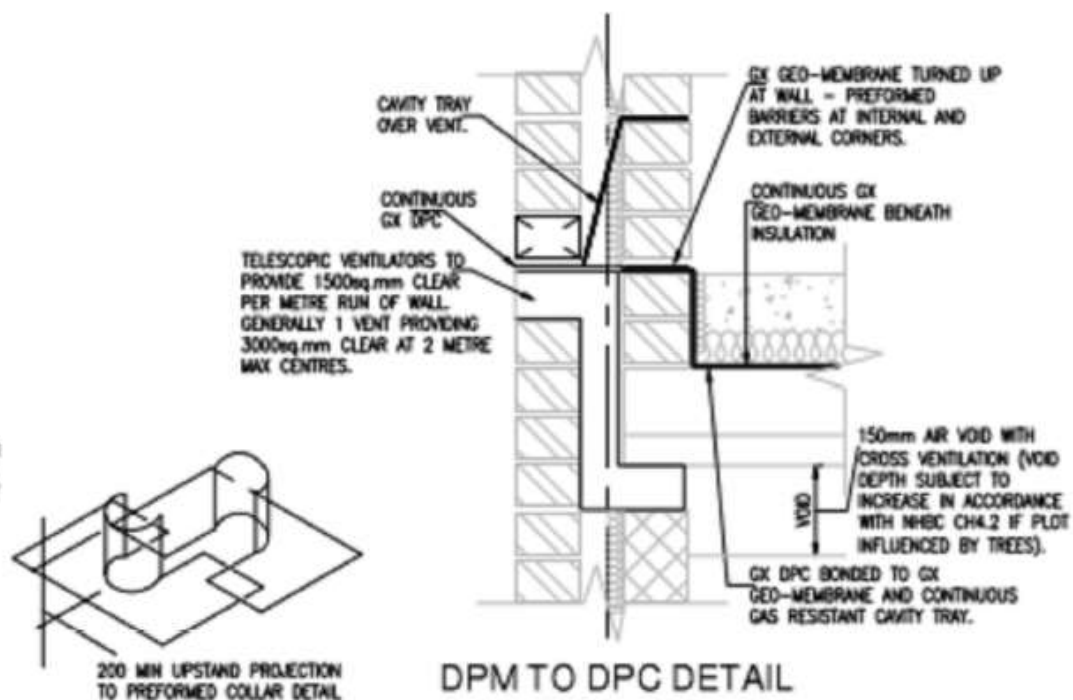
**COLLAR DETAIL (C)  
(OR SIMILAR)**

**DPM TO DPC DETAIL**

ALL MEMBRANES TO BE LAPPED AND SEALED AT JOINTS USING PROPRIETARY DOUBLE SIDED SEALING TAPE. ALL SERVICES ENTRIES ARE TO INCORPORATE A SEALED JOINT, TOP HAT OR SIMILAR.
