**Planning, Design, Access and Heritage Statement**  
**Rebuild of boundary wall and construction of new**  
**supporting outbuilding**  
**at**  
**Sandfield Natural Play Centre,**  
**Lickers Lane, Whiston, L35 3SR**

**1.0 Introduction**

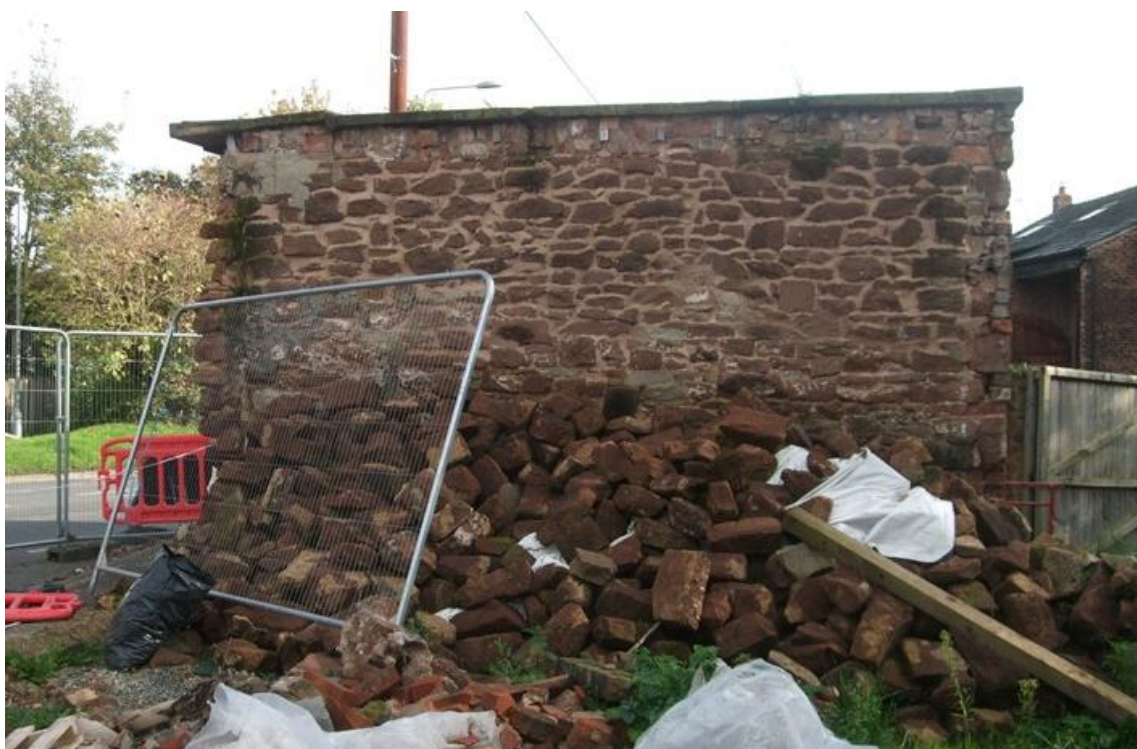
Figure 3: Still-standing portion of original wall, perpendicular to section requiring reconstruction (at left)

- 4.5 The boundary wall would be rebuilt in its original form – with two leaves of sandstone blocks bound together with header stones visible from both faces and infilled with a rubble core. The sandstone blocks and coping from the dismantled wall have been retained on site (see Figure 3) but some would need to be replaced and/or new stone needed as part of the reconstruction. Ideally, locally reclaimed stone would be sourced but, following heritage advice, St Bees or Corsehill sandstones would be used should this be unavailable. The rebuilt wall would be 450mm thick, the same as the original, ensuring that the original coping stones can be reinstated.

- 4.6 The front-facing elevation of the boundary wall was formerly laid in a semi-regular pattern of sandstone blocks arranged in 16 rows (Figure 4). The rear-facing elevation was more randomised, and was similar to that shown in Figure 3. The two faces of the rebuilt wall would match the appearance of the originals.

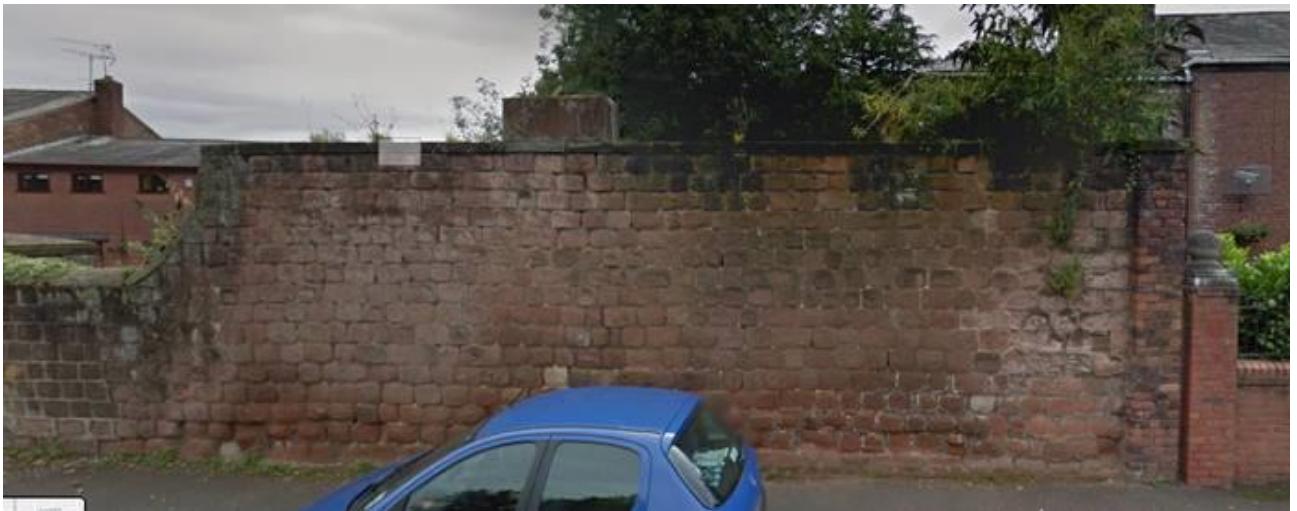
Figure 4: Original appearance of front elevation of currently dismantled boundary wall  
(image: Google Streetview)

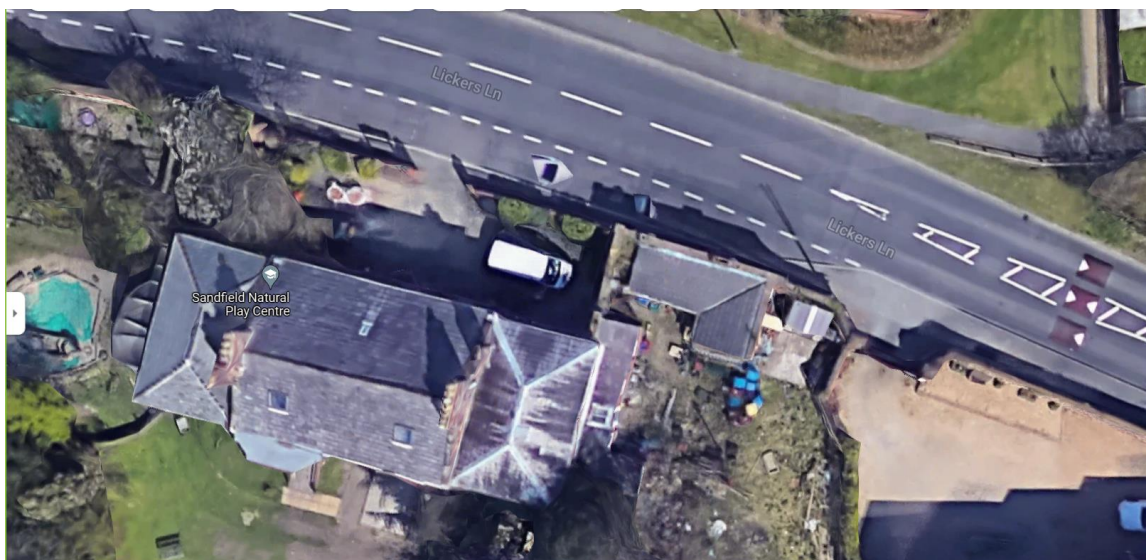
Figure 5: Aerial photograph of Sandfield House and former outdoor store to the immediate NE, prior to its removal (image: Google Maps)

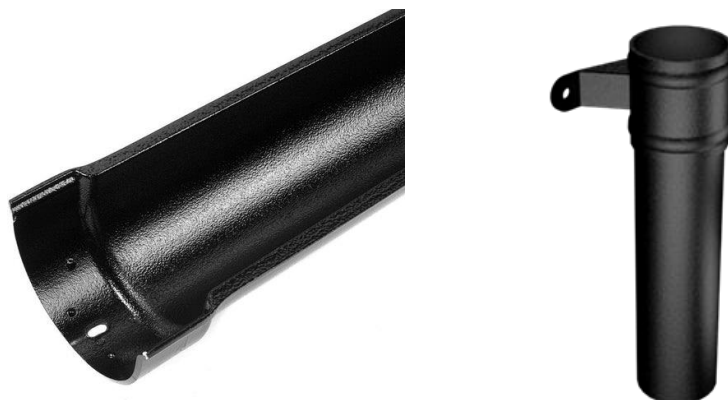
Figure 6: Sample rainwater goods

- 4.16 The roof would be a conventional softwood rafter roof laid with slates to closely match the main Sandfield House building. A wallplate would be required to be bolted to the sandstone walls to the rear, with the tie of the roof structure providing additional stability for these walls. The guttering would be a half-round Victorian cast aluminium system, approx. 125mm in diameter. The downpipes would be

approx. 76mm diameter round cast collared aluminium in design. Both are styled to give the appearance of cast iron.
