**Planning, Design, Access and Heritage Statement**  
**Rebuild of boundary wall and construction of new**  
**supporting outbuilding**  
**at**  
**Sandfield Natural Play Centre,**  
**Lickers Lane, Whiston, L35 3SR**

## **1.0 Introduction**

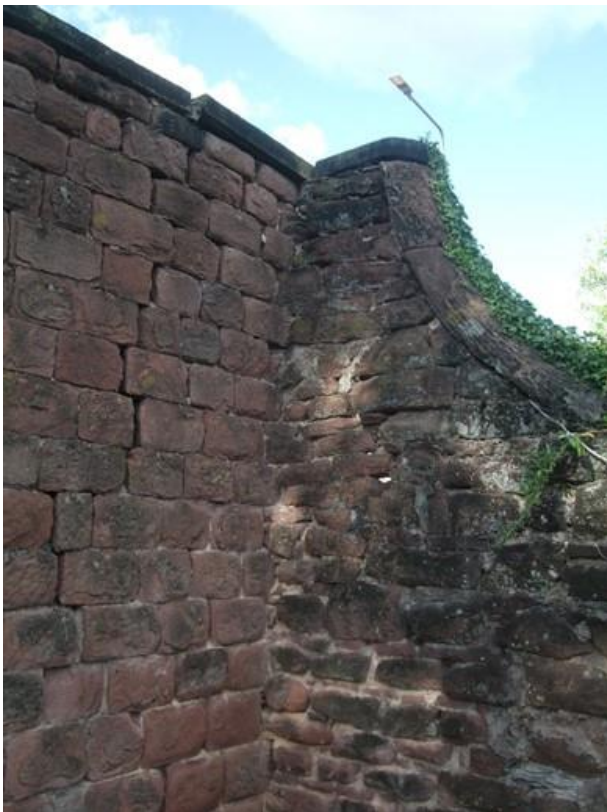
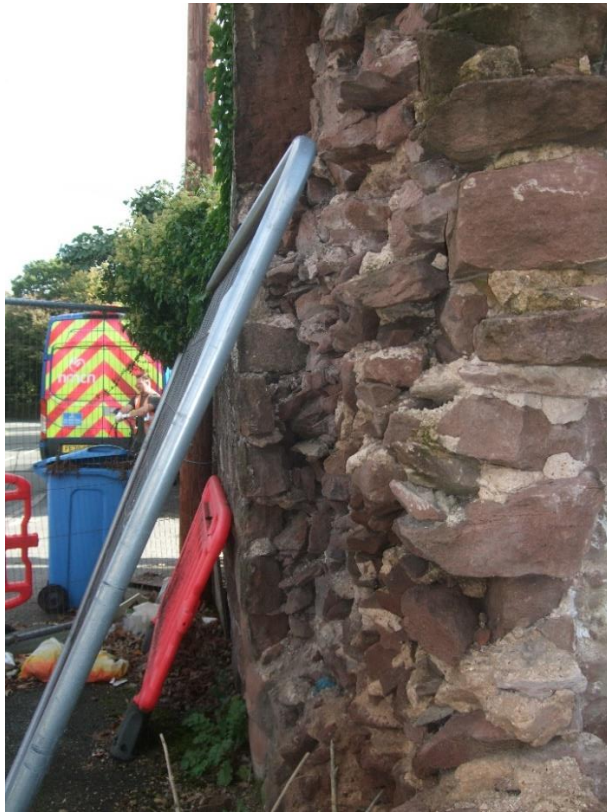
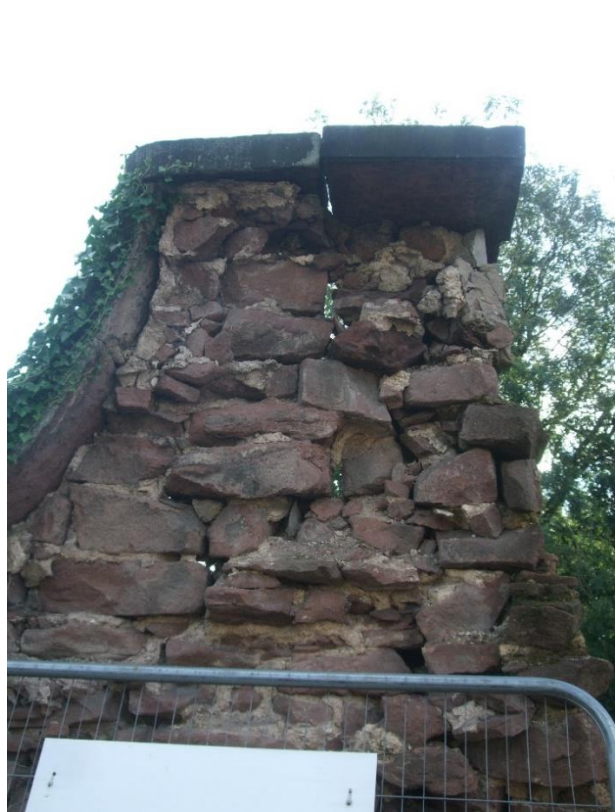
Figure 2a-d: Evidence of deterioration in still-standing sandstone boundary wall

- 4.1 The remaining section of the front boundary wall abuts a perpendicular length of wall extending onto the nursery grounds, as shown in Figures 2 and 3, and on Drawing 5558-1. Each of these sections of wall is displaying signs of serious structural movement and weather-related damage. The remaining boundary wall appears to be leaning onto the telegraph pole seen in Figure 2c. There is a risk of serious collapse unless remedial work is undertaken promptly.

- 4.3 The extent of the dismantling required varies along different parts of the wall. Facing Lickers Lane, the wall exhibits a marked lean outwards (Figure 2c) which requires correction, with the wall needing to be taken down to close to ground level. Further into the site, the perpendicular wall is in better condition but dismantling is required close to the abutment with the new boundary wall where a large crack has developed (Figure 2a). The stability of the remaining wall is paramount and it may be necessary to remove parts that appear in good condition in order to access damaged sections or to ensure that narrow lengths are not left unsupported.

- 4.8 The front-facing elevation of the boundary wall was formerly laid in a semi-regular pattern of sandstone blocks arranged in 16 rows (Figure 4), and this can still be seen on the eastward face of the perpendicular wall (Figure 2a). The rear-facing elevation was more randomised, and was similar to that shown in Figure 3. The two faces of the rebuilt wall would match the appearance of the originals.

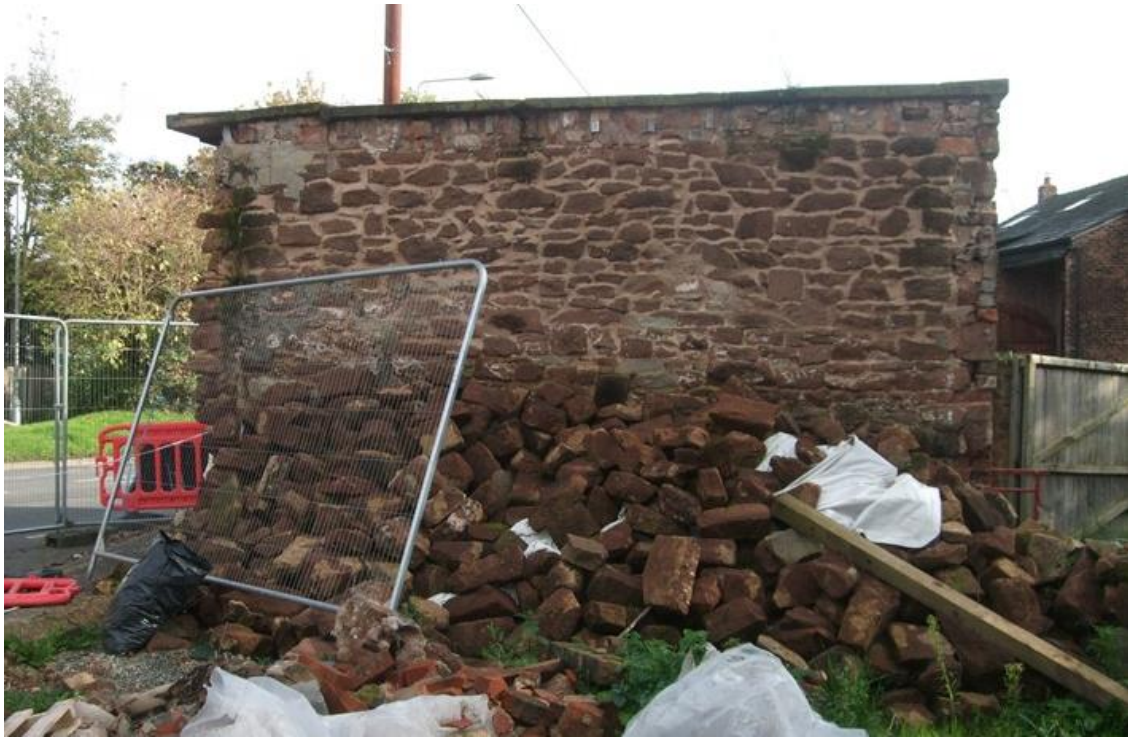
Figure 3: Still-standing portion of original wall, perpendicular to section requiring reconstruction (at left)

- 4.7 The boundary wall would be rebuilt in its original form – with two leaves of sandstone blocks bound together with header stones visible from both faces and infilled with a rubble core. The sandstone blocks and coping from the dismantled wall have been retained on site (see Figure 3) but some would need to be replaced and/or new stone needed as part of the reconstruction. Ideally, locally reclaimed stone would be sourced but, following heritage advice, St Bees or Corsehill sandstones would be used should this be unavailable. The rebuilt wall would be 450mm thick, the same as the original, ensuring that the original coping stones can be reinstated.

- 4.9 NHL 2 mortar would be used in the wall rebuild. This is a soft and slow-setting lime mortar suited to conservation applications where stonework is soft or deteriorating. It can be colour matched by the manufacturer upon receipt of a sample of existing mortar, and this would enable each face of the reconstructed wall to match the appearance of Figures 3 and 4. Pointing would be flush or slightly recessed.

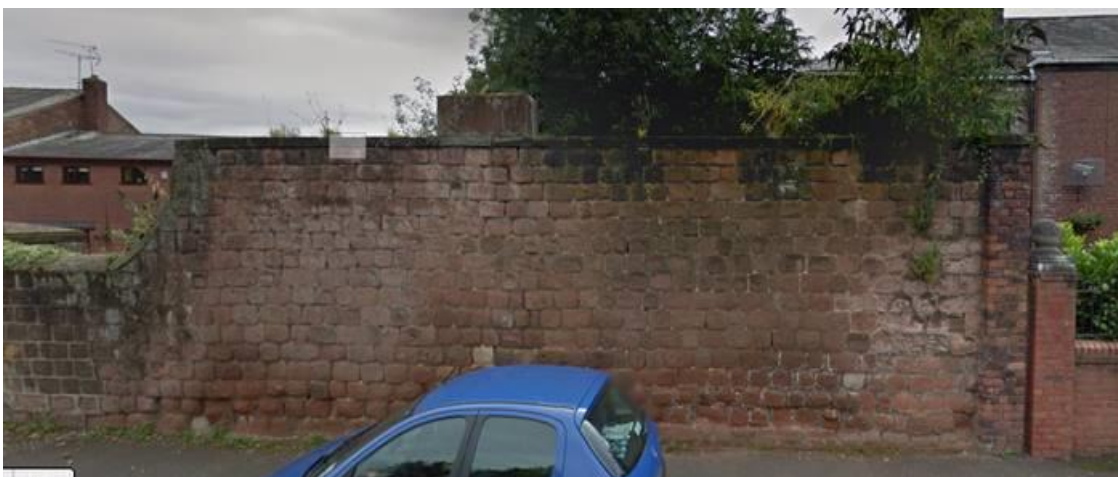
Figure 4: Original appearance of front elevation of currently dismantled boundary wall (image: Google Streetview)

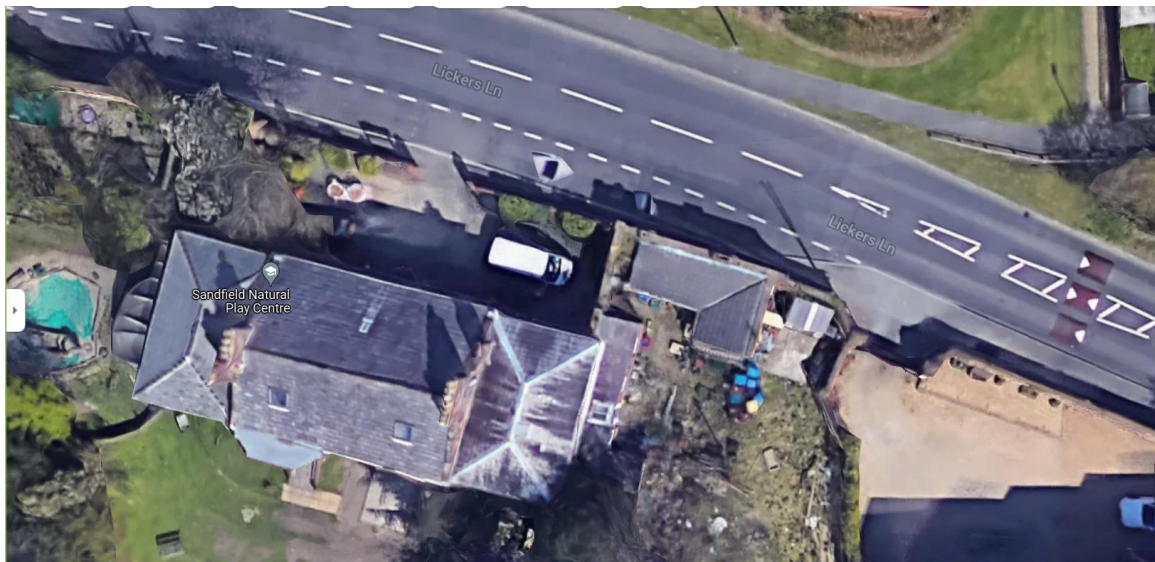
Figure 5: Aerial photograph of Sandfield House and former outdoor store to the immediate NE, prior to its removal (image: Google Maps)

- 4.14 The outdoor store was an L-shaped single-storey lean-to structure built against the boundary and perpendicular walls (Figure 5). It had lain redundant for many years prior to a survey carried out in July 2010 by Interim Consultancy Solutions Ltd, which identified defects to its walls and roof. It was subsequently taken down and the site has remained unoccupied since.

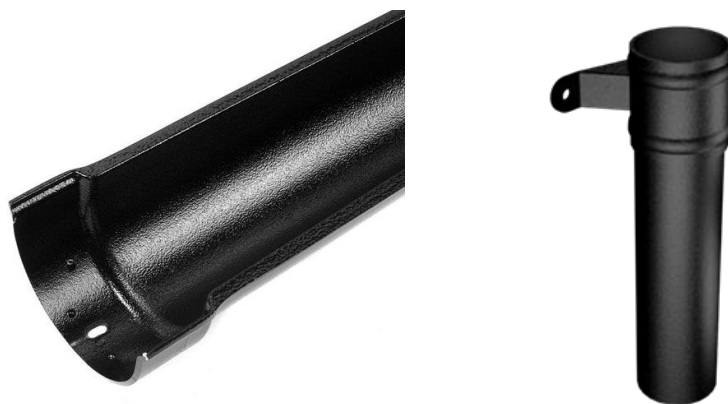
Figure 6: Sample rainwater goods

- 4.18 The roof would be a conventional softwood rafter roof laid with slates to closely match the main Sandfield House building. A wallplate would be required to be bolted to the sandstone walls to the rear, with the tie of the roof structure providing additional stability for these walls. The guttering would be a half-round Victorian cast aluminium system, approx. 125mm in diameter. The downpipes would be approx. 76mm diameter round cast collared aluminium in design. Both are styled to give the appearance of cast iron.
