## MOTT MACDONALD EA/NRW Surface Water 30 Year Return Depth Map (1:10,000)

Order Number: 167915730\_1\_1  
Customer Ref: 394359GE05  
National Grid Reference: 341330, 399790  
Slice: A  
Site Area (Ha): 5.08  
Search Buffer (m): 1000

Headbolt Lane Station, LIVERPOOL, L33 3AU

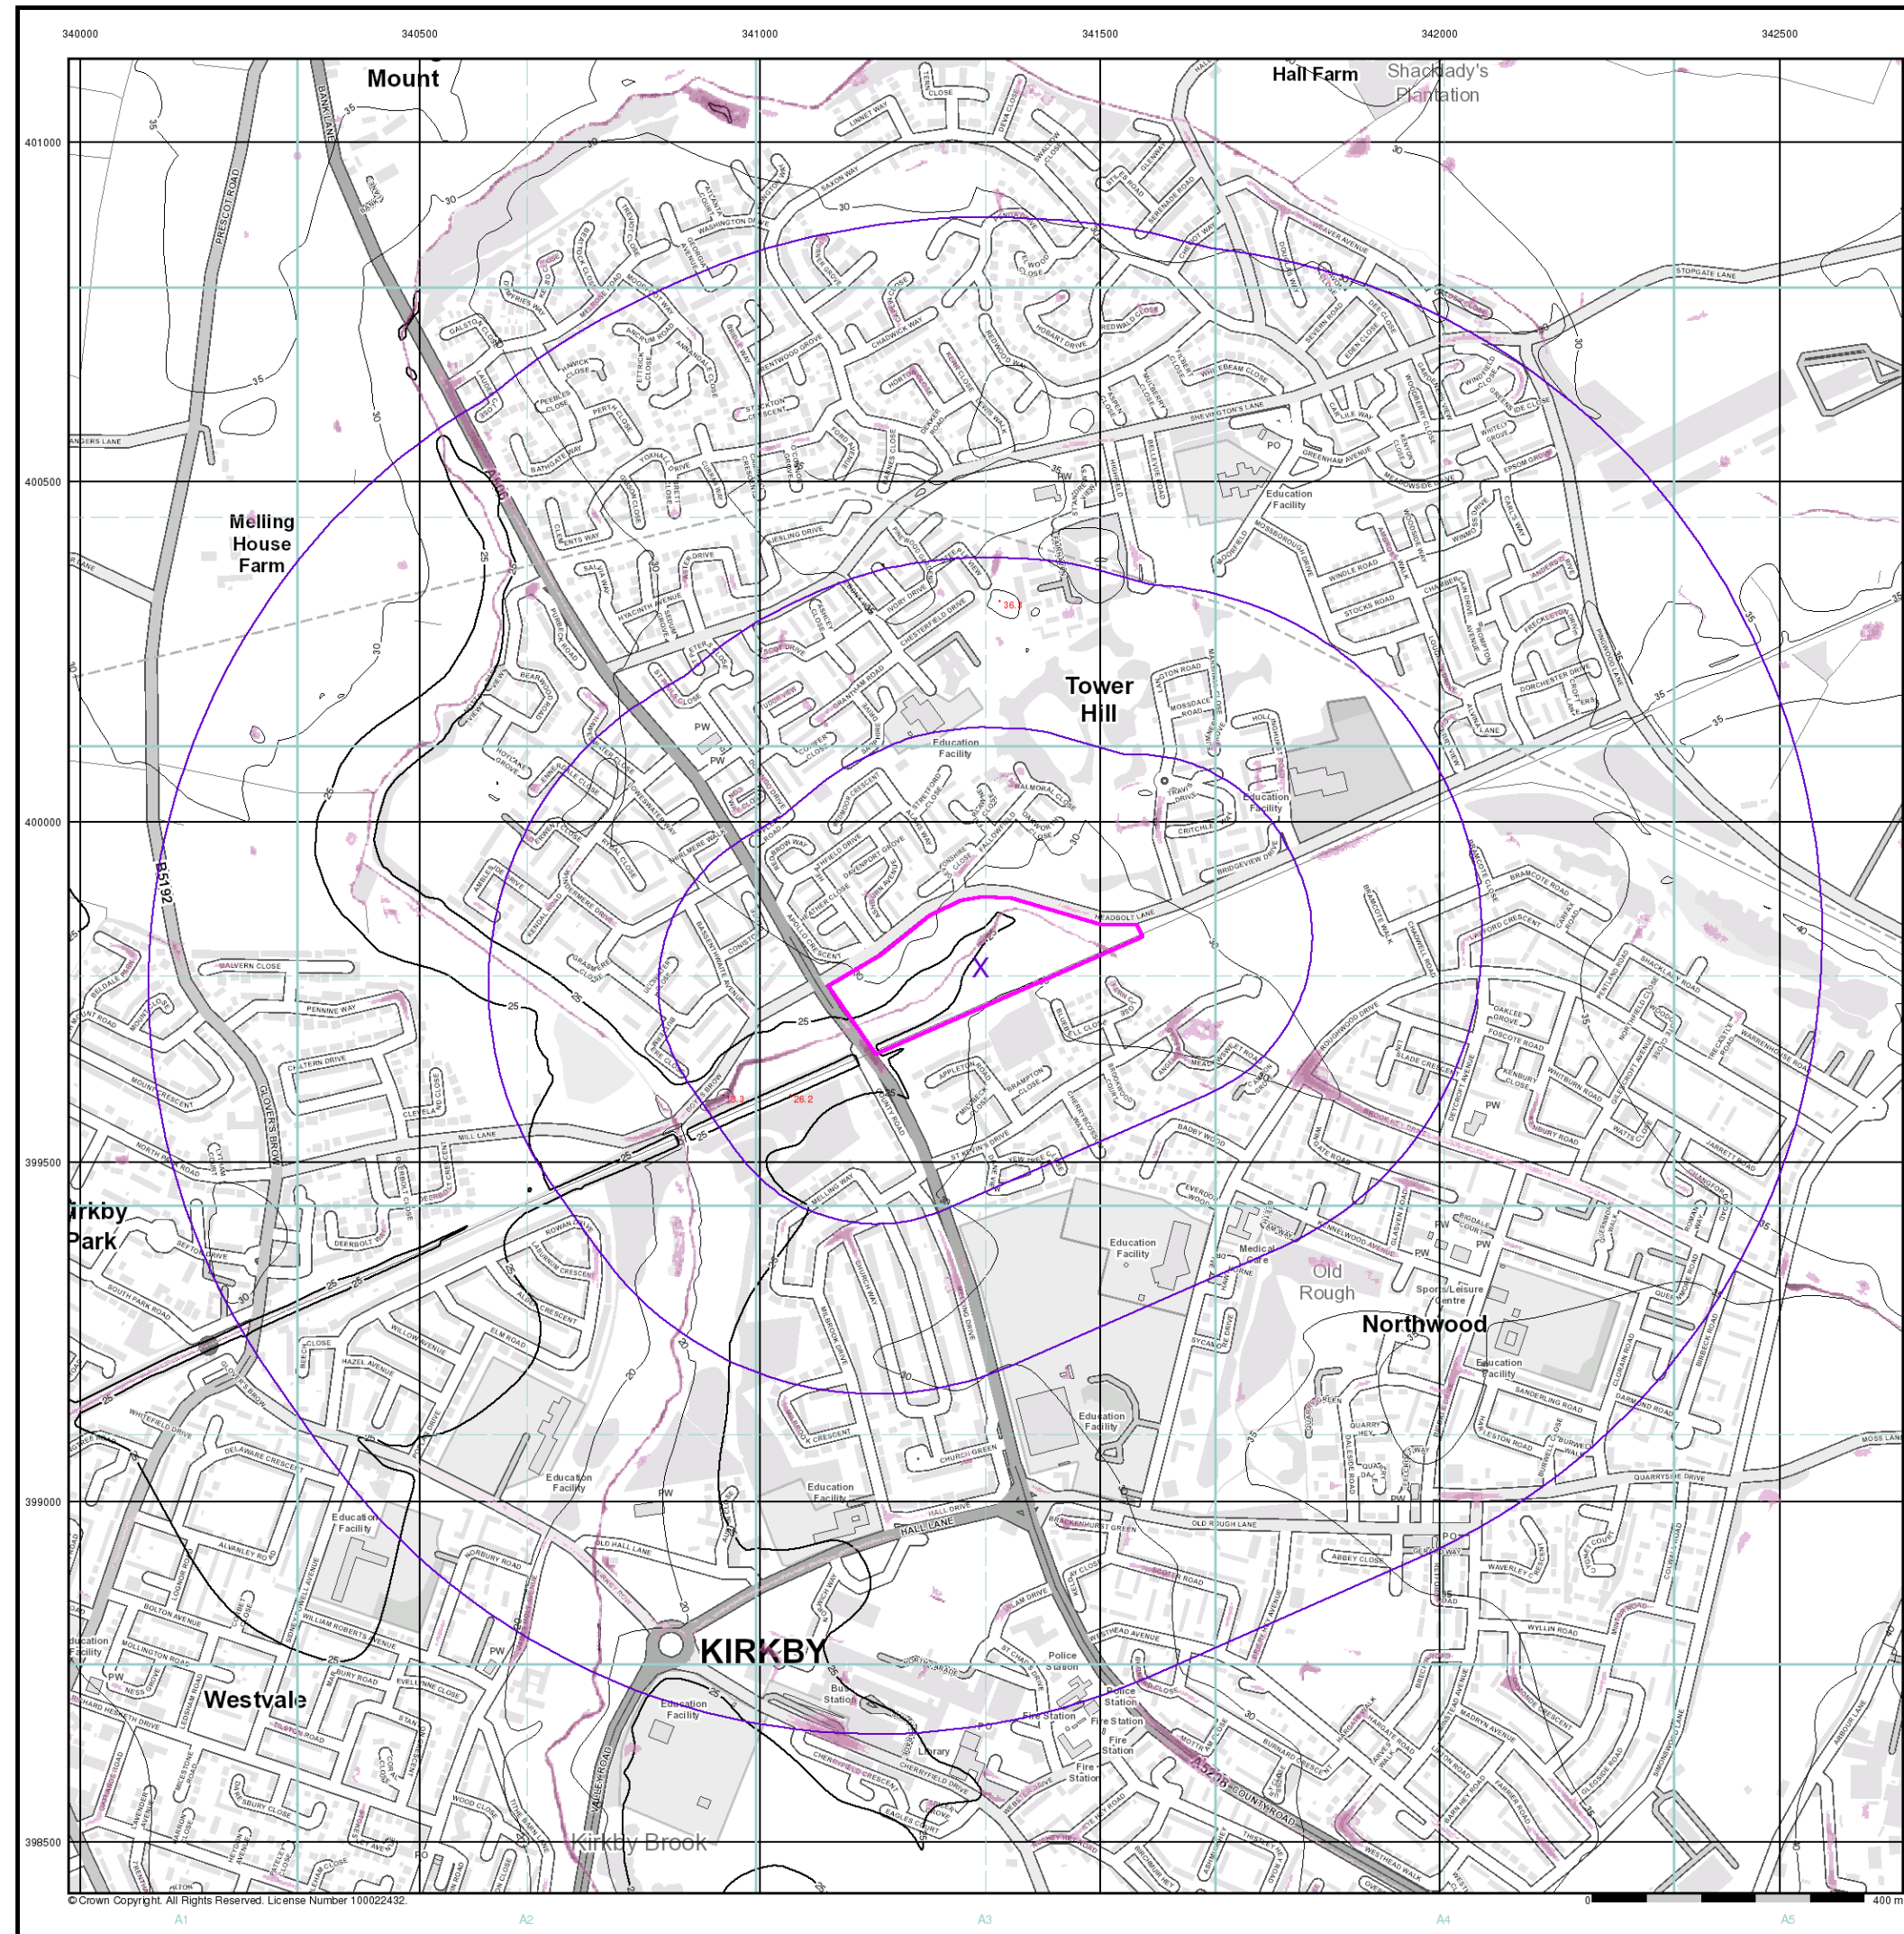
- General**
- Specified Site
  - Specified Buffer(s)
  - Bearing Reference Point
- Surface Water Depth**
- 0 - 0.15m
  - 0.15 - 0.30m
  - 0.30 - 0.60m
  - 0.60 - 0.90m
  - 0.90 - 1.20m
  - > 1.20m
- Contours (height in metres)**
- Standard Contour
  - Master Contour
  - Spot Height
- Suitability**
- See the suitability map below
- National to county
  - County to town
  - Town to street
  - Street to parcels of land
  - Property

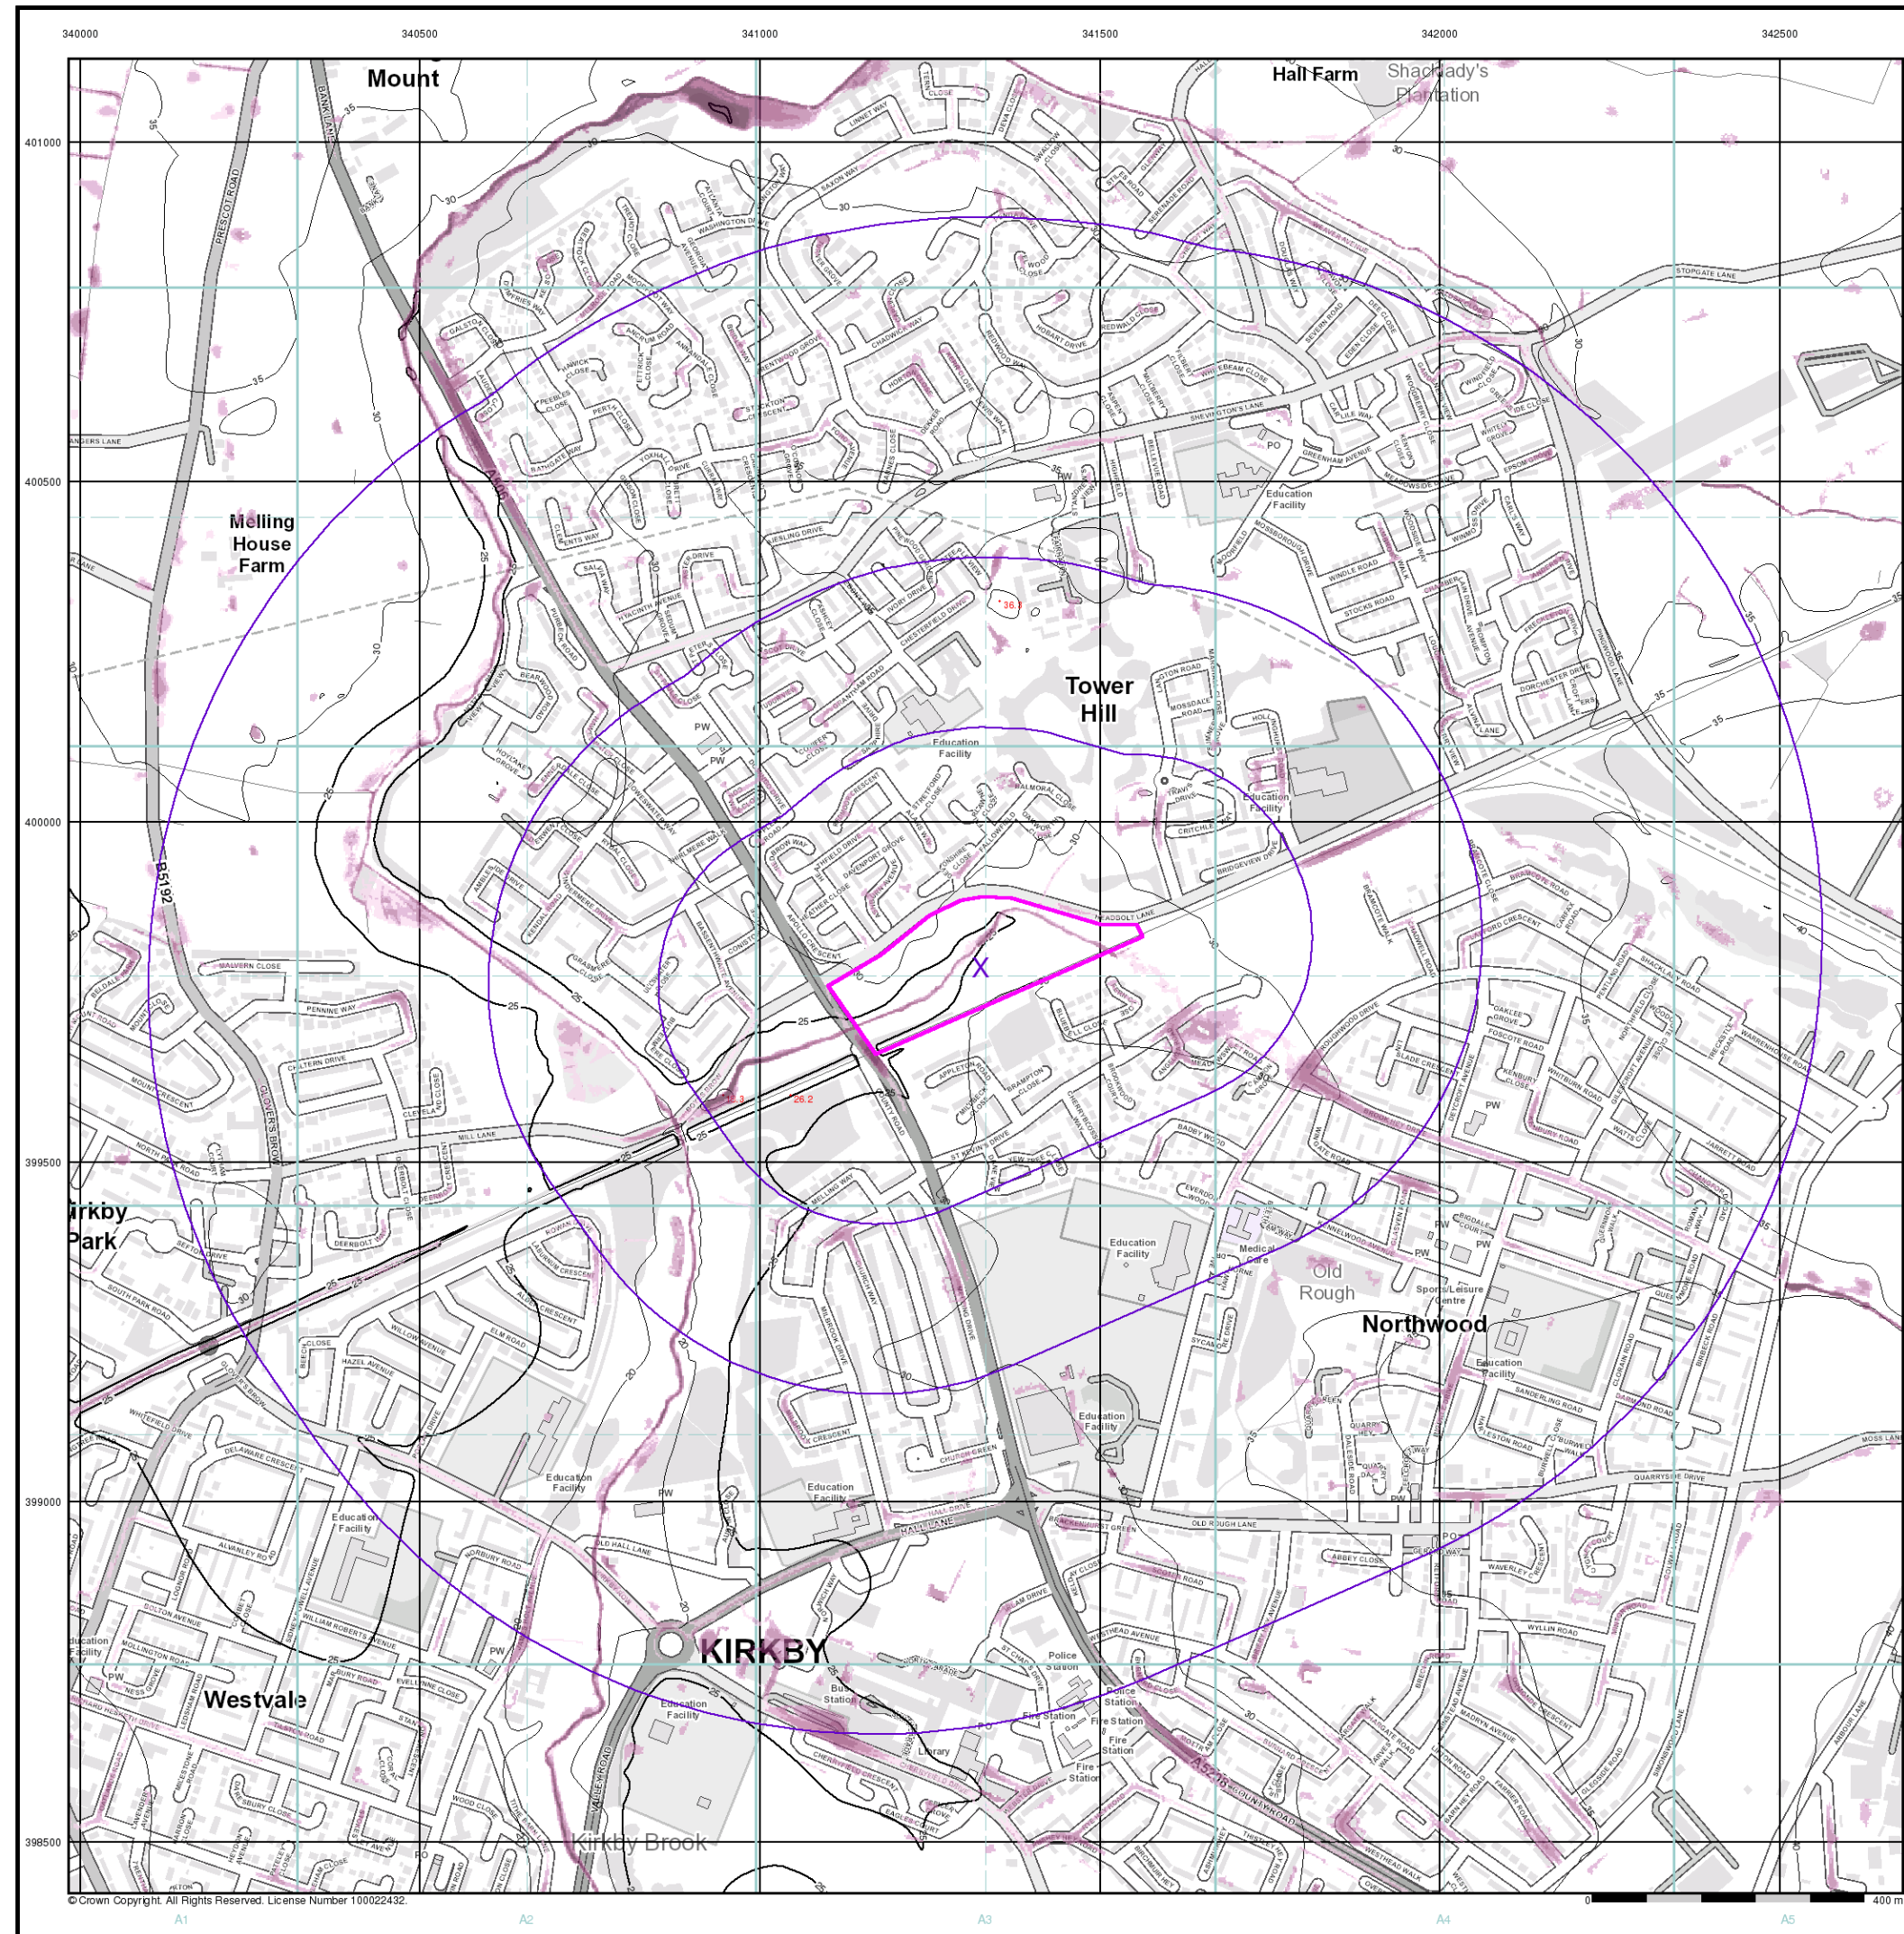
## MOTT MACDONALD EA/NRW Surface Water 100 Year Return Depth Map

- General**
- Specified Site
  - Specified Buffer(s)
  - Bearing Reference Point
- Surface Water Depth**
- 0 - 0.15m
  - 0.15 - 0.30m
  - 0.30 - 0.60m
  - 0.60 - 0.90m
  - 0.90 - 1.20m
  - > 1.20m
- Contours (height in metres)**
- Standard Contour
  - Master Contour
  - Spot Height
- Suitability**
- See the suitability map below
- National to county
  - County to town
  - Town to street
  - Street to parcels of land
  - Property

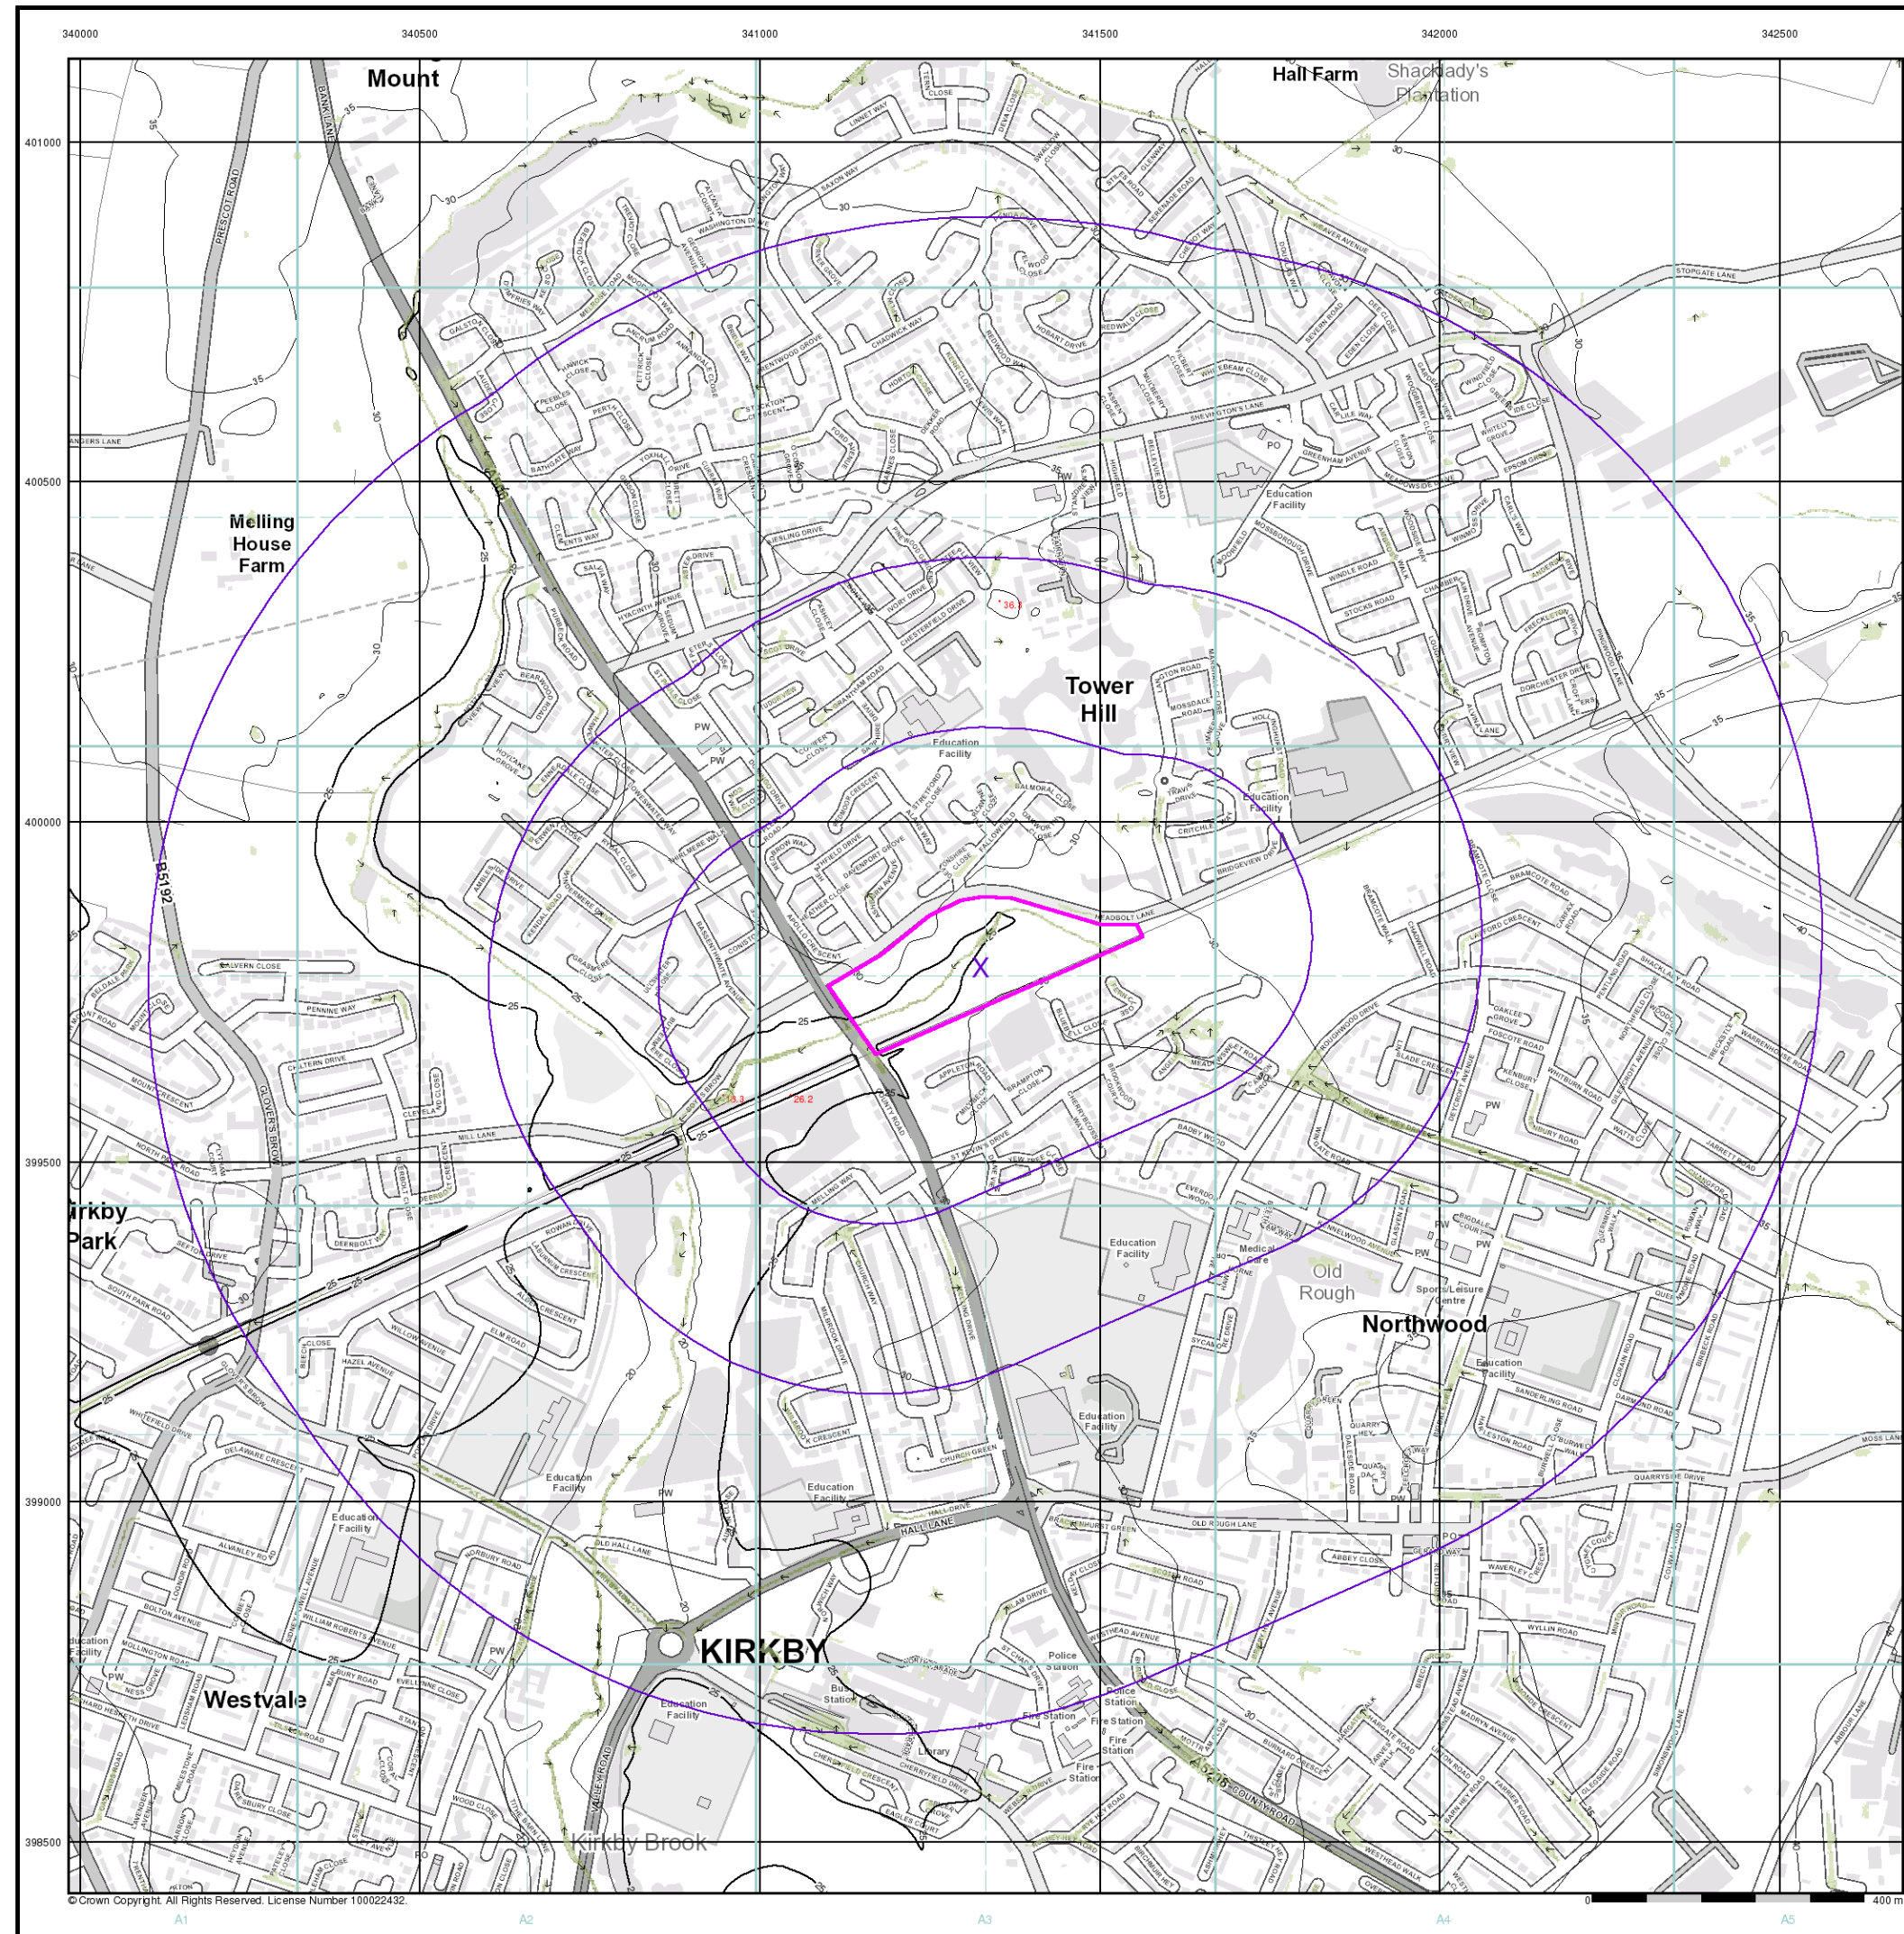
### EA/NRW Surface Water 30 Year Return Velocity and Flow Direction Map (1:10,000)

- 0.00 - 0.25m/s
- 0.25 - 0.50m/s
- 0.50 - 1.00m/s
- 1.00 - 2.00m/s
- > 2.00m/s

Flow Direction at maximum velocity

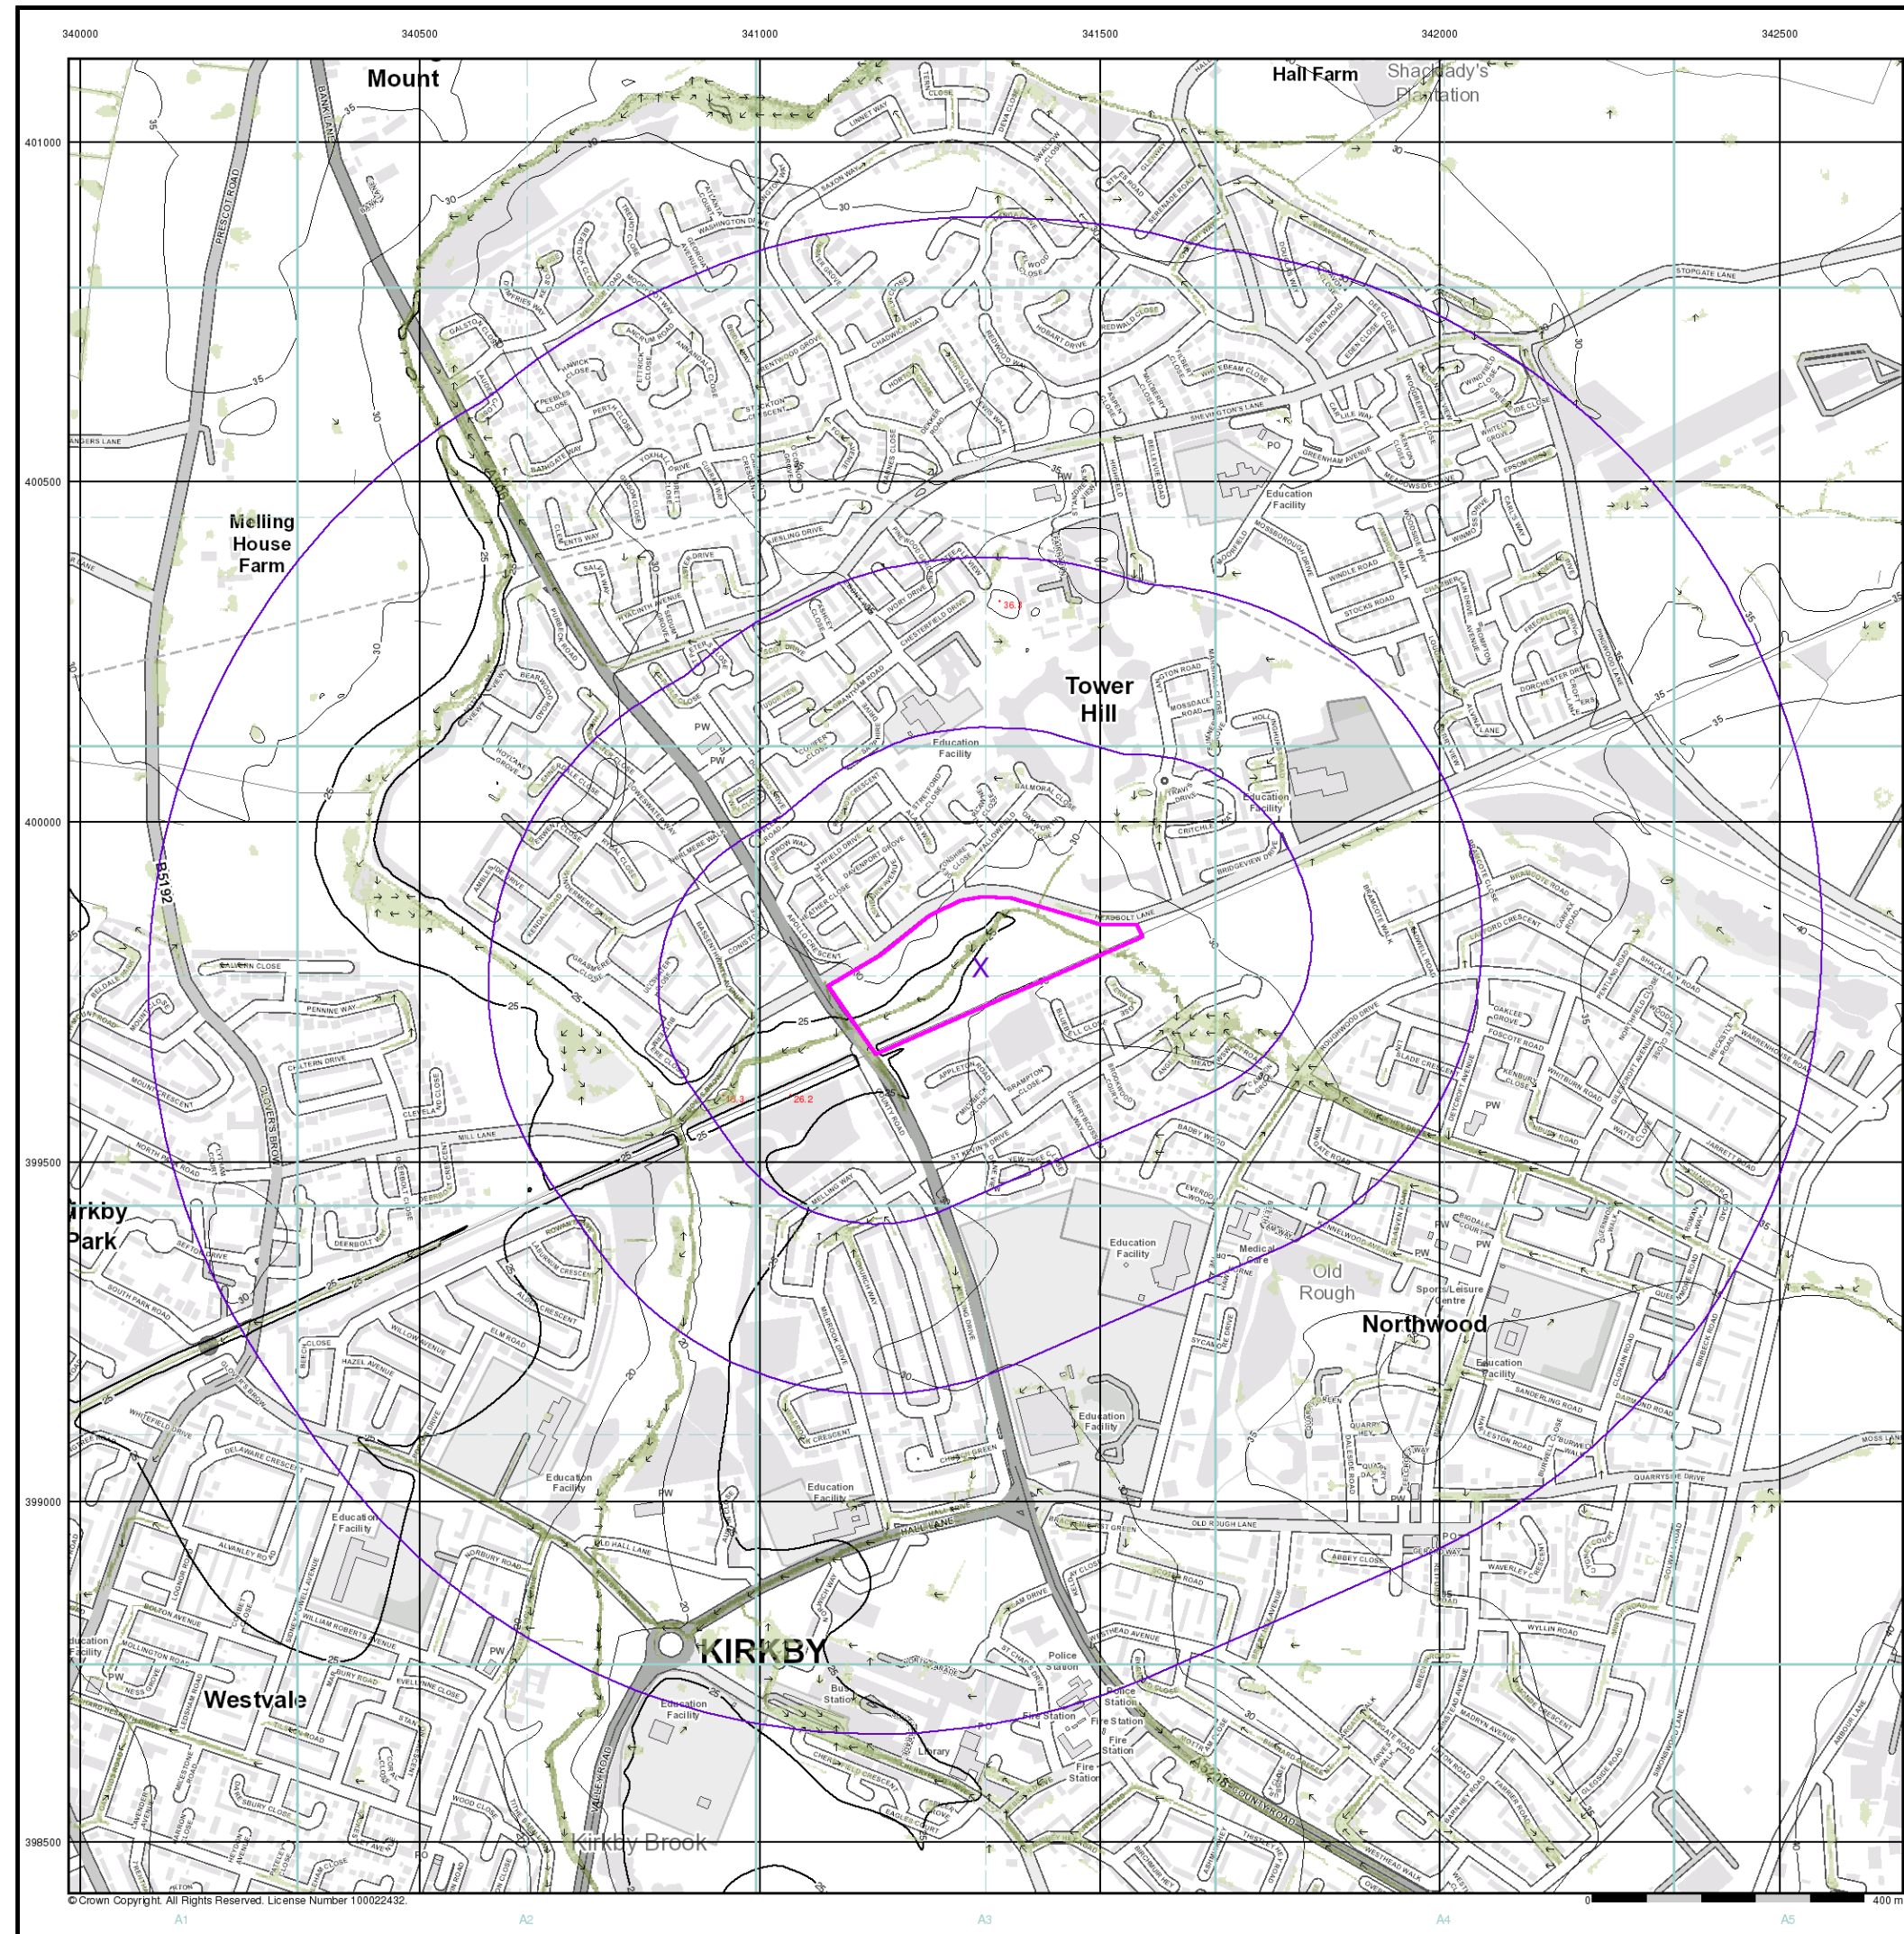
### EA/NRW Surface Water 100 Year Return Velocity and Flow Direction Map (1:10,000)

- 0.00 - 0.25m/s
- 0.25 - 0.50m/s
- 0.50 - 1.00m/s
- 1.00 - 2.00m/s
- > 2.00m/s

Flow Direction at maximum velocity

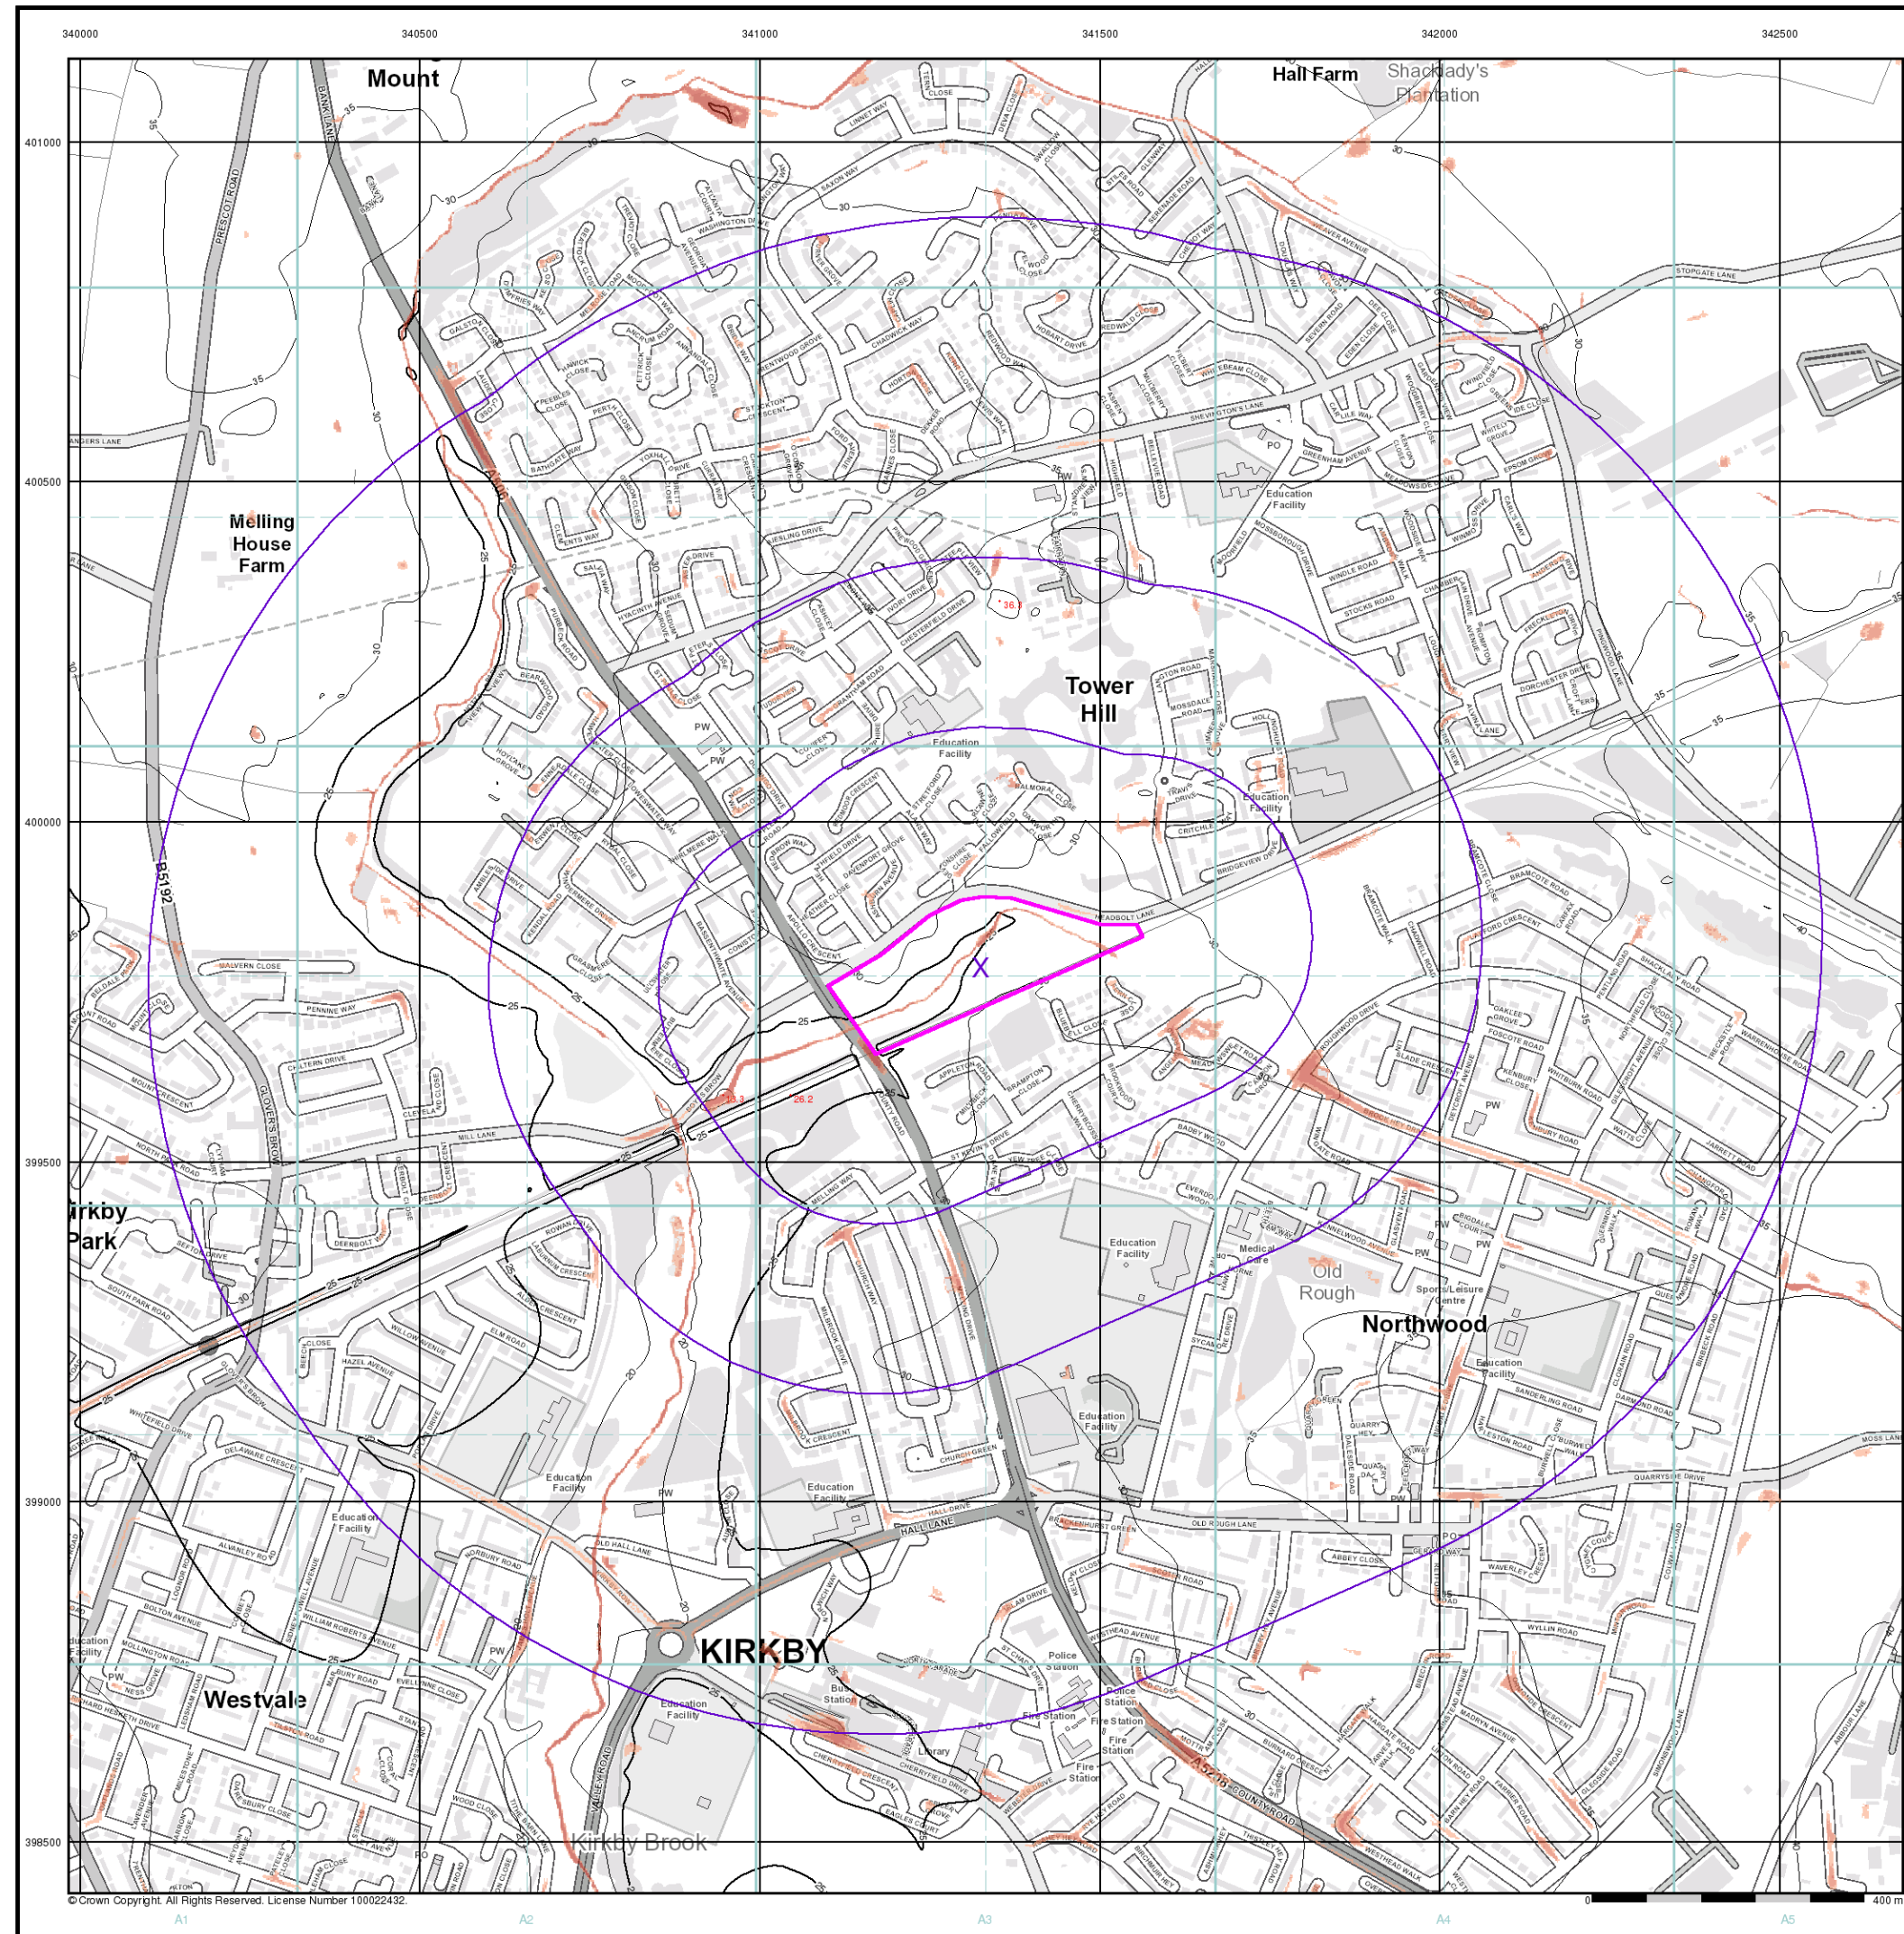
## MOTT MACDONALD EA/NRW Surface Water 30 Year Return Hazard Rating Map (1:10,000)

- General**
- Specified Site
  - Specified Buffer(s)
  - Bearing Reference Point
- Surface Water Hazard Rating**
- Low (0.5 – 0.75)
  - Moderate (0.75 – 1.25)
  - Significant (1.25 – 2.0)
  - Extreme (>2.0)

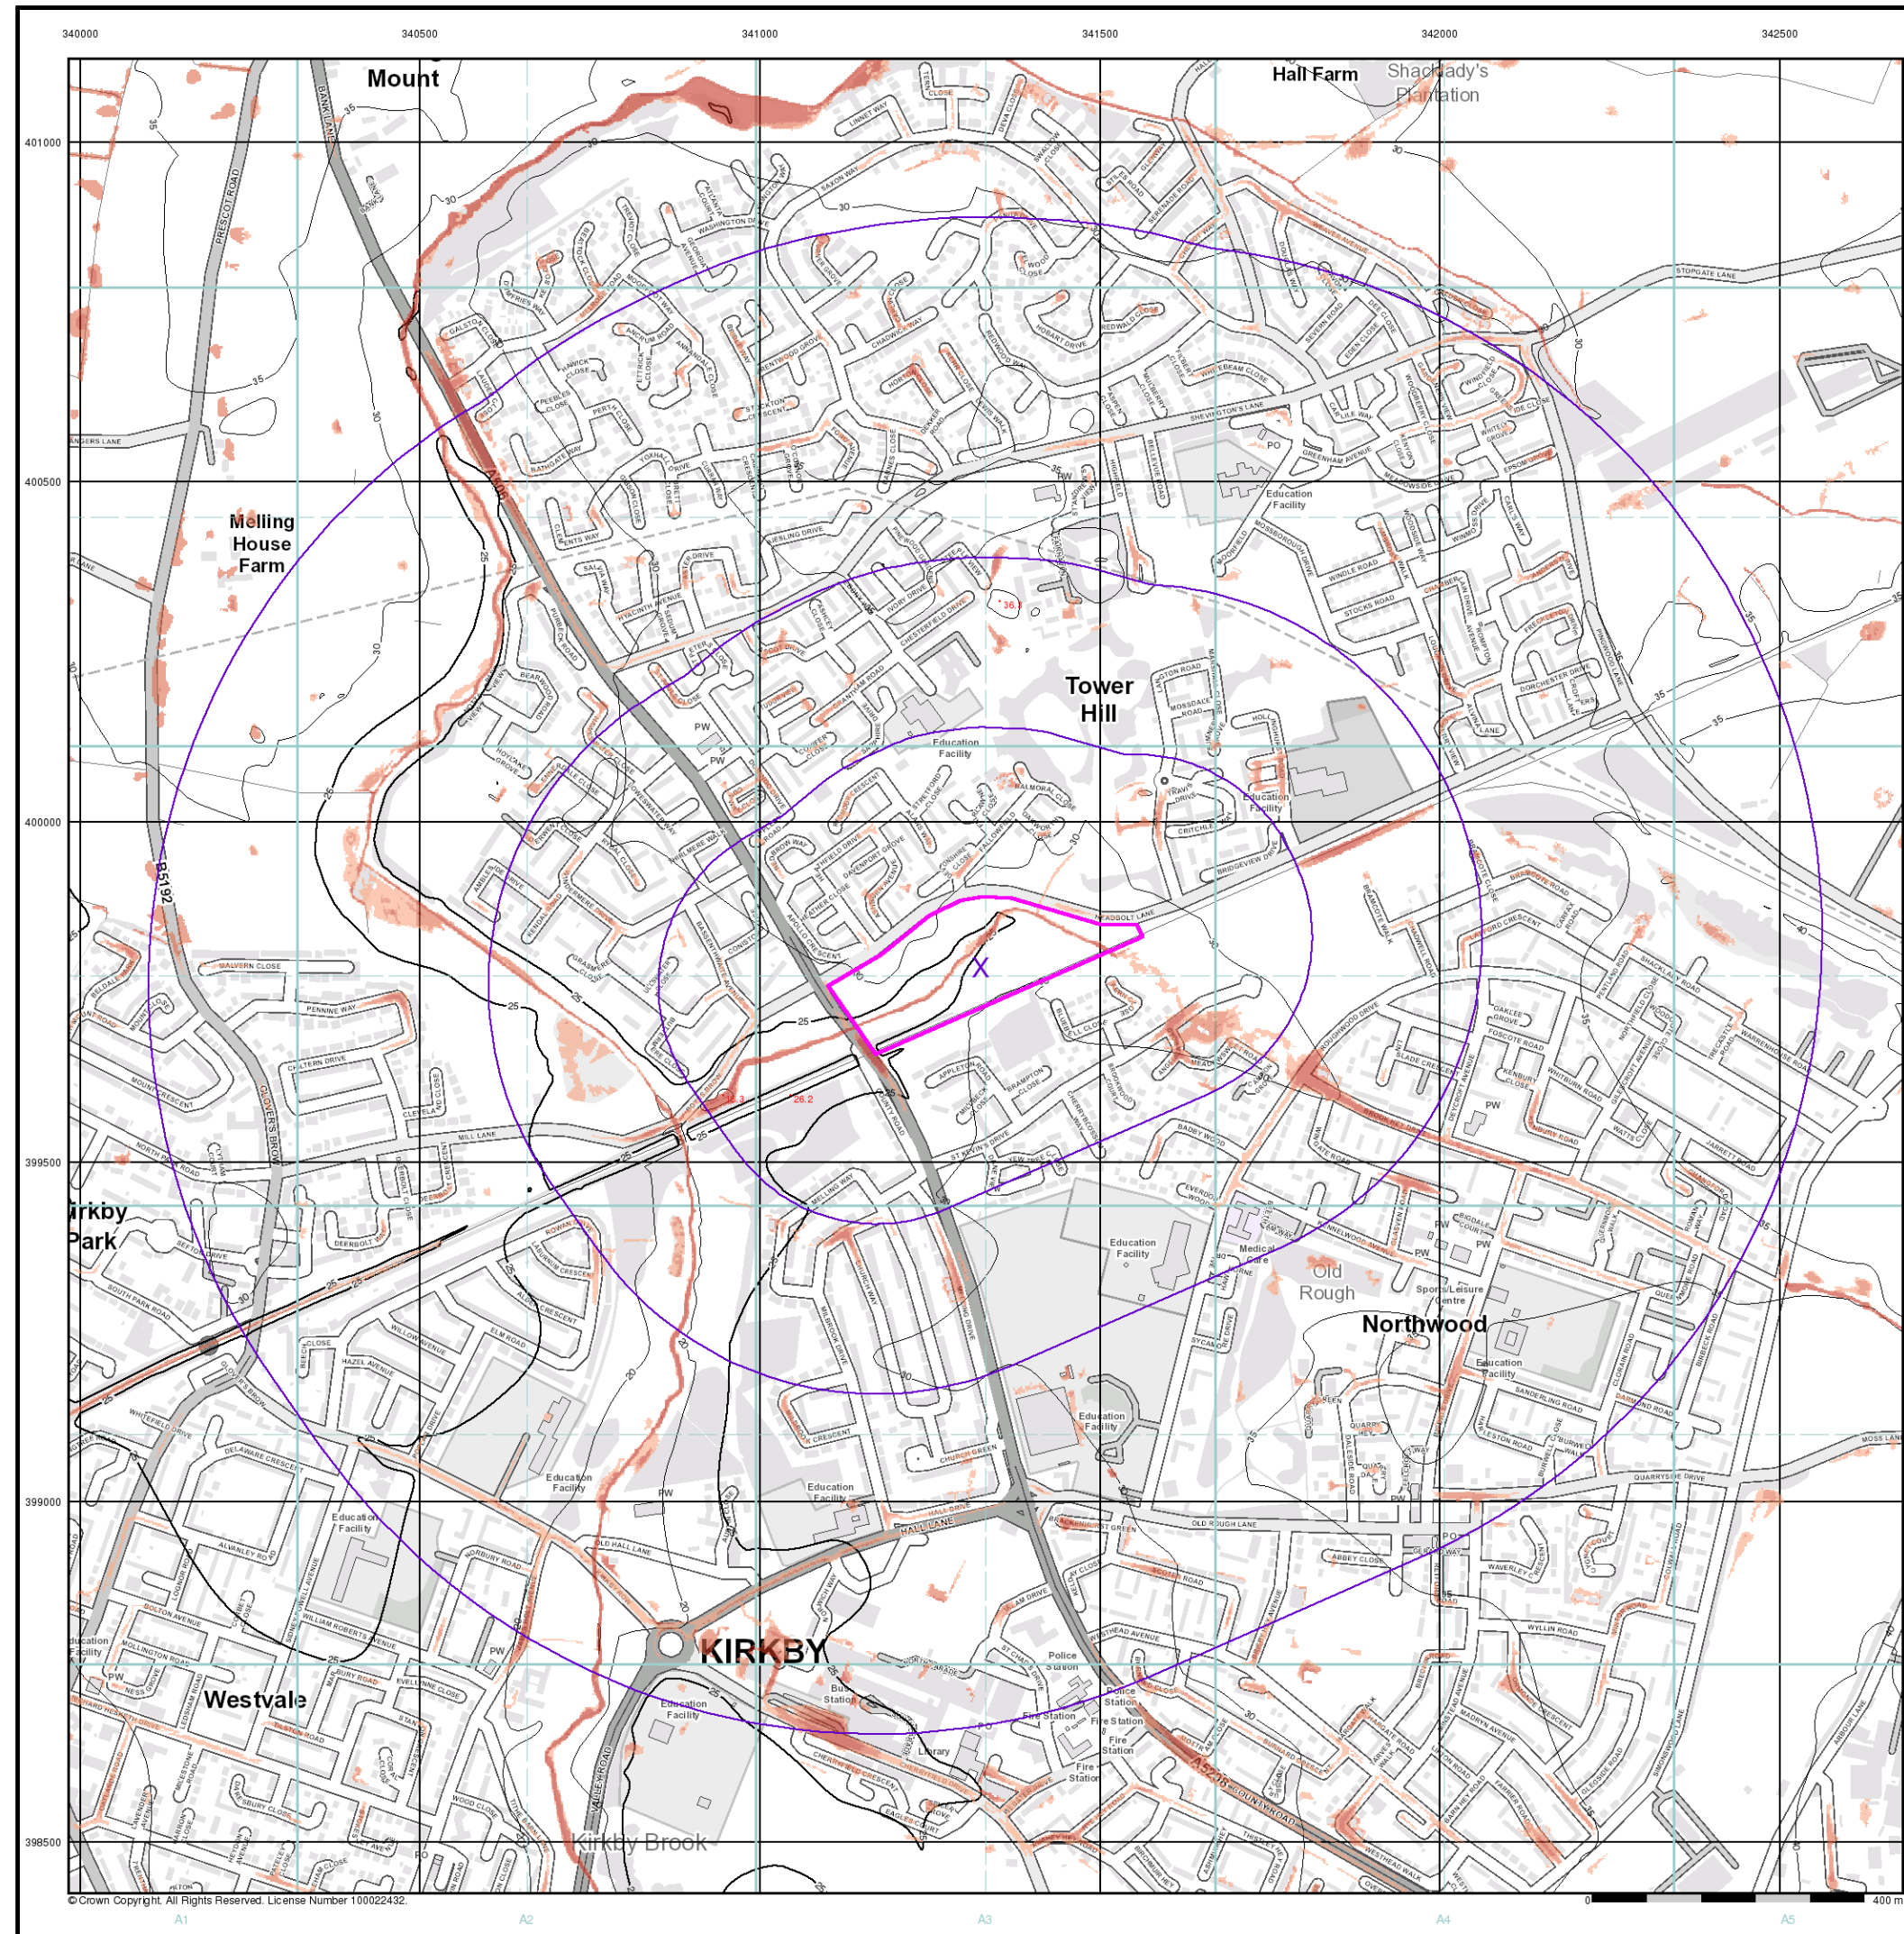
### EA/NRW Surface Water 100 Year Return Hazard Rating Map (1:10,000)

- General**
- Specified Site
  - Specified Buffer(s)
  - Bearing Reference Point
- Surface Water Hazard Rating**
- Low (0.5 – 0.75)
  - Moderate (0.75 – 1.25)
  - Significant (1.25 – 2.0)
  - Extreme (>2.0)
