## MOTT MACDONALD EA/NRW Surface Water 30 Year Return Depth Map (1:10,000)

Order Number: 167915730\_1\_1  
Customer Ref: 394359GE05  
National Grid Reference: 341330, 399790  
Slice: A  
Site Area (Ha): 5.08  
Search Buffer (m): 1000

Headbolt Lane Station, LIVERPOOL, L33 3AU

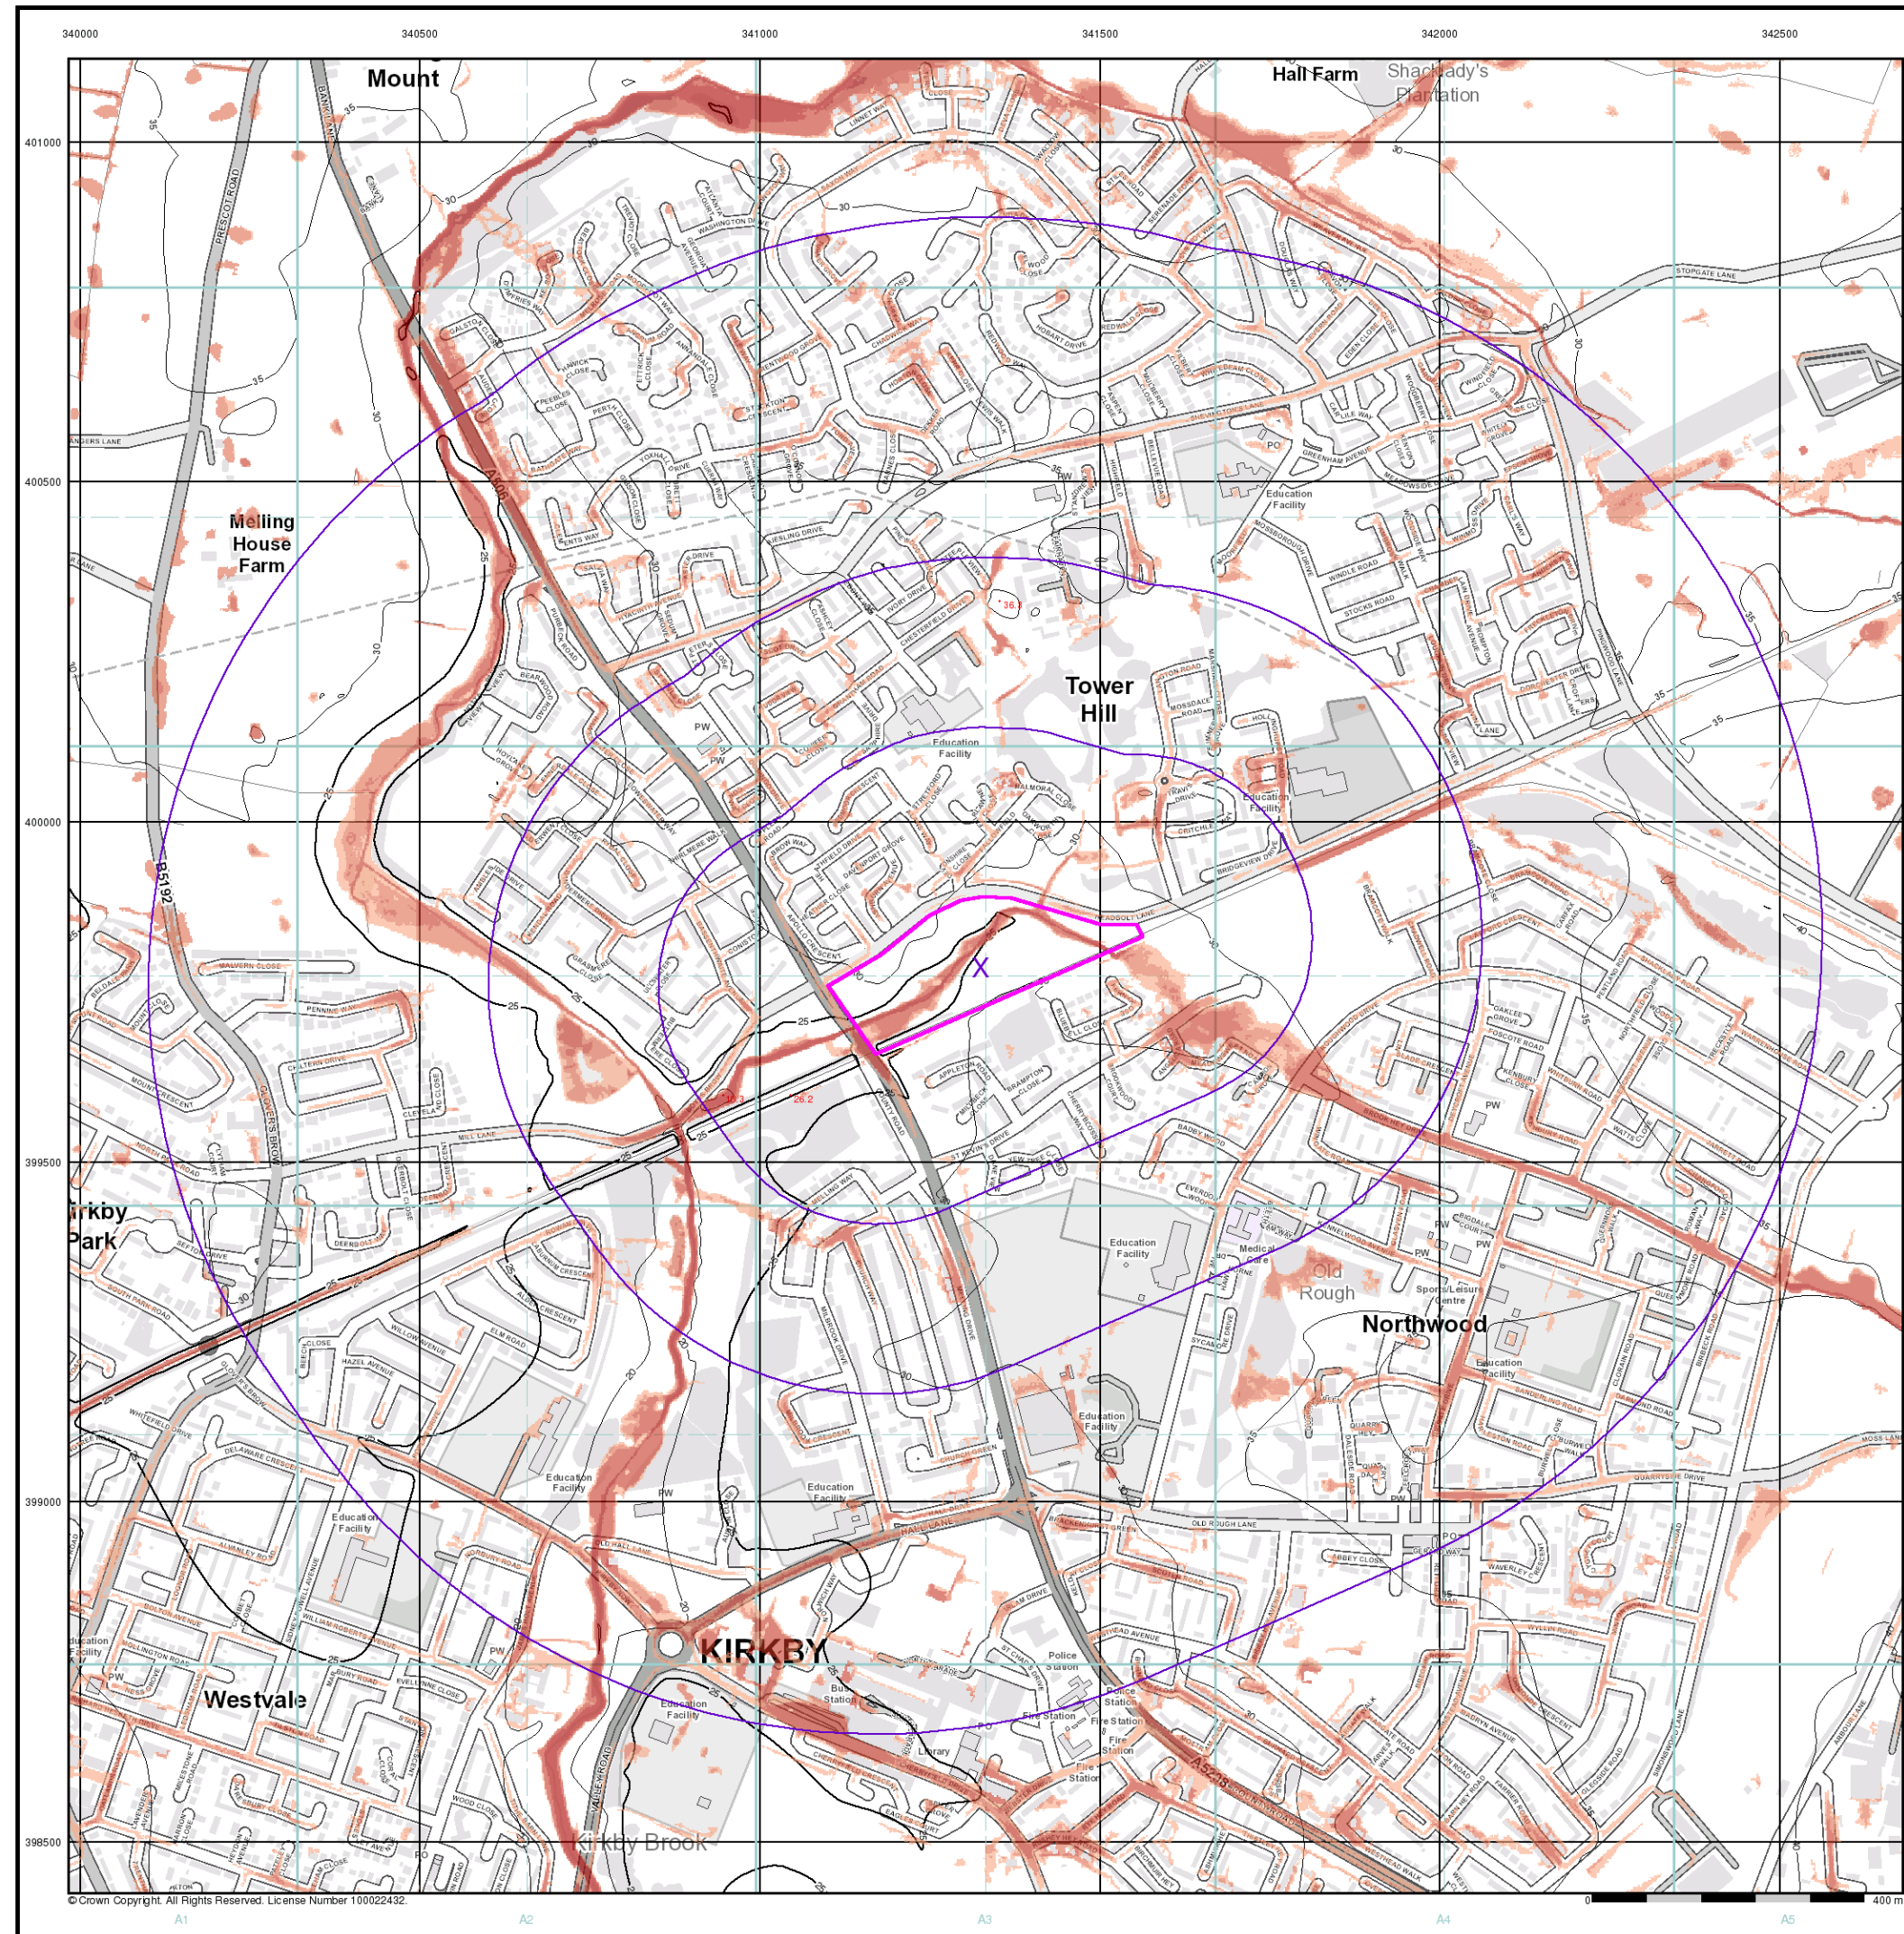
## MOTT MACDONALD EA/NRW Surface Water 1000 Year Return Hazard Rating Map (1:10,000)

- General**
- Specified Site
  - Specified Buffer(s)
  - Bearing Reference Point
- Surface Water Hazard Rating**
- Low (0.5 – 0.75)
  - Moderate (0.75 – 1.25)
  - Significant (1.25 – 2.0)
  - Extreme (>2.0)

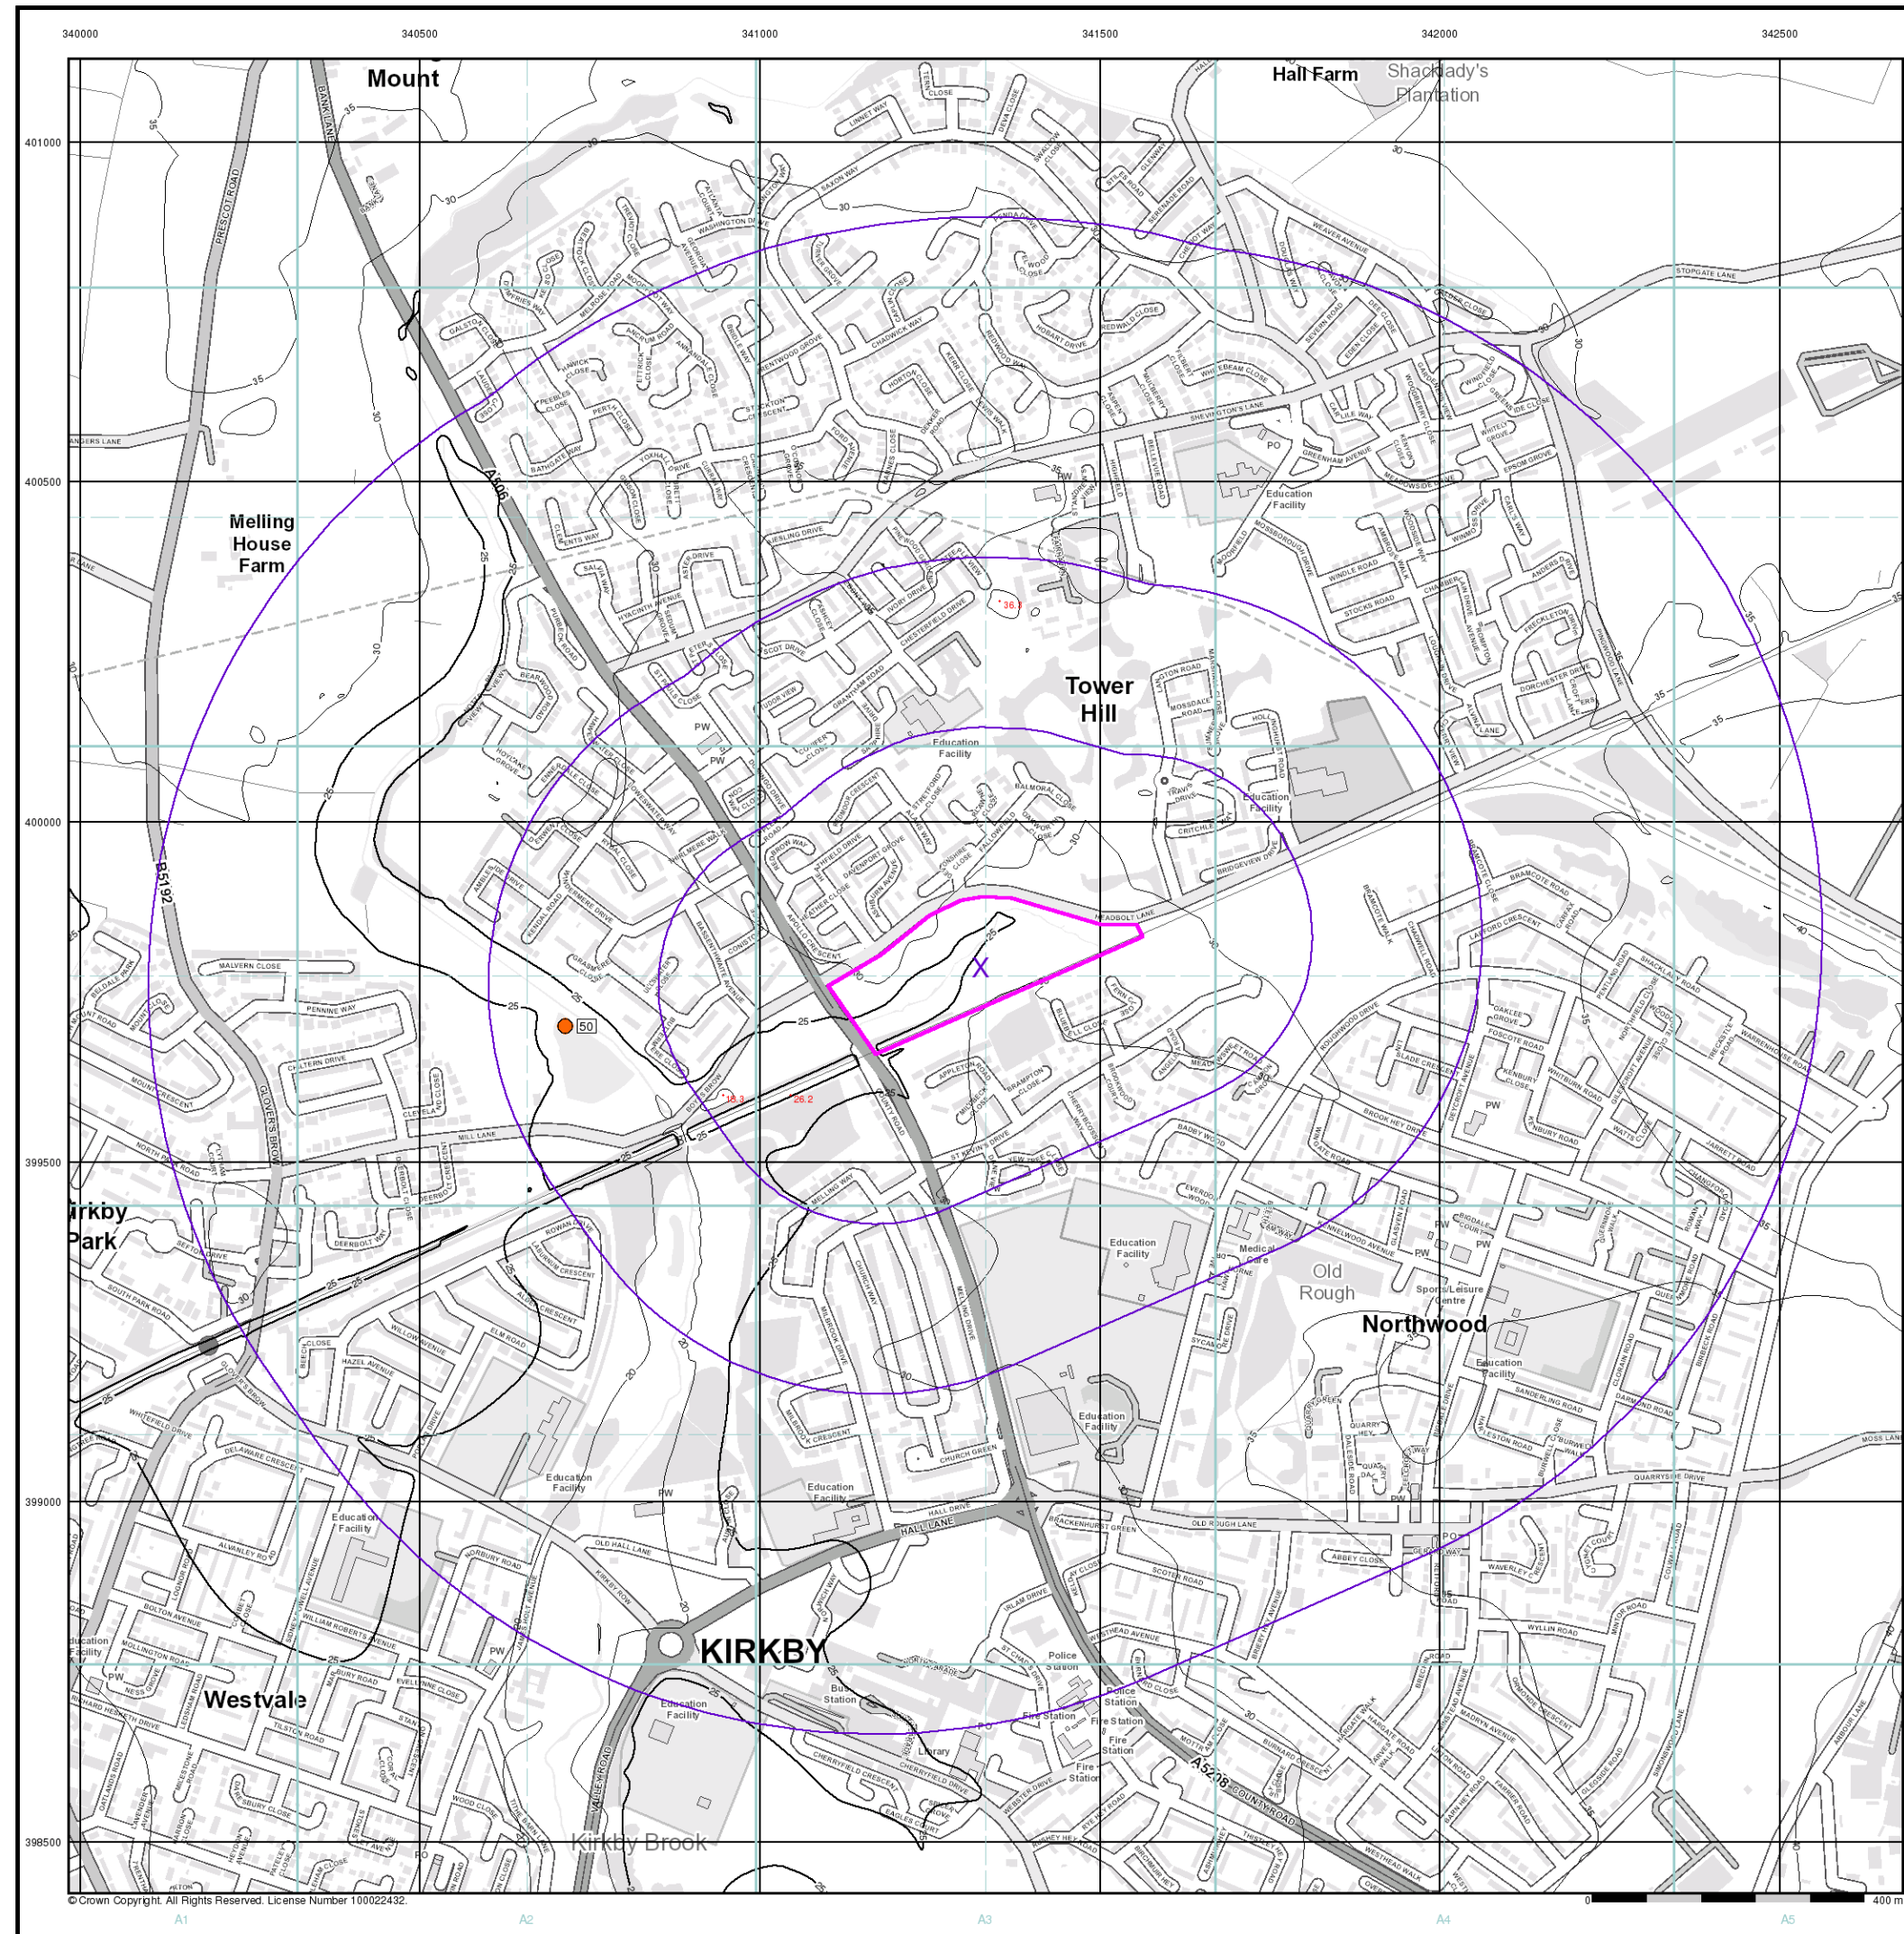
## MOTT MACDONALD EA/NRW Historic Flood Map (1:10,000)

- ### General
- Specified Site
  - Specified Buffer(s)
  - Bearing Reference Point
  - Map ID
- ### Historic Flood Events Data
- |                                                |                                       |
