## Proposed Roof repairs

### Change Grow Live

**22-24 Newtown Gardens Kirkby**

**25 - AREA OF ROOF REPAIR**

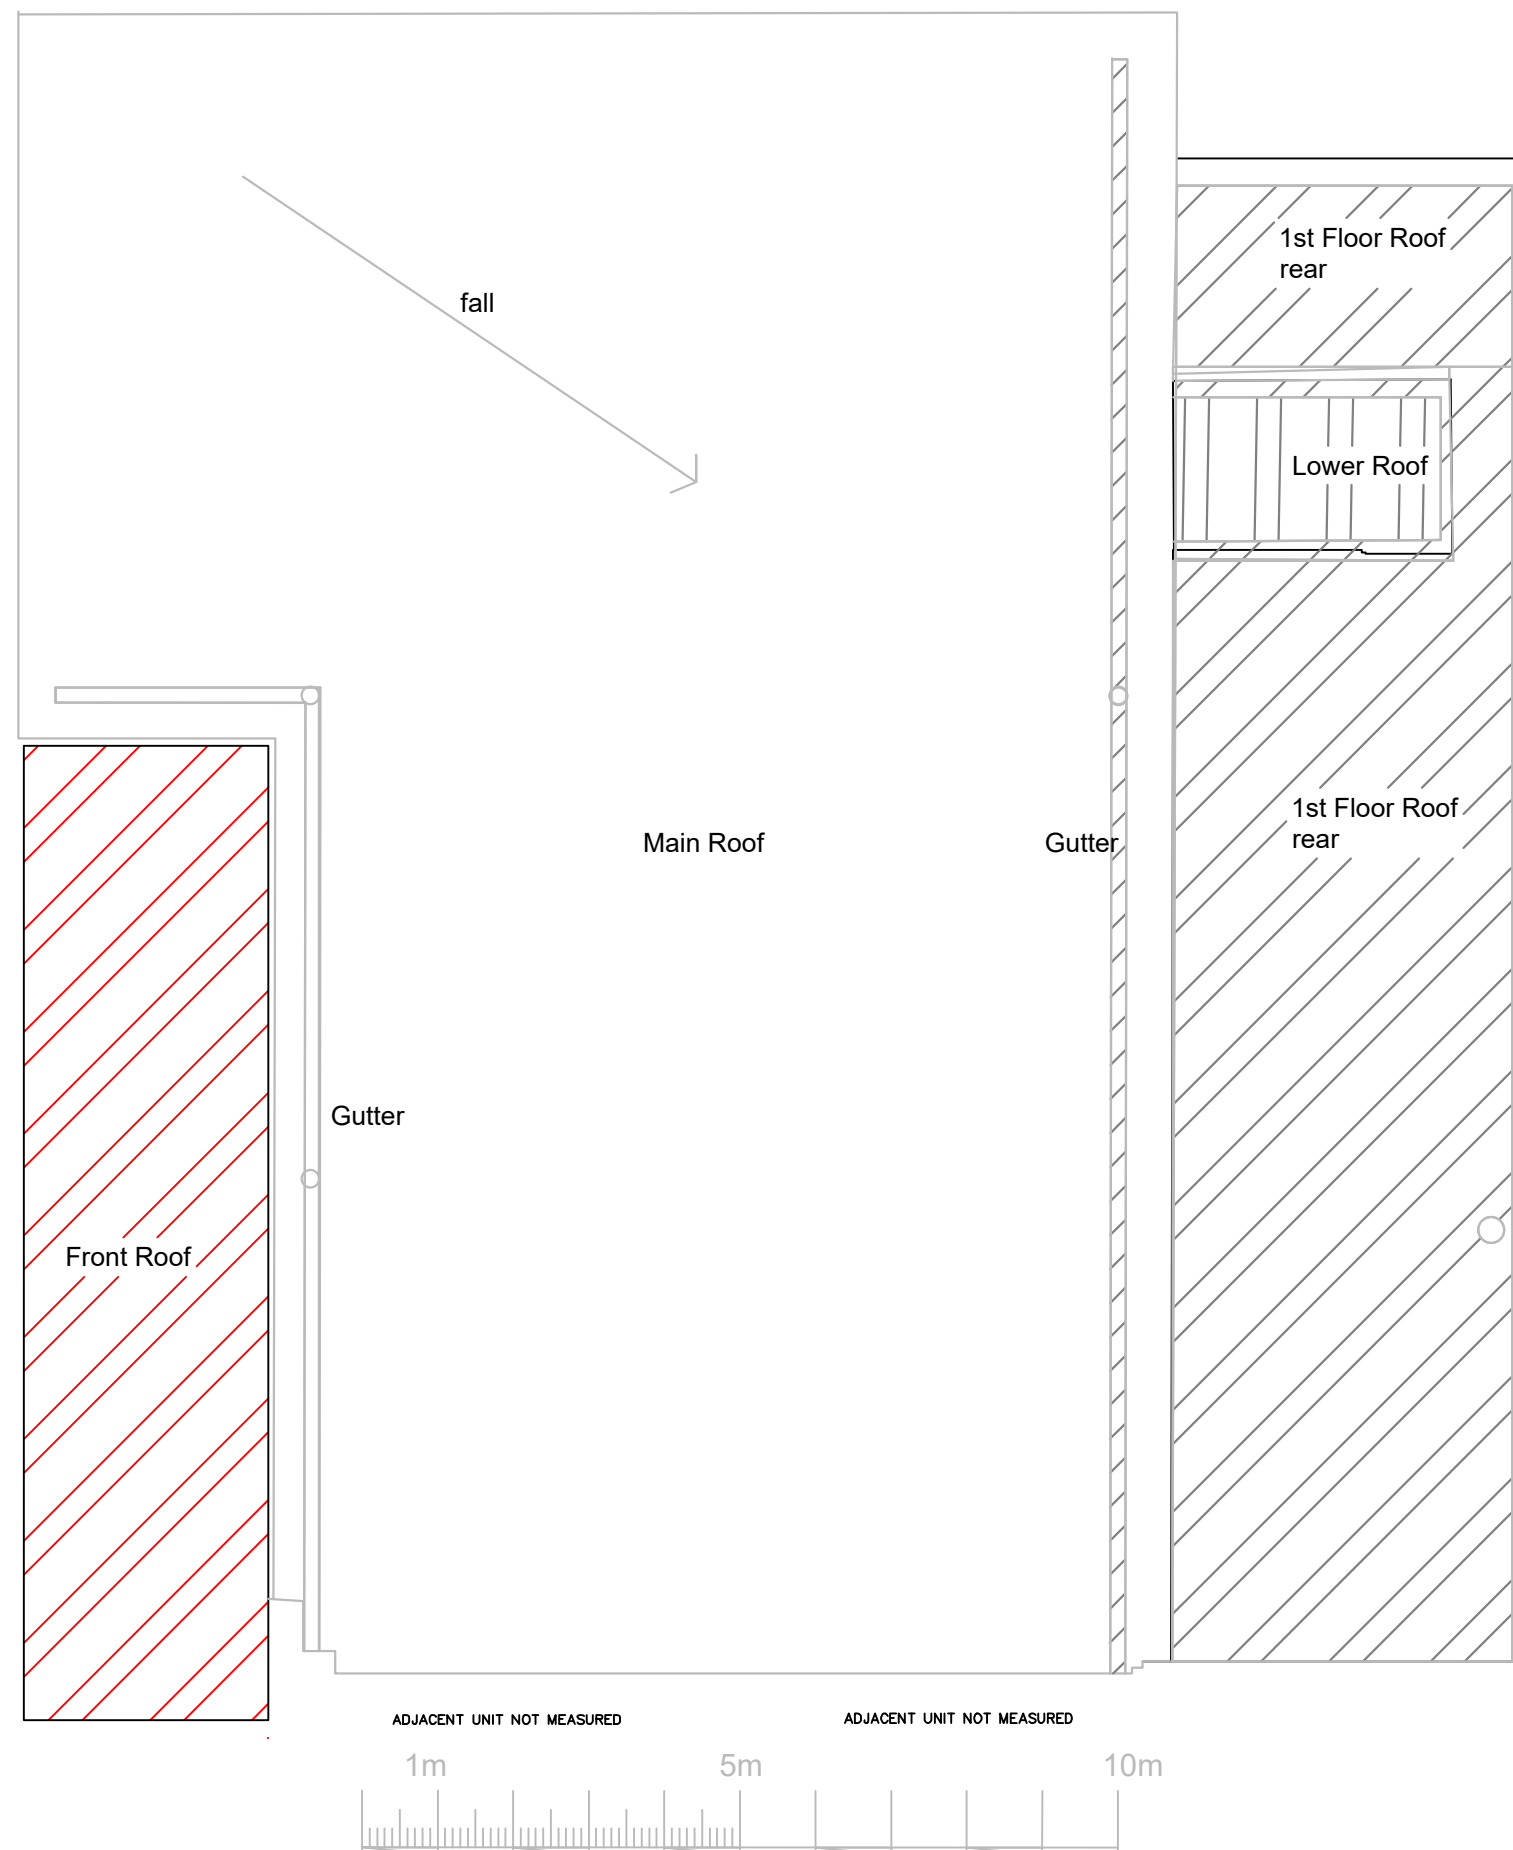
| | 1st Floor Roof rear CGL to repair |
| | Lower Roof CGL to repair |
| | Main Roof CGL to Repair |
| | Front Roof Landlord to repair as discussed with Paul Wilson |

The roof consists of concrete slab with drainage built in. Edges have no fascia board appears to be painted concrete.  
Apply liquid applied roofing membranes such as Dacfill HZ, Eagle Desmopol Liquid Polyurethane Membrane.  
Insulation is recommended internally, external will cause drainage issues

# AREA OF ROOF REPAIRS
