# ARBORICULTURAL METHOD STATEMENT

PROPOSED DEVELOPMENT

26 BAILEYS LANE  
KNOWSLEY

Ref: TRE/26BLK

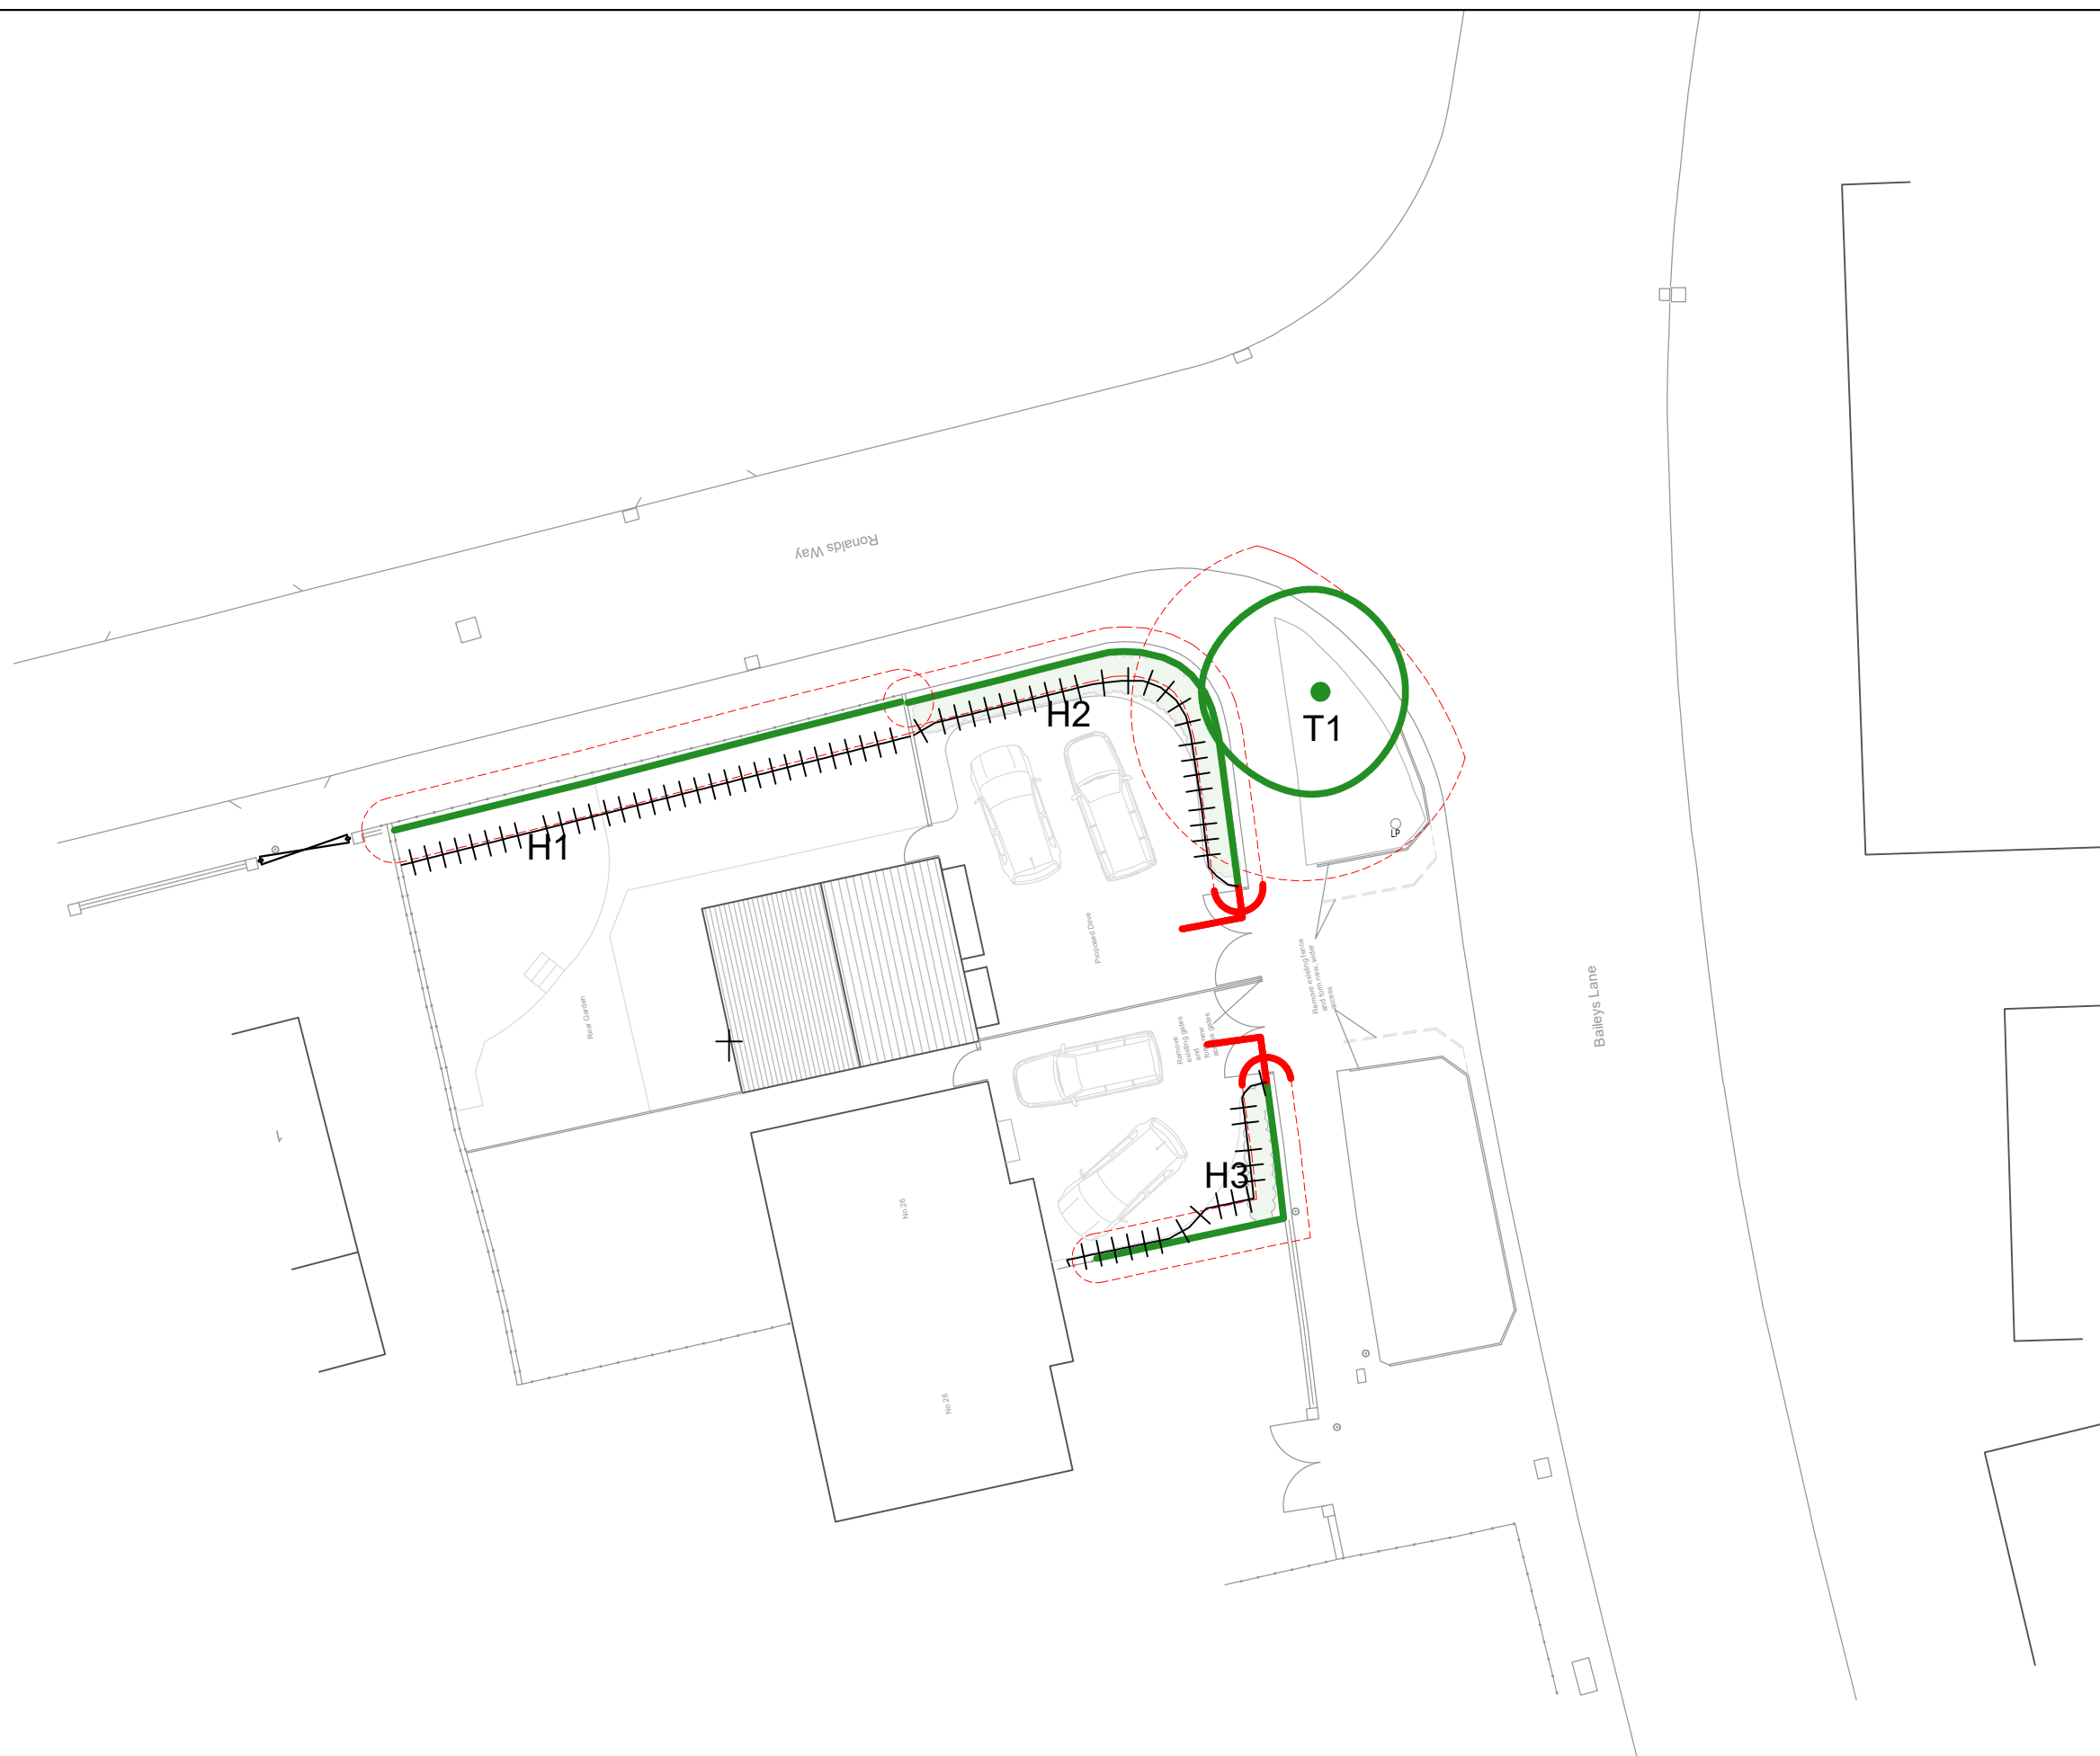
Drawing No:  
26BLH/MS/01

Existing Trees Retained
-

Existing Trees Removed
-

Root Protection Area
-

Tree protection fencing

Drawing Title:  
Method Statement Plan

| Tree No. | Proposed Works |
|---|---|
| H2 & H3 | Fell Small Section to Allow for Access |

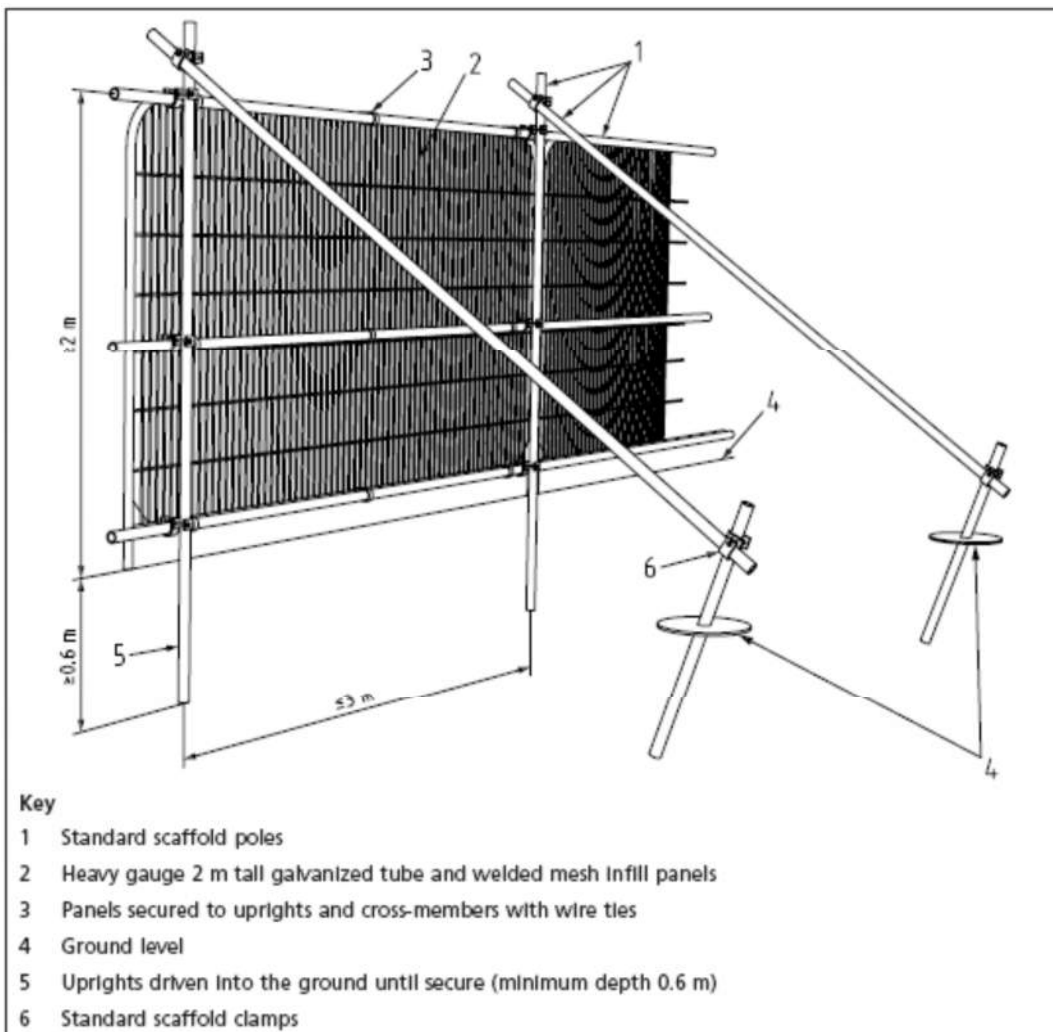
## Tree Protection Fencing (BS5837: 2012)

### **Tree Protection Fencing**

- 2.2.1 The fencing should be strong and suitable for local conditions. It should also take into account the degree of construction activity on the site.
- 2.2.2 The fencing should be at least 2.3m in height and should be erected with both a vertical and horizontal scaffolding framework capable of withstanding impact, with vertical tubes spaced at a maximum of 3 m. This should support either weldmesh panels which should be securely fixed with wire or scaffold clamps.
- 2.2.3 Notices should also be erected on the fencing stating ‘Protected Area - No operations within fenced area’.
- 2.2.4 The positioning of the protective fencing is also very important and should be erected in the proposed location identified in Appendix One. Once the fence has been erected it should never be crossed and particular care should be taken not to store any materials or soil within the protected area.
