# ARBORICULTURAL IMPLICATIONS ASSESSMENT

PROPOSED DEVELOPMENT

OLYMPIC OILS  
WHISTON

Author: C. Salisbury  
Date: 15 December 2023  
Ref: TRE/OOW

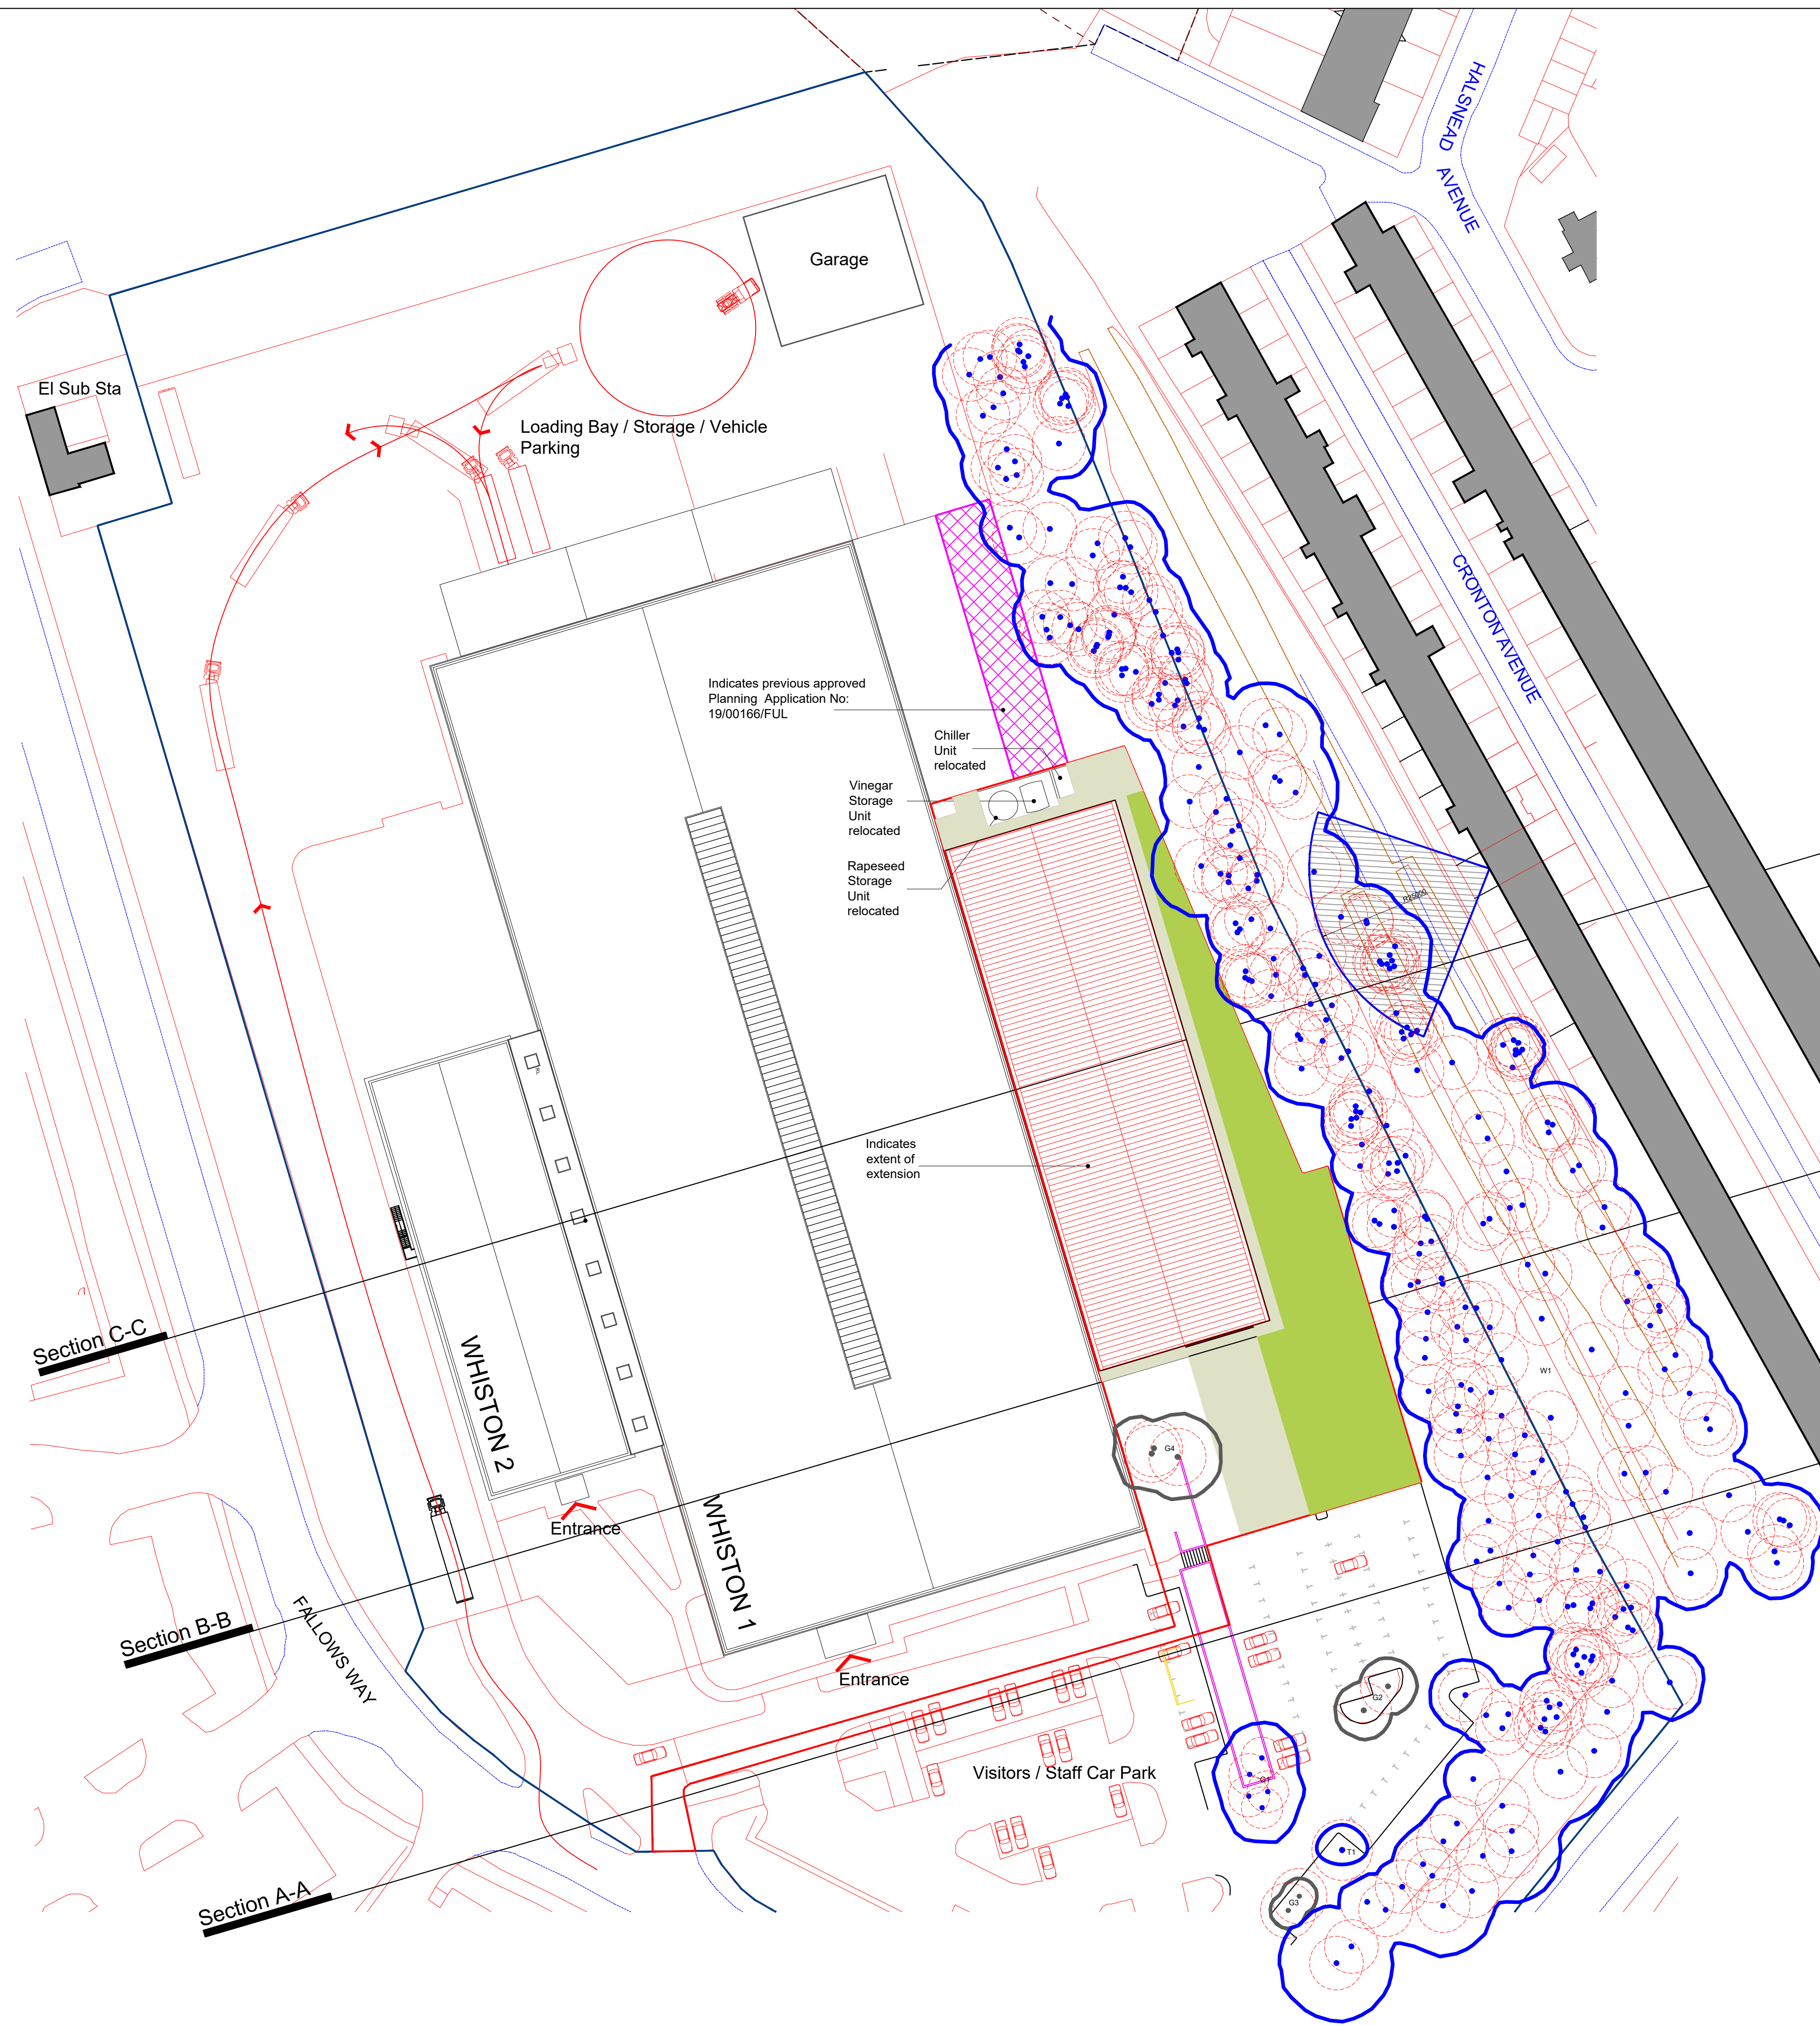
Drawing Title:  
 AIS Plan

- 3.1 Due to the proposed development and its associated infrastructure there are a number of locations where the proposals are in close proximity to the trees surveyed. The Site Layout Plan within appendix three identifies the trees in relation to the proposed development.
- 3.2 In order to fully assess the impact of the proposals an Impact Table has been created detailing each tree, which shows the proximity of the associated works to the tree.
- 3.3 This can then be assessed in accordance with BS 5837:2012 to determine whether the development will have a detrimental impact on the health of each tree. Once this has been determined remedial measures can be detailed to reduce the impact the proposals will have on the treescape.
