# Phase I and II Geoenvironmental Site Assessment

Site: Glen Dimplex, Prescott

Reference: 17-500-R1-2

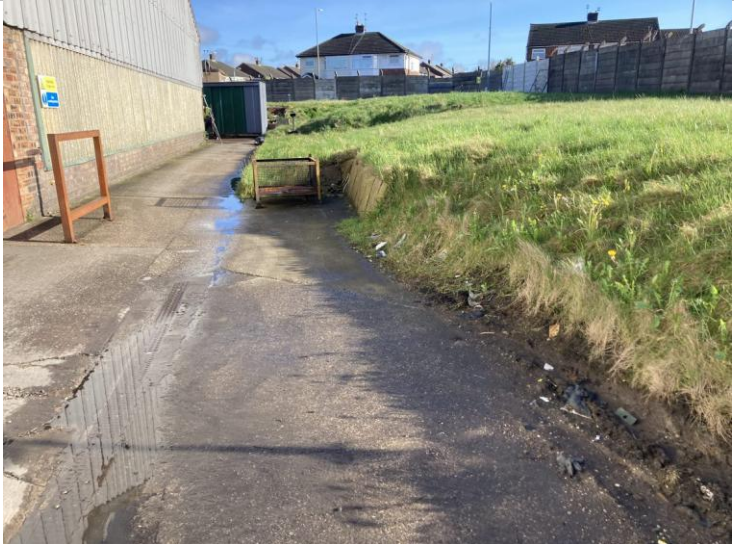
| FEATURE | DESCRIPTION | PHOTOGRAPHIC EVIDENCE |
|---|---|---|
| <b>Retaining Structures</b> | <p>Small retaining structures were noted in the small area of landscaping towards the east of the main factory structure.</p> <p>Further retaining walls were noted along the northern boundary adjacent to Stoney Lane to the north of the structure.</p> | |

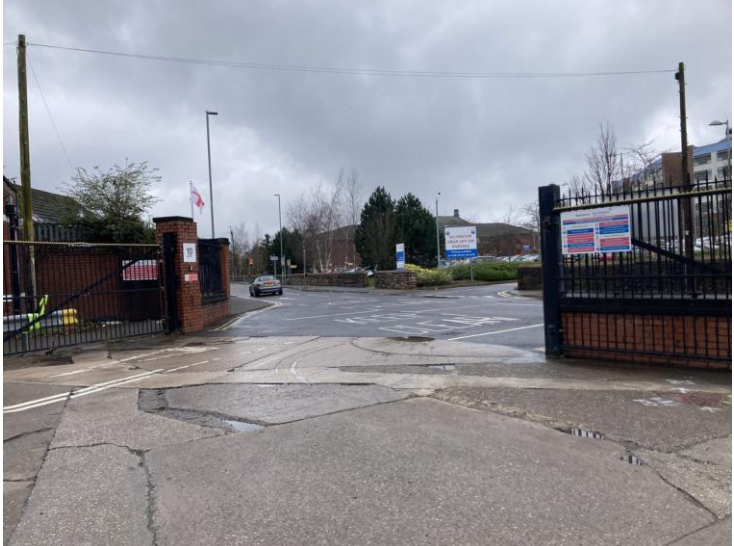
| FEATURE | DESCRIPTION | PHOTOGRAPHIC EVIDENCE |
|---|---|---|
| <b>Access</b> | <p>Surrounding the main factory structure, a service road is present to the south and the west, connecting to Stoney Lane at the north.</p> <p>Access for both pedestrians and vehicles can be gained at the northwest off Stoney Lane in Prescot.</p> <p>The access is restricted with security adjacent at the northwest, which is manned 24 hours.</p> | |

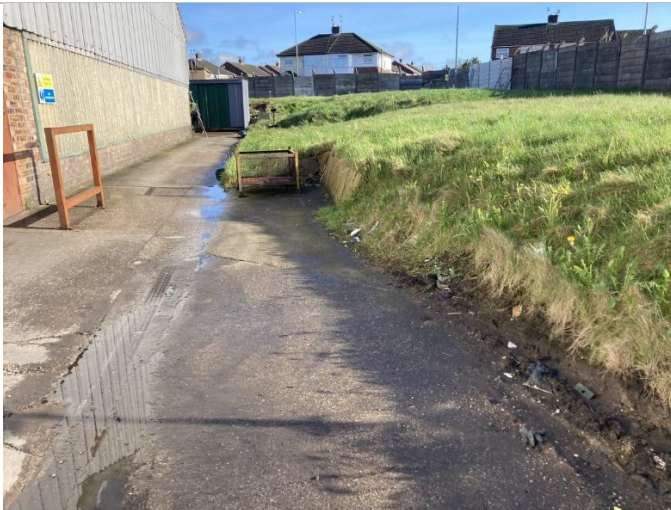
| FEATURE | DESCRIPTION | PHOTOGRAPHIC EVIDENCE |
|---|---|---|
| <b>Slope</b> | <p>Minor slopes were identified particularly at the northern boundary and towards the west at the soft cover adjacent to the structure.</p> <p>A small retaining structure is noted at the southern face adjacent to the building.</p> | |

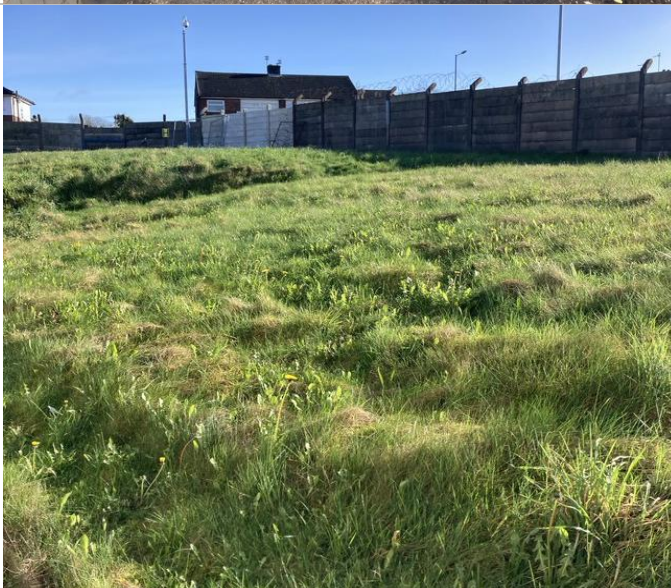
| FEATURE | DESCRIPTION | PHOTOGRAPHIC EVIDENCE |
|---|---|---|
| <b>Vegetation/Ecology</b> | <p>No significant instances of vegetation/ecology were noted with the exception of small areas of soft cover landscaping (managed grasses) are noted at the north and east of the structure, with semi sporadic semi-mature trees towards the northern boundary.</p> | |

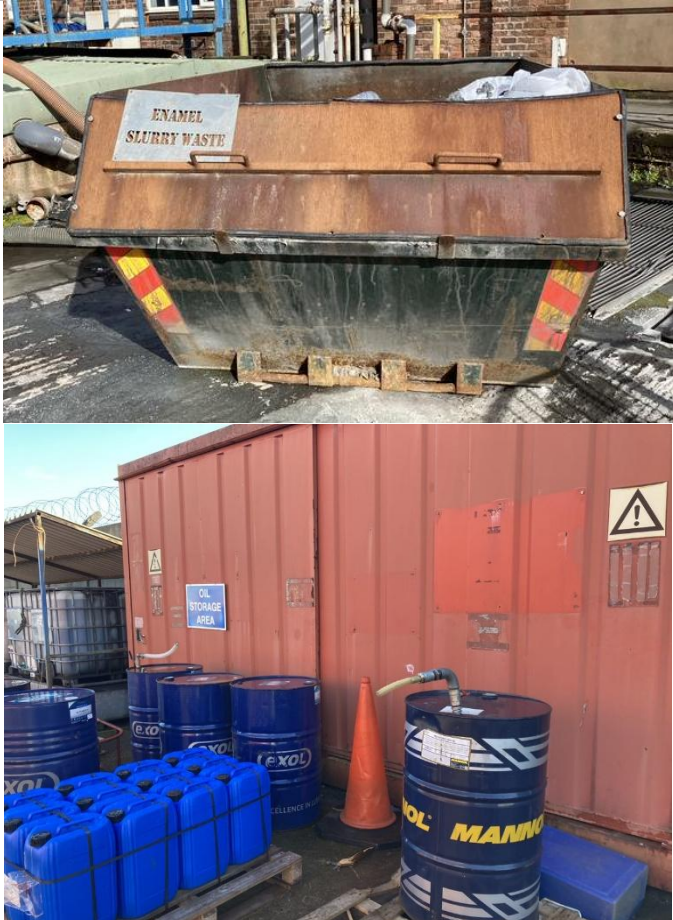
- ✳ Localised areas of elevated Trichloroethene (TCE), Dichloroethene (cis 1,2-Dichloroethene, and Trans 1,2-Dichloroethene), and Vinyl Chloride have been identified within soils in three locations (WS101 to WS103) across the southern boundary of the site, directly to the south of the main factory structure. It is noted that WS102 and WS103 are located within the immediate vicinity of the enamel slurry waste storage area, located to the southeast of the main factory structure. As such, the enamel slurry waste storage area may be the potential source of these exceedances.

| FEATURE | DESCRIPTION | PHOTOGRAPHIC EVIDENCE |
|---|---|---|
| <b>Hazardous Material Storage</b> | <p>An enamel slurry waste storage area was recorded to the southeast of the main factory structure both in an above ground waste skip pictured to the right, and in a below ground storage tank.</p> <p>Two large above ground oil storage containers were noted to the west of the structure, with all containers identified in good condition with no sign of damage.</p> <p>Further instances of hazardous material storage is anticipated within the factory. However, this has not been confirmed at the time of the walkover as a full survey of the factory interior has not been completed.</p> | <p>The top photograph shows a large, weathered metal waste skip with a sign that reads 'ENAMEL SLURRY WASTE'. The skip is situated outdoors on a paved area. The bottom photograph shows a red storage container with a sign that reads 'OIL STORAGE AREA'. In front of the container are several blue oil drums and a pallet of blue jerrycans. A yellow hazard warning sign is visible on the container.</p> |

- ✳ If the enamel slurry waste storage area is deemed to be the source, removal of the impacted material is recommended to mitigate any further migration and degradation of TCE into further areas of the site. Subject to the findings of further phases of intrusive ground investigation, further assessment in the form of a Detailed Quantitative Risk Assessment (DQRA) may also be required.

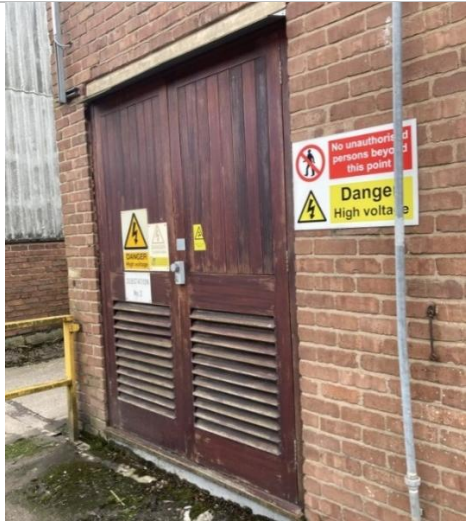
| FEATURE | DESCRIPTION | PHOTOGRAPHIC EVIDENCE |
|---|---|---|
| <b>Polychlorinated Biphenyls (PCBs)</b> | <p>Two electricity substations have been identified on-site towards the northwest and south, both of which were present prior to 1970. Therefore, it is considered likely PCBs are contained within the vicinity of these substations.</p> | |

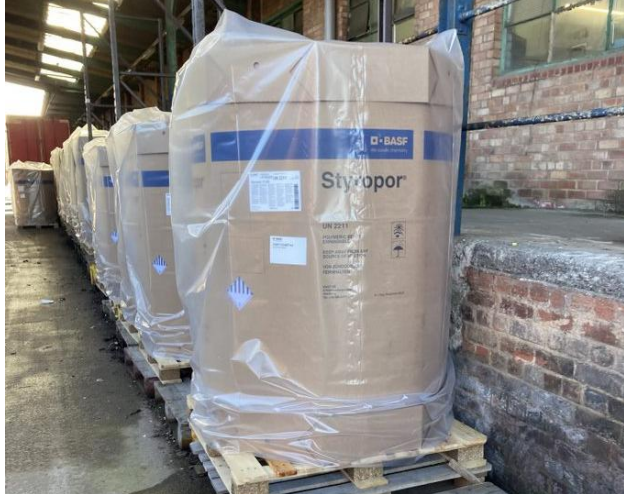
| FEATURE | DESCRIPTION | PHOTOGRAPHIC EVIDENCE |
|---|---|---|
| <b>Volatile Organic Compounds (VOCs)</b> | <p>An active polystyrene manufacturing plant was noted with large imports of polystyrene recorded at the northern boundary adjacent to the structure.</p> <p>This presents a potential source of VOCs within the vicinity of the polystyrene manufacturing plant (northern boundary), however all instances of polystyrene were well stored with all surrounding areas covered in hardstanding.</p> <p>It is understood the polystyrene manufacturing plant was constructed in 2006, and that during the site walkover, no evidence of above or below ground storage tanks of VOCs were identified. However, as access to the plant was restricted due to its active nature, the presence of storage tanks within the plants interior cannot be fully discounted at this time.</p> | |

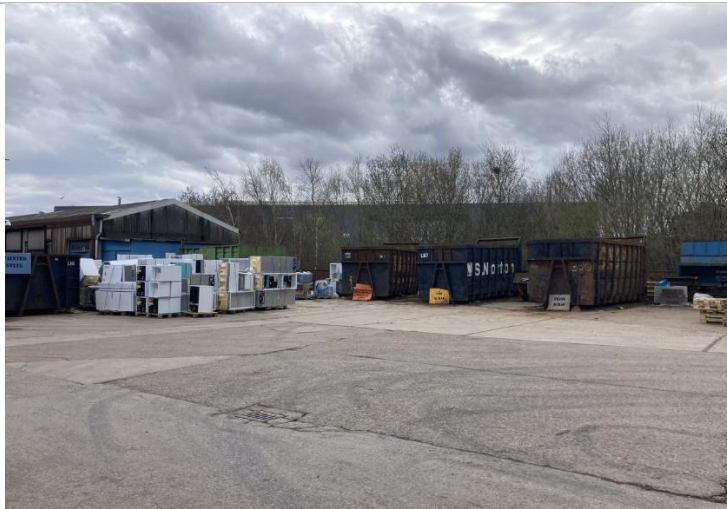
| FEATURE | DESCRIPTION | PHOTOGRAPHIC EVIDENCE |
|---|---|---|
| <b>Waste Storage</b> | <p>Non-hazardous waste storage was present in large containers to the south of the main factory structure adjacent to the two small outbuildings.</p> <p>Some localised areas of fly tipped material was noted across the site however none appeared hazardous.</p> | |

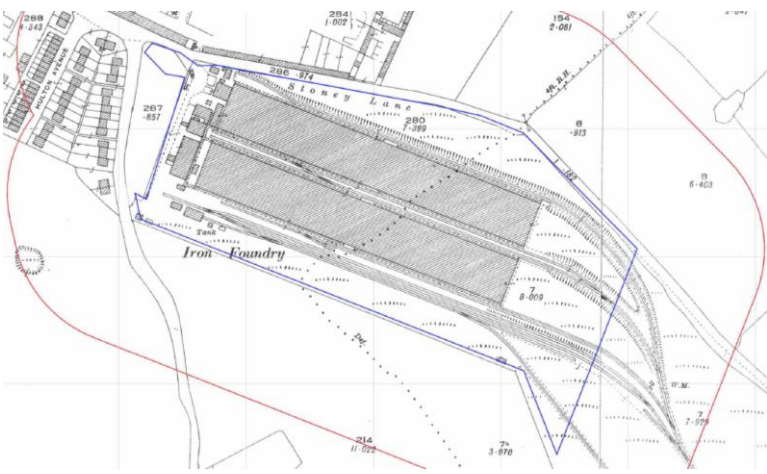
| MAP EDITION | HISTORICAL LAND USE | HISTORICAL MAP EXCERPT |
|---|---|---|
| <p><b>1927</b><br/><b>1:2,500</b></p> | <p>A tank is noted at the southern boundary adjacent to the railway sidings to the south of the structure.</p> <p>No other significant changes have been identified.</p> | |

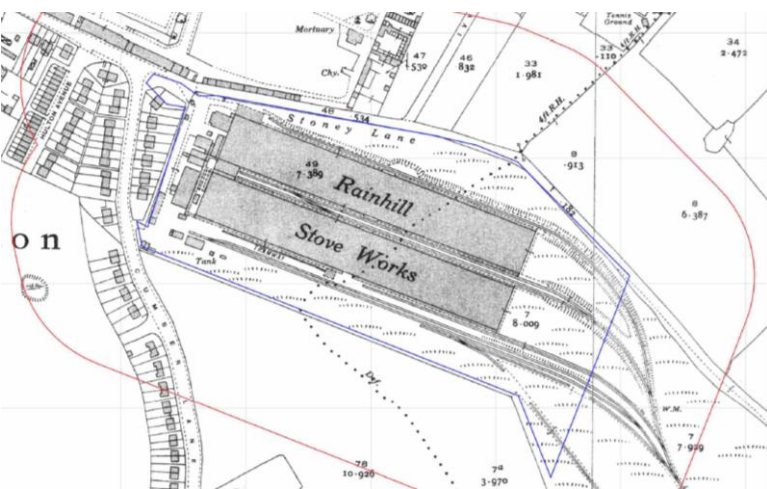
| MAP EDITION | HISTORICAL LAND USE | HISTORICAL MAP EXCERPT |
|---|---|---|
| <p><b>1937</b><br/><b>1:2,500</b></p> | <p>The site is now named Rainhill Stove Works.</p> <p>A small extension to the structure at the northeast of the works structure is noted.</p> <p>Changes to the cutting at the centre of the northern works structure is noted now protruding further north than previous mapping.</p> <p>The sidings to the south are now noted as tramway sidings, with a small portion of the branch traversing southeast removed.</p> | |

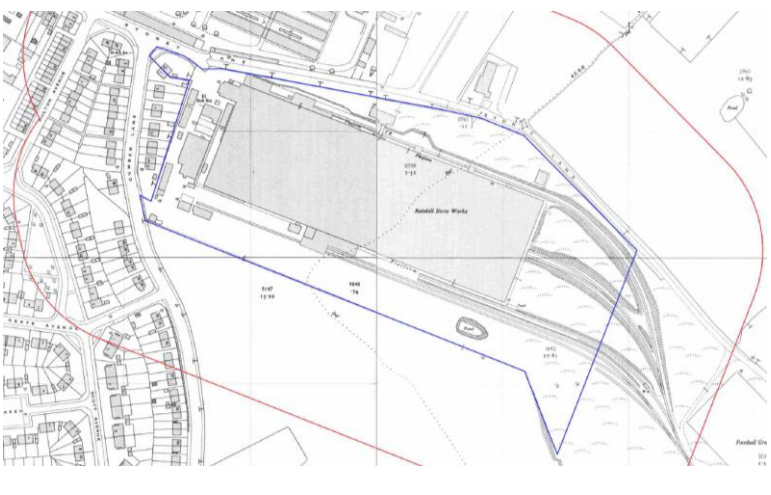
| MAP EDITION | HISTORICAL LAND USE | HISTORICAL MAP EXCERPT |
|---|---|---|
| <p><b>1954-1955</b><br/><b>1:1,250</b></p> | <p>The site now comprises one large structure, with the sidings previously noted segmenting the two structures removed.</p> <p>Additional outbuildings have been constructed towards the northeast of the site with an electricity substation noted to the northwest of the main factory structure.</p> <p>A small pond is noted at the southern boundary adjacent to the sidings towards the east.</p> <p>The tank previously recorded at the southwestern boundary has been removed with a new tank recorded present at the southeastern corner of the main factory structure.</p> <p>Two platforms at the north and south of the main factory structure are noted.</p> | |

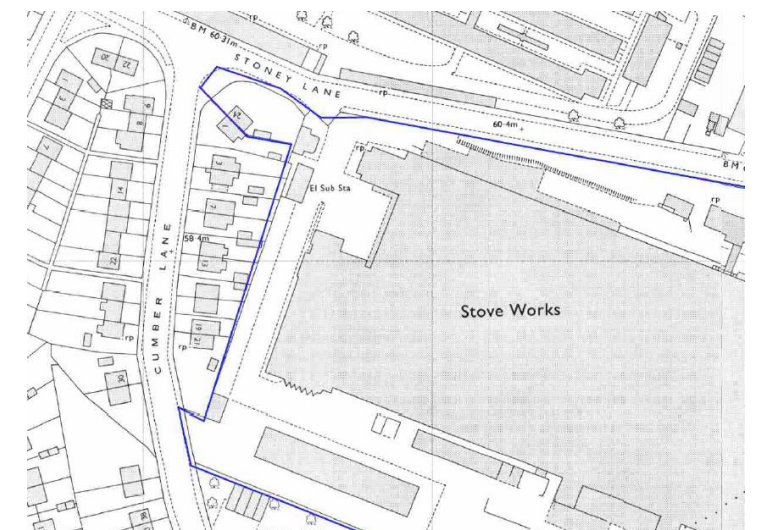
| MAP EDITION | HISTORICAL LAND USE | HISTORICAL MAP EXCERPT |
|---|---|---|
| <p><b>1972-1975</b><br/><b>1:1,250</b></p> | <p>The separated outbuildings previously noted along the western boundary have either been removed or incorporated into the main factory structure.</p> <p>An additional connecting structure is noted at the central northern point of the main factory structure.</p> <p>The structure at the southwestern sector of the site is noted as extended.</p> <p><i>Other sectors of the site are not available within historical mapping.</i></p> | |

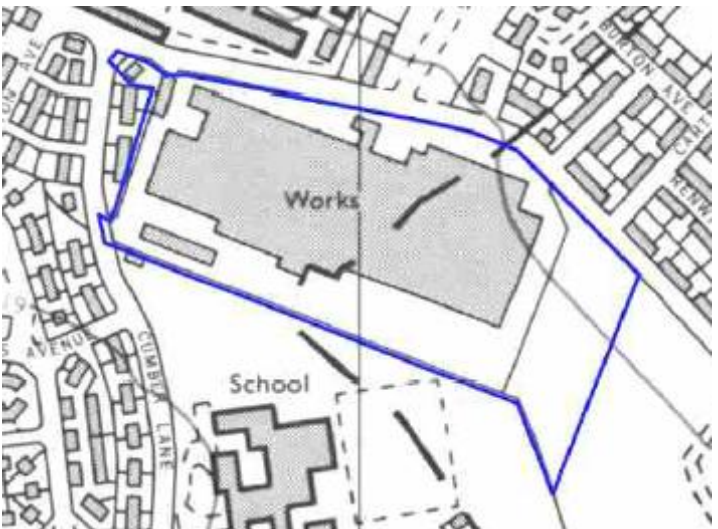
| MAP EDITION | HISTORICAL LAND USE | HISTORICAL MAP EXCERPT |
|---|---|---|
| <p><b>1978</b><br/><b>1:10,000</b></p> | <p>All railway and tramway sidings present in previous mapping have now been removed.</p> <p>A County Parish boundary is noted segmenting the site through the centre of the site.</p> <p>A segmenting boundary is noted at the eastern sector of the site, separating the area from the main works structure. It is assumed this is the construction of the car parking area.</p> | |

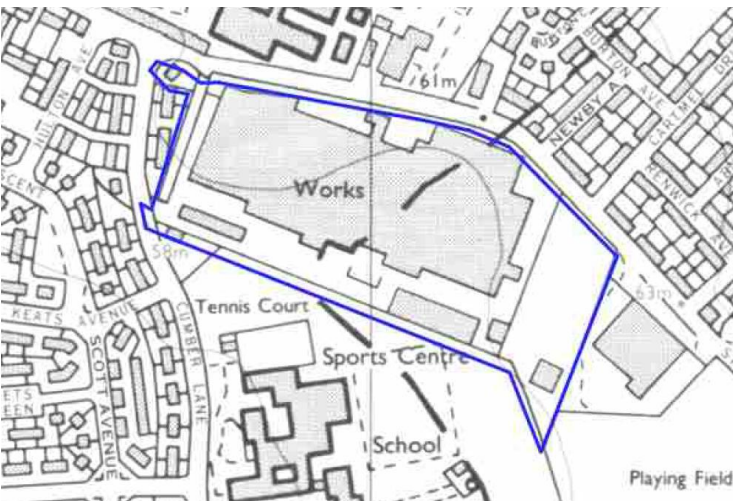
| MAP EDITION | HISTORICAL LAND USE | HISTORICAL MAP EXCERPT |
|---|---|---|
| <p><b>1990</b><br/><b>1:10,000</b></p> | <p>Small compositional changes to the main factory structure have been identified, with expansions noted towards the northern and southeastern sector of the main factory structure.</p> <p>Additional structures are noted at the southeastern and southern sectors of the site.</p> <p>Further boundaries segmenting the western sector of the site are noted.</p> | |

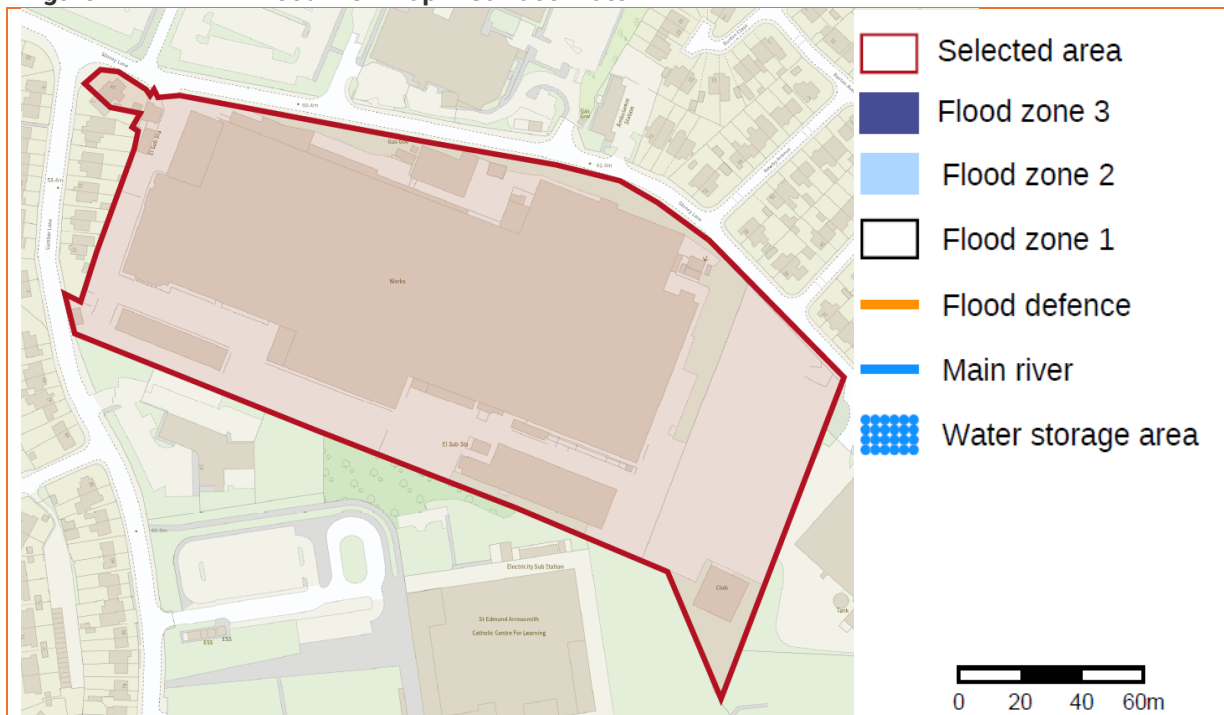
**Figure 1 EA Flood Risk Map – Surface Water**

The site is predominantly located within a currently defined “Flood Risk Zone 1”, defined as land assessed as having less than 1 in 1,000 annual probability of river or sea flooding (< 0.1%) and, as such, is considered to be unaffected by river flooding. In addition, the Groundsure report states there is a limited potential for groundwater flooding at the majority of the site, with discrete areas at the southeast at a moderate risk. The Environment Agency (EA) Flood Risk Maps for the site is presented in Figure 1 and Groundsure Groundwater Flooding Map in Figure 2.

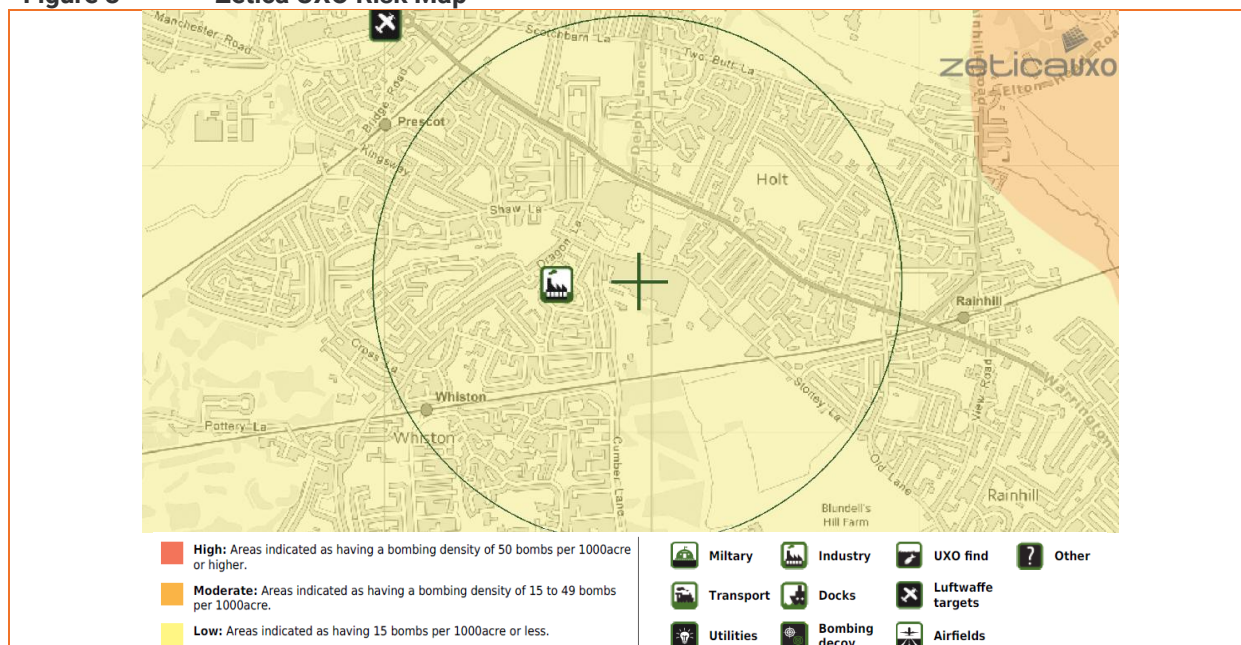
**Figure 3 Zetica UXO Risk Map**

The regional unexploded bomb risk map from Zetica (2014) indicates that the site is in an area at a low risk from possible unexploded ordnance (UXO) resulting from the Second World War. The Zetica UXO Risk Map is presented in Figure 3.

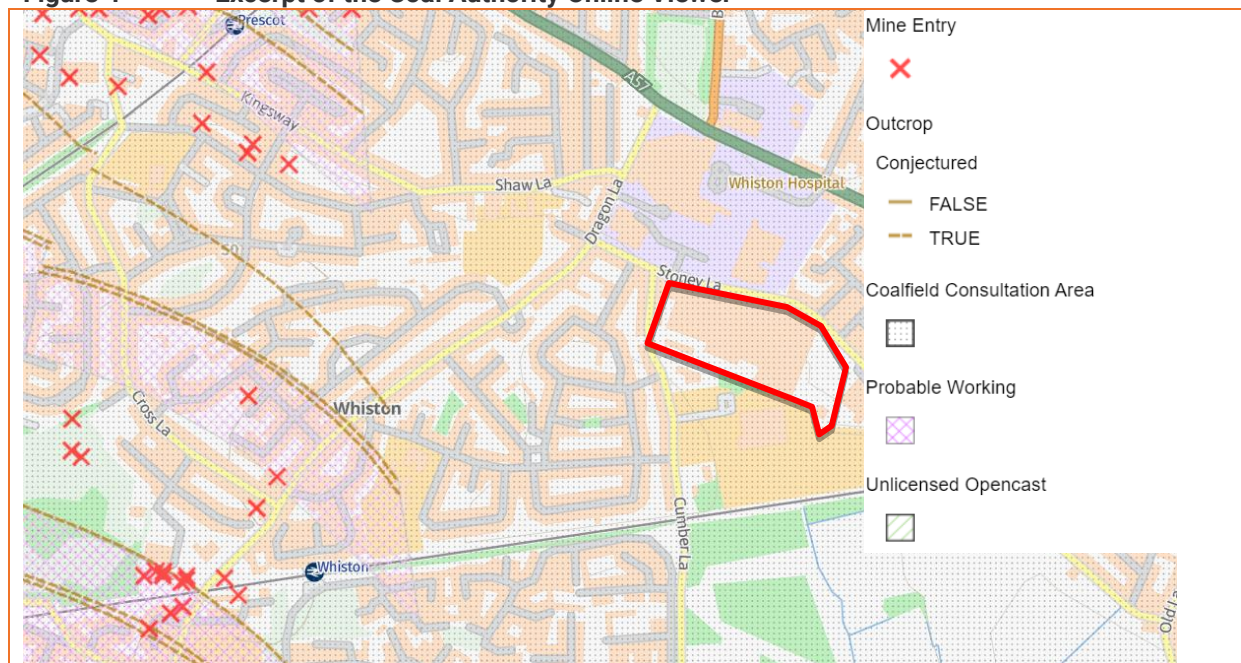
**Figure 4** Excerpt of the Coal Authority Online Viewer

In the first instance, E3P has reviewed the Coal Authority Online Viewer, and an excerpt of this is presented in Figure 4. This map shows that the site does not lie within a high-risk development area. No recorded coal seams are present on-site; the closest worked coal seam is located approximately 530 m to the west, which dip down away from the site.

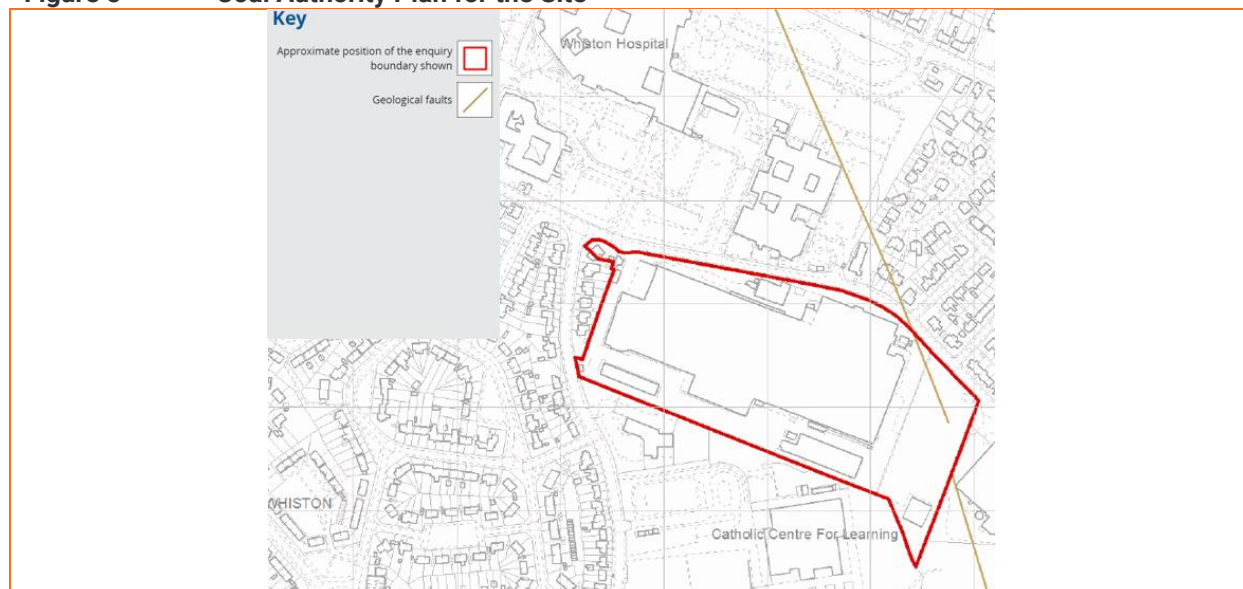
**Figure 5 Coal Authority Plan for the Site**

The Coal Authority plan referenced: MR-LARGE-PLOT-51003408185001-1709132950870 shows there are no hazardous mining associated features within the vicinity of the site as illustrated in Figure 5.

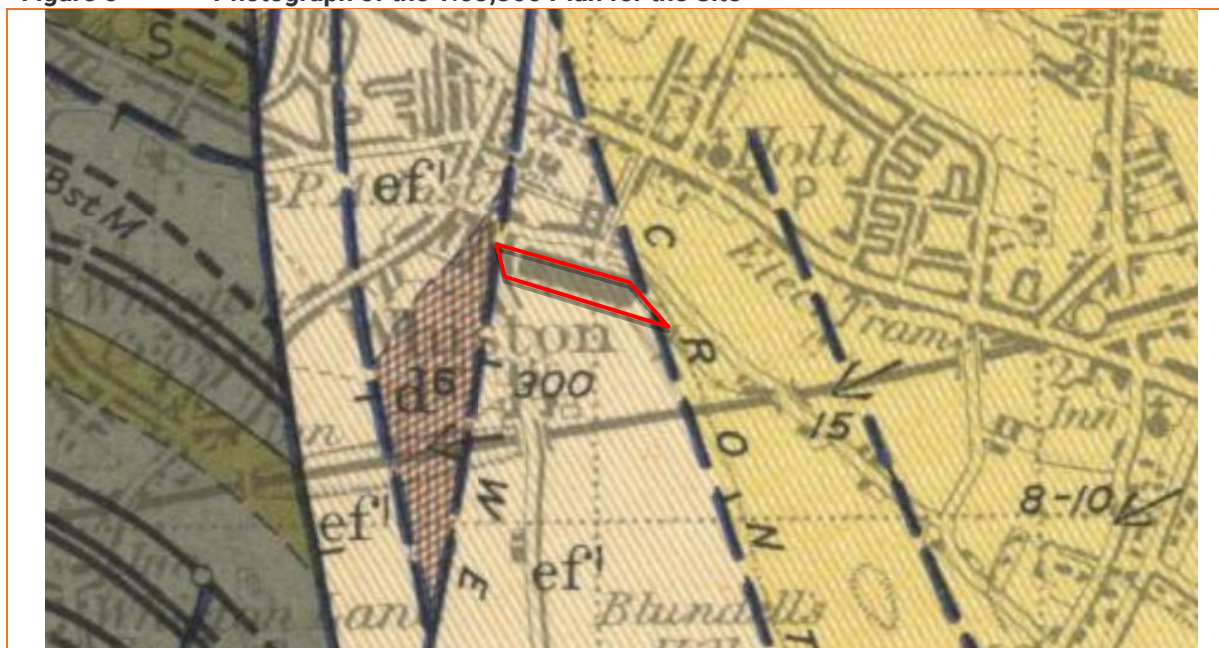
**Figure 6** Photograph of the 1:63,360 Plan for the Site

Figure 6 is a photograph of the 1:63,360 plan for the site, which shows a geological fault (Cronton Fault) traversing northwest to southeast through the eastern sector of the site, with a downthrow to the east.

No coal outcrops are recorded within an influencing distance to the site, with all known worked seams situated > 500 m to the west of the site within the Pennine Middle Coal Measures.

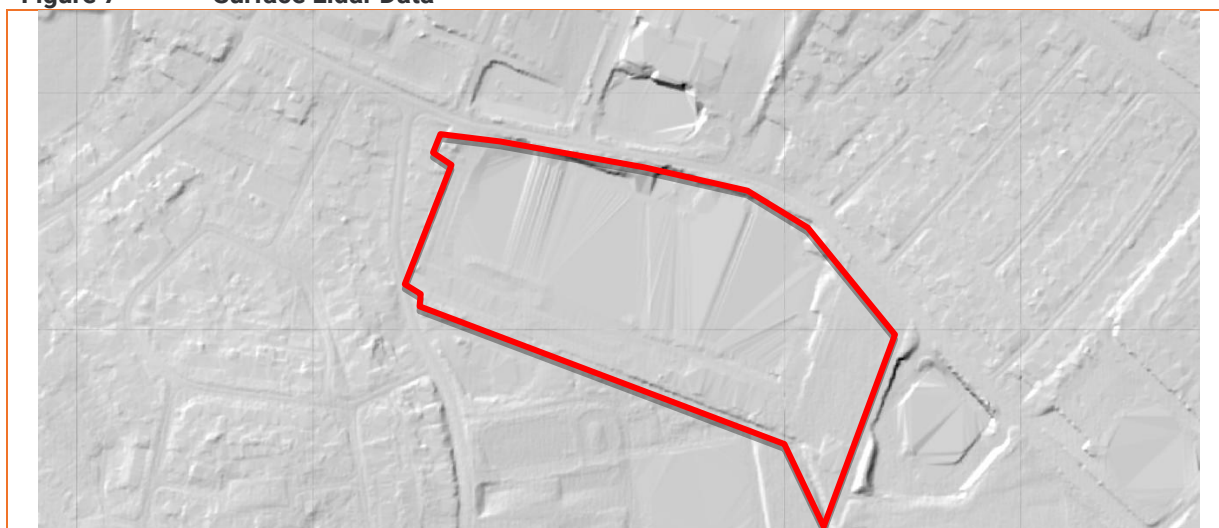
**Figure 7** Surface Lidar Data

It is possible that the historical level raising has resulted in a greater thickness of Made Ground overlying the natural glacial till and glaciofluvial deposits, and potentially underwent earthworks to create a development platform for the factory present.

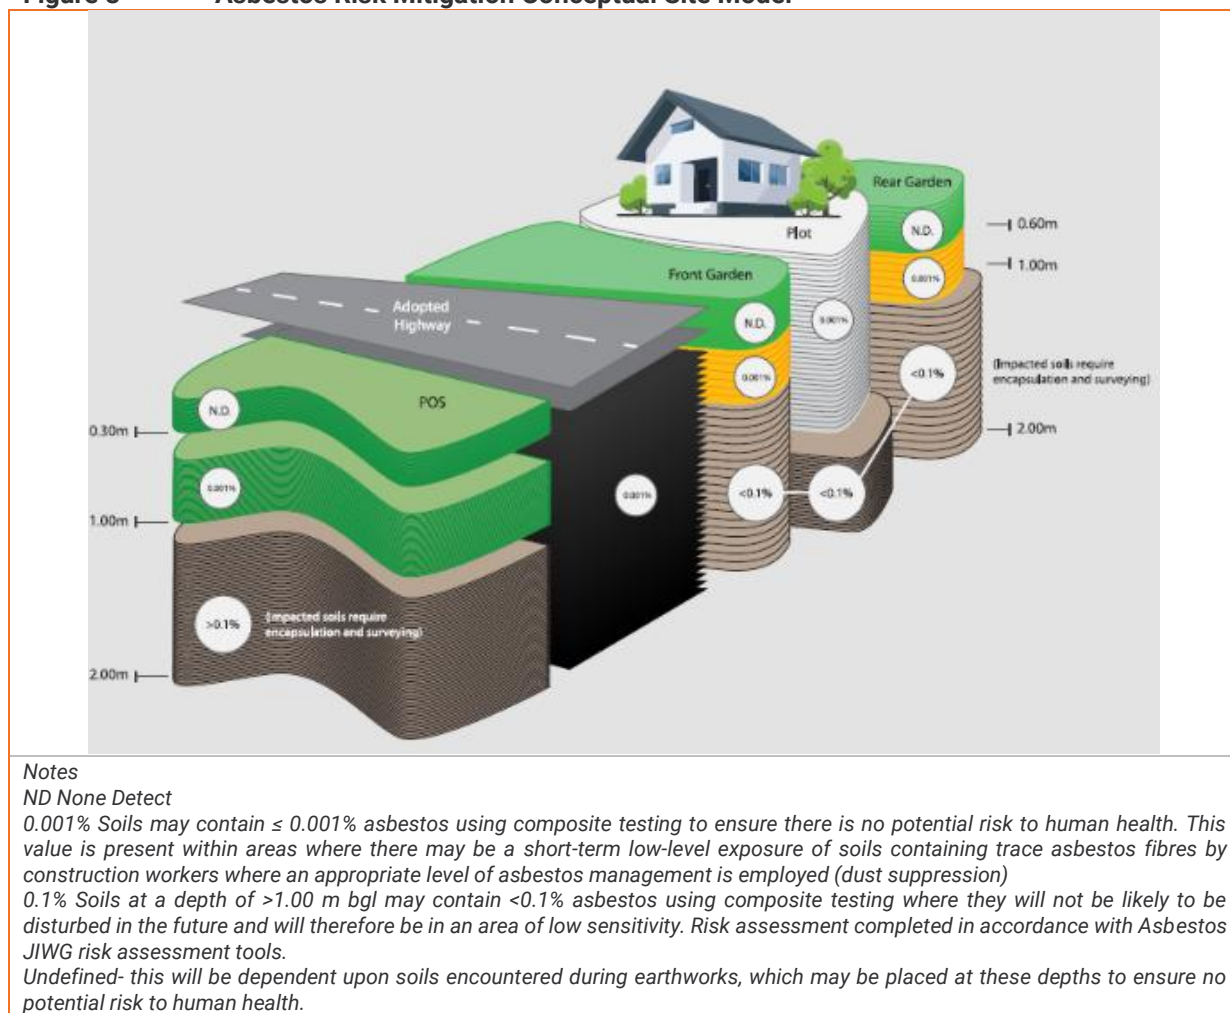
**Figure 8 Asbestos Risk Mitigation Conceptual Site Model**

If Asbestos fibres are encountered, a primary exposure pathway of inhalation of fibres (PL3) would be presented to site personnel and end users. Impacted soils should be managed according to the asbestos risk mitigation conceptual site model shown in Figure 8.

- ✳ No asbestos contamination was identified within any samples submitted for laboratory testing, however the fabric of the current main factory structure is known to contain asbestos throughout.
- ✳ Following demolition of the main factory structure, further investigation and subsequent testing is recommended in order to obtain representative soil samples of the underlying strata and determine whether the underlying soils are impacted with asbestos.
- ✳ If Asbestos fibres are encountered, a primary exposure pathway of inhalation of fibres (PL3) would be presented to site personnel and end users.
- ✳ Impacted soils should be managed according to the asbestos risk mitigation conceptual site model.

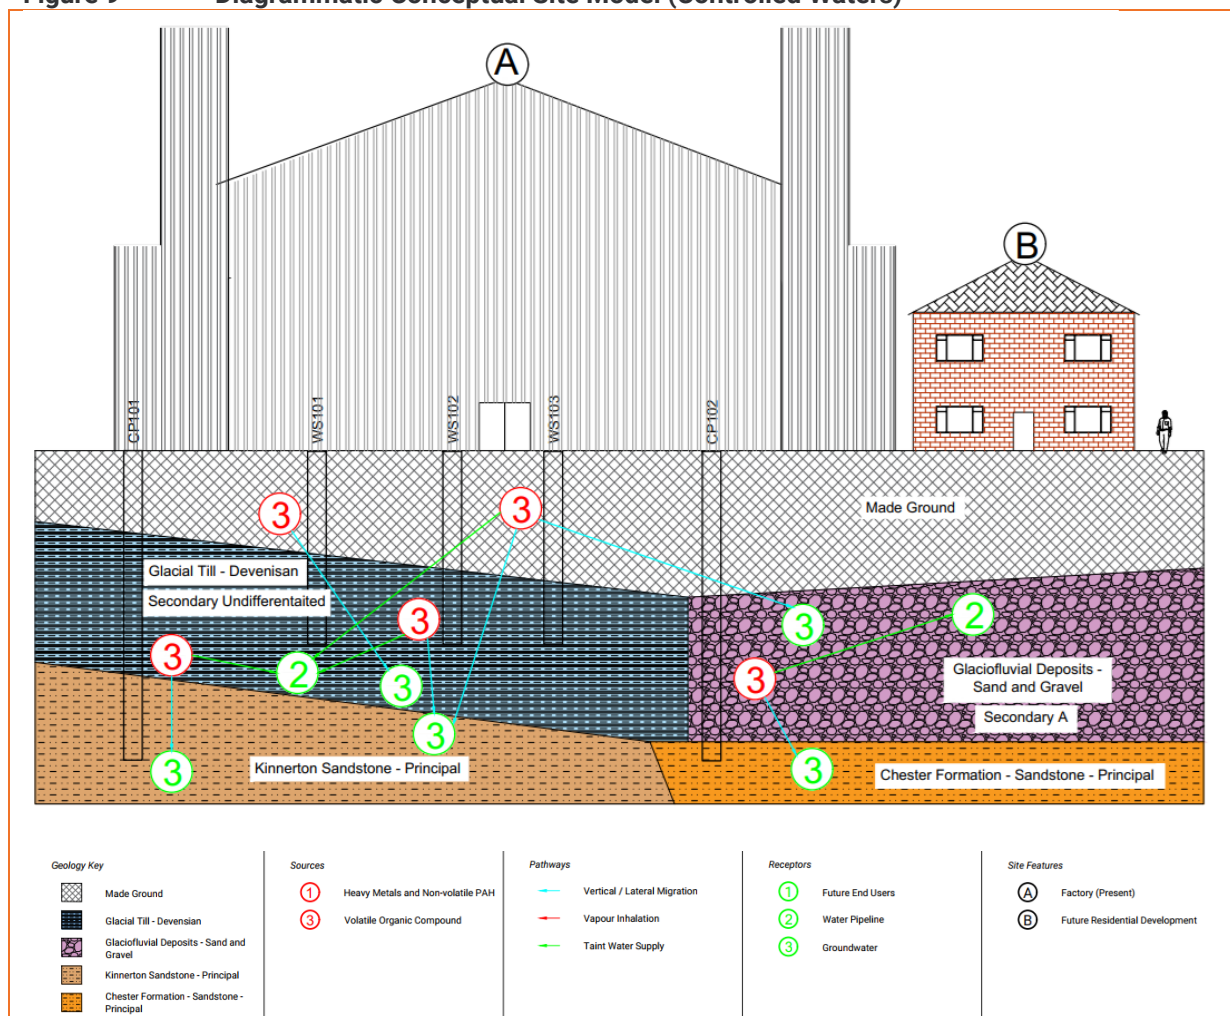
**Figure 9** Diagrammatic Conceptual Site Model (Controlled Waters)

In addition to above, E3P has developed a diagrammatic controlled waters conceptual model which considers the factors in Table 30. This is presented as Drawing 17-500-027 in APPENDIX IV and a snapshot is included in Figure 9.

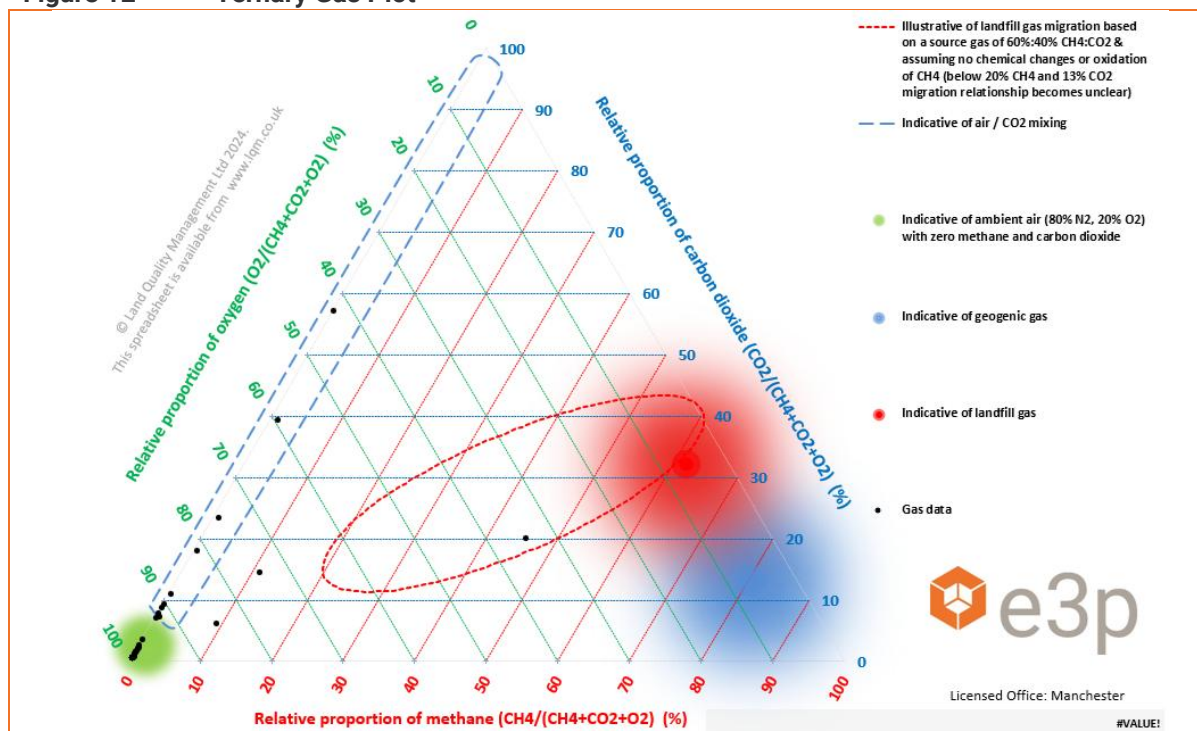
**Figure 12 Ternary Gas Plot**

Figure 12 shows the ternary gas plot for the gas monitoring data.

The ternary gas plot indicates the majority of the ground gas monitoring results have standard oxygen and generally low carbon dioxide concentrations with limited occasions of carbon dioxide concentrations above 5%, and no elevated methane, which is indicative of natural sources (green area on the ternary plot).

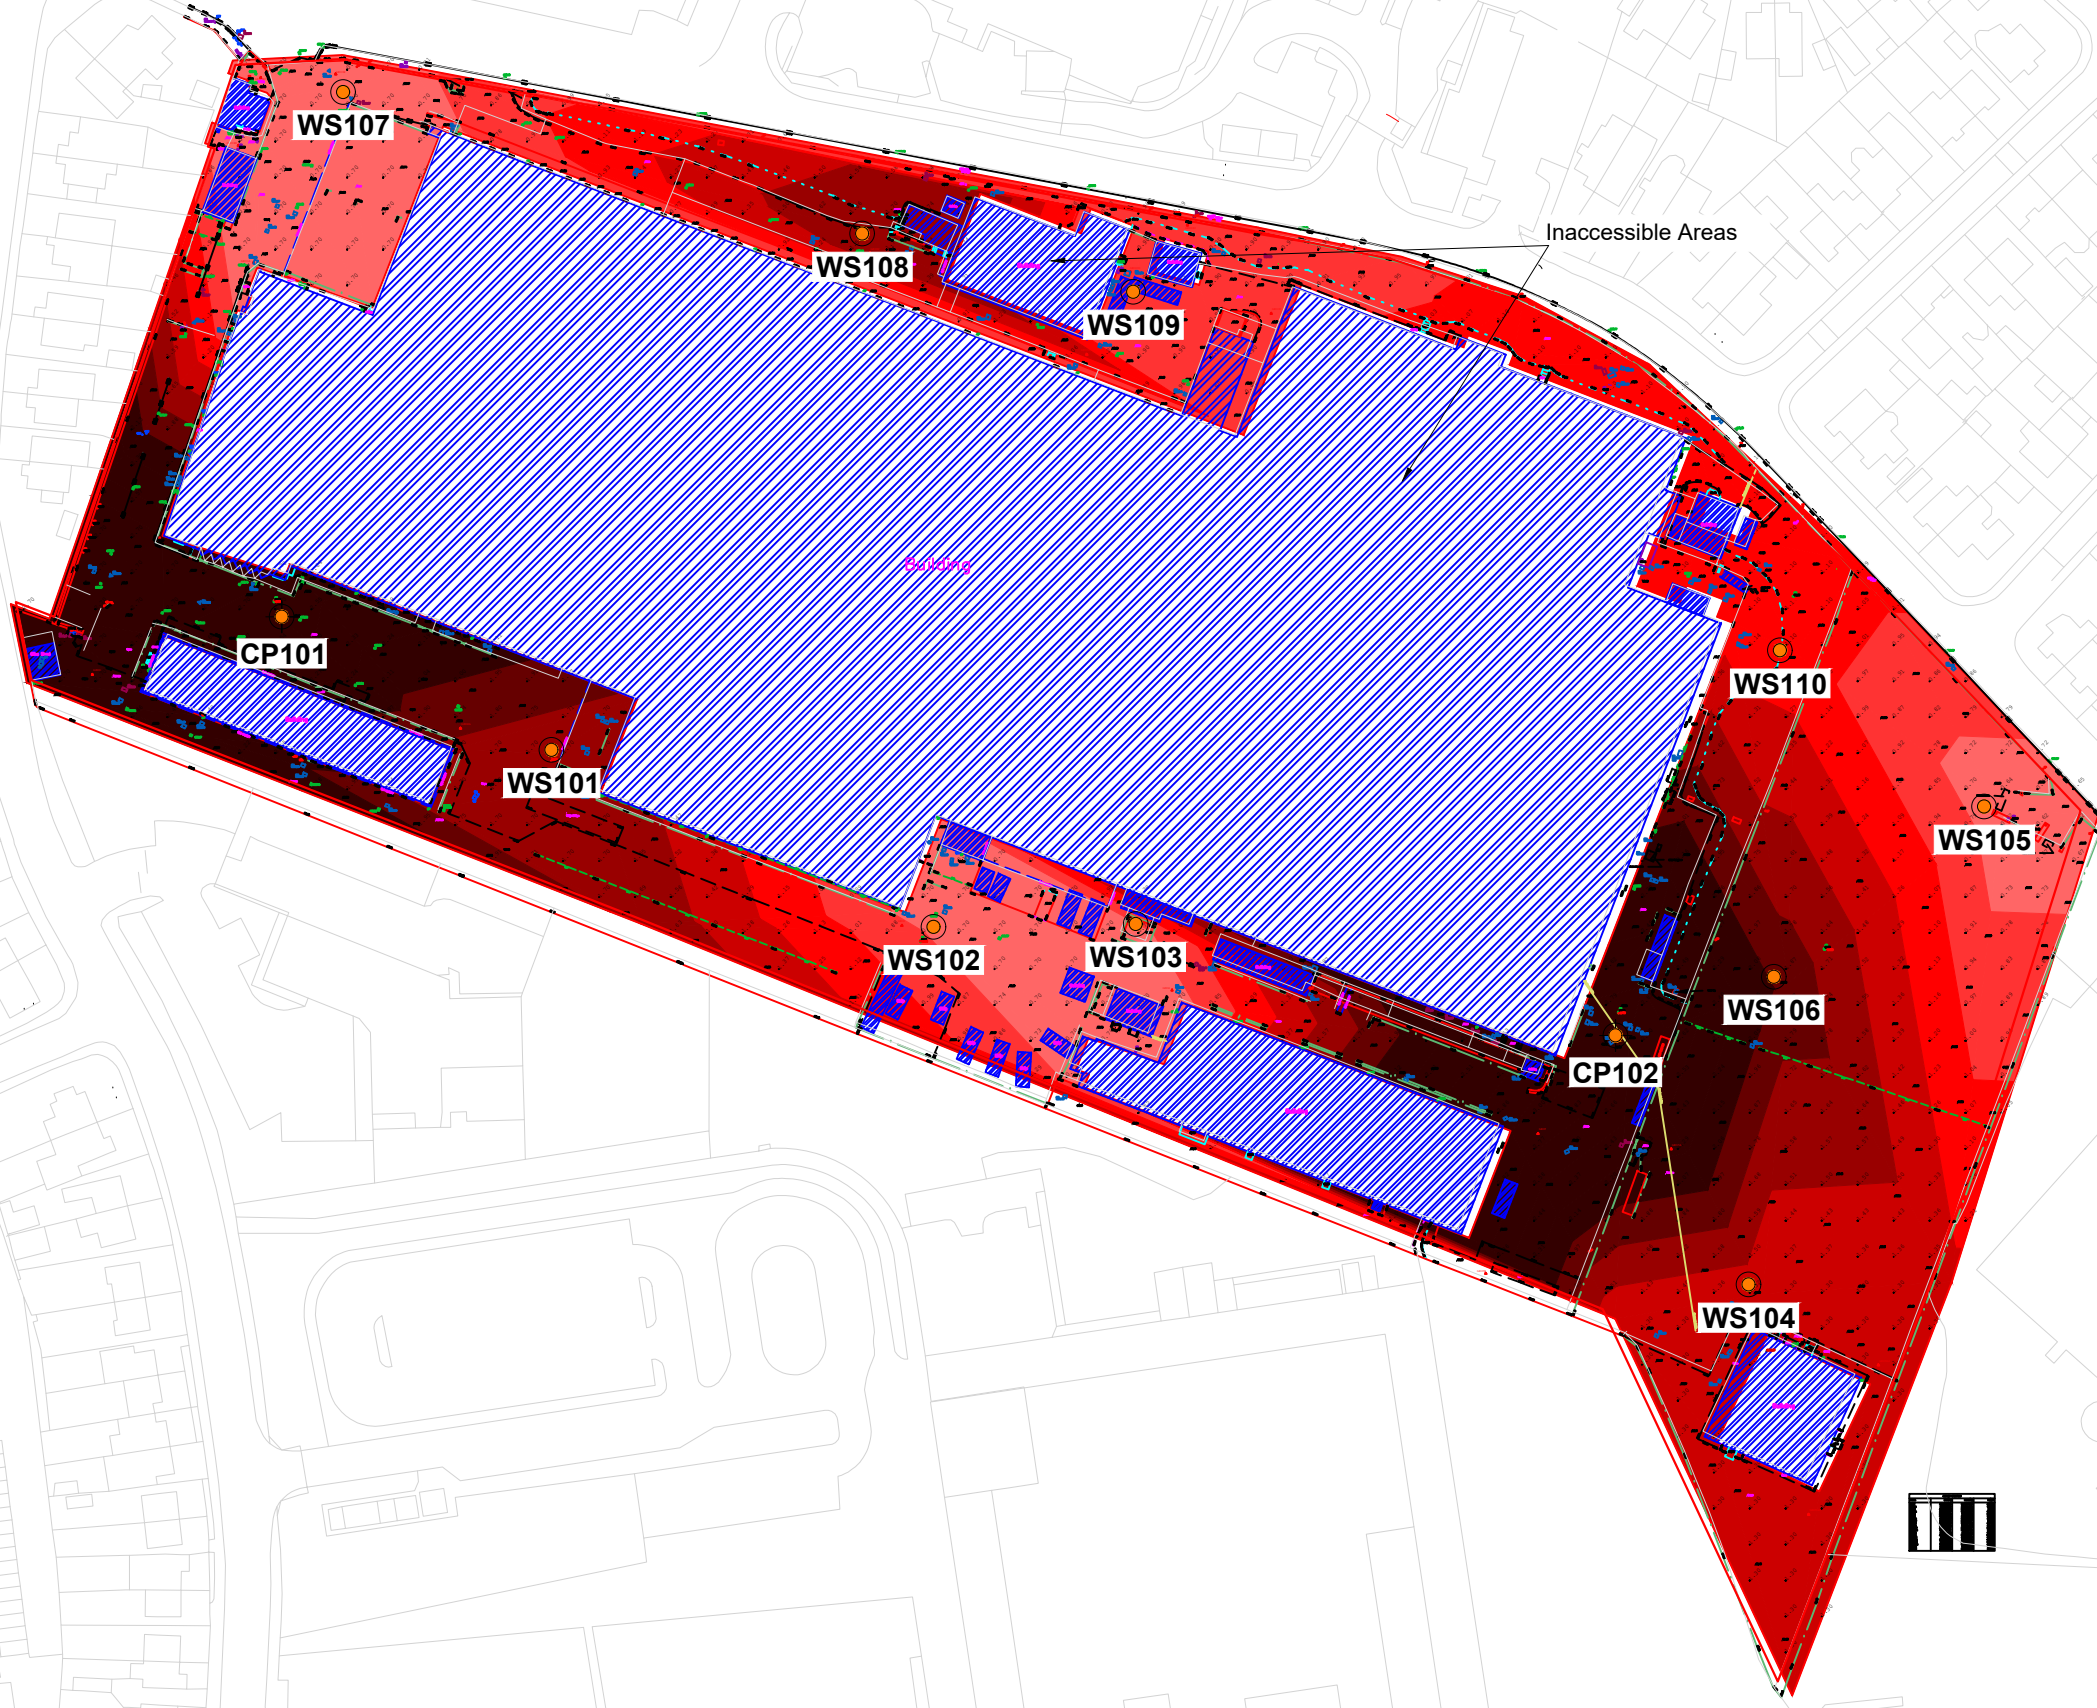
- Made Ground Depth (m)**
- Depth of Made Ground 0.50 - 0.74m
  - Depth of Made Ground 0.75 - 0.99m
  - Depth of Made Ground 1.00 - 1.24m
  - Depth of Made Ground 1.25 - 1.49m
  - Depth of Made Ground 1.50 - 1.74m
  - Depth of Made Ground 1.75 - 1.99m
  - Depth of Made Ground >2.00m
