# Phase I and II Geoenvironmental Site Assessment

Site: Glen Dimplex, Prescott

Reference: 17-500-R1-2

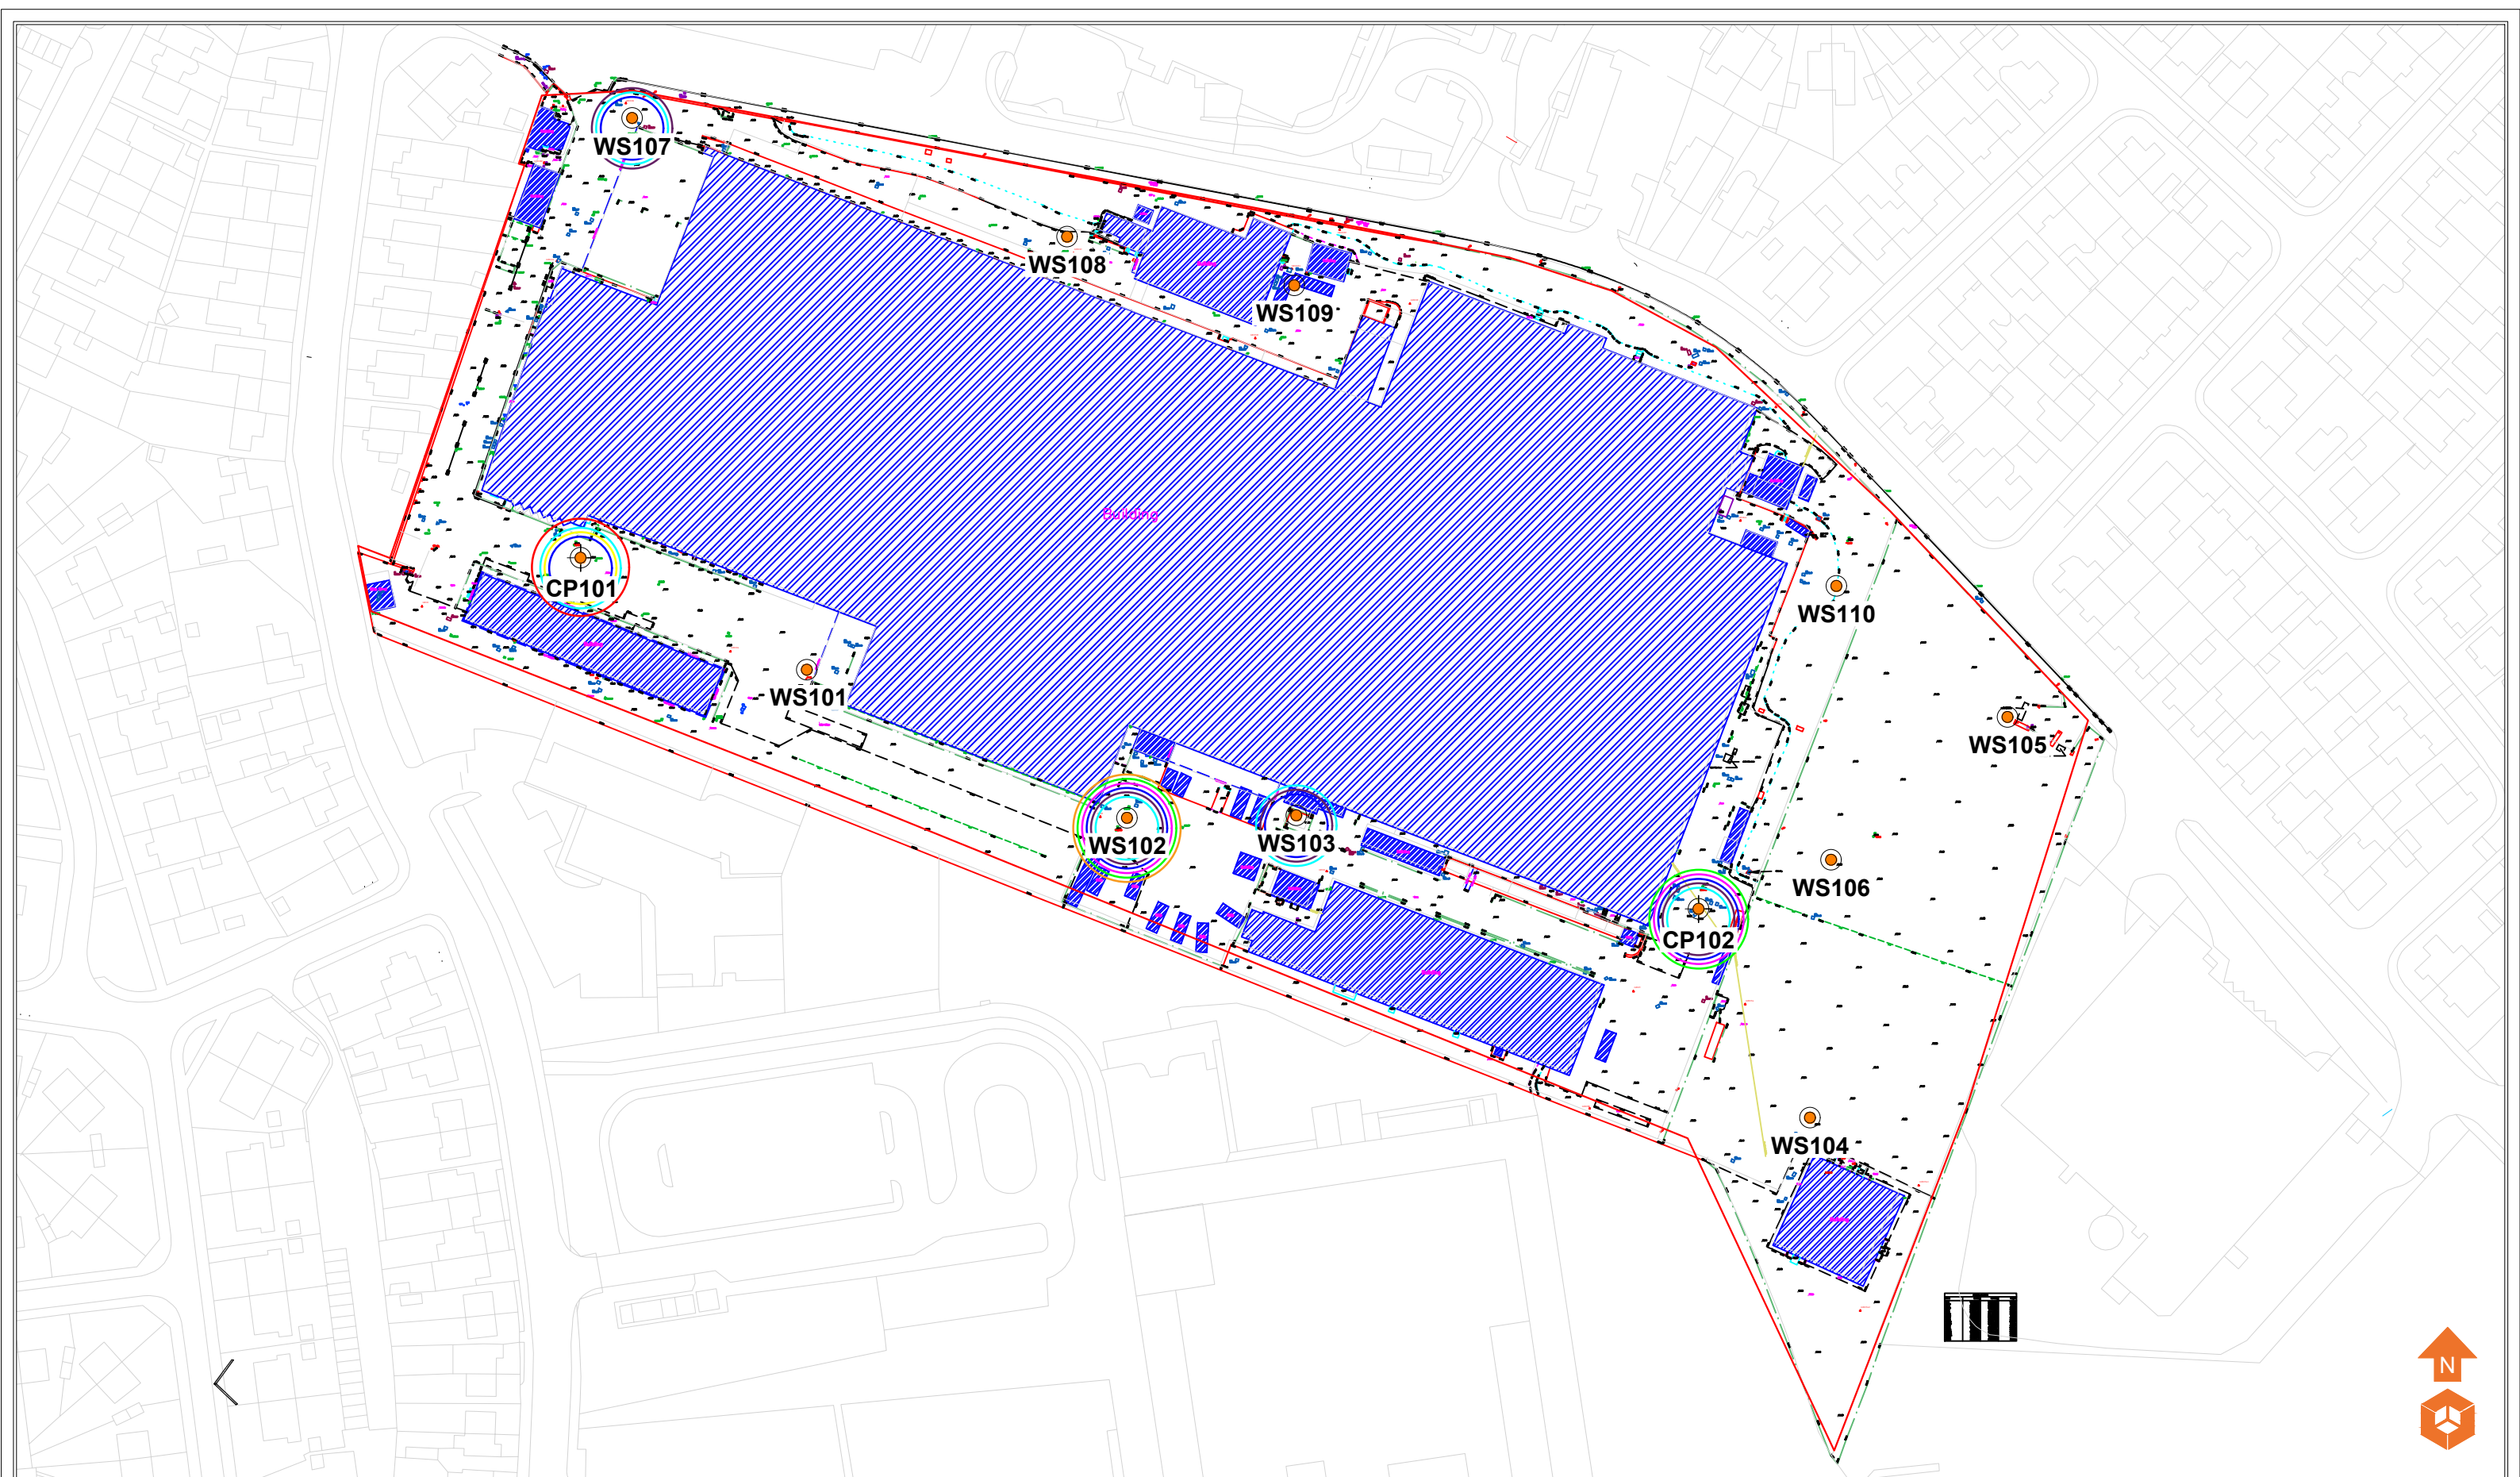
- Contamination Exceedances**
- Trichloroethene
  - Vinyl Chloride
  - Cis 1, 2 - Dichloroethene
  - Trans 1, 2 - Dichloroethene
  - 1 - 1 Dichloroethene
  - Benzene
  - Nickel
  - pH

- ✳ A plume of Trichloroethene (TCE), Dichloroethene variants, and Vinyl Chloride has been identified within groundwater monitoring data, extending from WS107 towards the northwestern entrance of the site, through to CP102 towards the southeast of the factory. It is noted that concentrations of VOCs were significantly higher in deeper groundwater monitoring wells, which suggests the plume is formed of DNAPL.

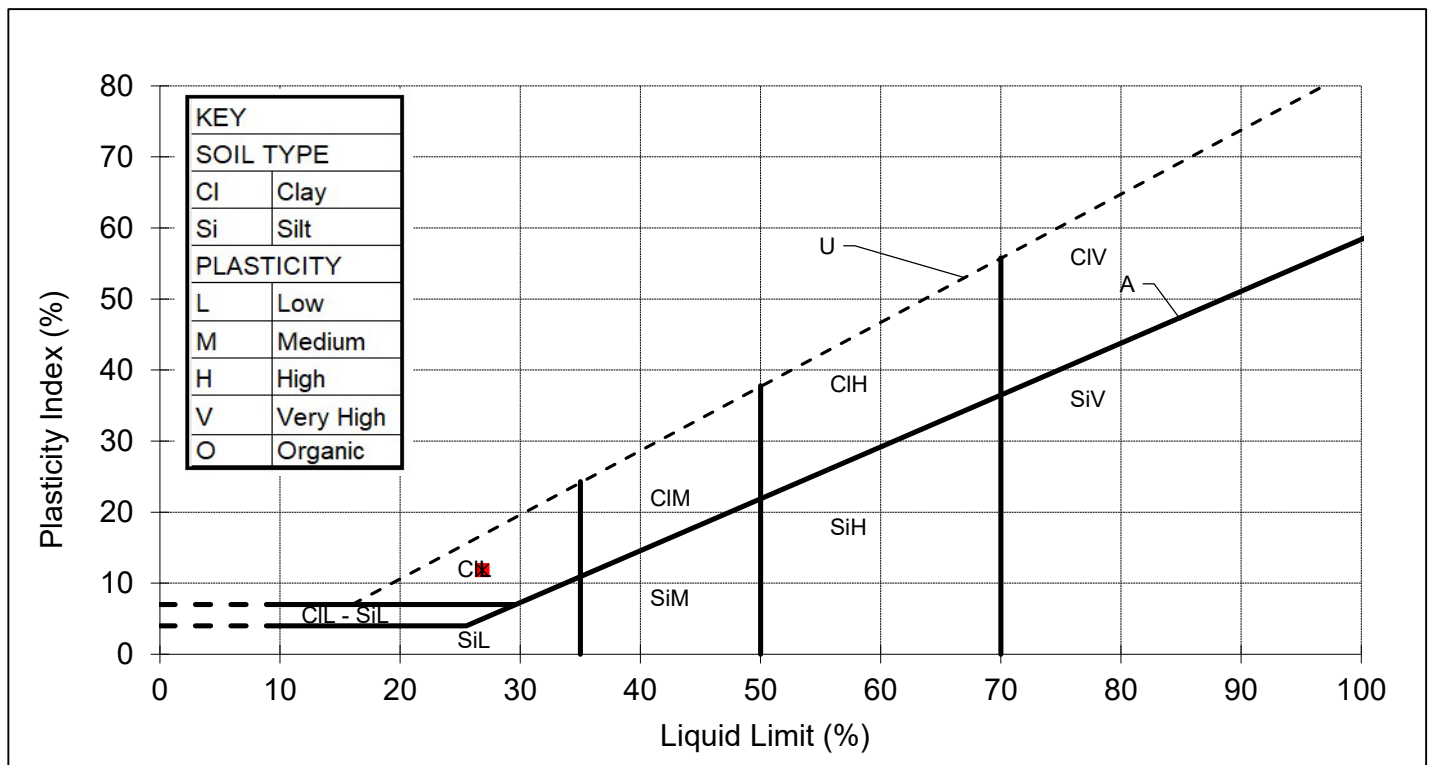
| Natural Moisture Content (%) | Liquid Limit (%) | Plastic Limit (%) | Plasticity Index (%) | Passing 425 micron (%) |
|---|---|---|---|---|
| 15.7 | 27 | 15 | 12 | 97 |

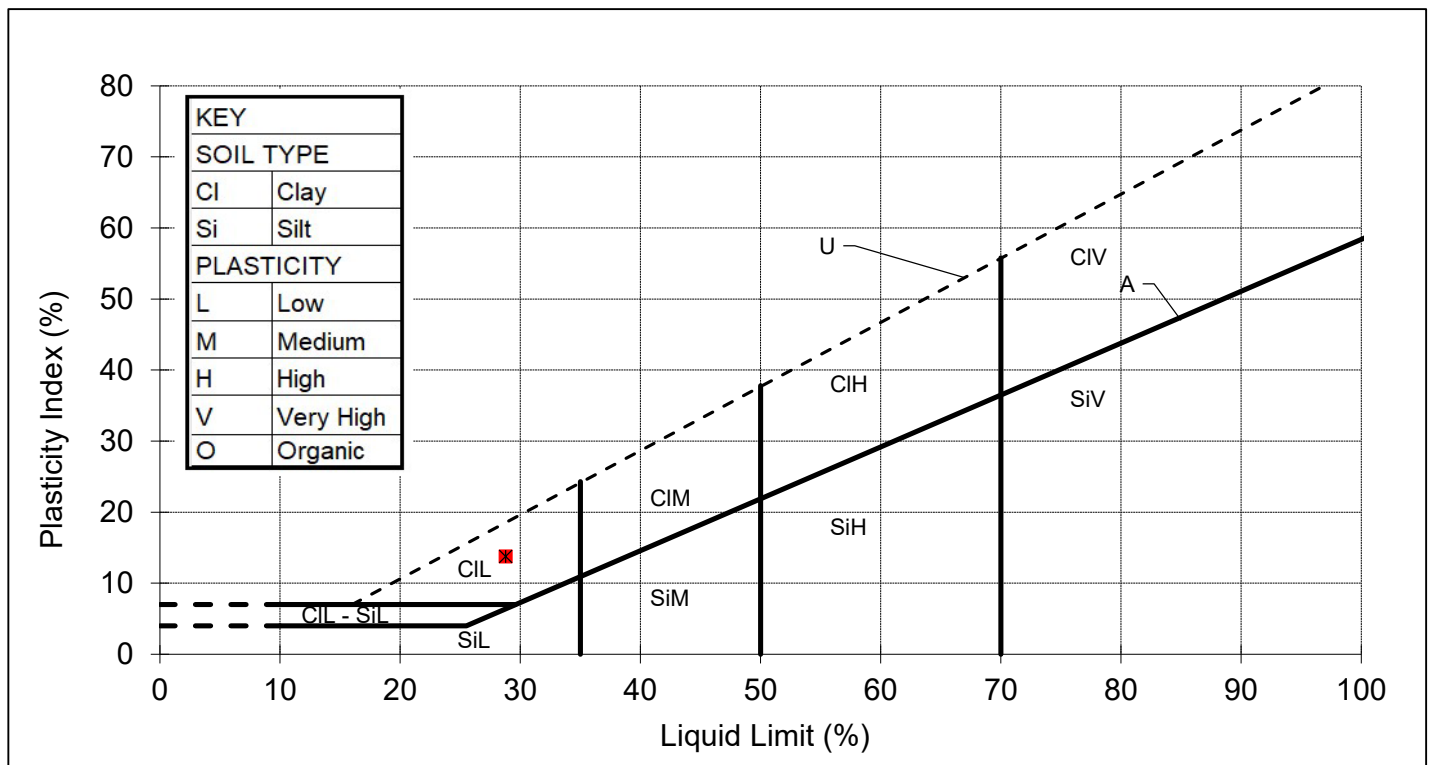
| Natural Moisture Content (%) | Liquid Limit (%) | Plastic Limit (%) | Plasticity Index (%) | Passing 425 micron (%) |
|---|---|---|---|---|
| 20.2 | 29 | 15 | 14 | 95 |

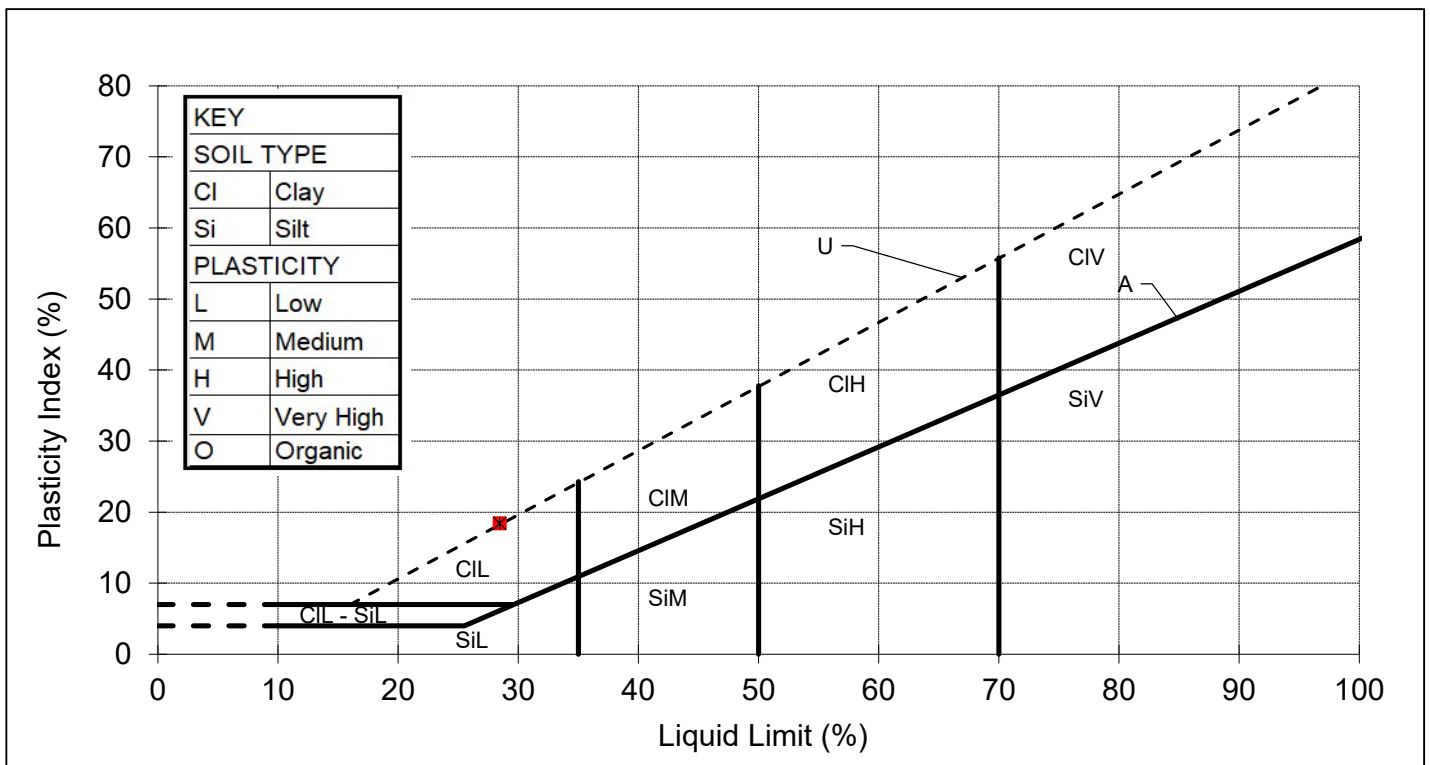
| Natural Moisture Content (%) | Liquid Limit (%) | Plastic Limit (%) | Plasticity Index (%) | Passing 425 micron (%) |
|---|---|---|---|---|
| 12.0 | 28 | 10 | 18 | 96 |

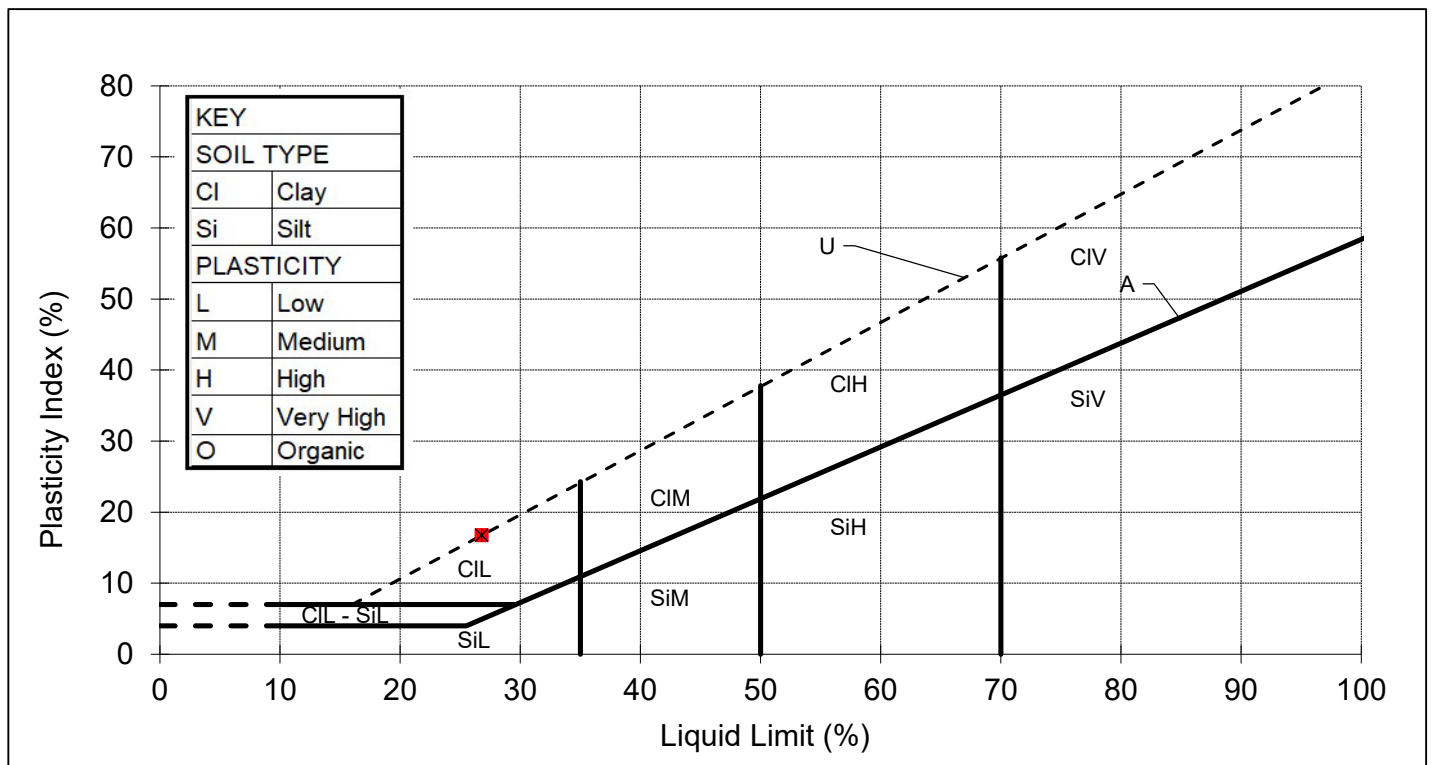
| Natural Moisture Content (%) | Liquid Limit (%) | Plastic Limit (%) | Plasticity Index (%) | Passing 425 micron (%) |
|---|---|---|---|---|
| 11.2 | 27 | 10 | 17 | 97 |

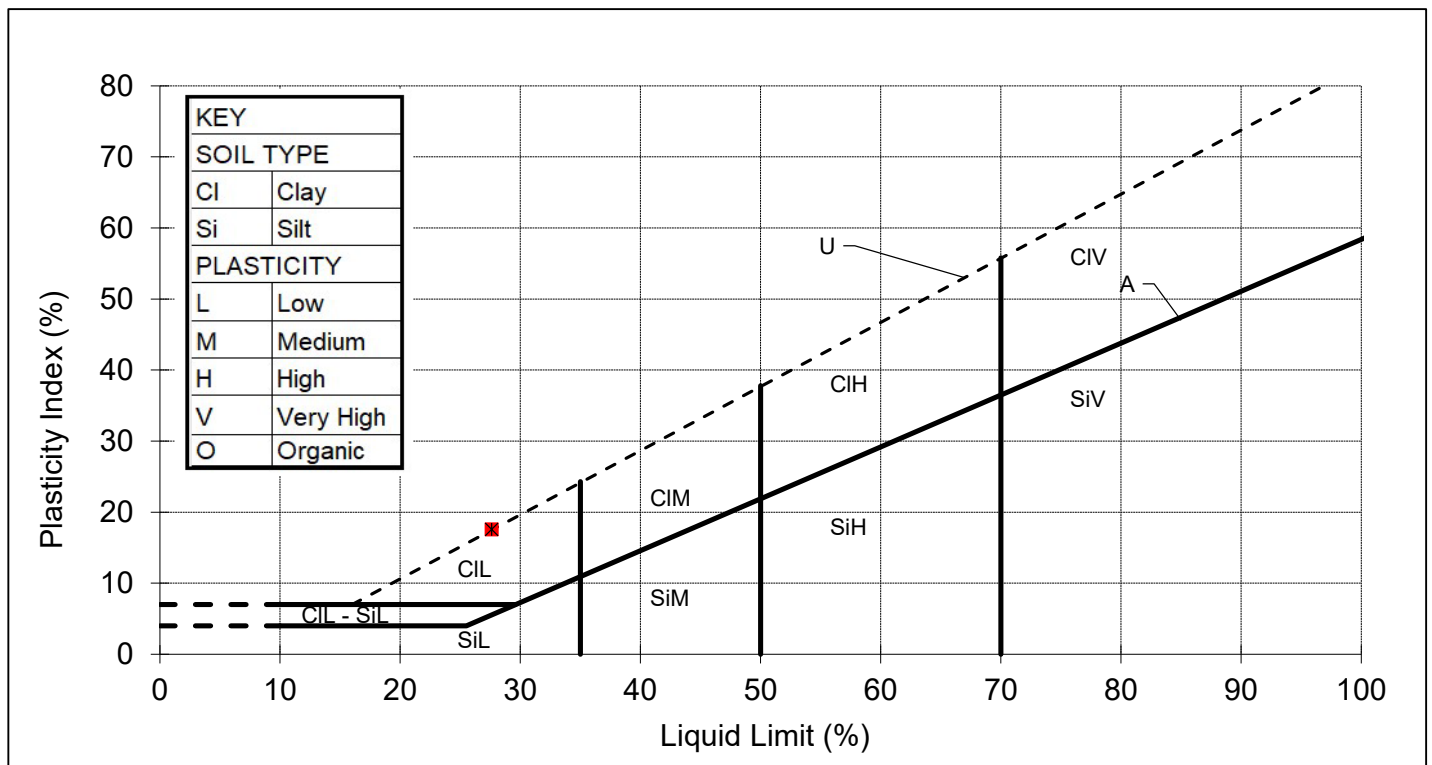
| Natural Moisture Content (%) | Liquid Limit (%) | Plastic Limit (%) | Plasticity Index (%) | Passing 425 micron (%) |
|---|---|---|---|---|
| 10.1 | 28 | 10 | 18 | 98 |

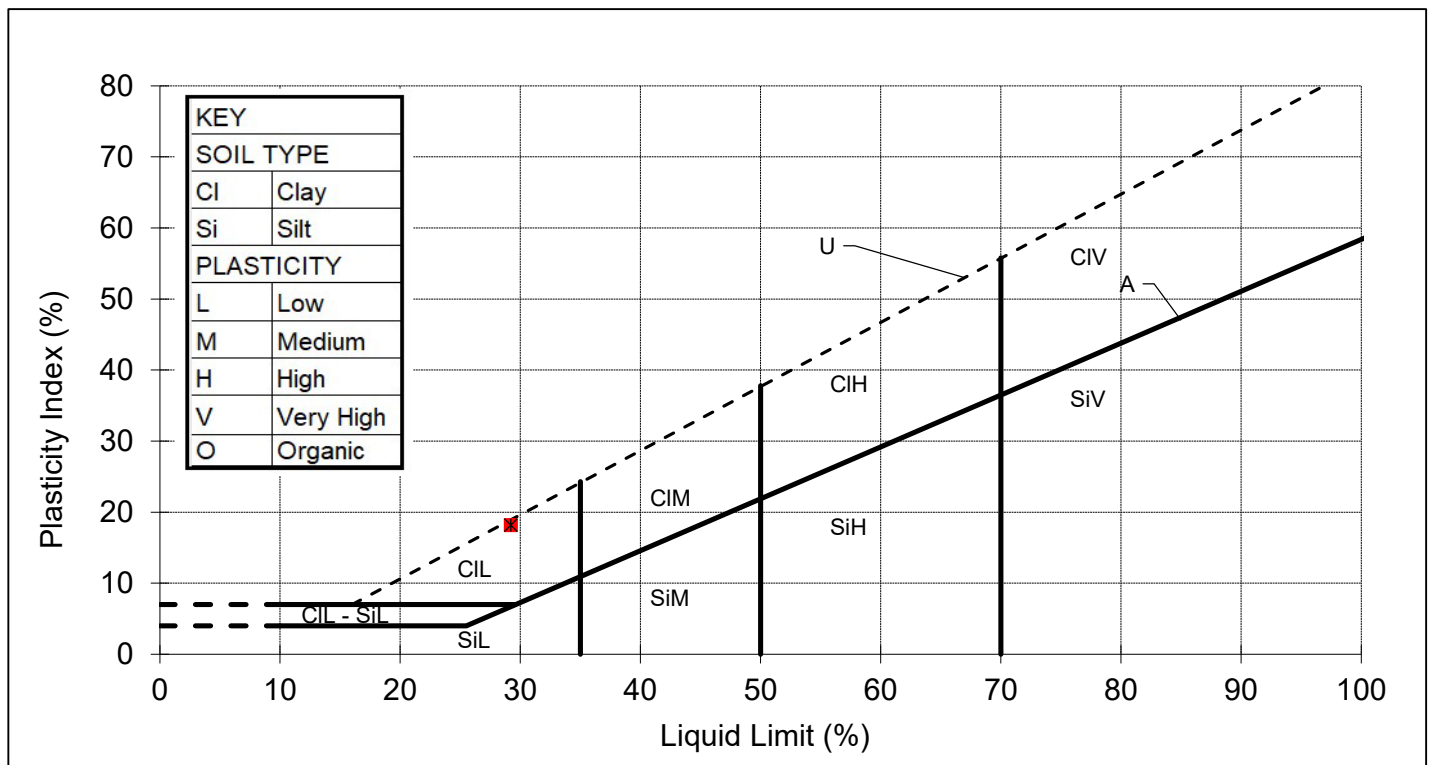
| Natural Moisture Content (%) | Liquid Limit (%) | Plastic Limit (%) | Plasticity Index (%) | Passing 425 micron (%) |
|---|---|---|---|---|
| 14.8 | 29 | 11 | 18 | 95 |

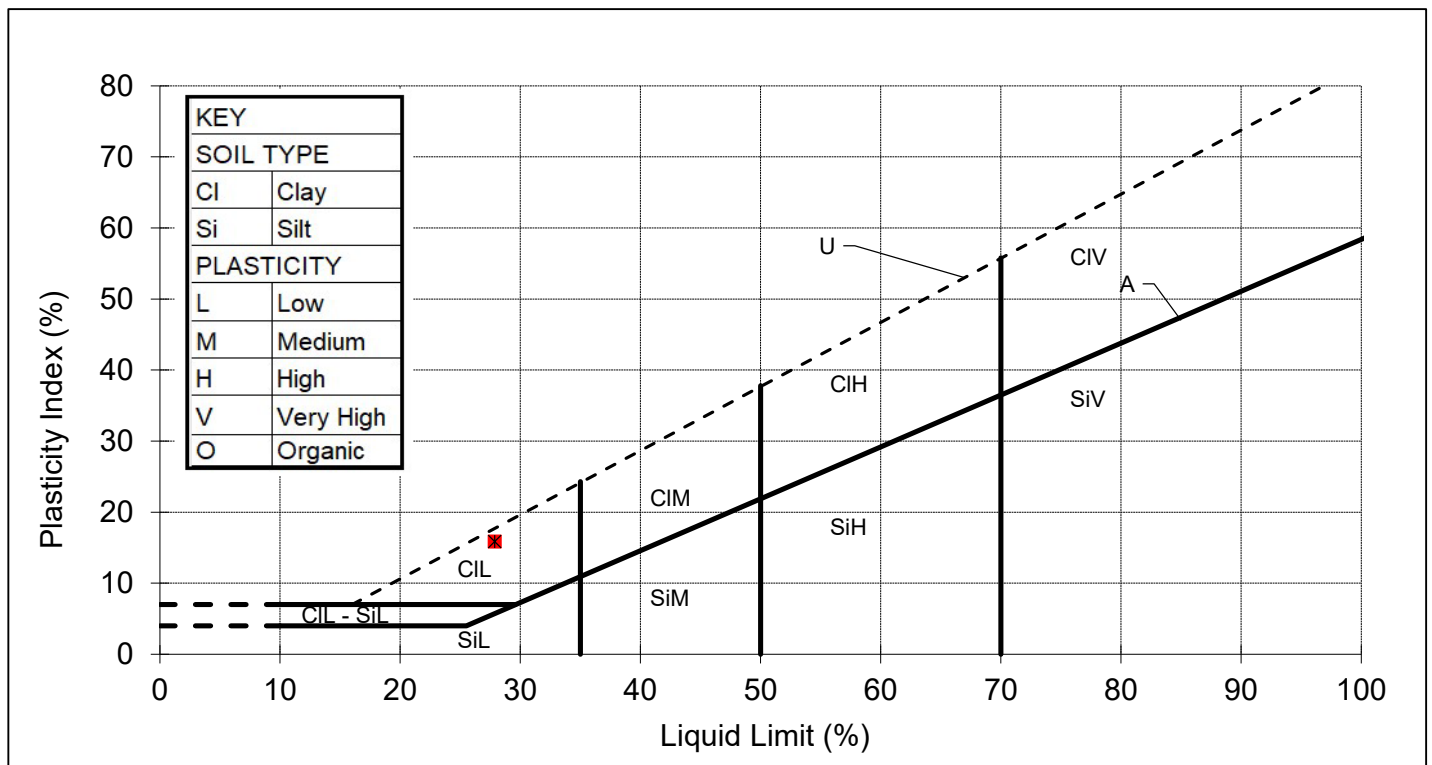
| Natural Moisture Content (%) | Liquid Limit (%) | Plastic Limit (%) | Plasticity Index (%) | Passing 425 micron (%) |
|---|---|---|---|---|
| 11.8 | 28 | 12 | 16 | 92 |

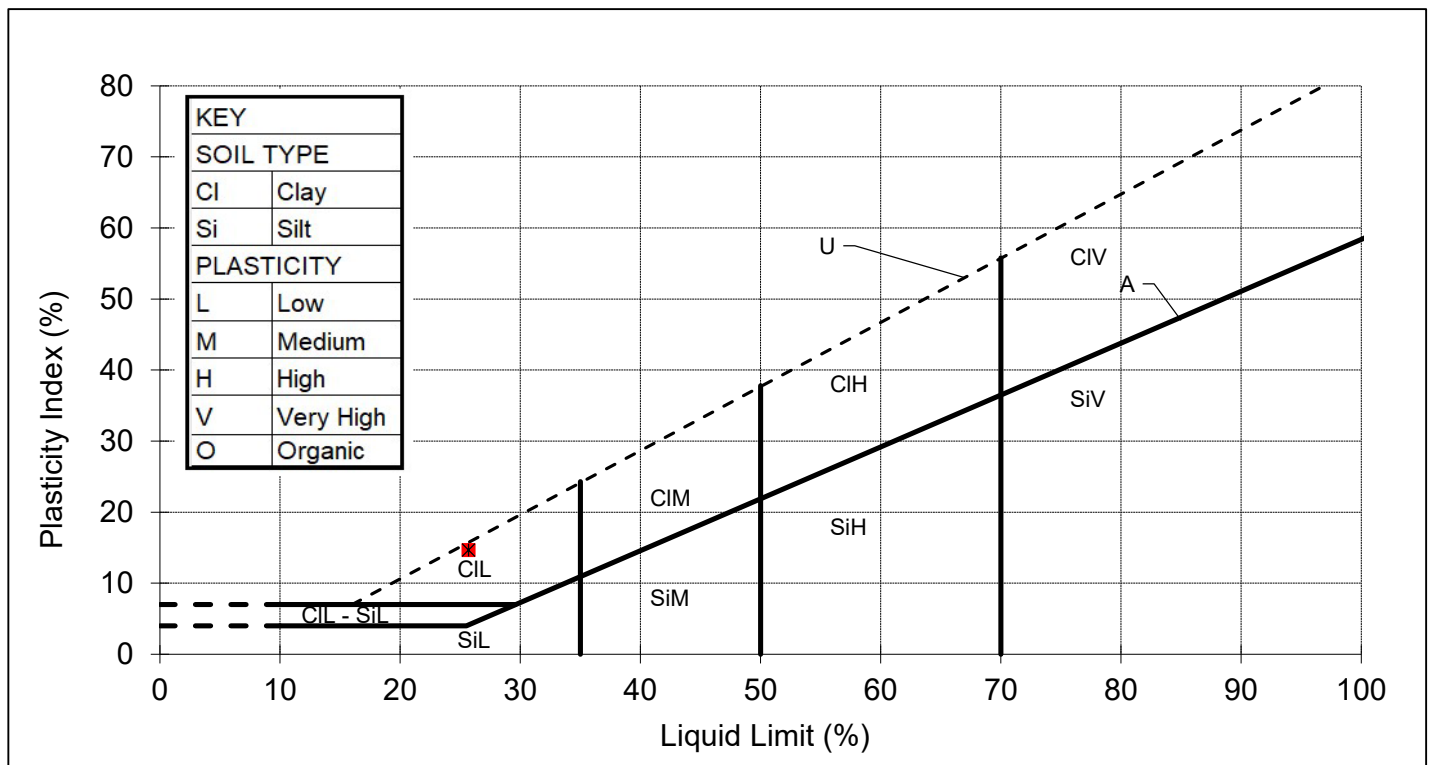
| Natural Moisture Content (%) | Liquid Limit (%) | Plastic Limit (%) | Plasticity Index (%) | Passing 425 micron (%) |
|---|---|---|---|---|
| 11.0 | 26 | 11 | 15 | 94 |

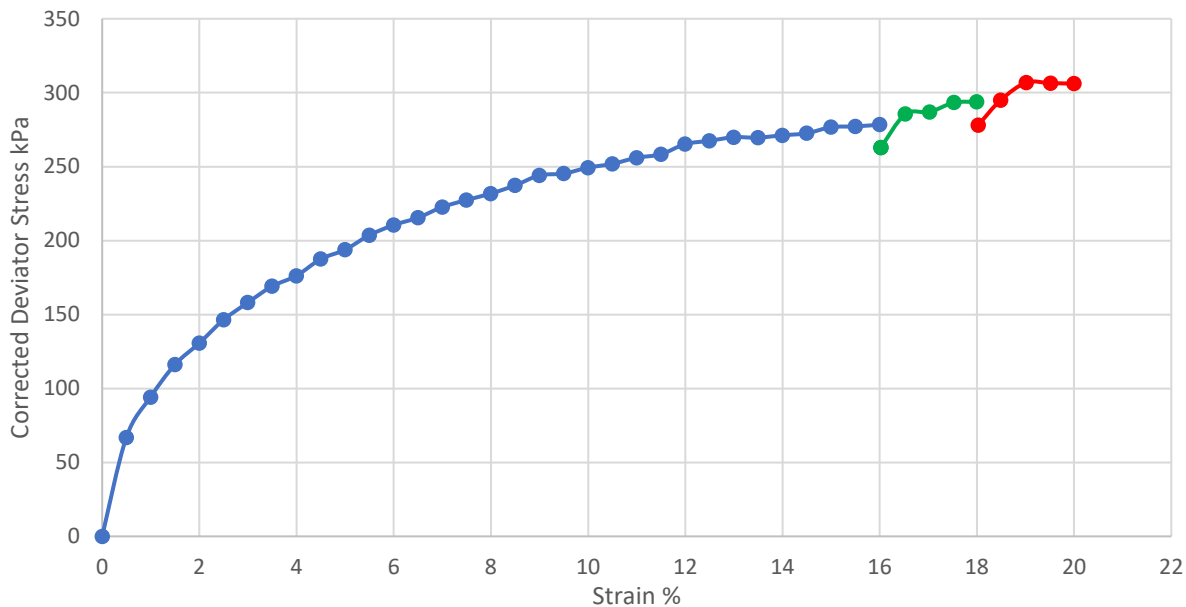
### CORRECTED DEVIATOR STRESS vs AXIAL STRAIN

TEST TYPE  
MULTI STAGE

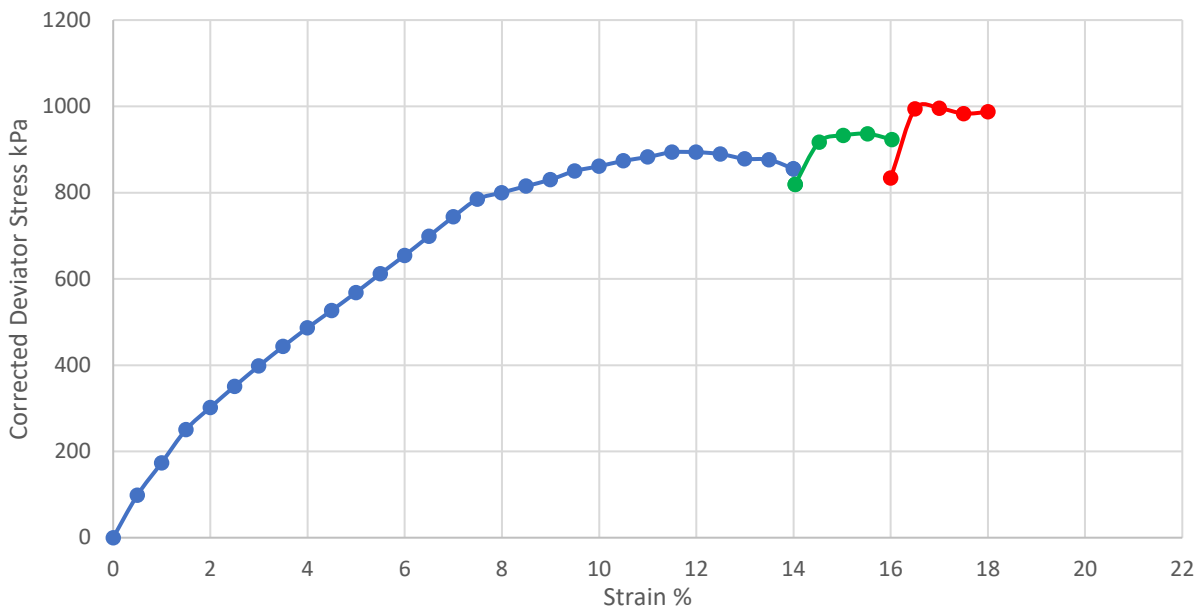
CORRECTED DEVIATOR STRESS vs AXIAL STRAIN

TEST TYPE  
MULTI STAGE

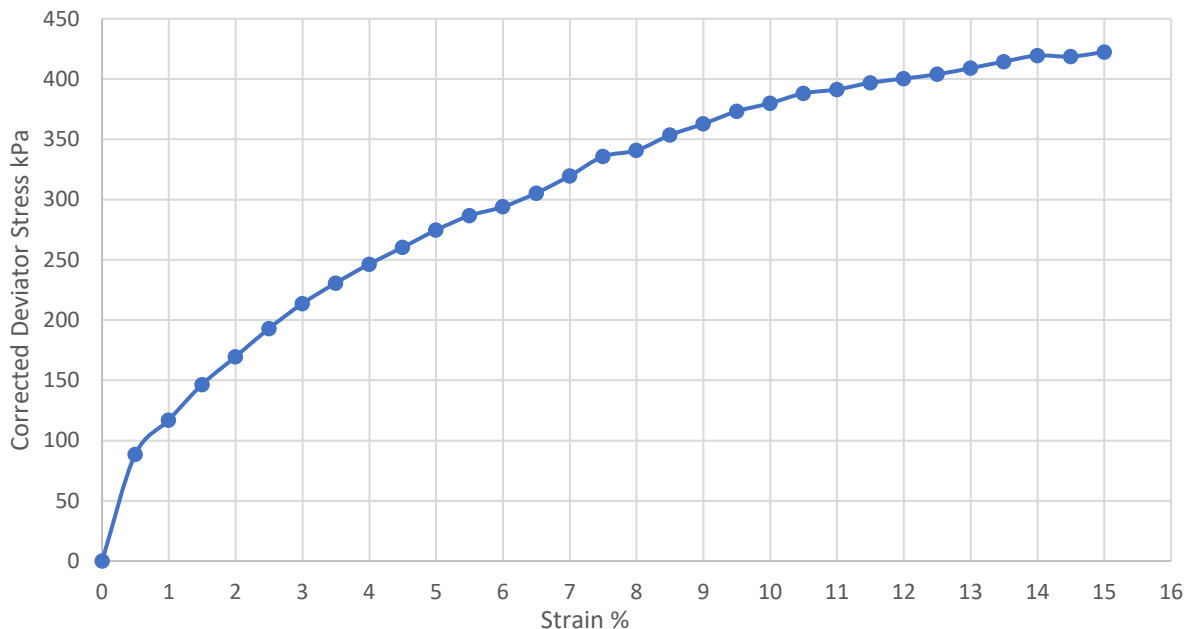
CORRECTED DEVIATOR STRESS vs AXIAL STRAIN

TEST TYPE  
SINGLE STAGE

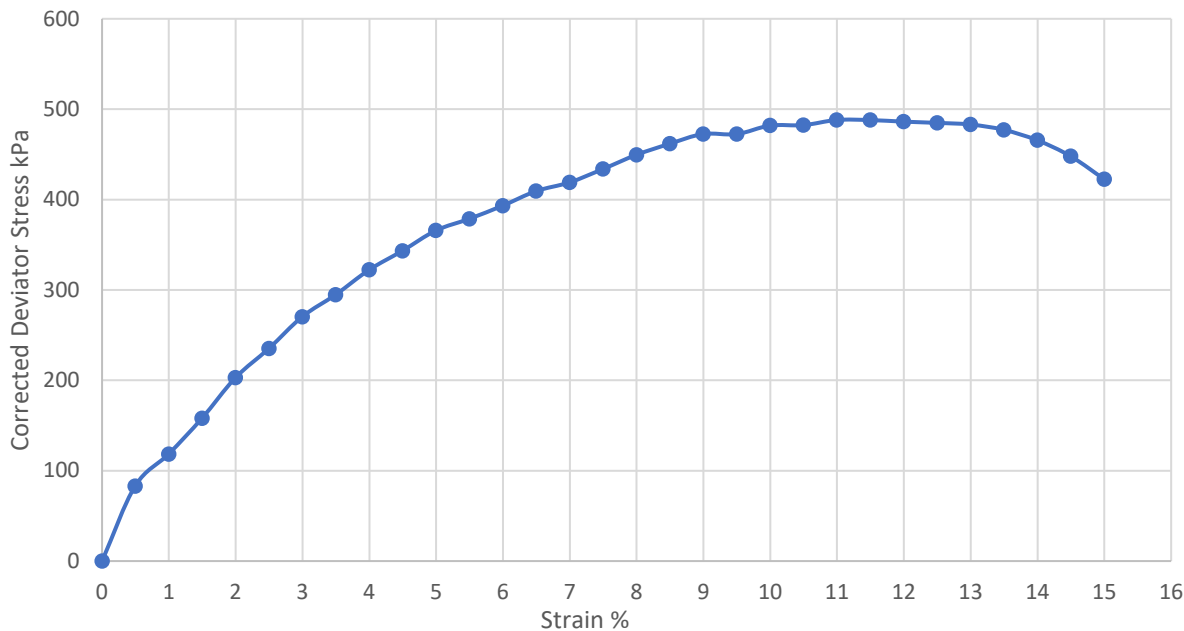
CORRECTED DEVIATOR STRESS vs AXIAL STRAIN

TEST TYPE  
SINGLE STAGE

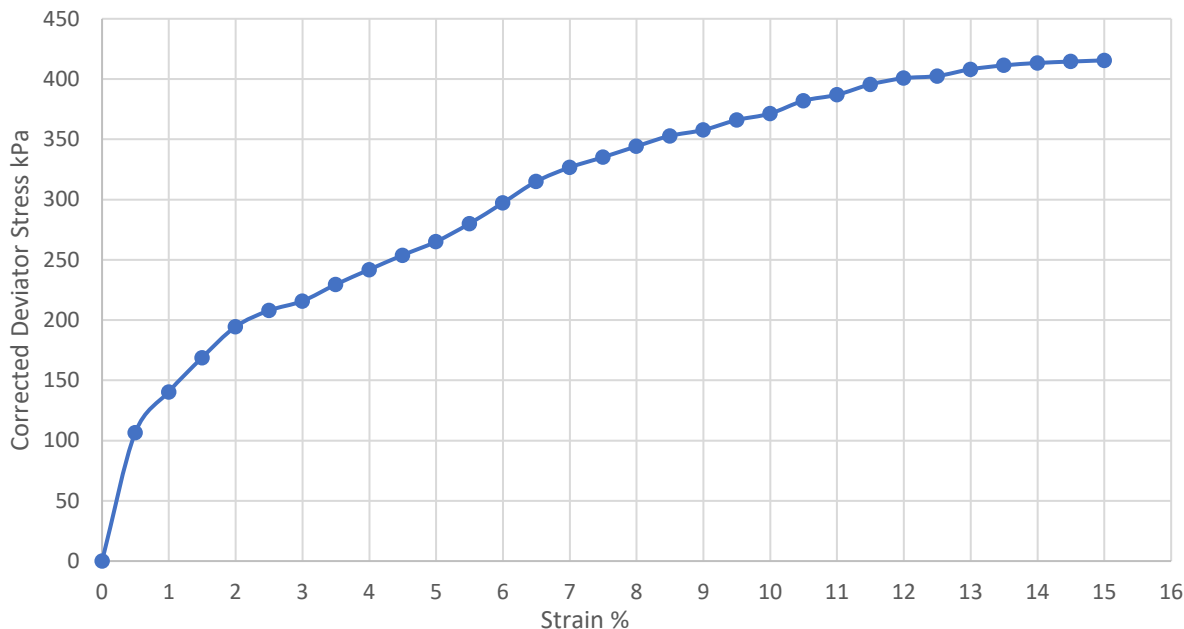
CORRECTED DEVIATOR STRESS vs AXIAL STRAIN

TEST TYPE  
SINGLE STAGE
