# BS5837 Report

## **Arboricultural Report Property Development based on BS5837**

59 Chapel Lane, Cronton, WA8 4NT

**Report Date:** 17/03/2025

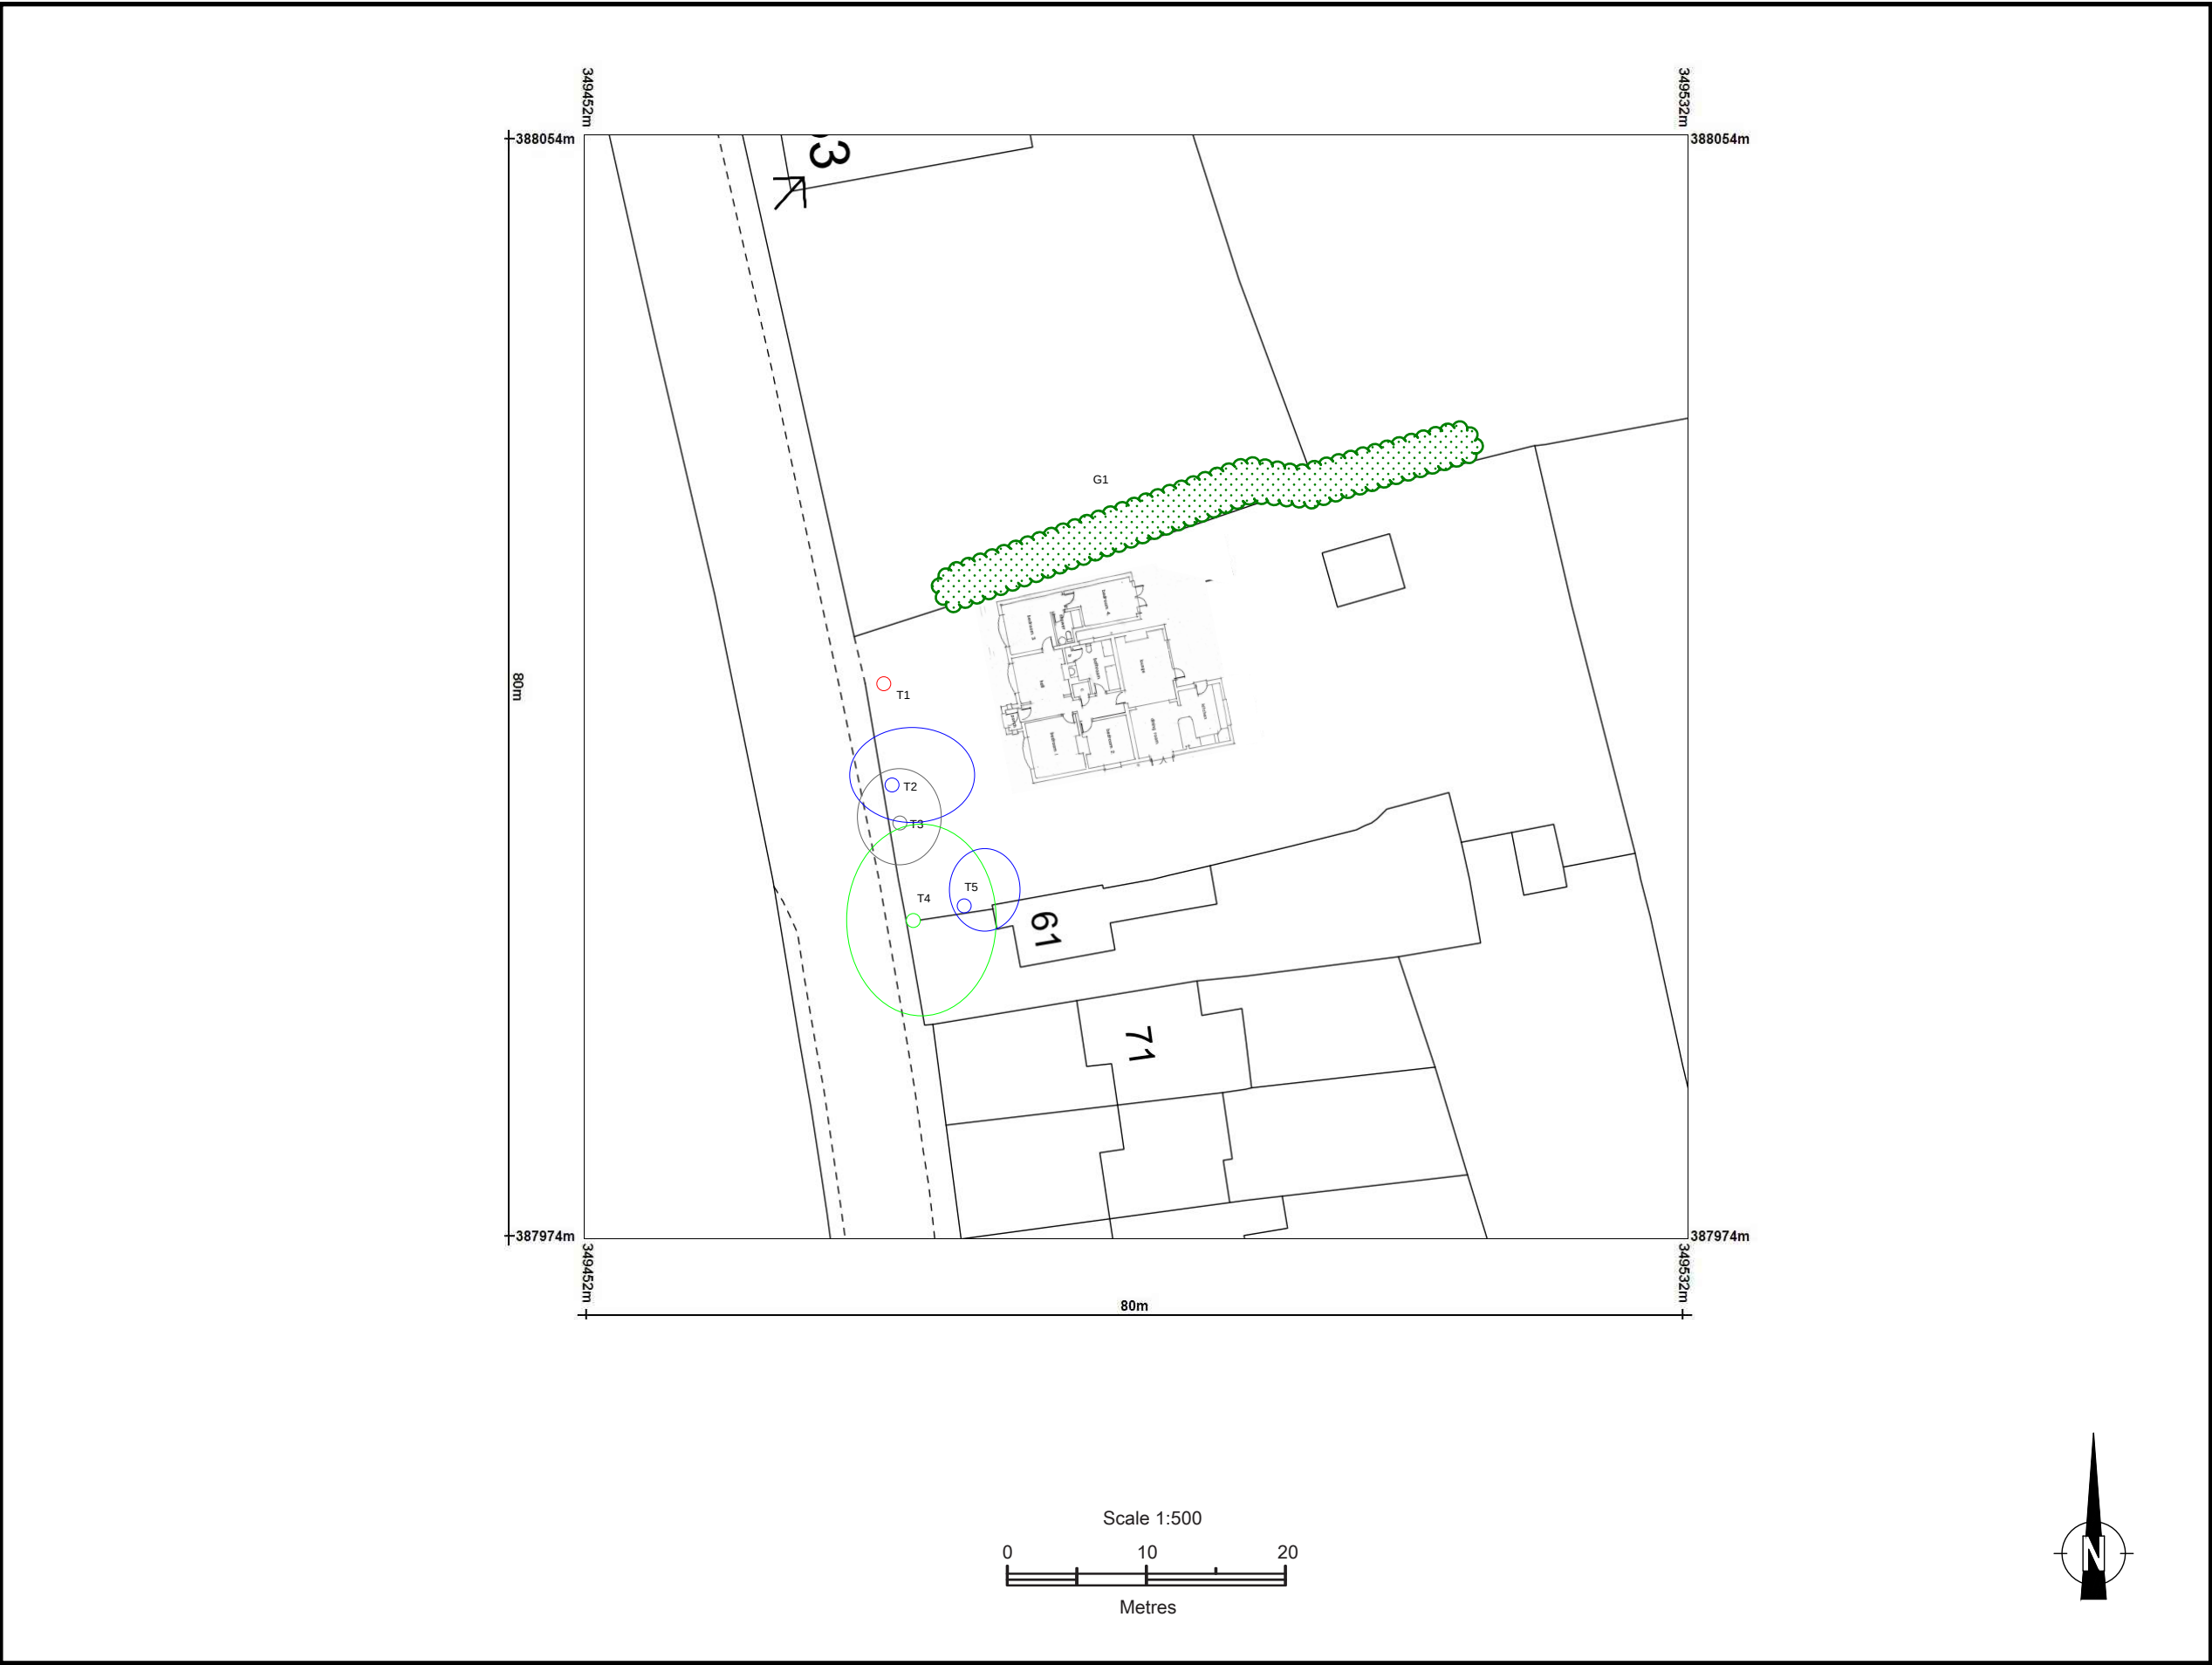
| Drawing Title: | Tree Layout Plan |

Canopy spread (N, S, E, W) is approximate. Stem diameter (DBH) is taken at 1.5m above ground level, whether of single or multi-stem trees. Stem diameter is functional to determine the extent of the Root Protection Area (RPA).

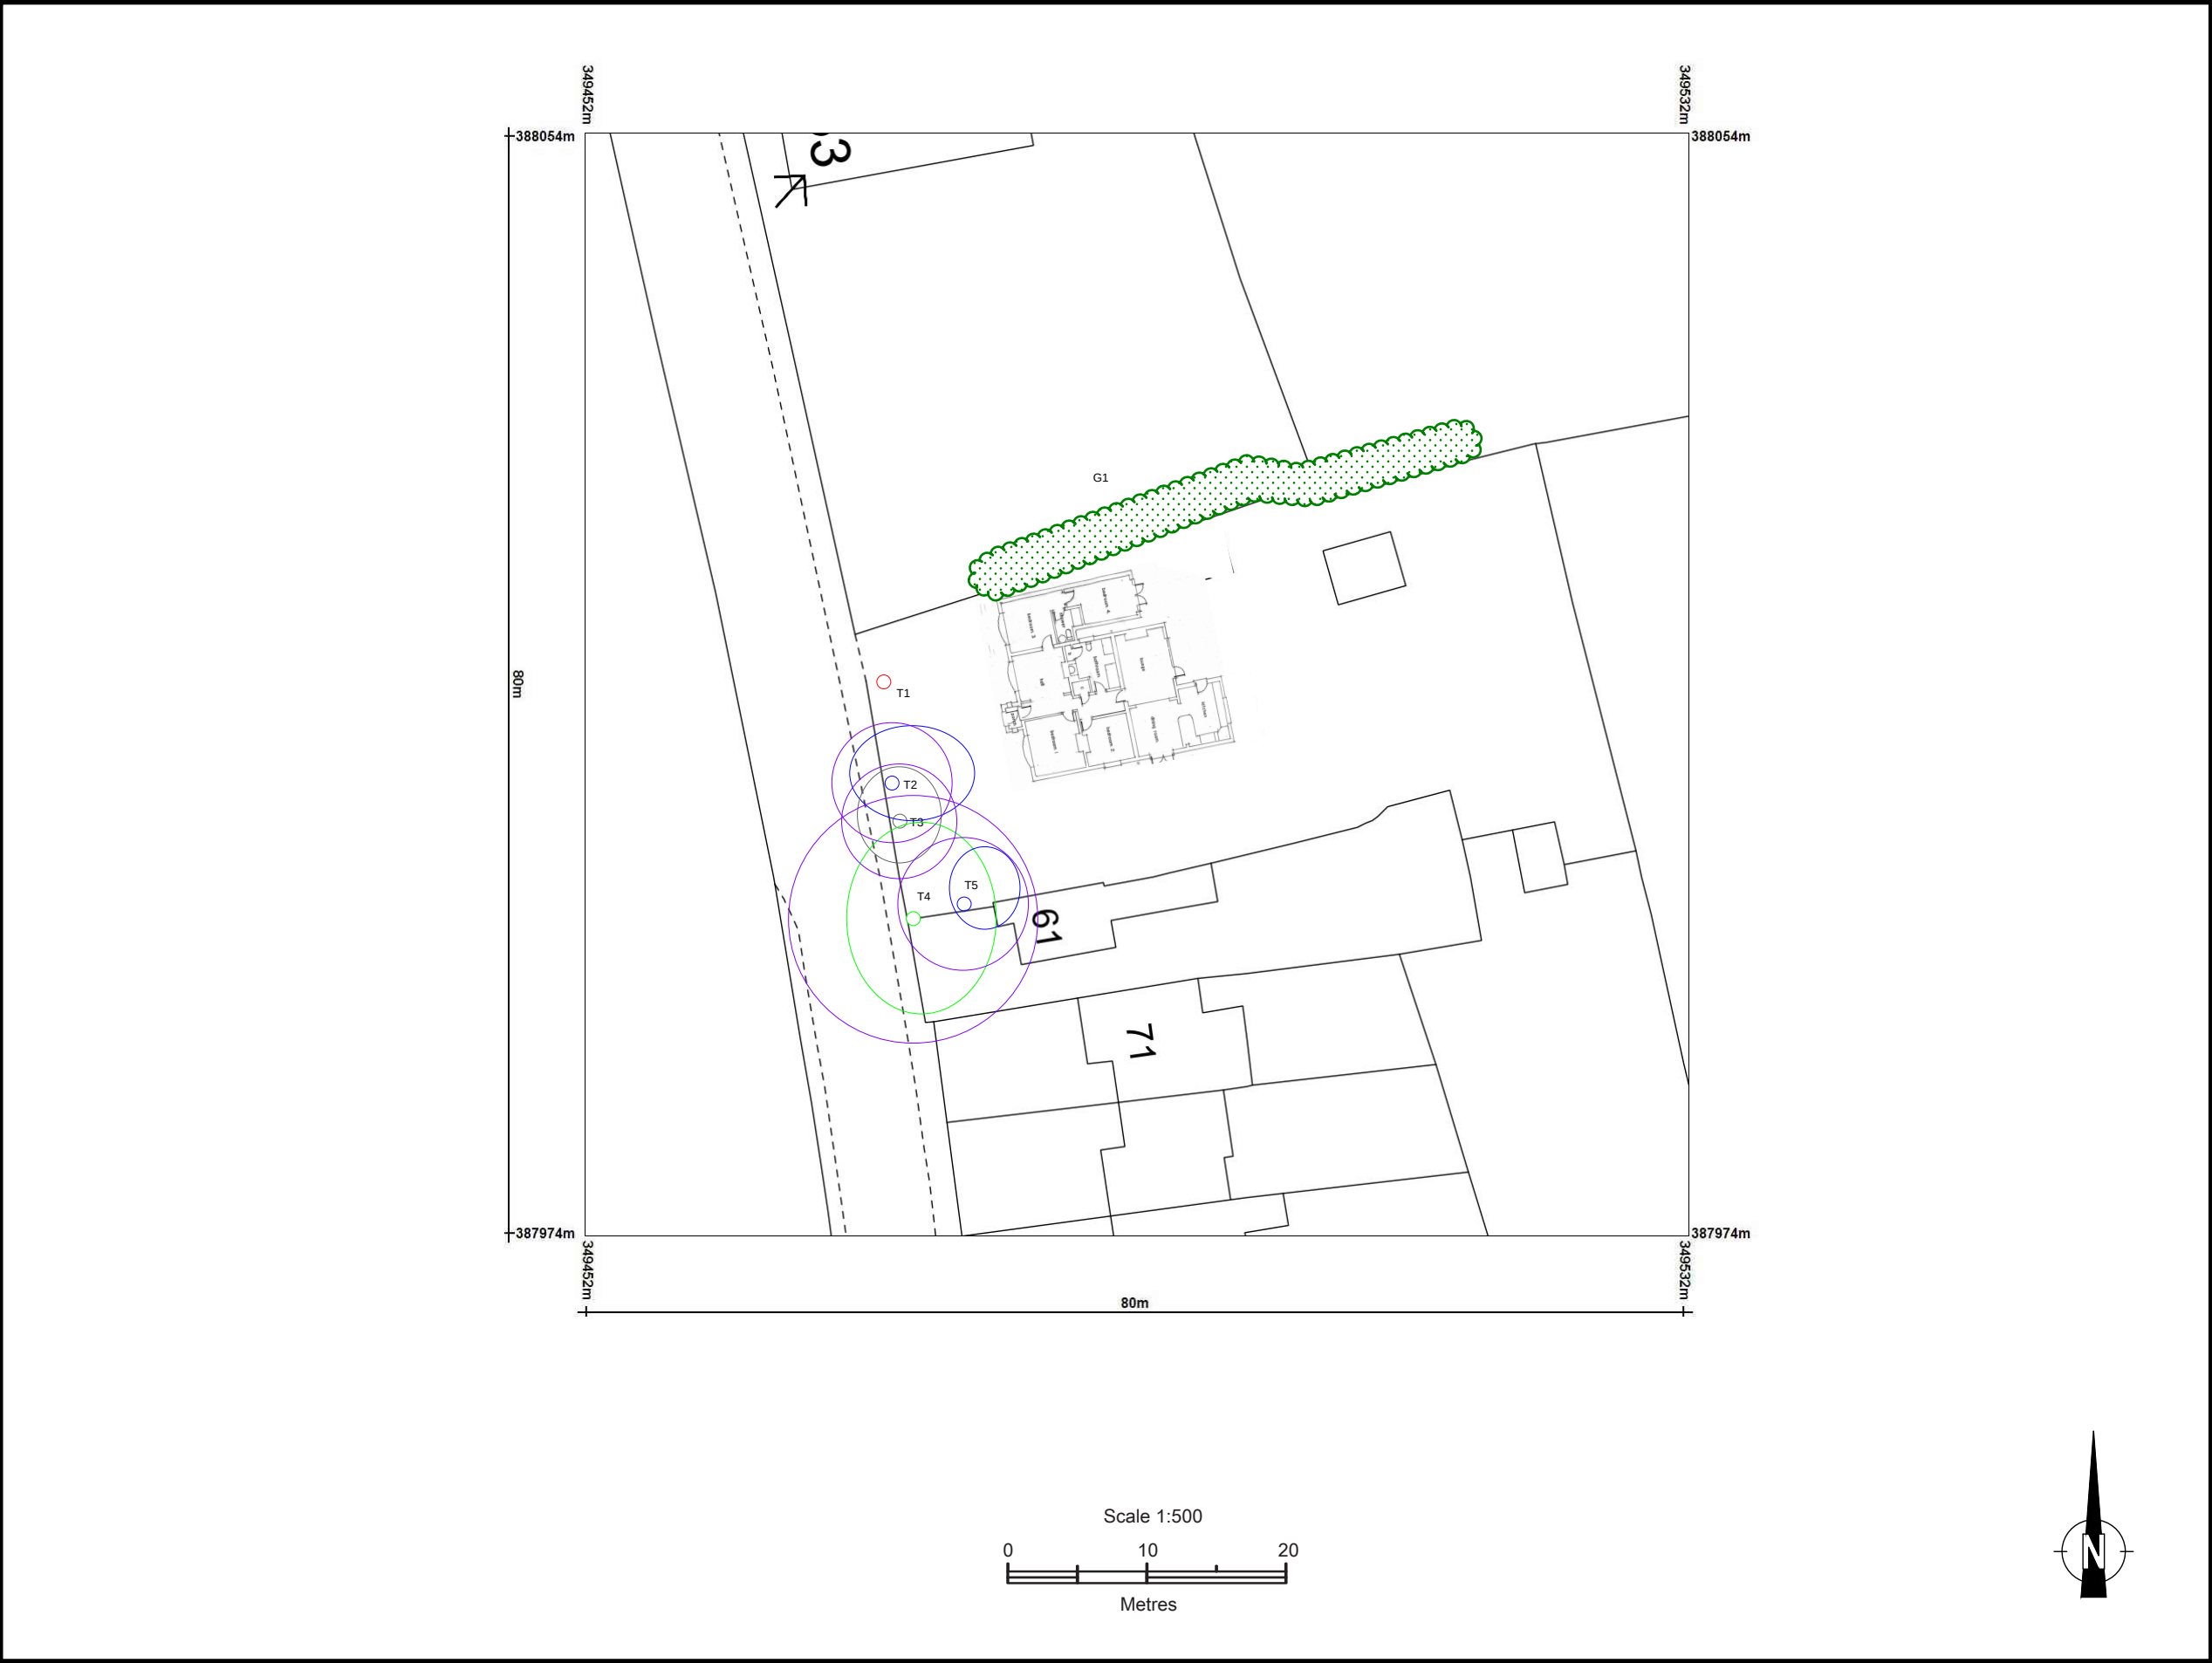
| Drawing Title: | Tree Constraints Plan |

Canopy spread (N, S, E, W) is approximate. Stem diameter (DBH) is taken at 1.5m above ground level, whether of single or multi-stem trees. Stem diameter is functional to determine the extent of the Root Protection Area (RPA).

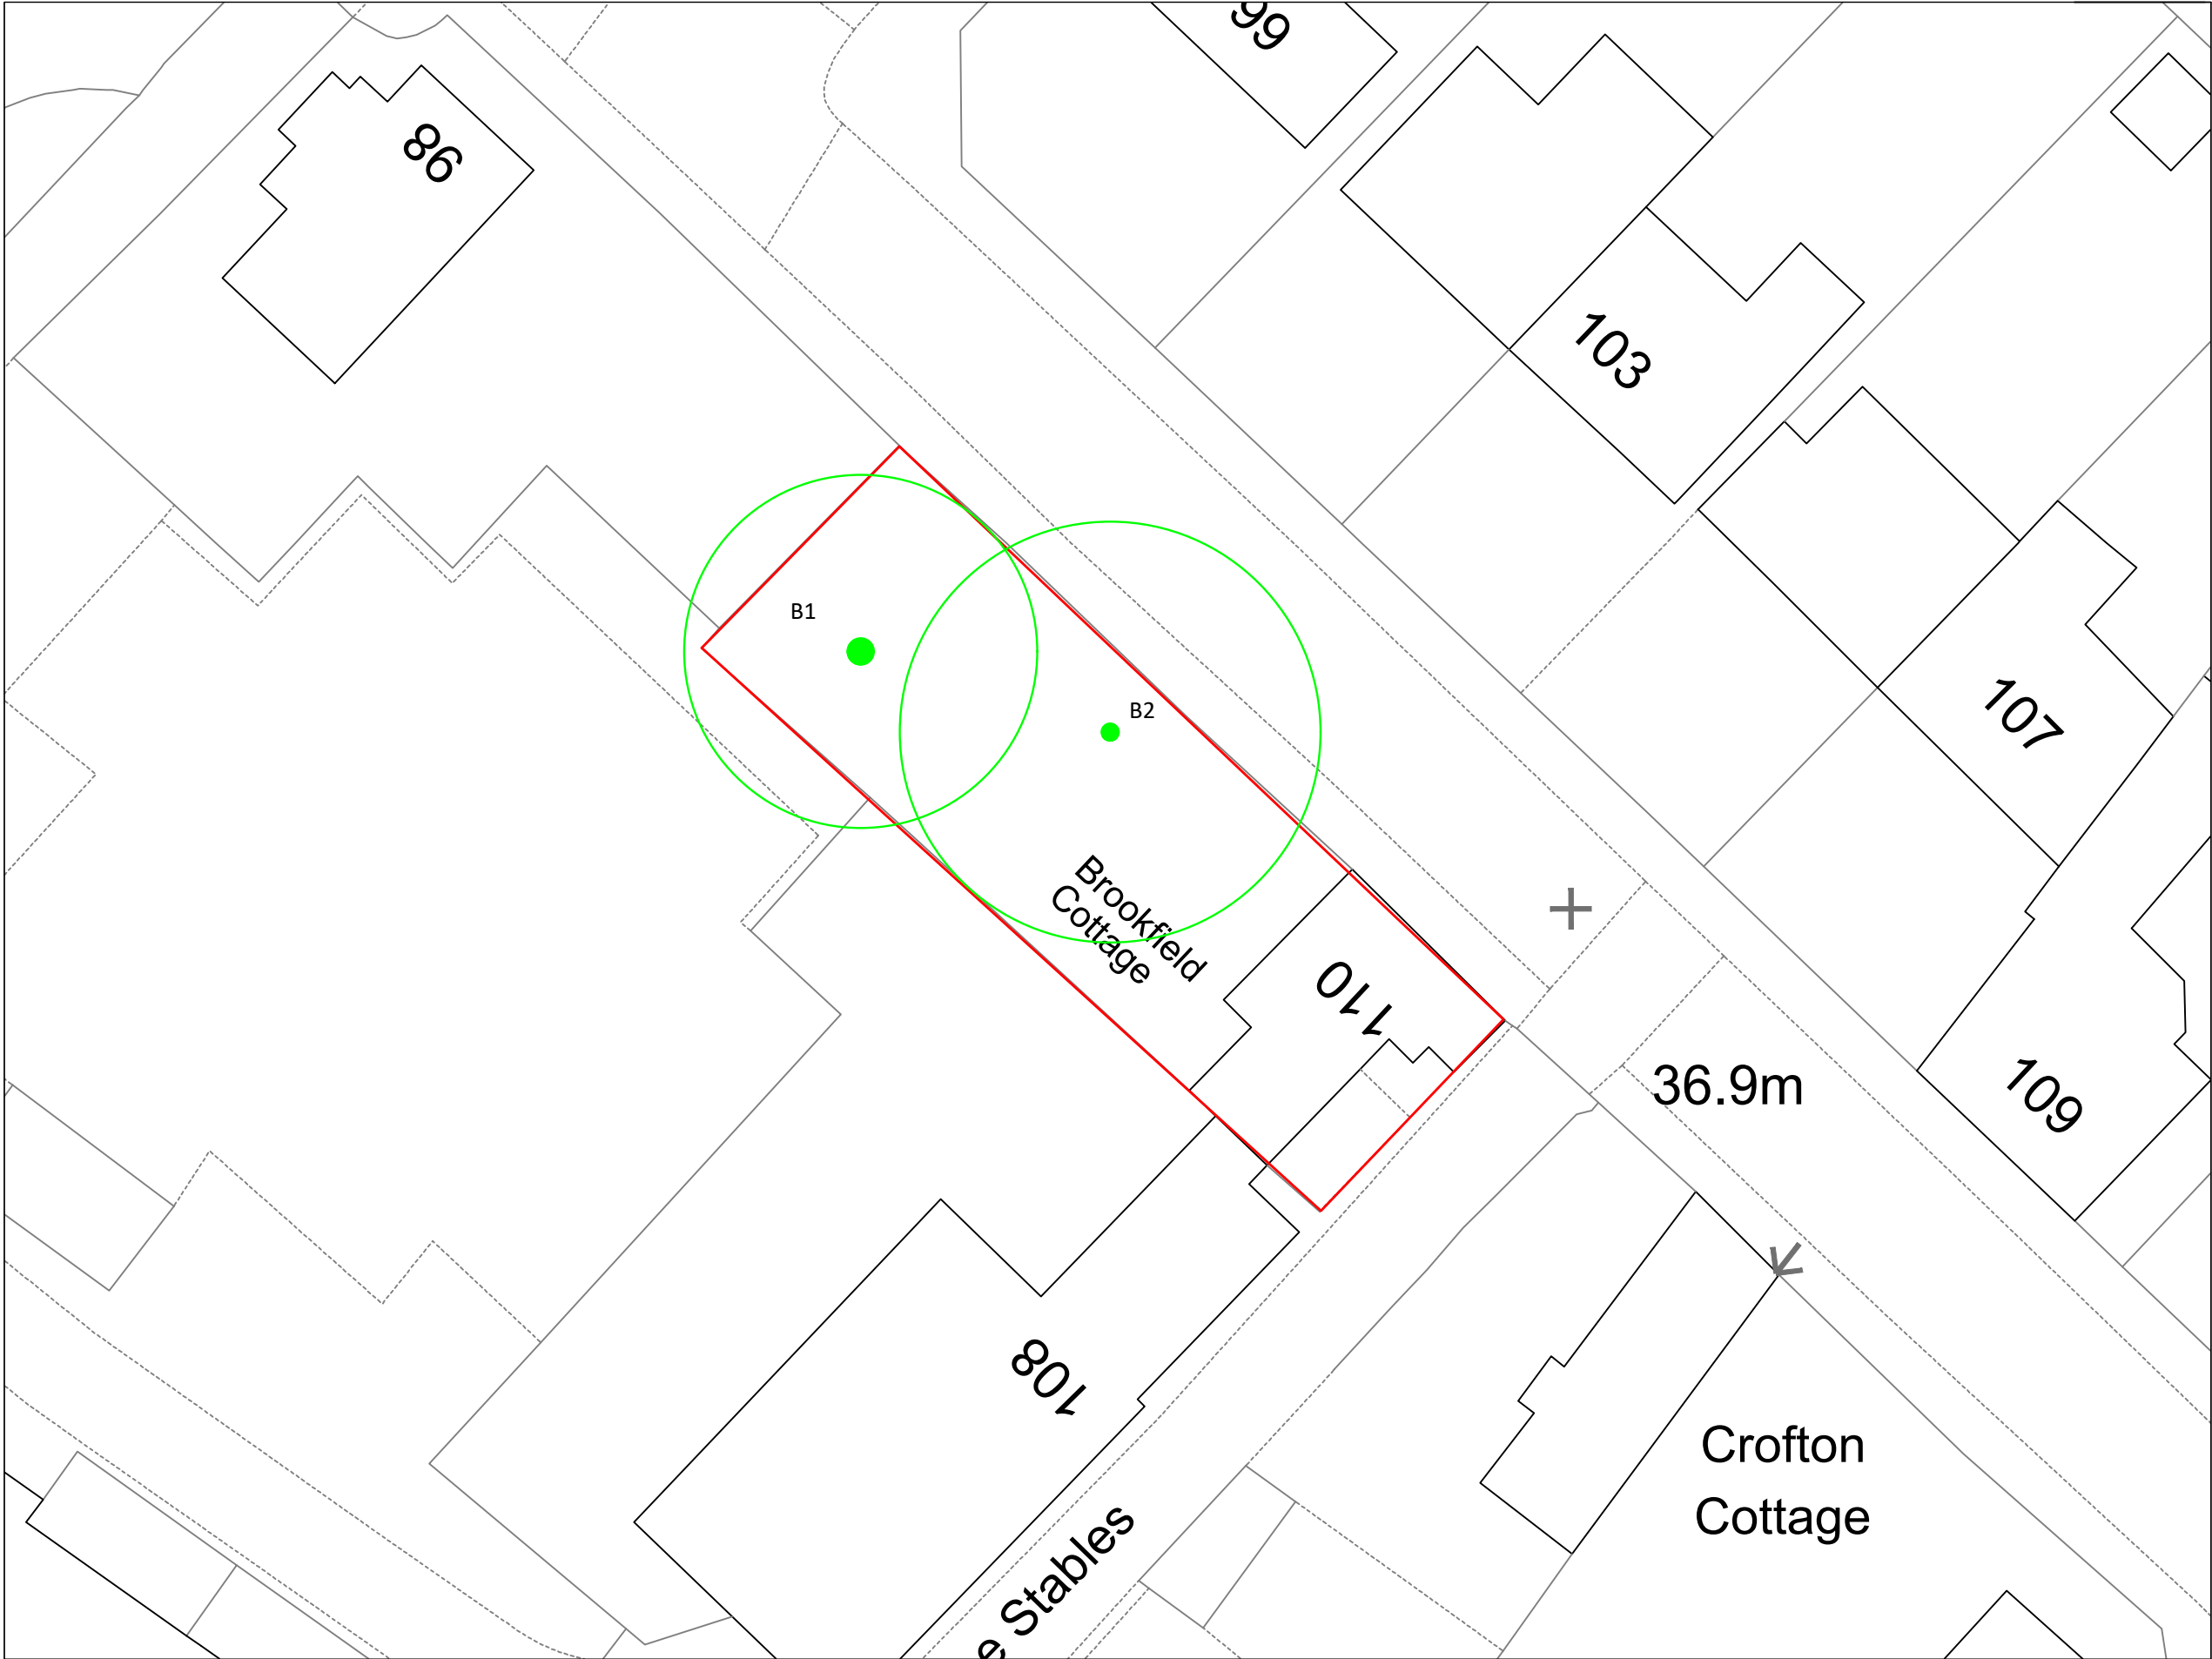
| Drawing Title: | Tree Constraint Plan |

Canopy spread (N, S, E, W) is approximate. Stem diameter (DBH) is taken at 1.5m above ground level, whether of single or multi-stem trees. Stem diameter is functional to determine the extent of the Root Protection Area (RPA).

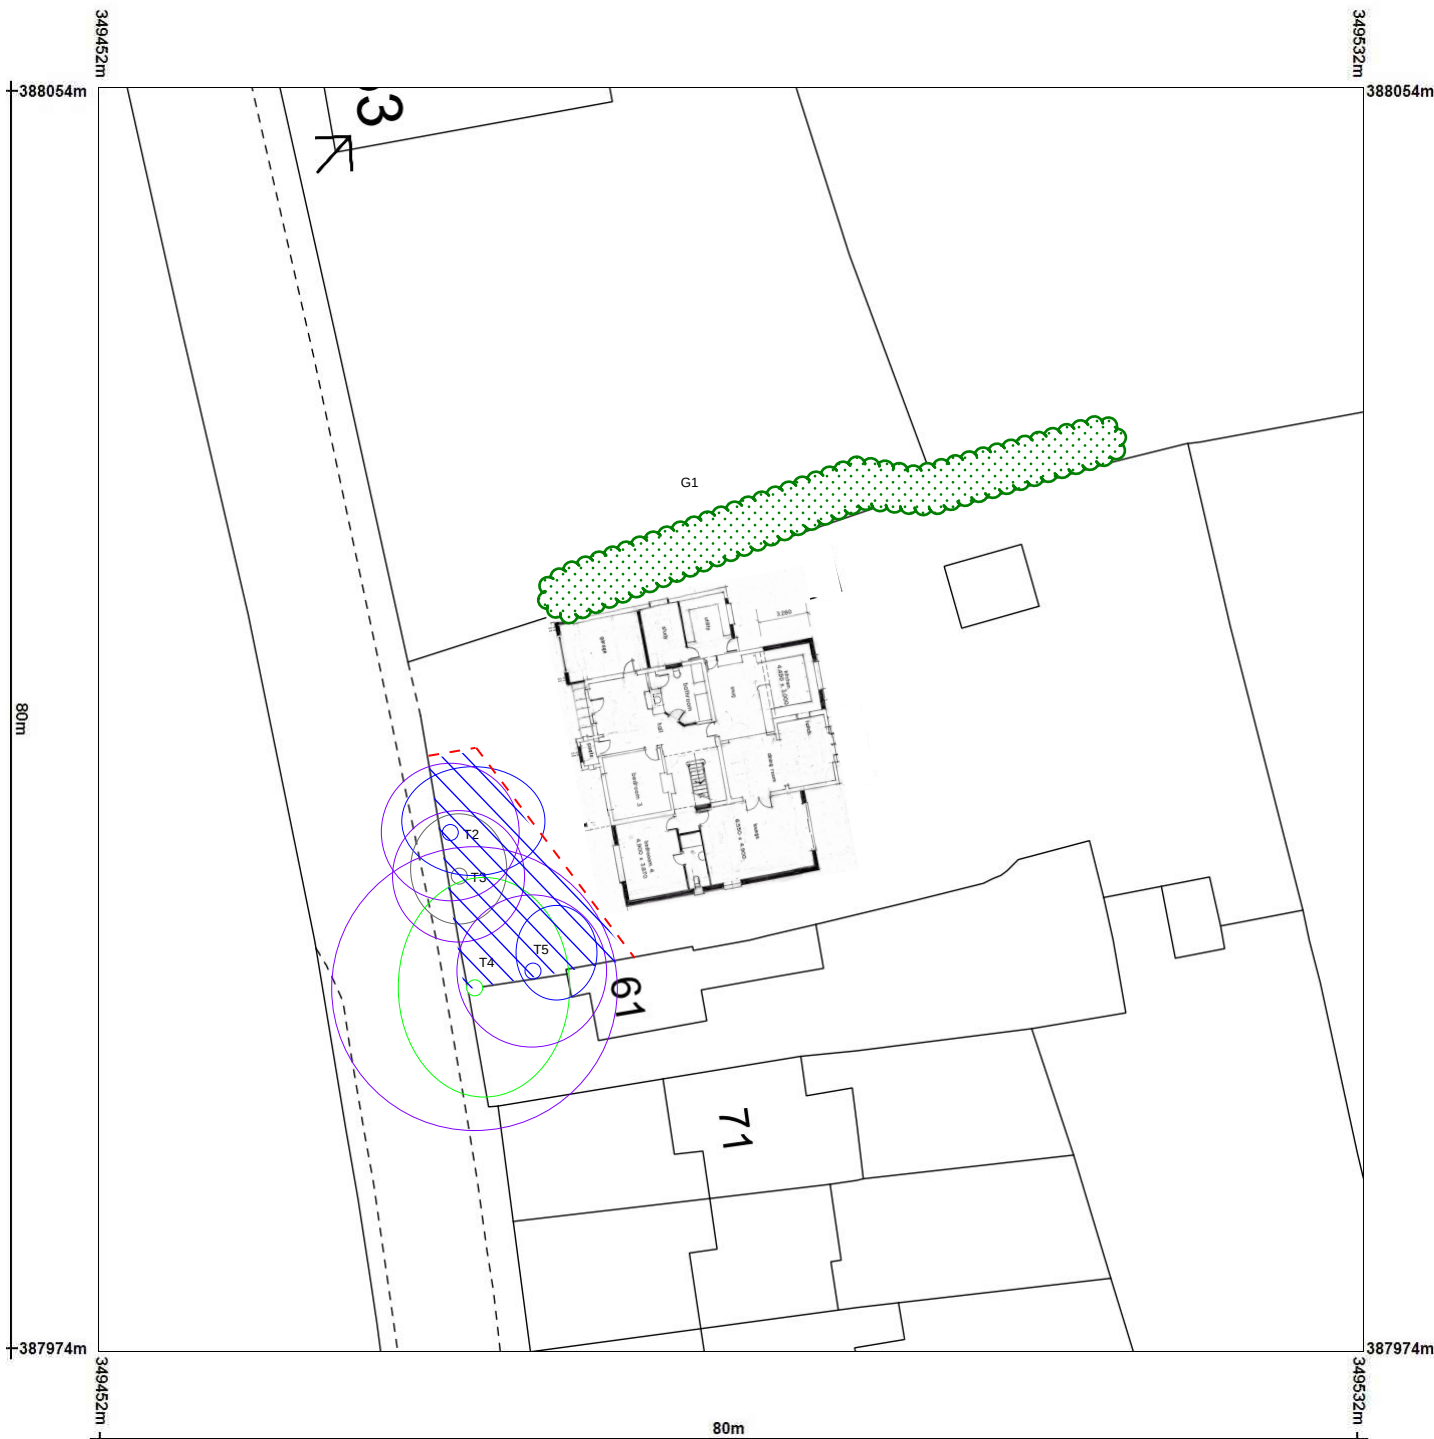
Method Statement

Temporary Ground Protection (Article 16)  
Within RPA's suitable ground protection should be capable of supporting required traffic. For pedestrian traffic, scaffold boards may be laid over woodchip. Where access is required for plant, Iros recommends commercial ground protection mats of suitable load bearing laid over 150mm of woodchip. [www.groundprotection.co.uk](http://www.groundprotection.co.uk)

Excavations within RPA's  
Any excavation with an RAZ must be carried out by hand or by Air Spade with any exposed roots greater 10mm to be wrapped in hessian and exposed for no longer than 5 days. Trench digging for utilities is not acceptable. Where utility access is required then trenchless techniques would be necessary. If required further details would need to be included.

Foundations  
Where a proposed construction development breaches an RPA, trench foundations must not be used. A pile and beam structure would be required. A design from a structural engineer would need to be included to set out the methodology

New hard surfacing within RPA's  
Any development of new hard surfacing may be subject to a maximum dig policy of 100mm. The hard surface would need to be laid over a commercial cellweb system of sufficient weight bearing capacity for the required purpose. Permeable surface material should be used and topographical levels would be required

Barriers (Article 15)  
The default specification should consist of a vertical and horizontal scaffold framework, well braced to resist impacts, as illustrated in Figure 2. The vertical tubes should be spaced at a maximum interval of 3 m and driven securely into the ground. Onto this framework, welded mesh panels should be securely fixed. Care should be exercised when locating the vertical poles to avoid underground services and, in the case of the bracing poles, also to avoid contact with structural roots. If the presence of underground services precludes the use of driven poles, an alternative specification should be prepared.

Hazardous Materials Management (Article 17)  
Any mixing of cement or cement based products and any hydrocarbon based products shall and will take place outside the restricted zones and shall be carried out within bunded areas to avoid unintended run off. All such processes shall be stored and carried out in accordance with COSHH Regulations and apart from protected zones.

Remedial Planting  
\*Tree Planting and maintenance to be in accordance with BS8545  
\*Planting to include for GreenBlue RoofRain Metro watering systems  
\*Tree ties to be hessian and to be adjusted annually  
\*Trees selected to be suitable for relative soils profiles as identified  
\*Statutory clearance of overhead services  
\*Local ecology including native species  
\*Tolerance of local climate such as urban or coastal  
\*Size and selection of stock  
\*Watering must be maintained during dry periods with no rainfall within 7 days.

Planting in Hard Landscape  
It should be noted that where trees are to be established in hard landscape, a suitable rootcell system such as GreenBlue Urban Rootspace 400 would need to be incorporated to allow for uncompacted soil with aeration and irrigation systems. A rootcell system allows for suitable conditions for root elongation and protects the hard landscape from secondary root growth and associated damage. For further information visit [www.greenblue.com](http://www.greenblue.com)

The GreenBlue Urban RootSpace system is manufactured with a unique design incorporating vertical and horizontal rootcells, giving excellent root volume for roots and to help retain moisture

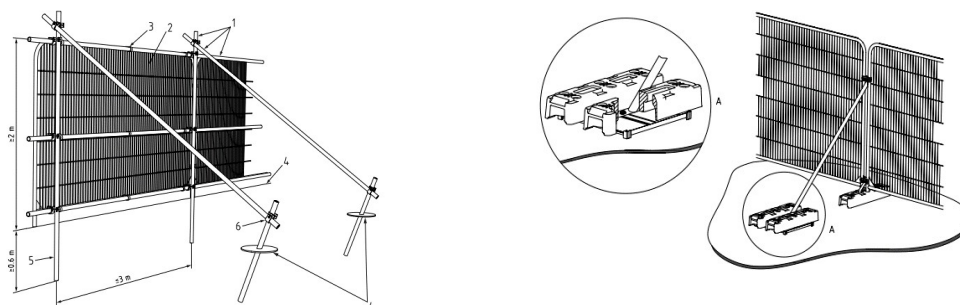
Specification for barrier

The barriers may be of a scaffold and wire mesh type fixed into the ground or a back stay design where a ground fix may not be practical and should be secured with anti-tamper fixings. IROS recommends CLD Fence Safe System. Barriers should be maintained and kept in good condition

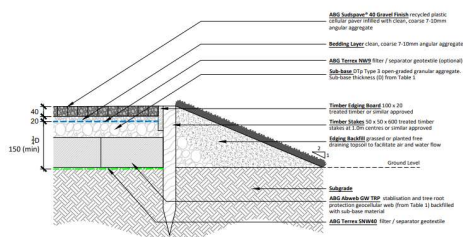
Where paving or walkways are required within an RPA zone, a "no dig" policy would be expected. It would be required therefore to install a cellweb system. An example would be the ABG Abweb TRP Sysytem [www.abg ltd.com](http://www.abg ltd.com)

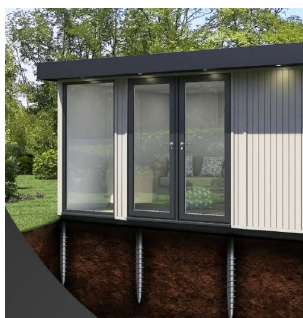
For installation of timber structures such as decking, walkways and garden buildings, ground screws would be a suitable installation within RPA's. Guidance is that a maximum of 15% of an RPA is affected. These are available from [www.terra-uk.com](http://www.terra-uk.com)

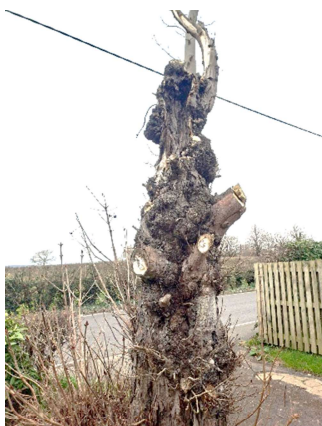
| Ref. | Species | Full Structure | Measurements | Survey Notes | Retention Category | RPA | Comments | Measurements2 | Recommendations |
|---|---|---|---|---|---|---|---|---|---|
| T001 | Horse chestnut<br>( <i>Aesculus hippocastanum</i> ) | Tree | Height (m): 9<br>Stem Diam(mm): 750<br>Spread (m): 1N, 1E, 1S, 1W<br>Crown Clearance (m): 7<br>Life Stage: Over Mature<br>Rem. Contrib.: <10 years | Very poor condition and collapsing with heavy decay. Adjacent to the road. | U | N/A | Tree to be removed but only due to condition. | Other Reference:<br>Physiological Condition: Diseased<br>Structural Condition: Collapsing<br>Public Amenity Value: Low<br>Inspection Limitations: None | Pre construction:<br>Remove tree.<br><br>During construction:<br>No action required.<br><br>Post construction:<br>No action required. |

- 1) None of the trees to the front of the property are impacted by the development
- 2) A construction exclusion zone is shown in Appendix 5
- 3) T001 is to be removed as in a collapsing state
- 4) Group 001 consists of a number of self seeded Sycamore Trees. These appear to be on neighbouring property
- 5) Group 001 not accessible

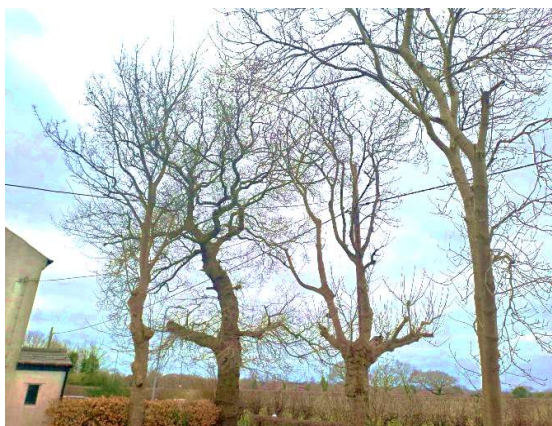
T002 - T005

| Ref. | Species | Full Structure | Measurements | Survey Notes | Retention Category | RPA | Comments | Measurements2 | Recommendations |
|---|---|---|---|---|---|---|---|---|---|
| T002 | Ash<br>( <i>Fraxinus sp.</i> ) | Tree<br>2 stems | Height (m): 11<br>2 stems (mm): 230,290<br>Spread (m): 4N, 6E, 3S, 3W<br>Crown Clearance (m): 4<br>Lowest Branch (m): 4(N)<br>Life Stage: Early Mature<br>Rem. Contrib.: 20+ Years | Good overall Physiological and Structural condition. | B | Radius: 4.4m.<br>Area: 61 sq m. | This tree will not have to be removed to facilitate a proposed future development. | Other Reference:<br>Physiological Condition: Good<br>Structural Condition: Good<br>Public Amenity Value: High<br>Inspection Limitations: None | Pre construction:<br>No action required.<br><br>During construction:<br>Protect trees with protective barriers - as shown on plans.<br><br>Post construction:<br>No action required. |
| T003 | Sycamore<br>( <i>Acer pseudoplatanus</i> ) | Tree | Height (m): 9<br>Stem Diam(mm): 350<br>Spread (m): 4N, 3E, 3S, 3W<br>Crown Clearance (m): 3<br>Lowest Branch (m): 3(N)<br>Life Stage: Early Mature<br>Rem. Contrib.: 20+ Years | Rather Poor overall Physiological and Structural condition. Pruned around wires | C | Radius: 4.2m.<br>Area: 55 sq m. | This tree will not have to be removed to facilitate a proposed future development. | Other Reference:<br>Physiological Condition: Fair<br>Structural Condition: Fair<br>Public Amenity Value: Good<br>Inspection Limitations: None | Pre construction:<br>No action required.<br><br>During construction:<br>Protect trees with protective barriers - as shown on plans.<br><br>Post construction:<br>No action required. |
| T004 | Pedunculate oak<br>( <i>Quercus robur</i> ) | Tree | Height (m): 10<br>Stem Diam(mm): 760<br>Spread (m): 7N, 6E, 7S, 5W<br>Crown Clearance (m): 3<br>Lowest Branch (m): 3(N)<br>Life Stage: Mature<br>Rem. Contrib.: 20+ Years | Good overall Physiological and Structural condition. Some fibre buckling. Tree is subject to a TPO | A | Radius: 9.1m.<br>Area: 260 sq m. | This tree will not have to be removed to facilitate a proposed future development. | Other Reference:<br>Physiological Condition: Good<br>Public Amenity Value: Very High<br>Inspection Limitations: None | Pre construction:<br>No action required.<br><br>During construction:<br>Protect trees with protective barriers - as shown on plans.<br><br>Post construction:<br>No action required. |

| Ref. | Species | Full Structure | Measurements | Survey Notes | Retention Category | RPA | Comments | Measurements2 | Recommendations |
|---|---|---|---|---|---|---|---|---|---|
| T005 | Sycamore<br>( <i>Acer pseudoplatanus</i> ) | Tree | Height (m): 10<br>Stem Diam(mm): 400<br>Spread (m): 4N, 4E, 2S, 1W<br>Crown Clearance (m): 5<br>Lowest Branch (m): 5(S)<br>Life Stage: Early Mature<br>Rem. Contrib.: 20+ Years | Fair overall Physiological and Structural condition. | B | Radius: 4.8m.<br>Area: 72 sq m. | This tree will not have to be removed to facilitate a proposed future development. | Other Reference:<br>Physiological Condition: Fair<br>Structural Condition: Good<br>Distance1:<br>Distance2:<br>You customise:<br>Public Amenity Value: Good<br>Inspection Limitations: None<br>Bat Habitat: | Pre construction:<br>No action required.<br><br>During construction:<br>Protect trees with protective barriers - as shown on plans.<br><br>Post construction:<br>No action required. |
