# **WINDY ARBOR ROAD PLAYING FIELDS CAR PARK**

Phase 1 Geo-Environmental Assessment and  
Coal Mining Risk Assessment

**PROJECT NO. 70057126**

**DATE: JUNE 2021**

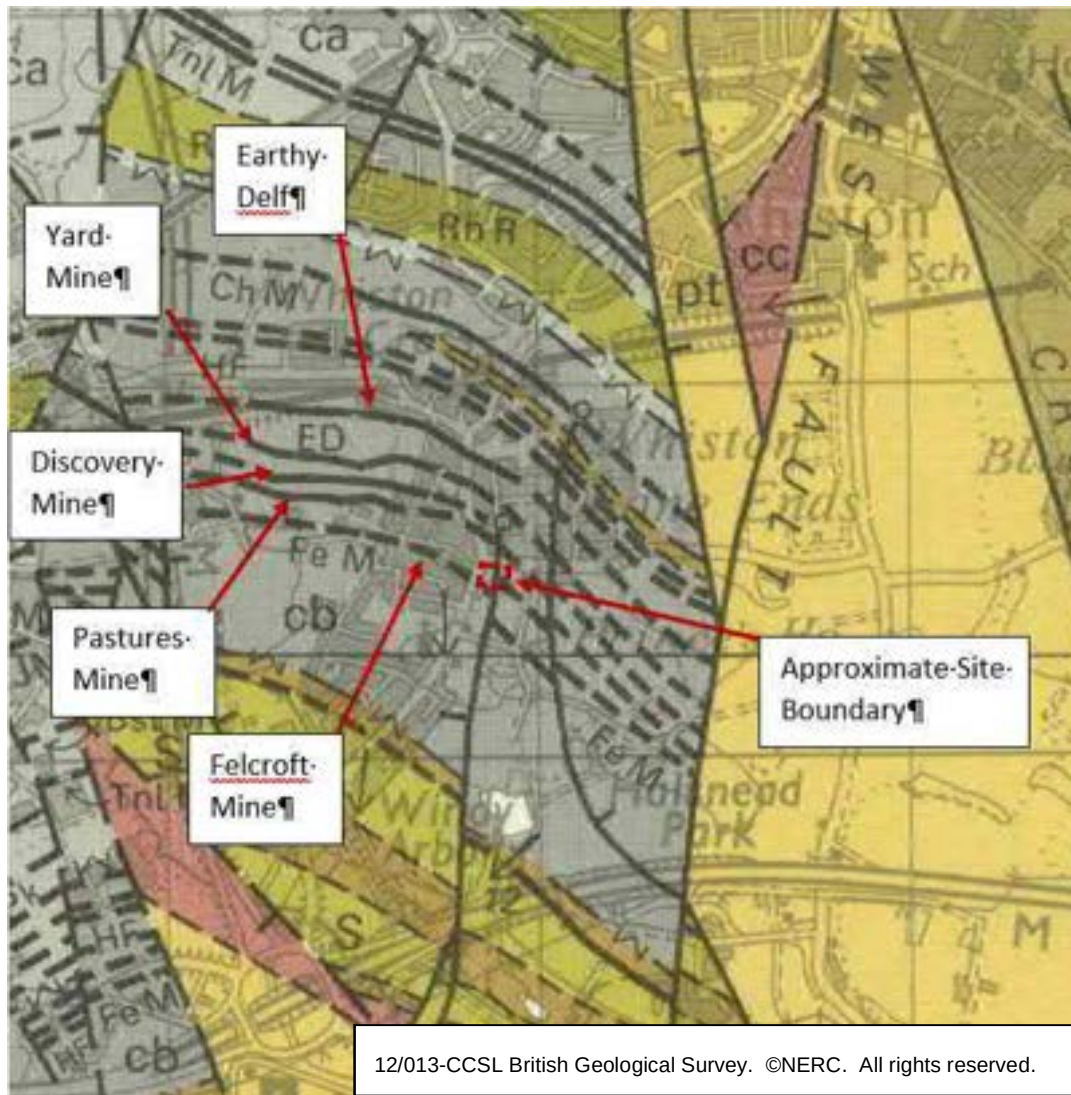
**Figure 5-1 - Extract from BGS Mapping (Sheet 97)**

- 5.3.2. There are numerous coal subcrops shown within close proximity to the site boundary, as shown in **Figure 5-1** (and annotated for clarity). The coal seam subcrops are identified as conjectured, meaning there is some uncertainty as to their exact location.

- Drift deposits noted as Glacial Till.
- Solid geology noted as Pennine Middle Coal Measures Formation. The structural geology of the site and wider area is characterised by numerous fault lines, with one bisecting the site in a north to south orientation, downthrown to the west. A further fault, also trending north to south, is noted approximately 150m to the east of the site, downthrown to the east. The regional dip of the strata is recorded to the south/south west at an inclination of approximately 12 degrees (although this is likely to vary locally given the faulting in the area).

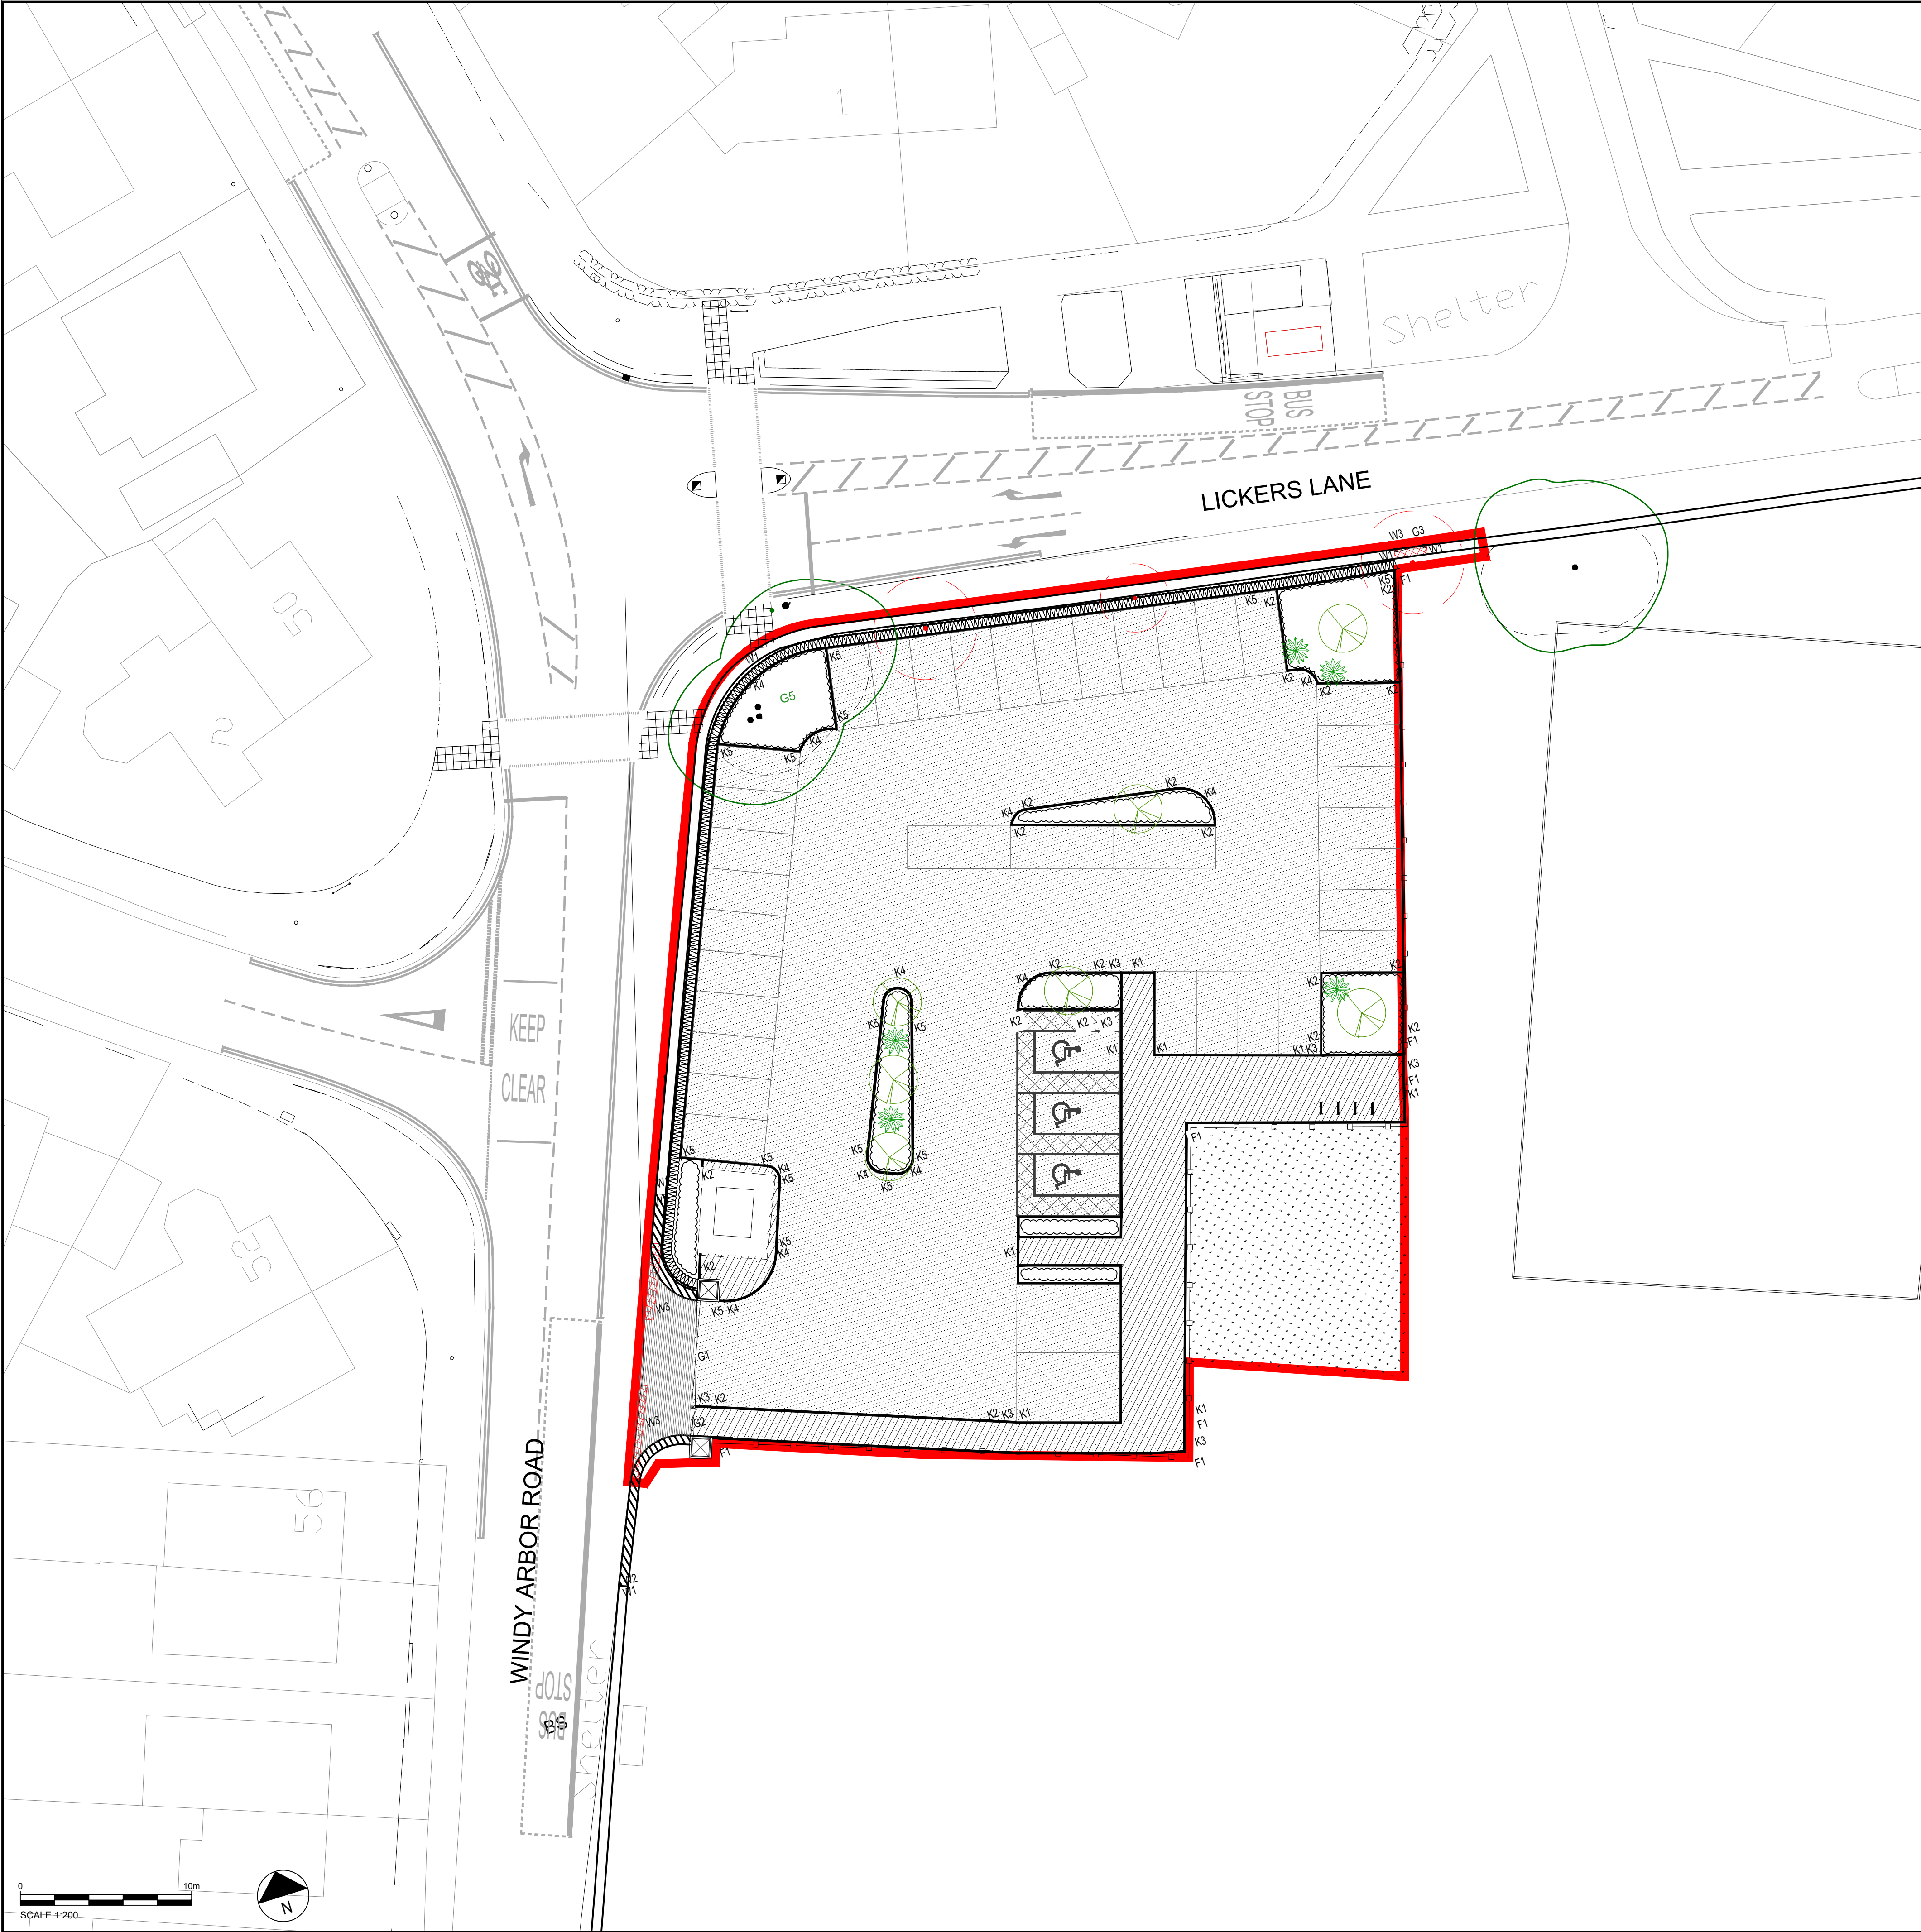
- KEY**
- Red line boundary
- FENCING / FEATURES**
- W1 Existing sandstone boundary wall, with curved sandstone capping stone.
- W2 Proposed Retaining Wall  
Stone finish, copings and pier caps to be specified by Engineer to match existing. Top of Wall (TOW) heights as shown on drawings 70057126\_WSP\_XX\_XX\_DR\_LA\_0005

- W3 Retaining wall section to be removed
- G2 / G3 Pedestrian gate
- Stone pier - To match existing wall .
- G1 Double gate vehicular gate
- F1 Cheshire Estate Fencing (or equivalent) steel fencing 1.2m high, black.

- Proposed cycle stands - 4no. (8 spaces)  
Woodscape Cycle Parking Bollard (or equivalent) 200W x 1000H mm (above ground) Durable Hardwood Timber, Stained

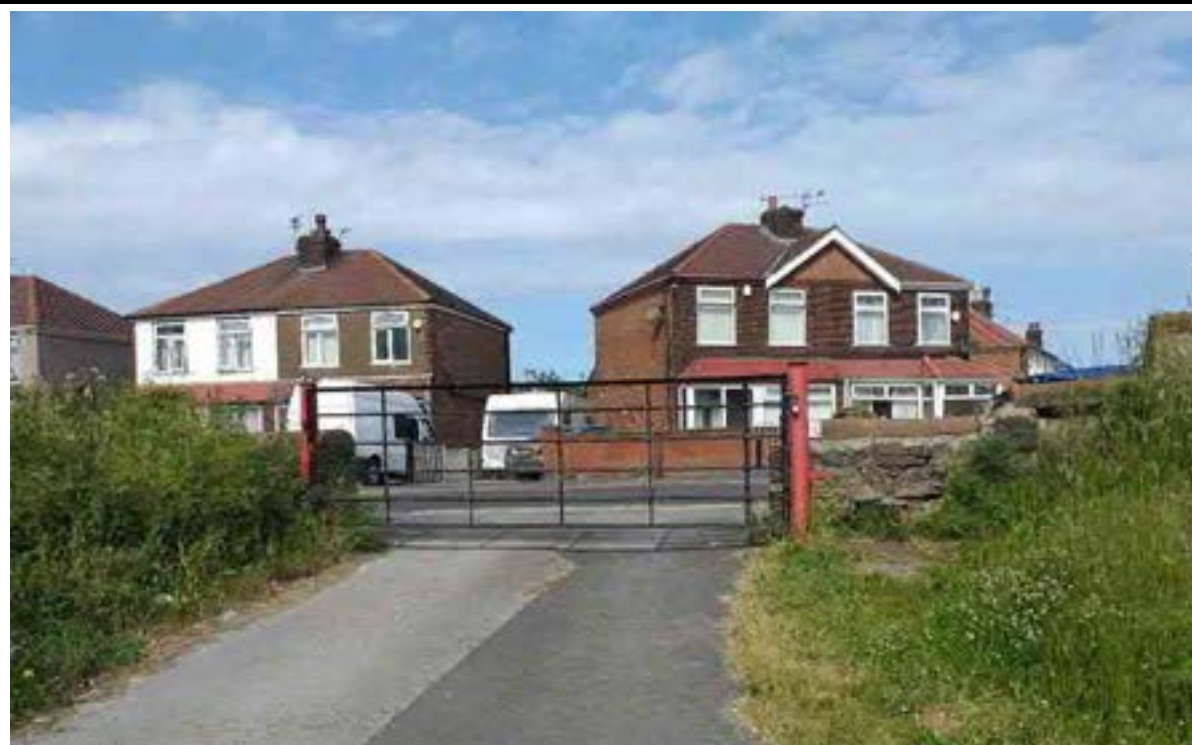
Photo 4: Gated vehicle access from Windy Arbor Road. Evidence of scarring presented by asphalt surface indicating past repair (photograph taken facing west).

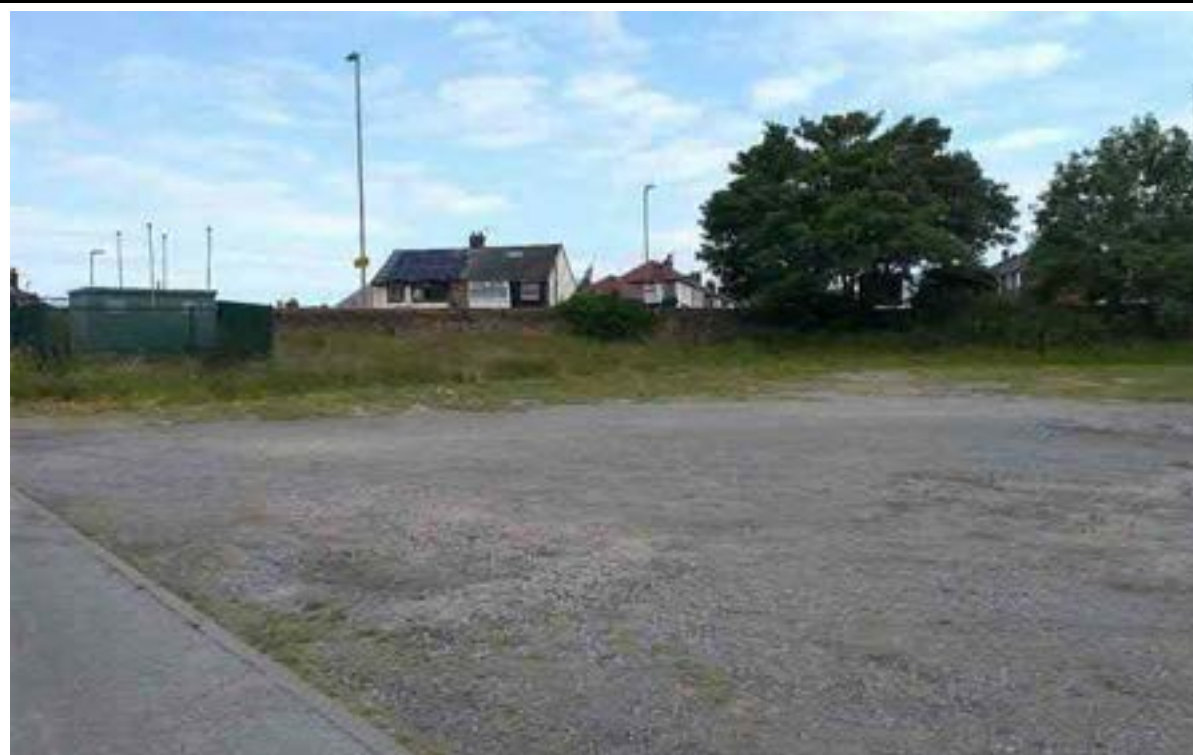
Photo 7: Existing car park in foreground with onsite gas service station and overgrown grassland in the background (photograph taken facing northwest).

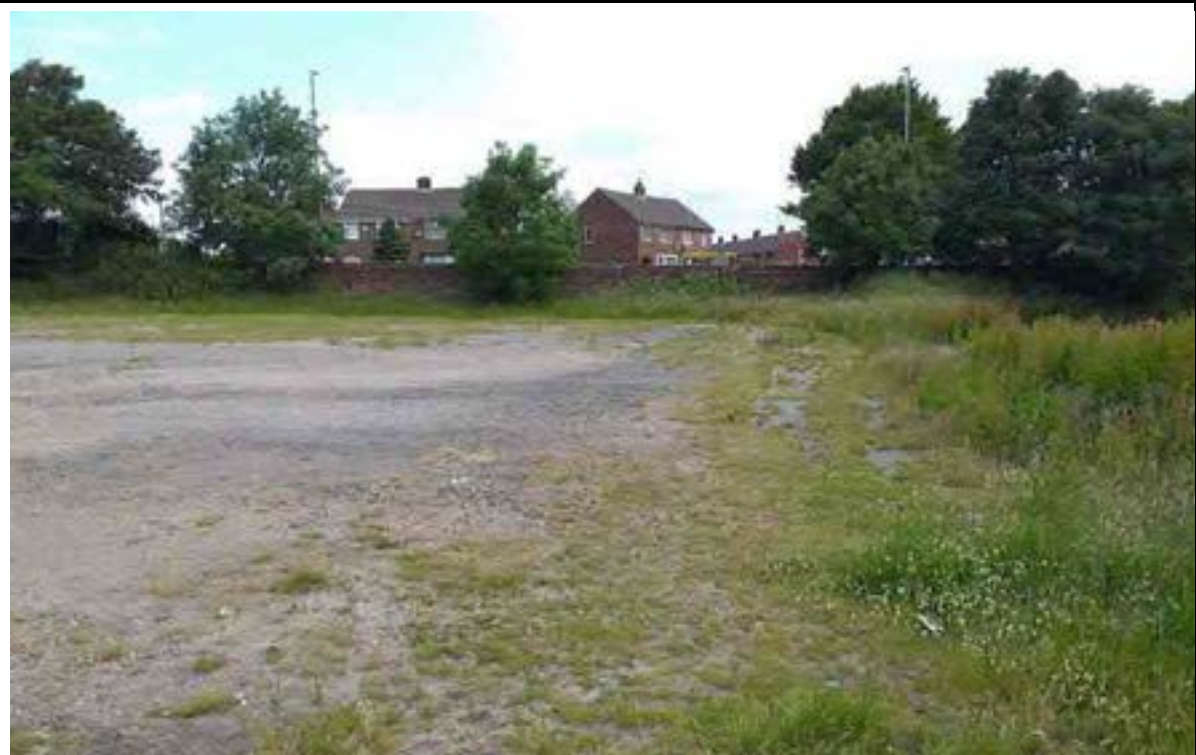
Photo 9: Existing car park with overgrown grassland and a low wooden post fence (0.4m in height) along the eastern boundary (photograph taken facing north).

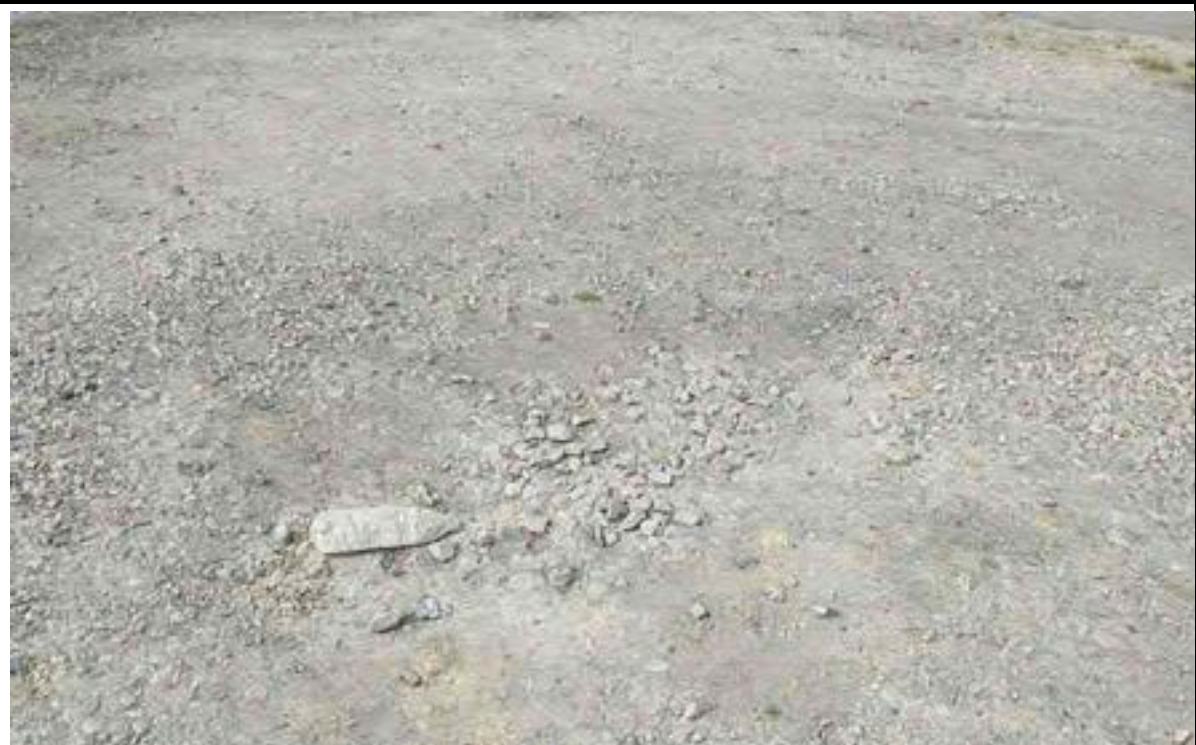
Photo 10: Car park surface composed of fine to coarse gravel of granite and limestone. Surface is uneven and is in poor condition.

- 7.3.2. The site is currently surfaced with a permeable layer of compacted gravel hard core. Formal tarmac surfacing is likely to be significantly less permeable which could lead to changes in any mine gas regime present beneath the site. It is therefore recommended to undertake a programme of gas and groundwater monitoring of the borehole installations in accordance with the frequency and monitoring period recommended in CIRIA 665 - Assessing Risks Posed By Hazardous Ground Gases to Buildings, (2007). Whilst no buildings are proposed, the purpose is to determine if mine gas is present in the underlying strata and if so, could formal surfacing of the site change the regime and impact nearby properties (including the existing gas governor building).

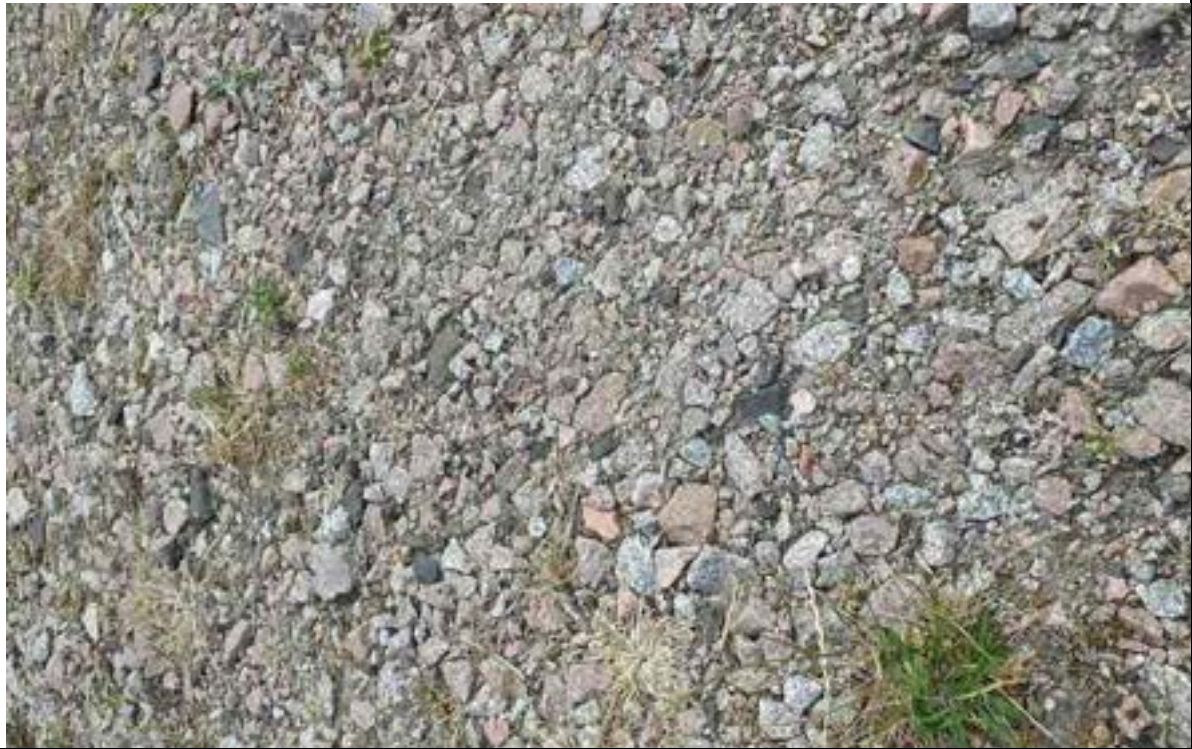
Photo 11: Car park surface composed of fine to coarse gravel of granite and limestone.

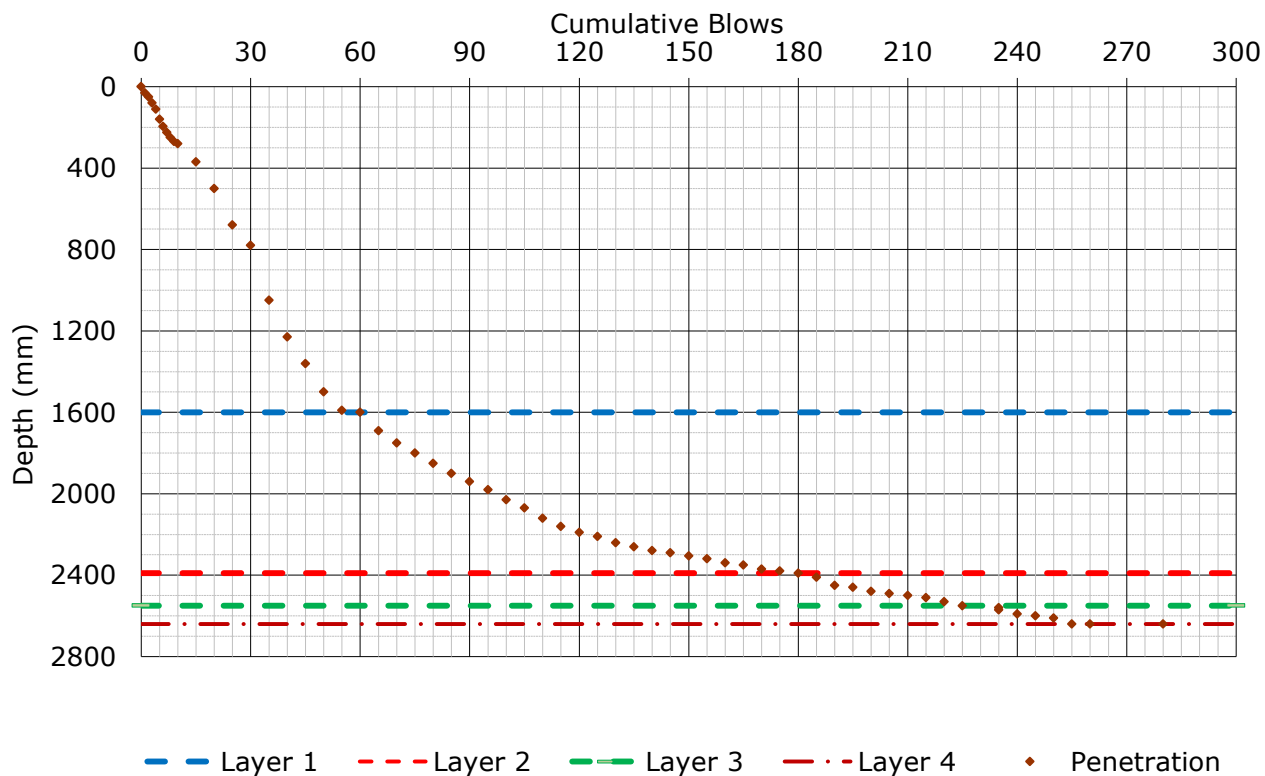
### GRAPH DETAILING RESULTS

| Layer | No. of Blows | Cumulative No. of Blows | CBR (%) | Layer Thickness (mm) | Total Depth (mm) |

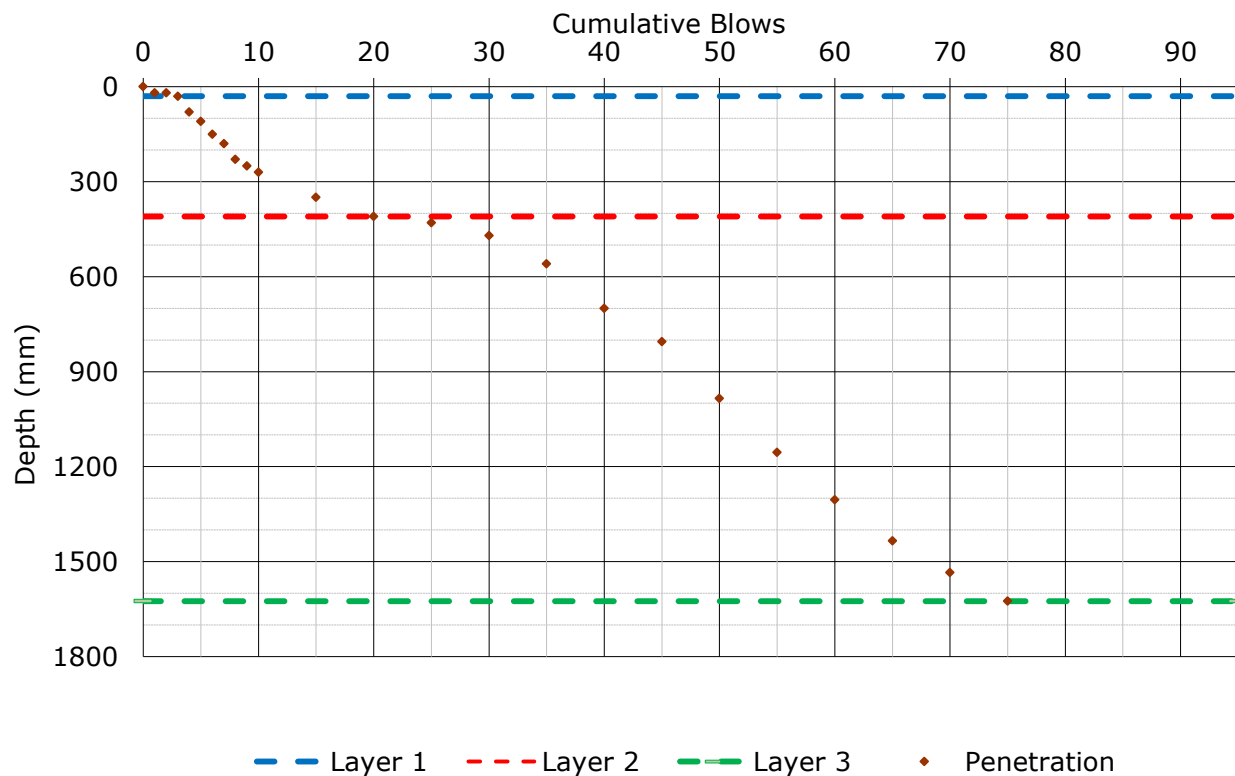
### GRAPH DETAILING RESULTS

| Layer | No. of Blows | Cumulative No. of Blows | CBR (%) | Layer Thickness (mm) | Total Depth (mm) |

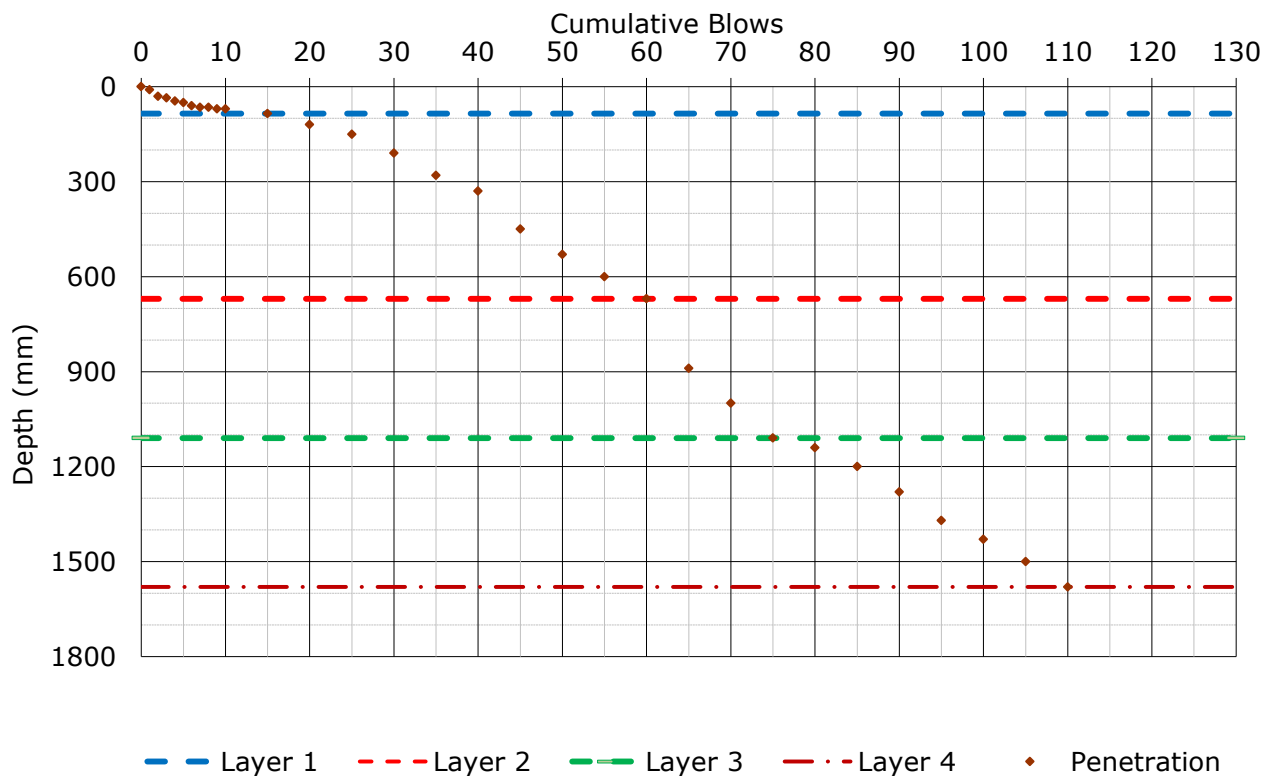
### GRAPH DETAILING RESULTS

| Layer | No. of Blows | Cumulative No. of Blows | CBR (%) | Layer Thickness (mm) | Total Depth (mm) |

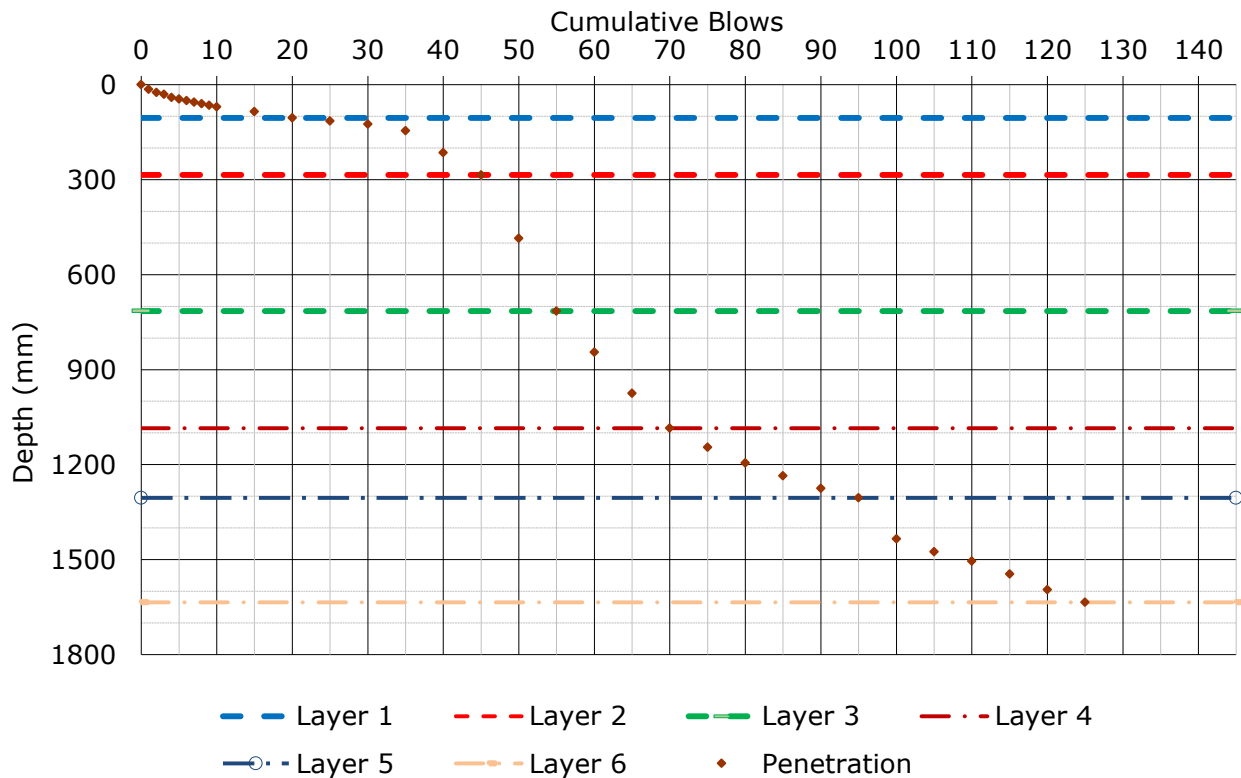
### GRAPH DETAILING RESULTS

| Layer | No. of Blows | Cumulative No. of Blows | CBR (%) | Layer Thickness (mm) | Total Depth (mm) |
