# ARBORICULTURAL IMPLICATIONS ASSESSMENT

PROPOSED DEVELOPMENT

DYE HOUSE  
PRESCOT

Author: C. Salisbury  
Date: 25 September 2023  
Ref: TRE/DHLR/Rev D

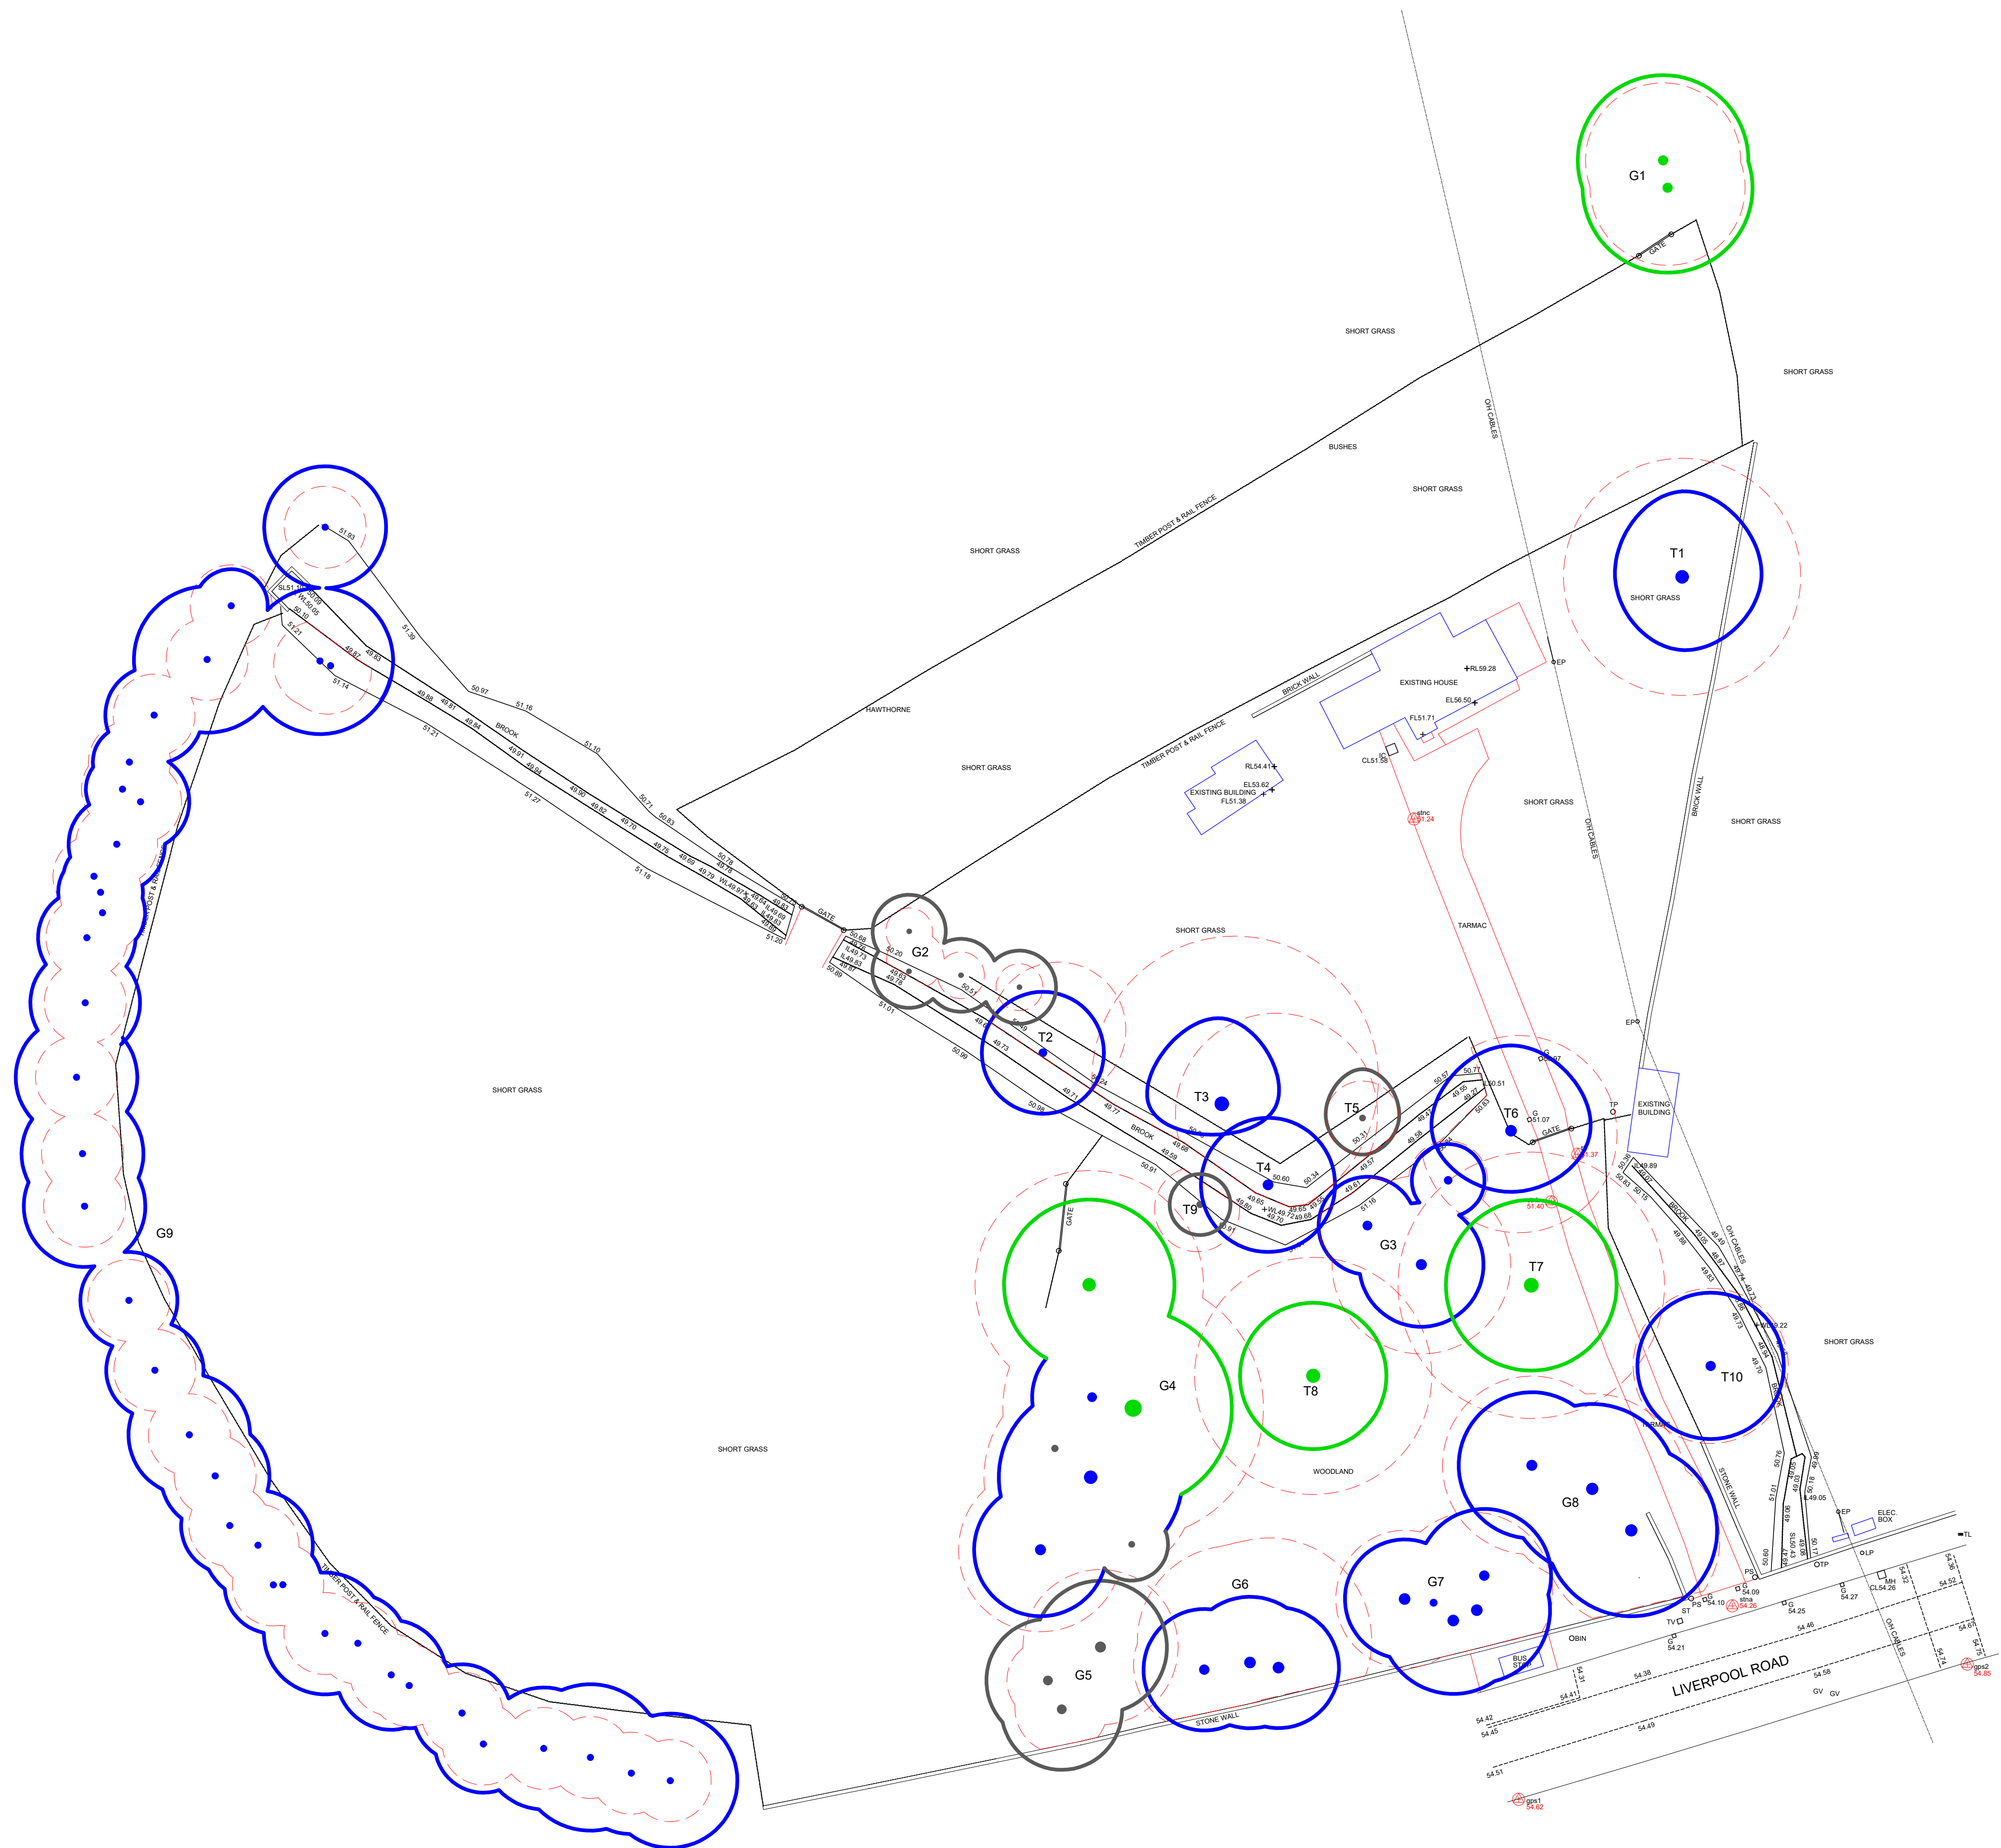
Drawing No:  
DHLRP/BS/01

Root protection area

Drawing Title:  
BS5837 Plan

- 3.1 Due to the proposed development and its associated infrastructure there are a number of locations where the proposals are in close proximity to the trees surveyed. The Site Layout Plan within appendix three identifies the trees in relation to the proposed development.
- 3.2 In order to fully assess the impact of the proposals an Impact Table has been created detailing each tree, which shows the proximity of the associated works to the tree.
- 3.3 This can then be assessed in accordance with BS 5837:2012 to determine whether the development will have a detrimental impact on the health of each tree. Once this has been determined remedial measures can be detailed to reduce the impact the proposals will have on the treescape.

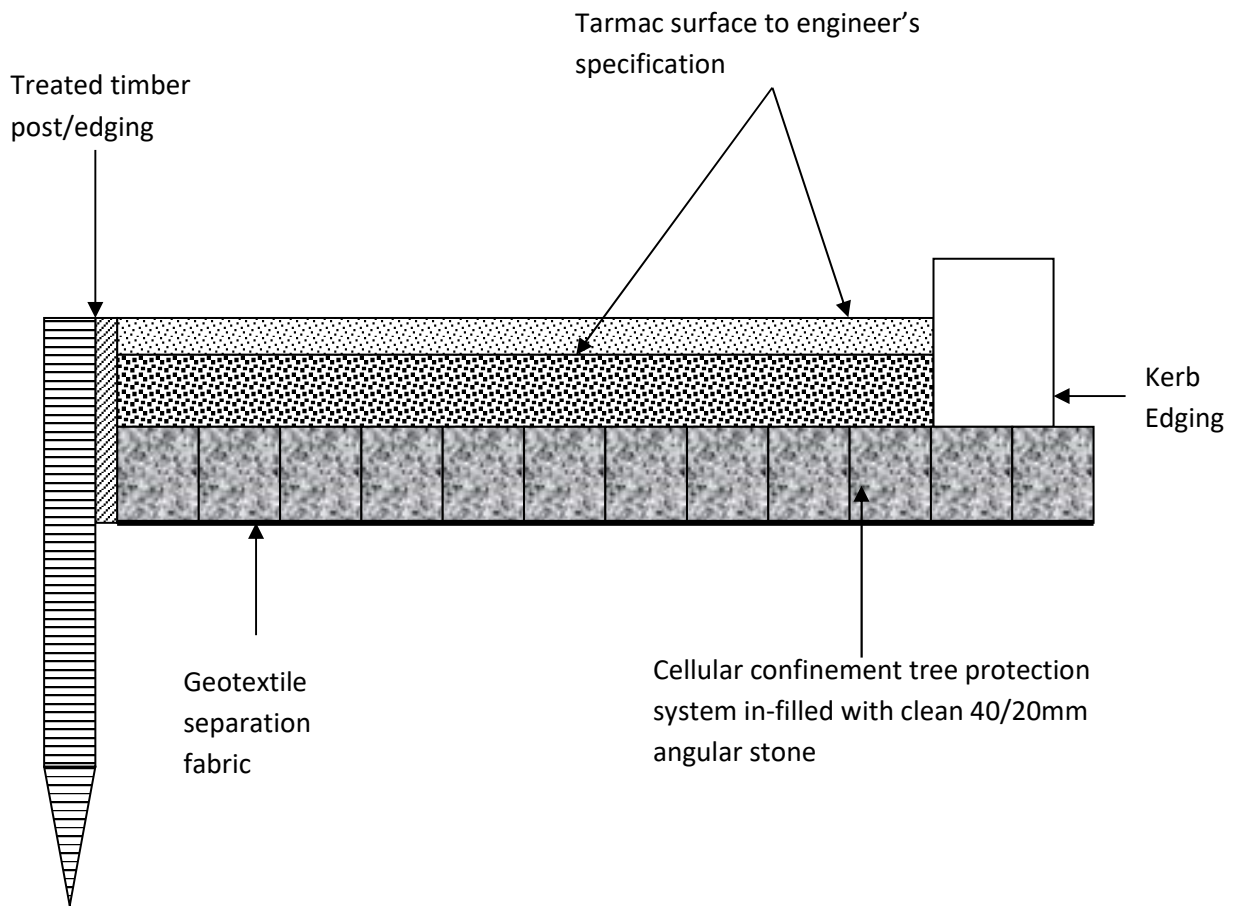
### Tarmac Surface

## GEOWEB BASED CONSTRUCTION – (INDICATIVE ONLY)

Depth of confinement system variable according to use- refer to manufacturer

5.3.4 A cellular confinement system provides a load transfer mattress which prevents direct loads on tree roots and reduces the bearing pressure on subsoil's by stabilising aggregate surfaces against rutting under wheel loads.

5.3.5 A proposed methodology and cross-sectional diagram for the construction of the hard standing can be found in appendix four of this report. Should this be used for the hard standing, in the area effecting the identified trees then the proposals should not have a detrimental effect upon them.

The following methodology supports the drawing indicating the construction of the proposed hard standing. The methodology is prepared on the basis of the sequence of operations necessary to complete the construction of the hard standing with the minimum damage to the trees proposed for retention.

- Surface layer to be scraped off. This can be done either by hand or by very small machinery.
- Erect protective fencing to the edge of the construction area.
- Spread a sub grade material over the length of the hard standing to fill any small ruts.
- Construct edging using treated timber if required.
- Lay geotextile mat over smoothed area.
- Extend the Geoweb perforated tree root protection system over the area of the driveway with sufficient overlap such that kerbs can be constructed on top of the Geoweb.
- Fill the voids within the Geoweb with reduced fines Type 1 material working into the site over the top of the Geoweb.
- Lay kerbs and surface over the Geoweb such that the construction binds itself together.
- Construct finished surface as required in line with guidance illustrations below.
