**Molyneux House 11 High St Prescot L34 3LD**

## **PLANNING APPLICATION AND LISTED BUILDING CONSENT**

### **HERITAGE STATEMENT**

### **ISSUE 3 – 29 SEPT 2026**

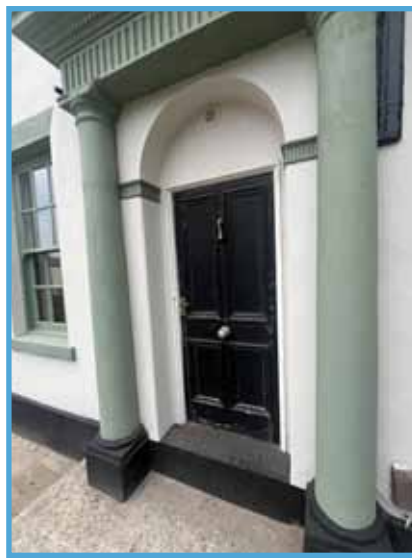
Existing pedimented doorcase

It is a substantial, three-storey brick house that has been painted white. The front elevation is symmetrically arranged, being five windows wide, and features a central front door highlighted by a pedimented doorcase with Doric half-columns.

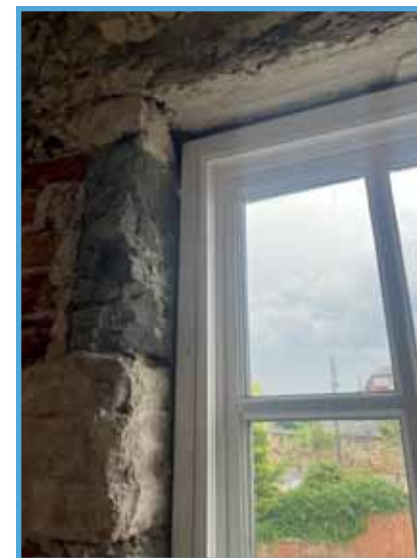
Example of 1980s workmanship to infill window sash with lightweight blockwork

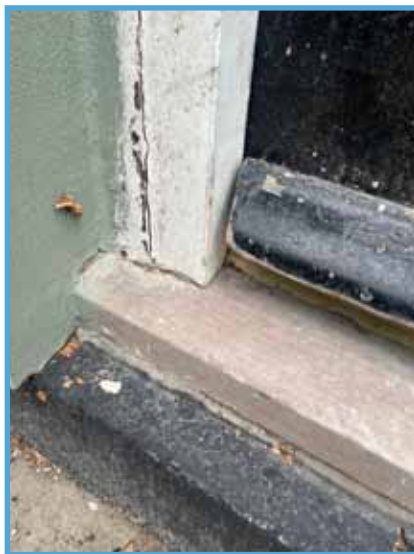
Existing 1980s side entrance door.  
Ply faced fire door with planted on softwood beading to form panels  
The cill is placed directly upon the facing brickwork

Upon inspection it was ascertained that the existing side door is not historical to the original building and it would suggest from the frame and door that this was installed as part of the conversion and adaptation works in the mid 1980's. The door is a ply faced solid core door with softwood beading installed on the face to appear like a panelled door. The frame appears to be hardwood with a hardwood cill from the same era placed upon a brickwork cill. This can be seen in the photographs

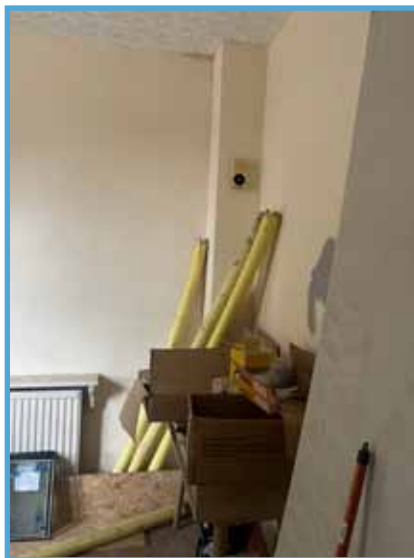
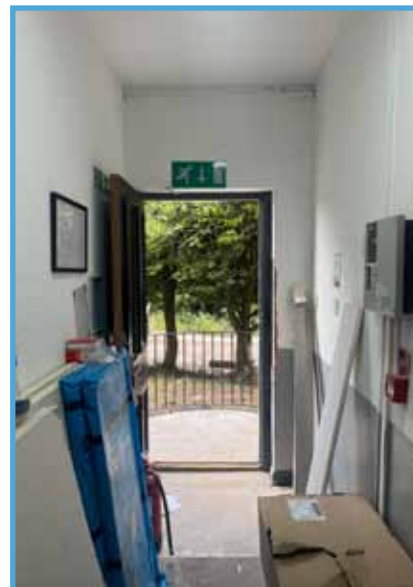
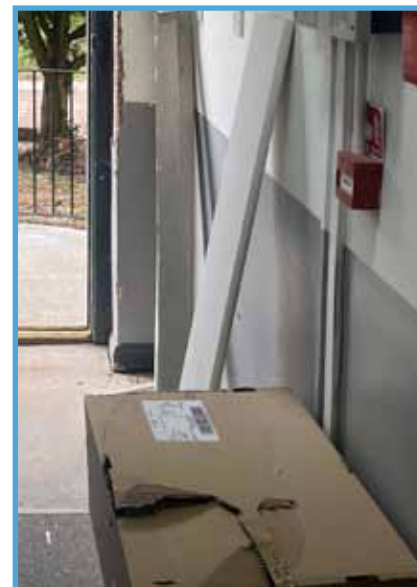
Photographic evidence demonstrating the lack of historic detail within the existing building in particular the existing entrance hall in question, which was formed during the mid-1980s conversion

A lot of the historic internal character of the building was lost during the conversion and adaptation to apartments in the mid 1980s. Therefore there is very little left in terms of historic features.

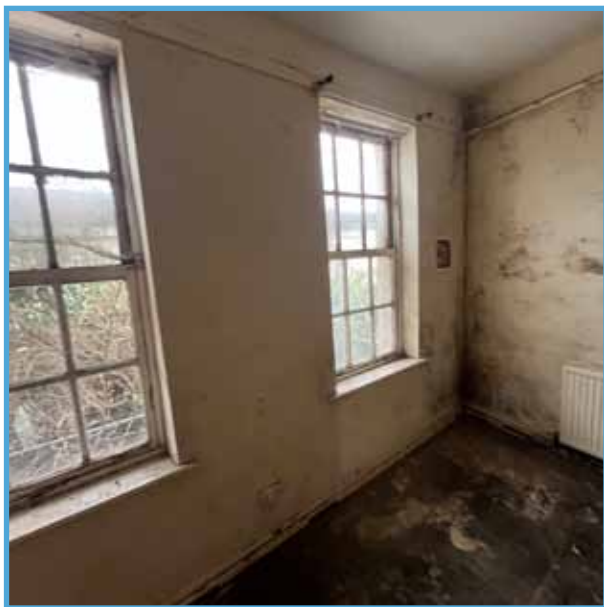
Examples damp plasterwork prior to commencement of the works

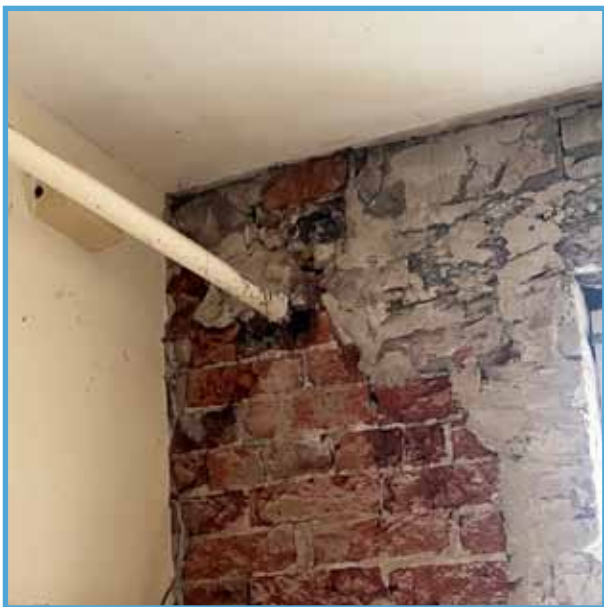
Examples of areas that require new plasterwork

Specification for traditional internal three-coat lime plaster applied directly to solid brickwork,

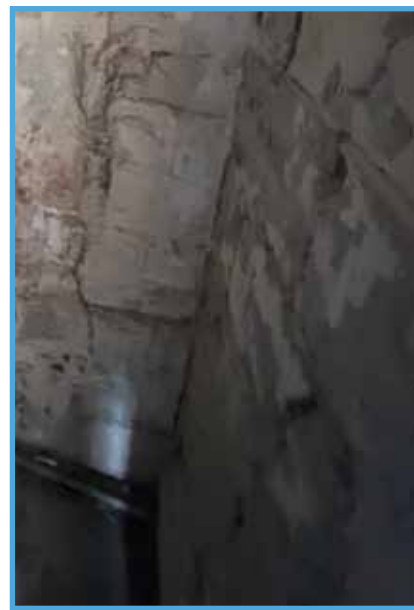
**Existing plasterwork to blockwork to rear of front entrance**

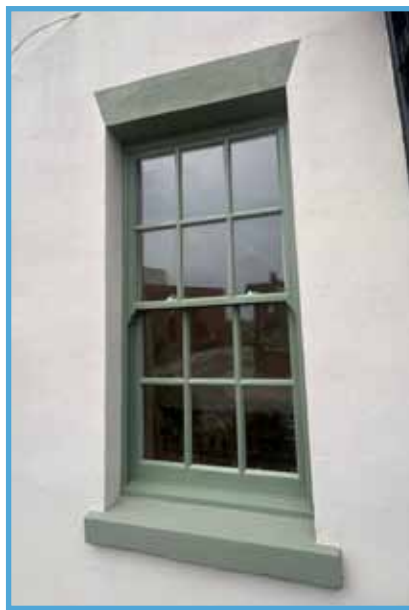
Typical new window installation
