# Heritage Statement

The Clock Face, Derby Street, Prescott

Daniel Thwaites PLC

DECEMBER 2023

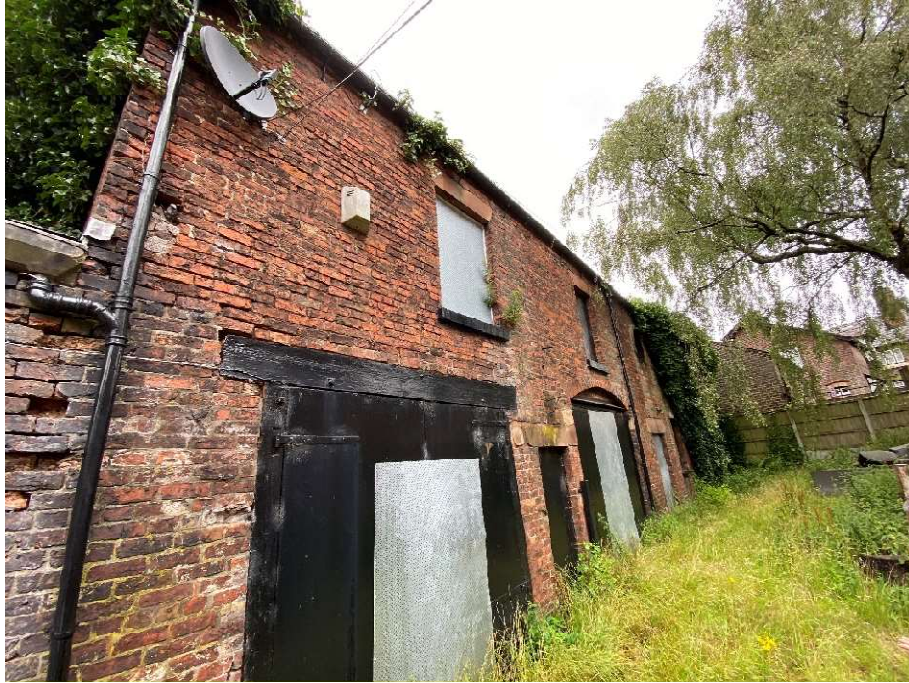
*Plate 1 – south elevation of the stable block with satellite dish to left and vegetation growth to the right (east) end.*

| <b>Proposed Works</b> | <b>Justification / Explanation for the Works</b> | <b>Assessment</b> | <b>Impact upon Significance</b> |
|---|---|---|---|
| Removal of Ivy from Stable block range | To prevent deterioration of fabric through growth in mortar joints, through vegetation holding moisture against fabric and through concealment of defects. | It is proposed that vegetation growth is removed from the exterior of the building by cutting the vegetation growth at the root initially prior to de-veg of the elevation. This will allow for any localised pointing and brickwork repairs and clearing and repair of the guttering and downpipes to be undertaken. | Beneficial impact upon the significance of the stable block.<br><br>Neutral impact to the significance of the Clock Face and Prescott Conservation Area. |

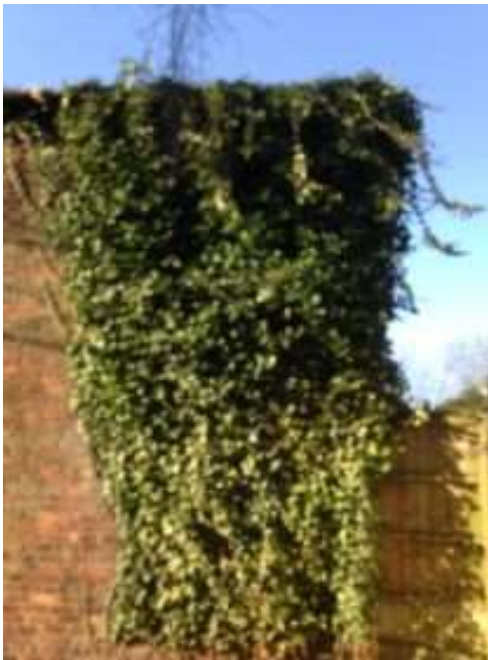
*Plate 2 – Vegetation growth to the east end of the south frontage of the stable block.*

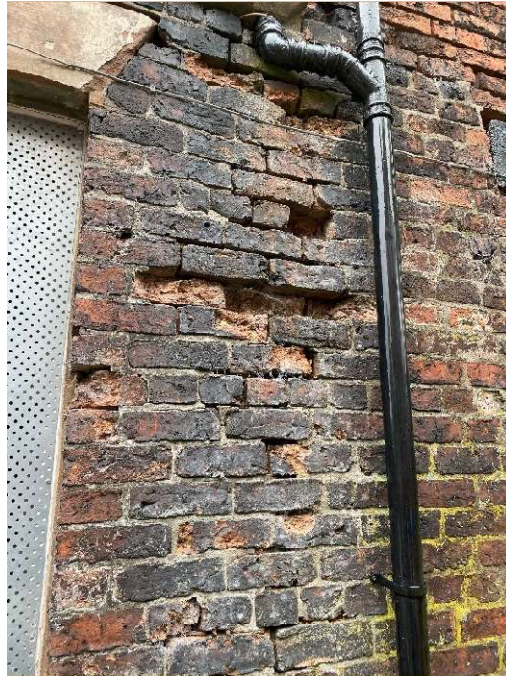
*Plate 3 – Spalled brickwork and open joints to south elevation. Deterioration is aligned where end cap is missing from the guttering.*

| <b>Proposed Works</b> | <b>Justification / Explanation for the Works</b> | <b>Assessment</b> | <b>Impact upon Significance</b> |
|---|---|---|---|
| Repairs to rainwater goods to comprise clearing of debris and vegetation and replacement of missing sections. | To ensure that rainwater is adequately collected and disposed to prevent water ingress and deterioration of historic fabric. | The gutting and downpipes are generally in good working order with no obvious sign of defect such as cracks and splits. An end cap is however missing to the guttering to the frontage. Following removal of the vegetation cover from the east end of the building, the | Beneficial impact upon the significance of the stable block.<br><br>Neutral impact to the significance of the Clock |

| Localised repointing and replacement of spalled brickwork on a like for like basis. | To protect the historic fabric from accelerated decay through water ingress and freeze thaw action. | There are areas of open mortar joints and spalled brickwork to the front elevation of the stable block, and it is proposed that open and missing mortar joints are repointed to protect the historic brickwork from accelerated deterioration and that significantly decayed sections of brickwork are cut out and new brickwork, to match the existing in terms of colour, texture, size and bond pattern, are bed and pointed to prevent water ingress and loss of fabric. Repointing is to be undertaken in accordance with Historic England best practice and will be undertaken using a lime and sand mortar with the sand selected based upon the colour and texture of the original mortar and brickwork. The final mix can be subject to a sample panel for agreement with Conservation Officer. | Beneficial impact upon the significance of the stable block.<br>Neutral impact to the significance of the Clock Face and Prescott Conservation Area. |

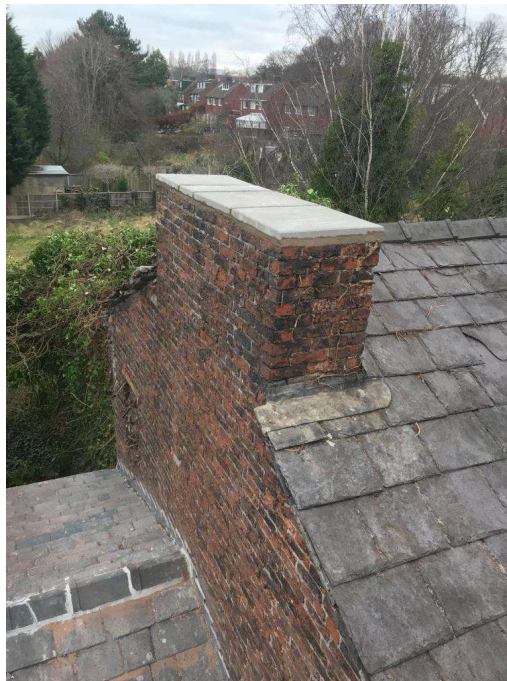
*Plate 4 – Partially dismantled chimney stack to the stable block.*

| <b>Proposed Works</b> | <b>Justification / Explanation for the Works</b> | <b>Assessment</b> | <b>Impact upon Significance</b> |
|---|---|---|---|
| Rebuilding of dismantled chimney stack on the outbuilding range. Works to follow the methodology included within Appendix 3. | The chimney stack was partially dismantled following the advice of a structural engineer. The repairs seek to reinstate the stack using the existing bricks salvaged from dismantling and new bricks, where required, to match the existing in terms of colour, size, and texture. | The reinstatement of the upper courses of the stack will ensure a historic feature is retained. The stack provides evidence as to the function of this part of the building and is important in understanding the historic, multi-use nature of the building which include heated, domestic accommodation. | Beneficial impact upon the significance of the stable block.<br><br>Neutral impact to the significance of the Clock Face and Prescott Conservation Area. |

- a. Erect scaffold to provide safe access to stack.
- b. Remove existing concrete capping slabs.
- c. Rebuild stack by six courses of brickwork to replicate the original height and corbelled upper stages using brickwork salvaged during the initial dismantling. Bricks retained from dismantling to be reused. Where new brickwork is required, this should match the existing brickwork in terms colour, size, and texture. Samples of new brickwork for use in the repairs are to be agreed with KMBC Conservation Officer in advance of use. Check existing flaunching for cracks and missing sections. Internal flues to be reinstated to the reinstated upper course.

- d. Salvaged stone capping to be reinstated and positioned to replicate the slight projection over the face of the brickwork to throw water. Where the condition of the salvaged capping prevents reinstatement, a matching red stone capping stone will be sourced and used – the existing capping will be used to form the basis for sourcing / designing the new capping. .

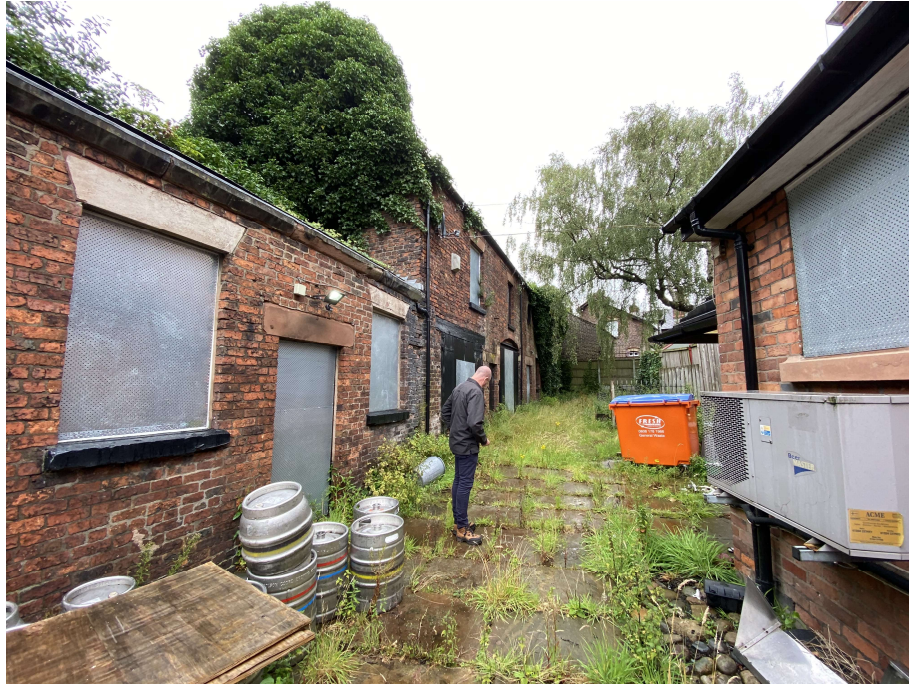
*Plate 5 – Rear stable yard area with cellar colling units to the north elevation of the Clock Face to right of image.*

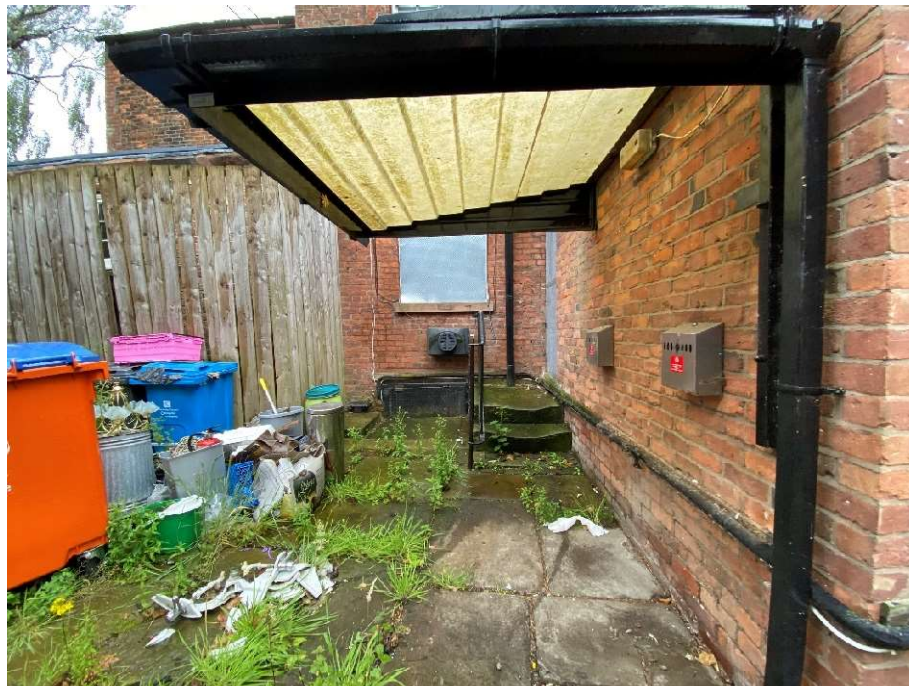
*Plate 6 – Canopy shelter to the east elevation of the WC block of the Clock Face which is to be removed.*

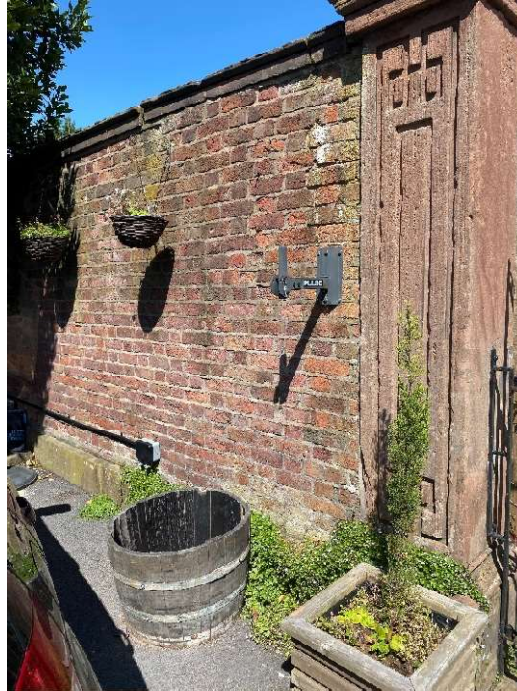
*Plate 7 – Tv bracket installed to the southwest elevation of the enclosing brickwork wall which is to be removed.*

| Decluttering of the external elevations of the stable block, Clock Face, and enclosing brick walls through removal of redundant cabling, alarm box and TV bracket etc. | To enhance the overall appearance of the buildings and its associated curtilage structures. | The removal of cabling from the stable block where found to be redundant alongside the removal of redundant equipment from the exterior of the buildings and the enclosing brick wall to the rear stable yard will enhance the overall appearance of the buildings. | Beneficial impact upon the significance of the stable block.<br><br>Neutral impact to the significance of the Clock Face and Prescott Conservation Area. |

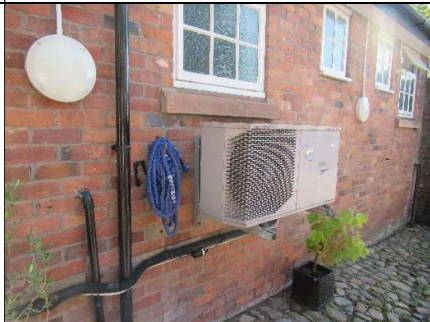
| Item | Location | Time in Situ | Retain / Remove | Photos |
|---|---|---|---|---|
| Cellar cooling unit | North elevation of the WC block of the main Clock Face building | More than 4 years | Retain – included within submitted LBC application. | |

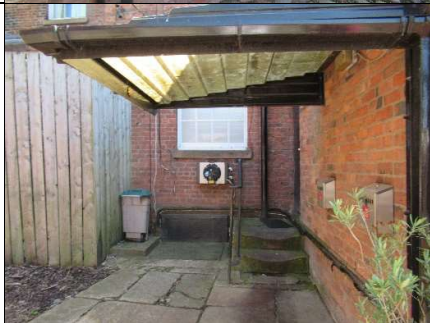
| Item | Location | Time in Situ | Retain / Remove | Photos |
|---|---|---|---|---|
| Soft drink cooling unit | North elevation of the main Clock Face building. | More than 4 years | Retain – included within the submitted LBC application. | |

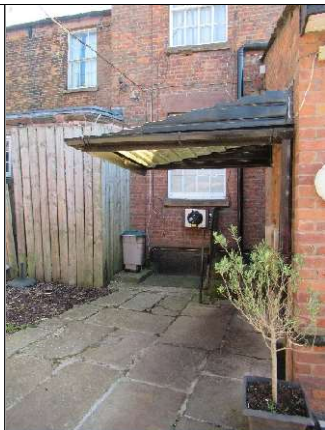
| Canopy cover | Northeast elevation of the WC block of the main Clock Face building | Erected during Covid pandemic. | Remove. LBC is not being sought to retain the canopy. | |

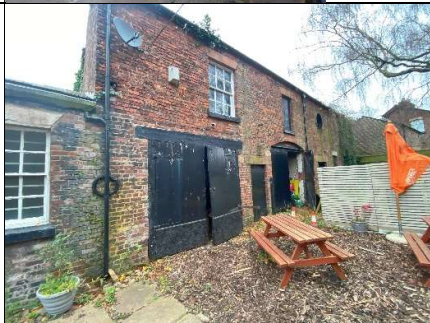
| Sky dish, CC camera and external security lighting | South elevation of the outbuilding / stable range. | More than 4 years | Retain. Included within the current LBC application. | |

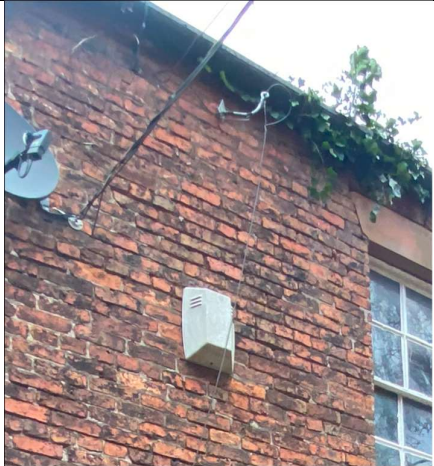
| Alarm Box | South elevation of the outbuilding / stable range. | More than 4 years | Remove. LBC is not being sought to retain the alarm box. | |

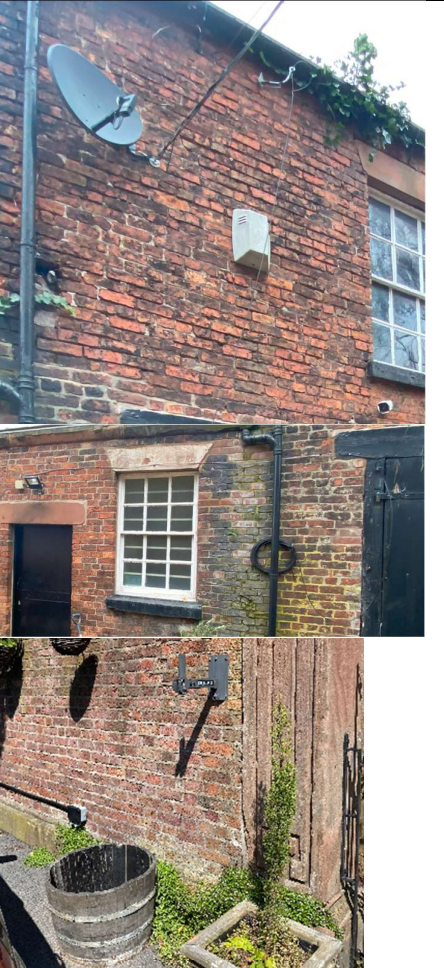
| External Cabling | South elevation of the outbuilding / stable range, south and west elevations of the enclosing brick walls. | More than 4 years. | Removal of external cabling where it is found to be redundant and defunct. Retention of non-defunct cabling is included within the current LBC submission. | |

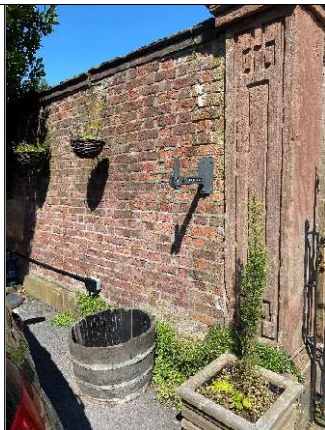
| TV Bracket | West elevation of the garden wall enclosing the rear courtyard. | Installed during Covid Pandemic. | Remove. LBC is not being sought to retain the TV Bracket. | |

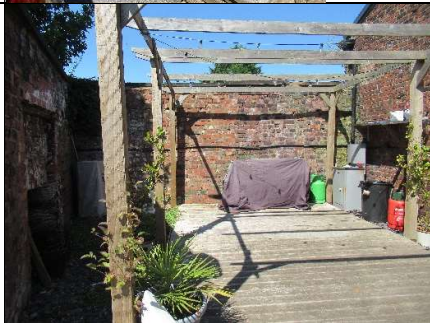
| Timber Pergola and decking | West of the outbuilding / stable range within the enclosed, rear courtyard area. | Installed during Covid Pandemic. | Remove. LBC is not being sought to retain the pergola and decking. | |
