Arboricultural  
Impact Assessment  
with  
Arboricultural Method Statement

**31 Ormskirk Road  
Knowsley  
L34 8HB**

Project No. AIA.13732.01

29<sup>th</sup> November 2023

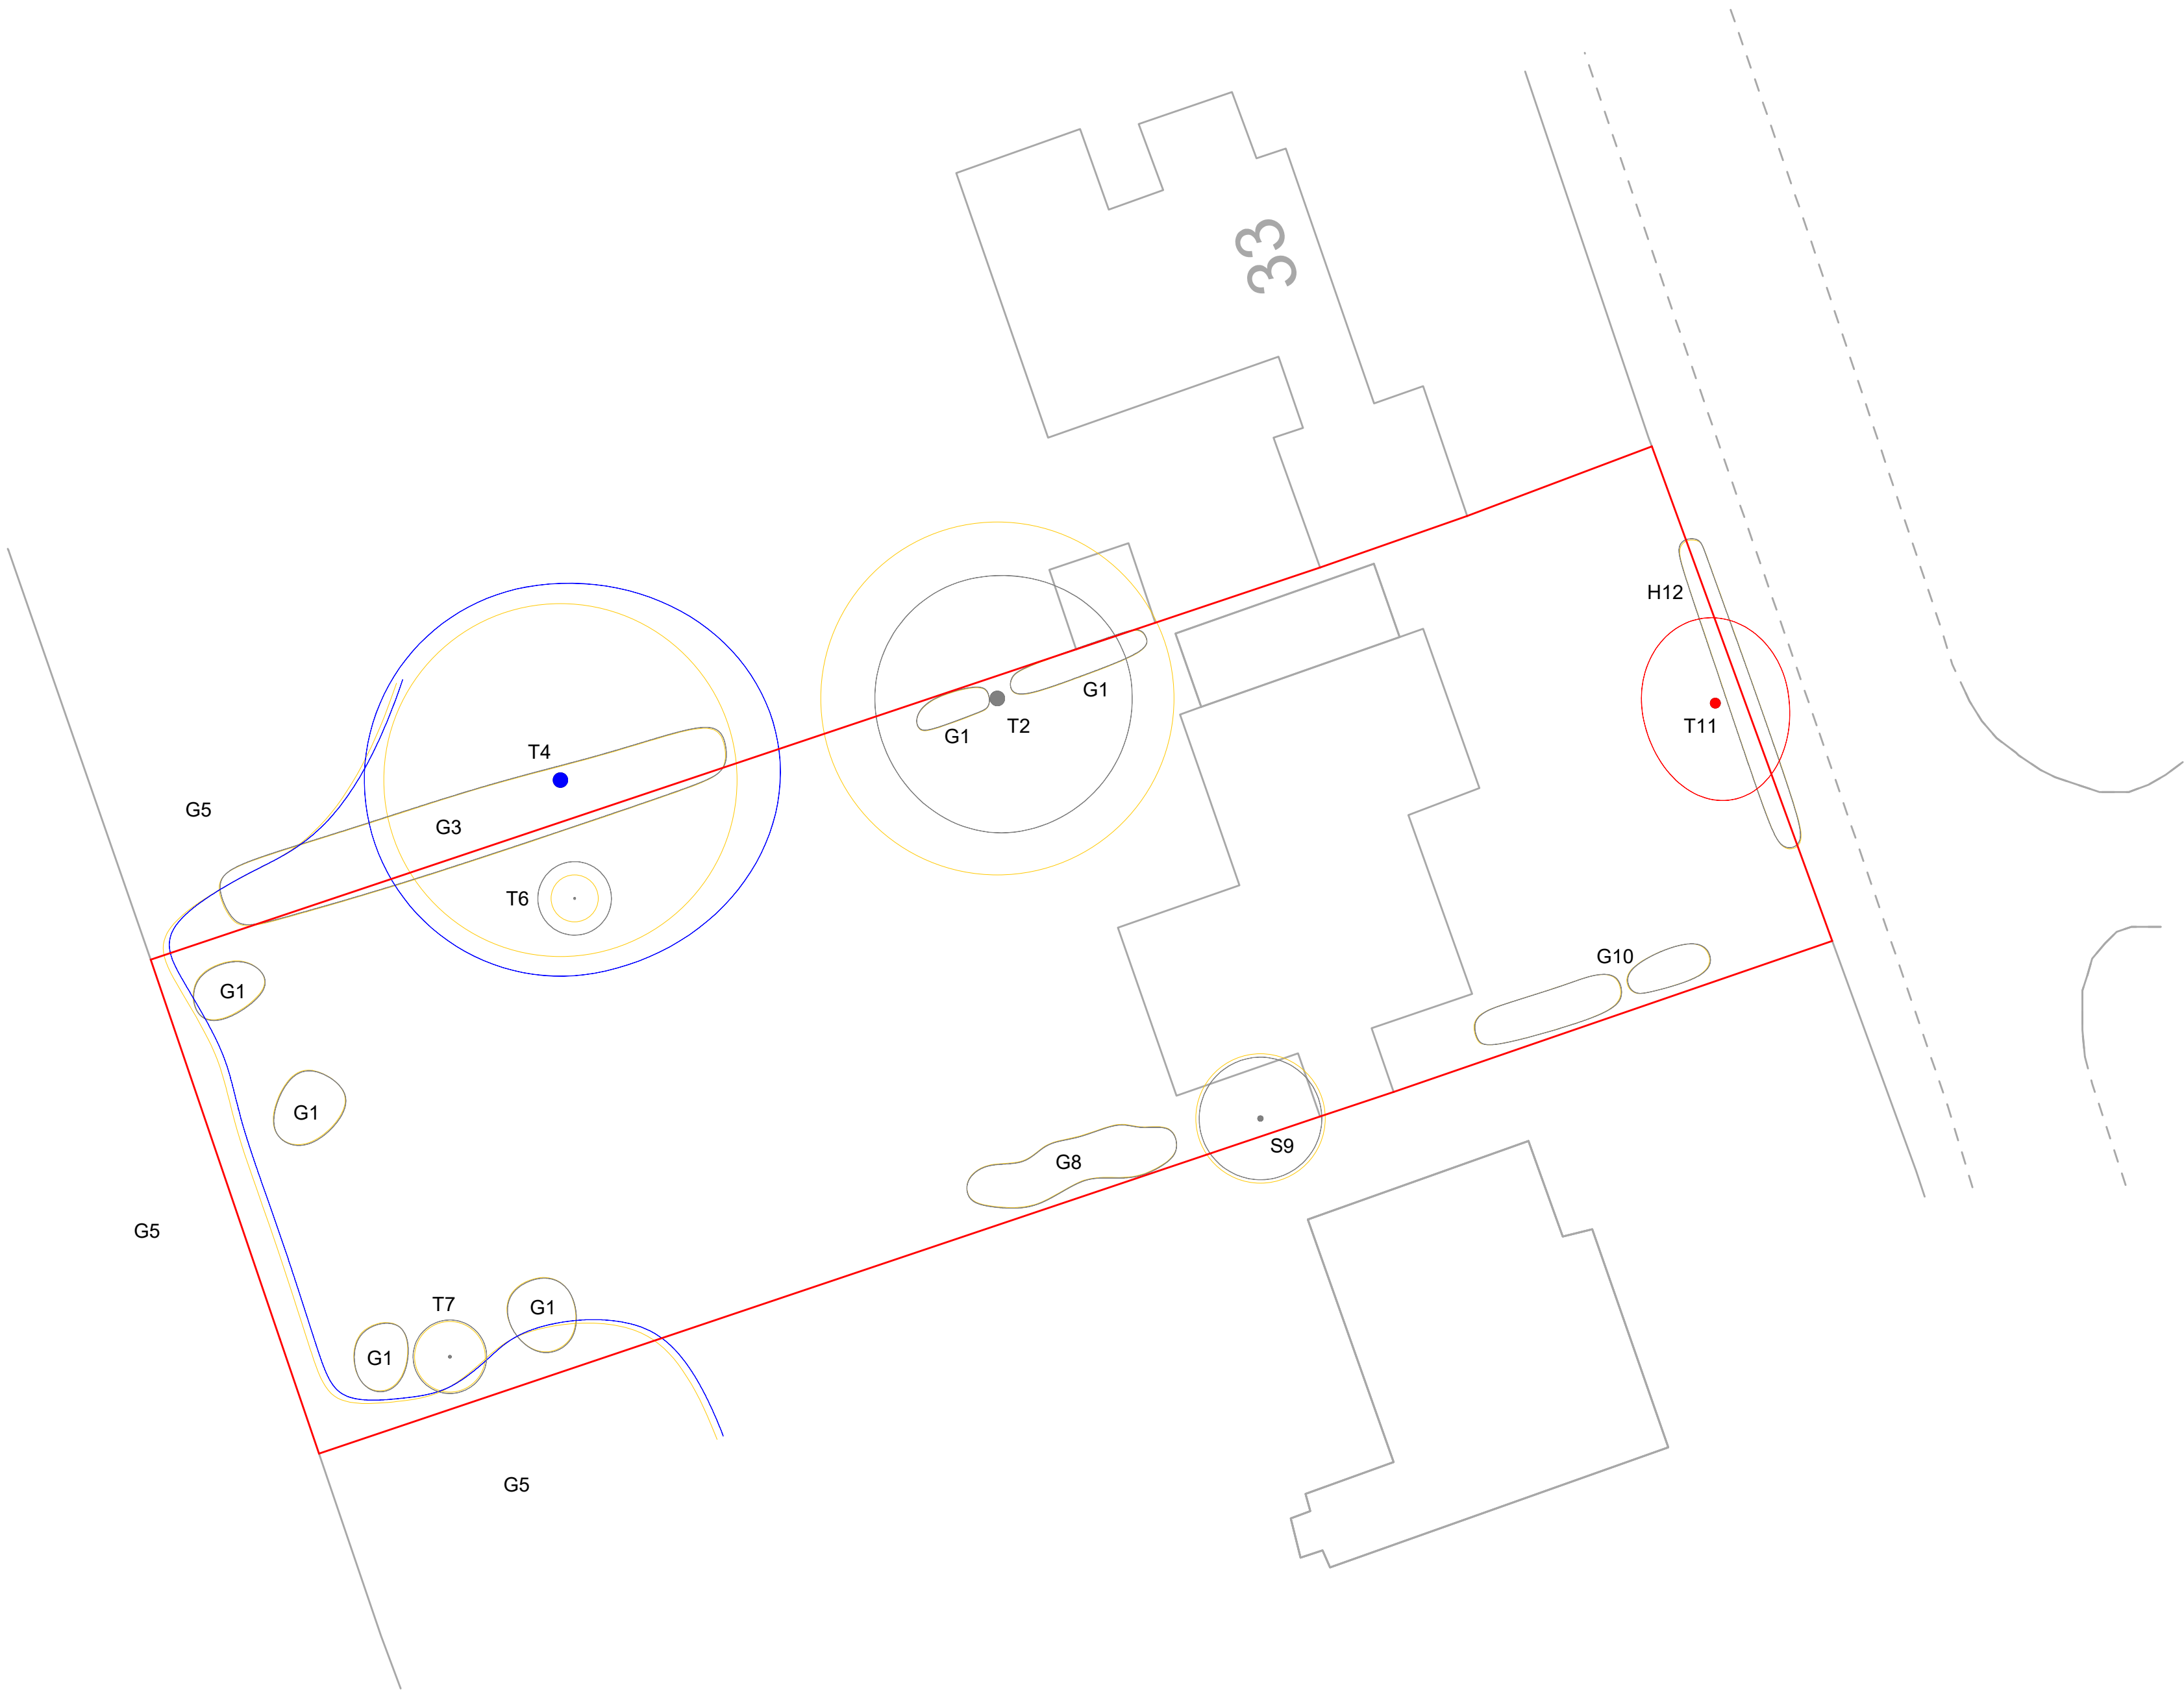
## Drawing 1. Tree Constraints Plan

The Root Protection Area (RPA) is a layout design tool highlighting the underground tree constraints. Along with the tree stem and branches the RPA must be considered prior to and during development.

2.2.1. Please see *Appendix 1* for the detailed list of existing species, age class, dimensions and condition of trees within the site, and *Appendix 2* for an explanation of retention category criteria. Tree locations can be seen on the *Tree Constraints Plan* at the rear of this report (*Drawing 1*).

- 2.3.1. The tree Root Protection Area (RPA) is a layout design tool indicating the area around a tree that, along with the tree stem and branches, must be considered during development. The protection of the roots and soil structure within the RPA should be treated as a priority. The RPA of each tree or group is marked on the *Tree Constraints Plan* at the rear of this report.

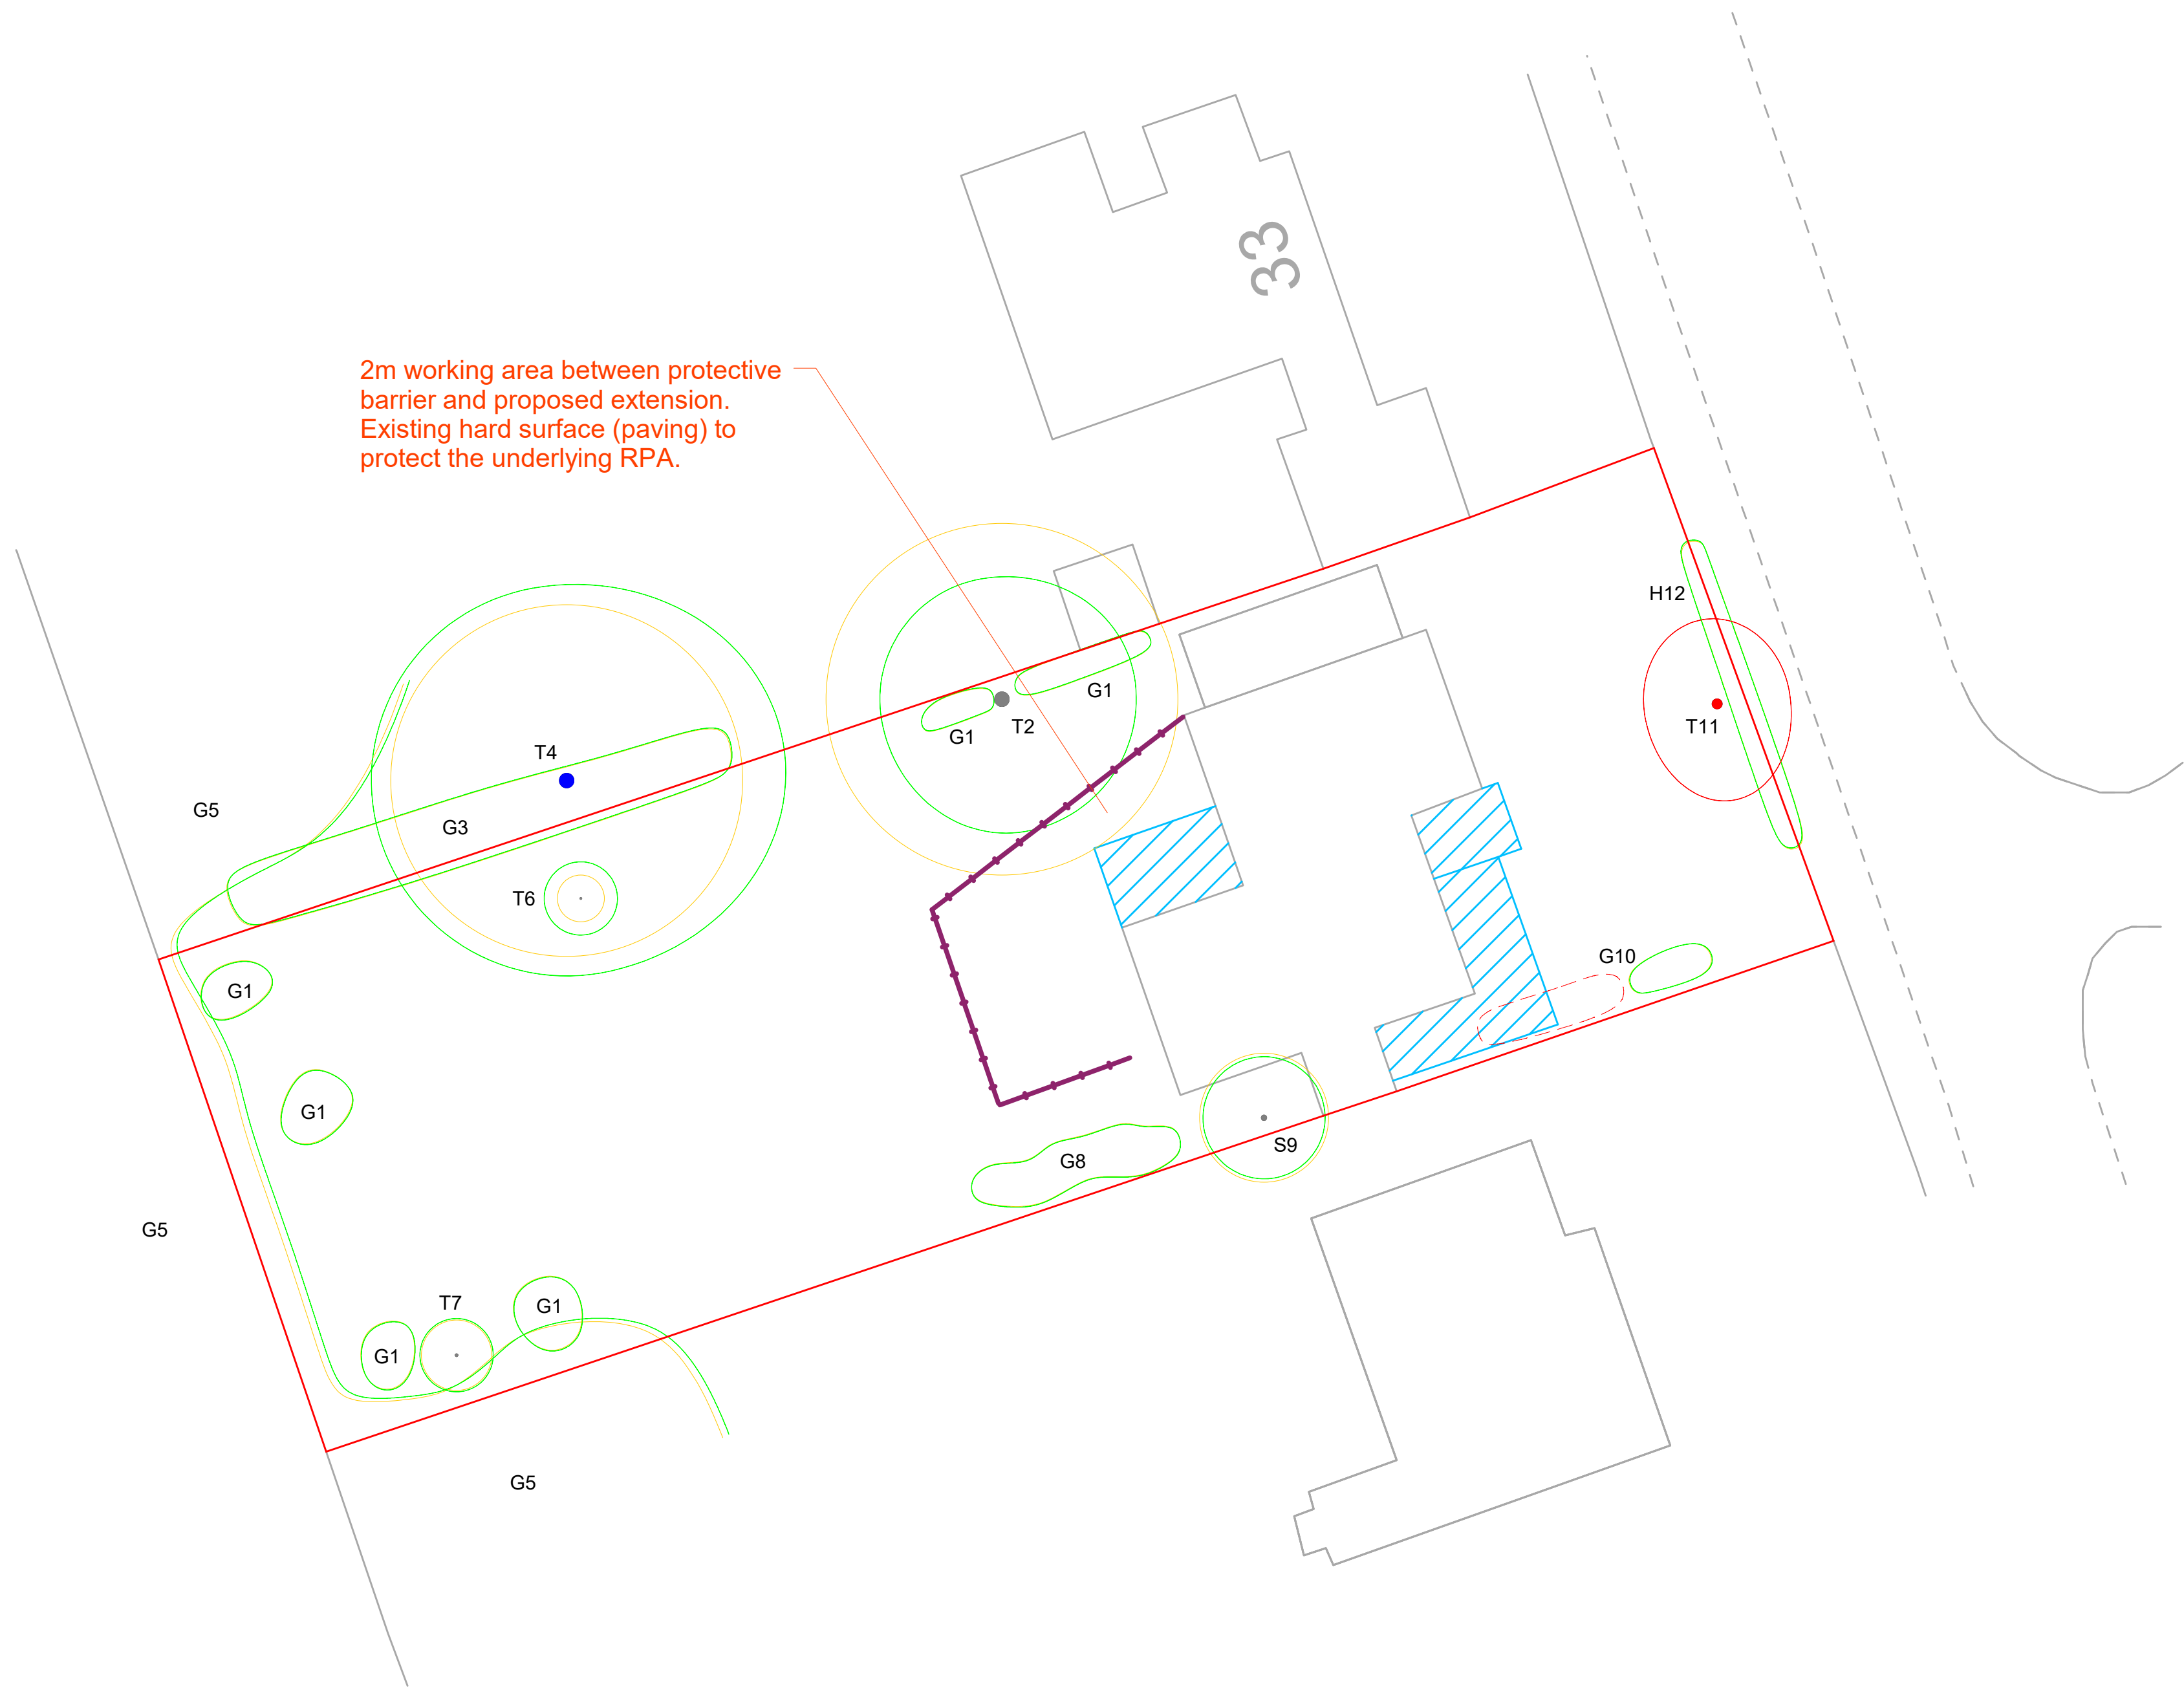
## Drawing 2. Tree Protection Plan

2m working area between protective barrier and proposed extension. Existing hard surface (paving) to protect the underlying RPA.

- 3.1.1. Front and rear extensions are proposed to the existing dwelling. The proposed layout drawing can be seen within the *Tree Protection Plan* to the rear of this report. This drawing has been used to assess the potential direct and indirect arboricultural impacts.

- 4.2.3. Please see *Appendix 4* for suggested barrier construction detail. It is recommended that in this instance the protective barrier shown in *Figure 2* would be appropriate. The suggested location for protective fencing is shown on the *Tree Protection Plan (Drawing 2)*.
