Remediation and Enabling Works Strategy  
Cherryfield Drive, Kirkby

Reference:15-280-R2-6  
Date: June 2025

# REMEDIATION AND ENABLING WORKS STRATEGY

Cherryfield Drive  
Kirkby  
Liverpool  
L32 8RX

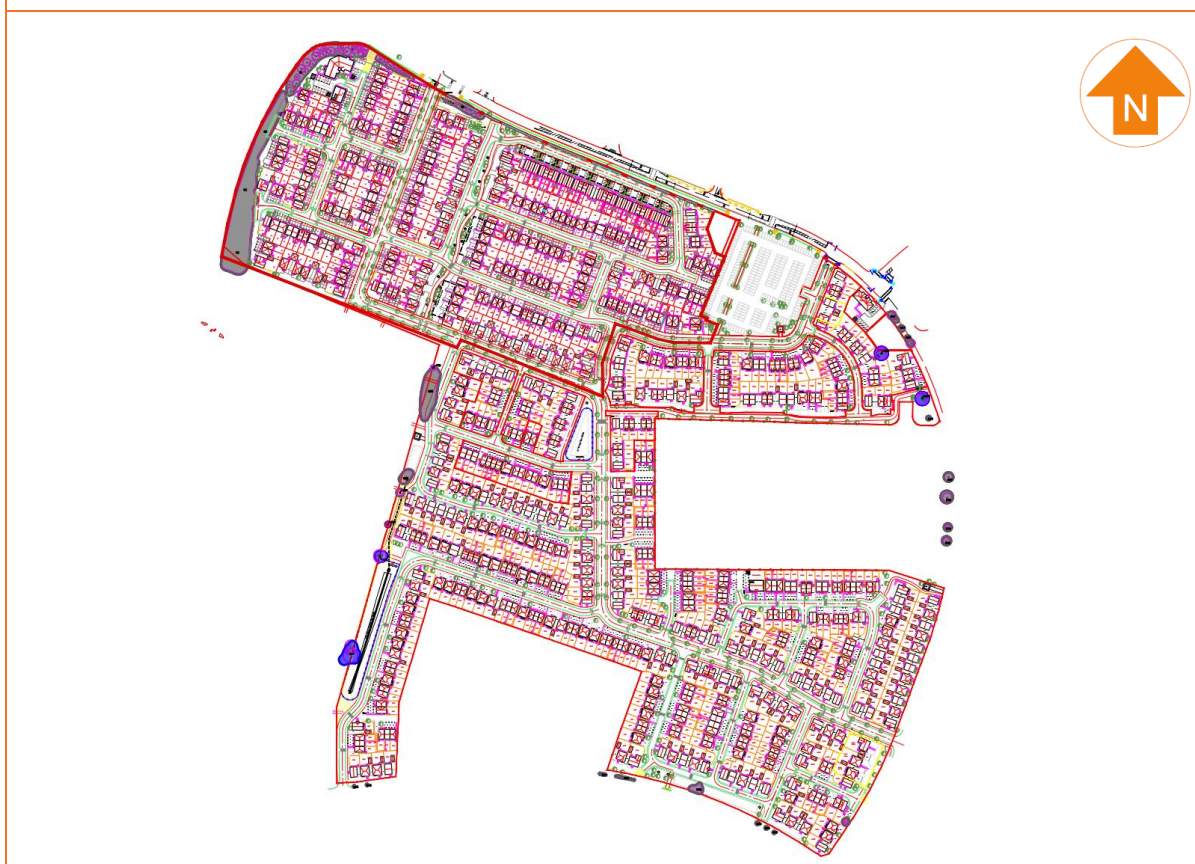
FIGURE 1.1      SNAPSHOT OF PROPOSED DEVELOPMENT

E3P has been provided with a draft planning layout a snapshot of which is indicated in Figure 1.1.

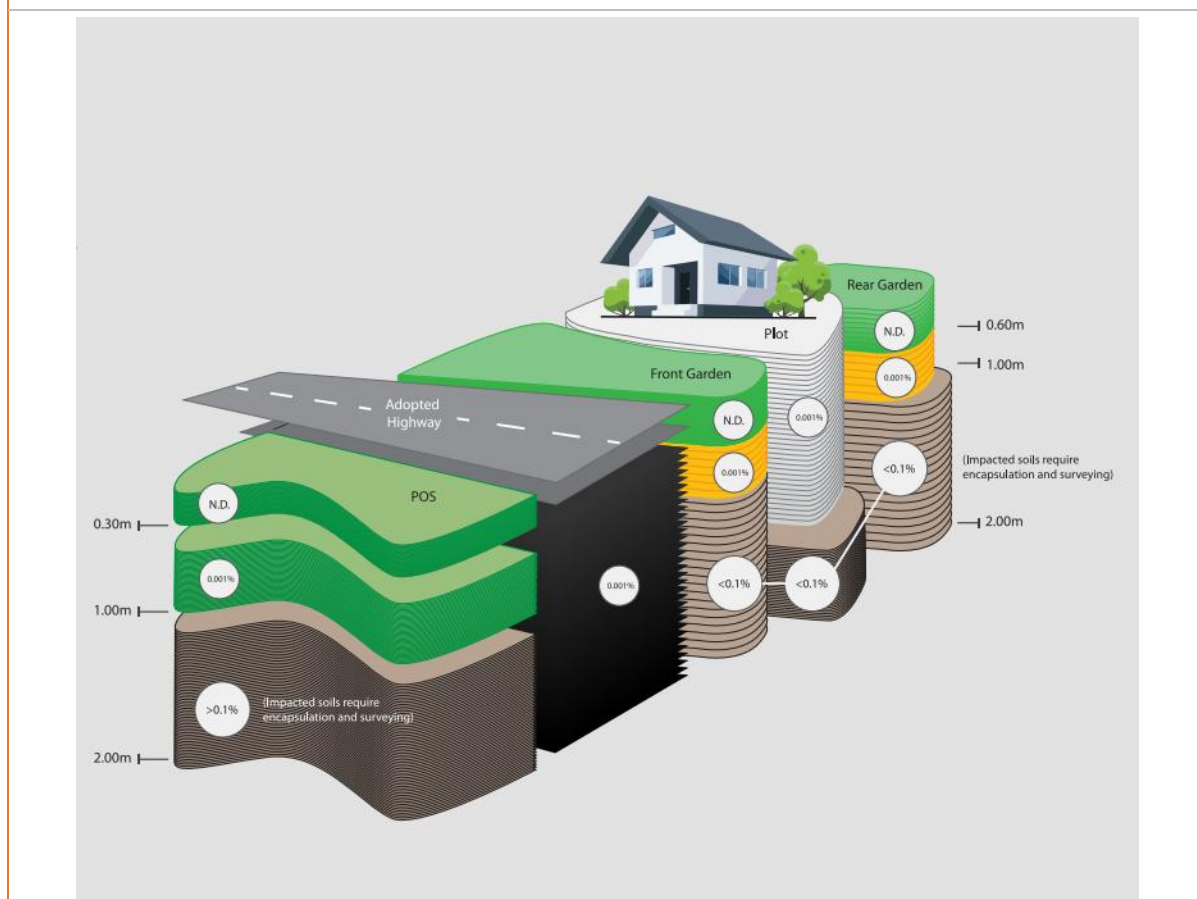
FIGURE 2.1 ASBESTOS CONCEPTUAL SITE MODEL

Asbestos in the form of chrysotile, crocidolite and amosite has been identified within shallow Made Ground deposits. Out of 62 samples tested, five samples had a positive identification for asbestos where quantification has confirmed soils to contain between <0.001% and 0.009% by hand picking weight. It is considered that asbestos loose fibres will be present throughout the Made Ground across the site due to the nature of the fill materials on-site. However, levels of asbestos identified above <0.001% are considered to be localised and should undergo a hotspot removal.

Asbestos has been identified in five locations. Asbestos in the form of loose chrysotile and crocidolite fibres have been identified in the granular Made Ground in TP132 at 0.20 bgl; Chrysotile loose fibrous debris, loose fibres and bitumen have been identified in the reworked topsoil in TP140 at 0.10m bgl; and in the Made Ground within TP202 at 1.00m bgl and WS206 at 0.90m bgl. Loose amosite fibres have been identified in the granular Made Ground in TP118 at 0.50m. Additionally, suspected asbestos sheeting was visually identified within WS141 within the overlying topsoil deposits.

It should be assumed that asbestos fibres are present throughout the Made Ground on site. The risk to chronic human health associated with the elevated concentrations of loose chrysotile and fibres (<0.001%) can be mitigated through the installation of a suitable cover system in all proposed landscaping and hardstanding to remove any potential for direct exposure to impacted soils.

In addition to the above, previous investigations completed by ALM Consult have identified asbestos loose fibres (including Amosite, Chrysotile and Tremolite) noted extensively across the eastern part of the site and in the southwest of the site in Cohesive and Granular fills. Previous site investigations from Buro Happold also notes visual evidence of cement bound asbestos site wide. No asbestos was detected within the Clancy Consulting investigation, however asbestos fibres were encountered within 5 samples of the Ian Farmers report. Based on the above, it is not possible to determine specific sources of asbestos across the site and it must be assumed that asbestos fibres are present in the Made Ground site wide.

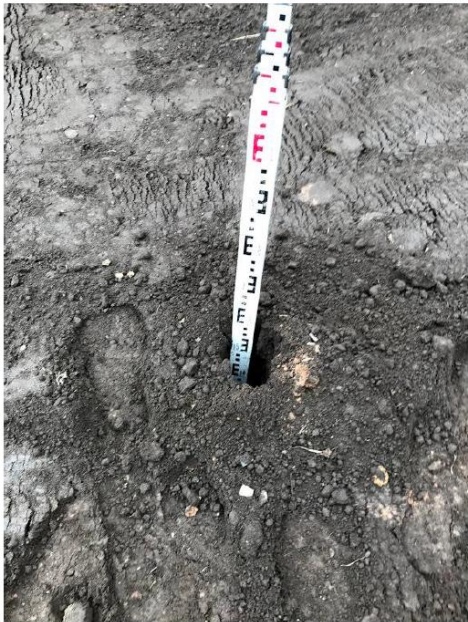
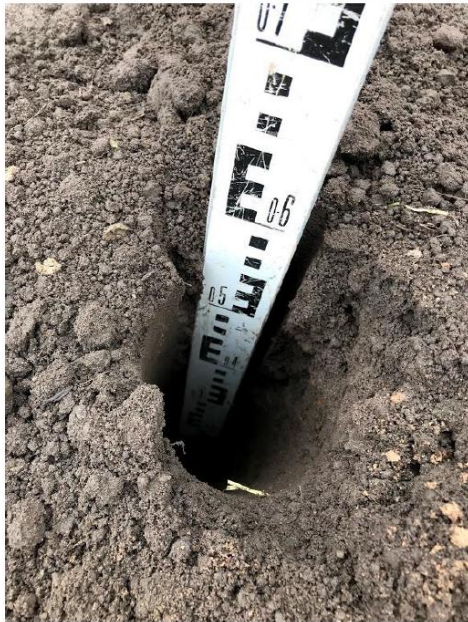
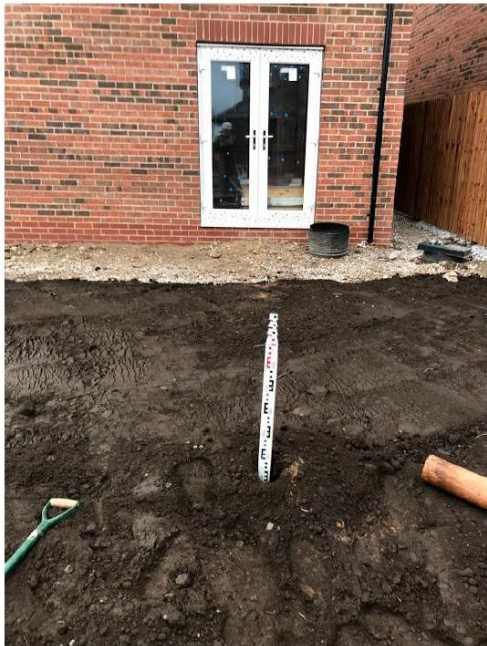
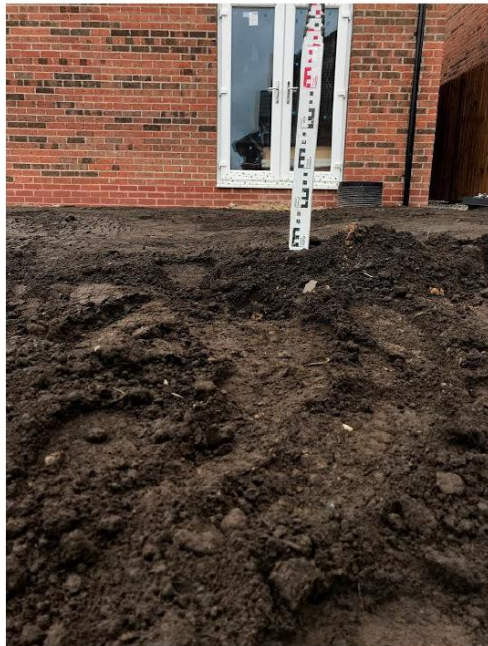
| <b>Depth of Cover System Materials</b> | | <b>Depth of Cover System Materials</b> |

| | 0.15-0.60 | Validated SUBSOIL |
| <b>Depth of Cover System at Ground Level</b> | | <b>Depth of Cover System in Relation to Plot</b> |

- ✦ **Capping** of site with a suitable certified clean cover system comprising 150mm topsoil and 450mm subsoil will remove any future direct exposure pathways to future end users.
- ✦ **Excavation and off site removal** of hazardous materials which cannot be treated will be required, this operation needs to be limited to materials that cannot be treated on-site to promote sustainability and ensure viable regeneration.
- ✦ **Excavation of hotspot materials** for placement in areas of low sensitivity or removal off-site.
- ✦ **Removal of impacted materials surrounding petrol filling station off-site.**

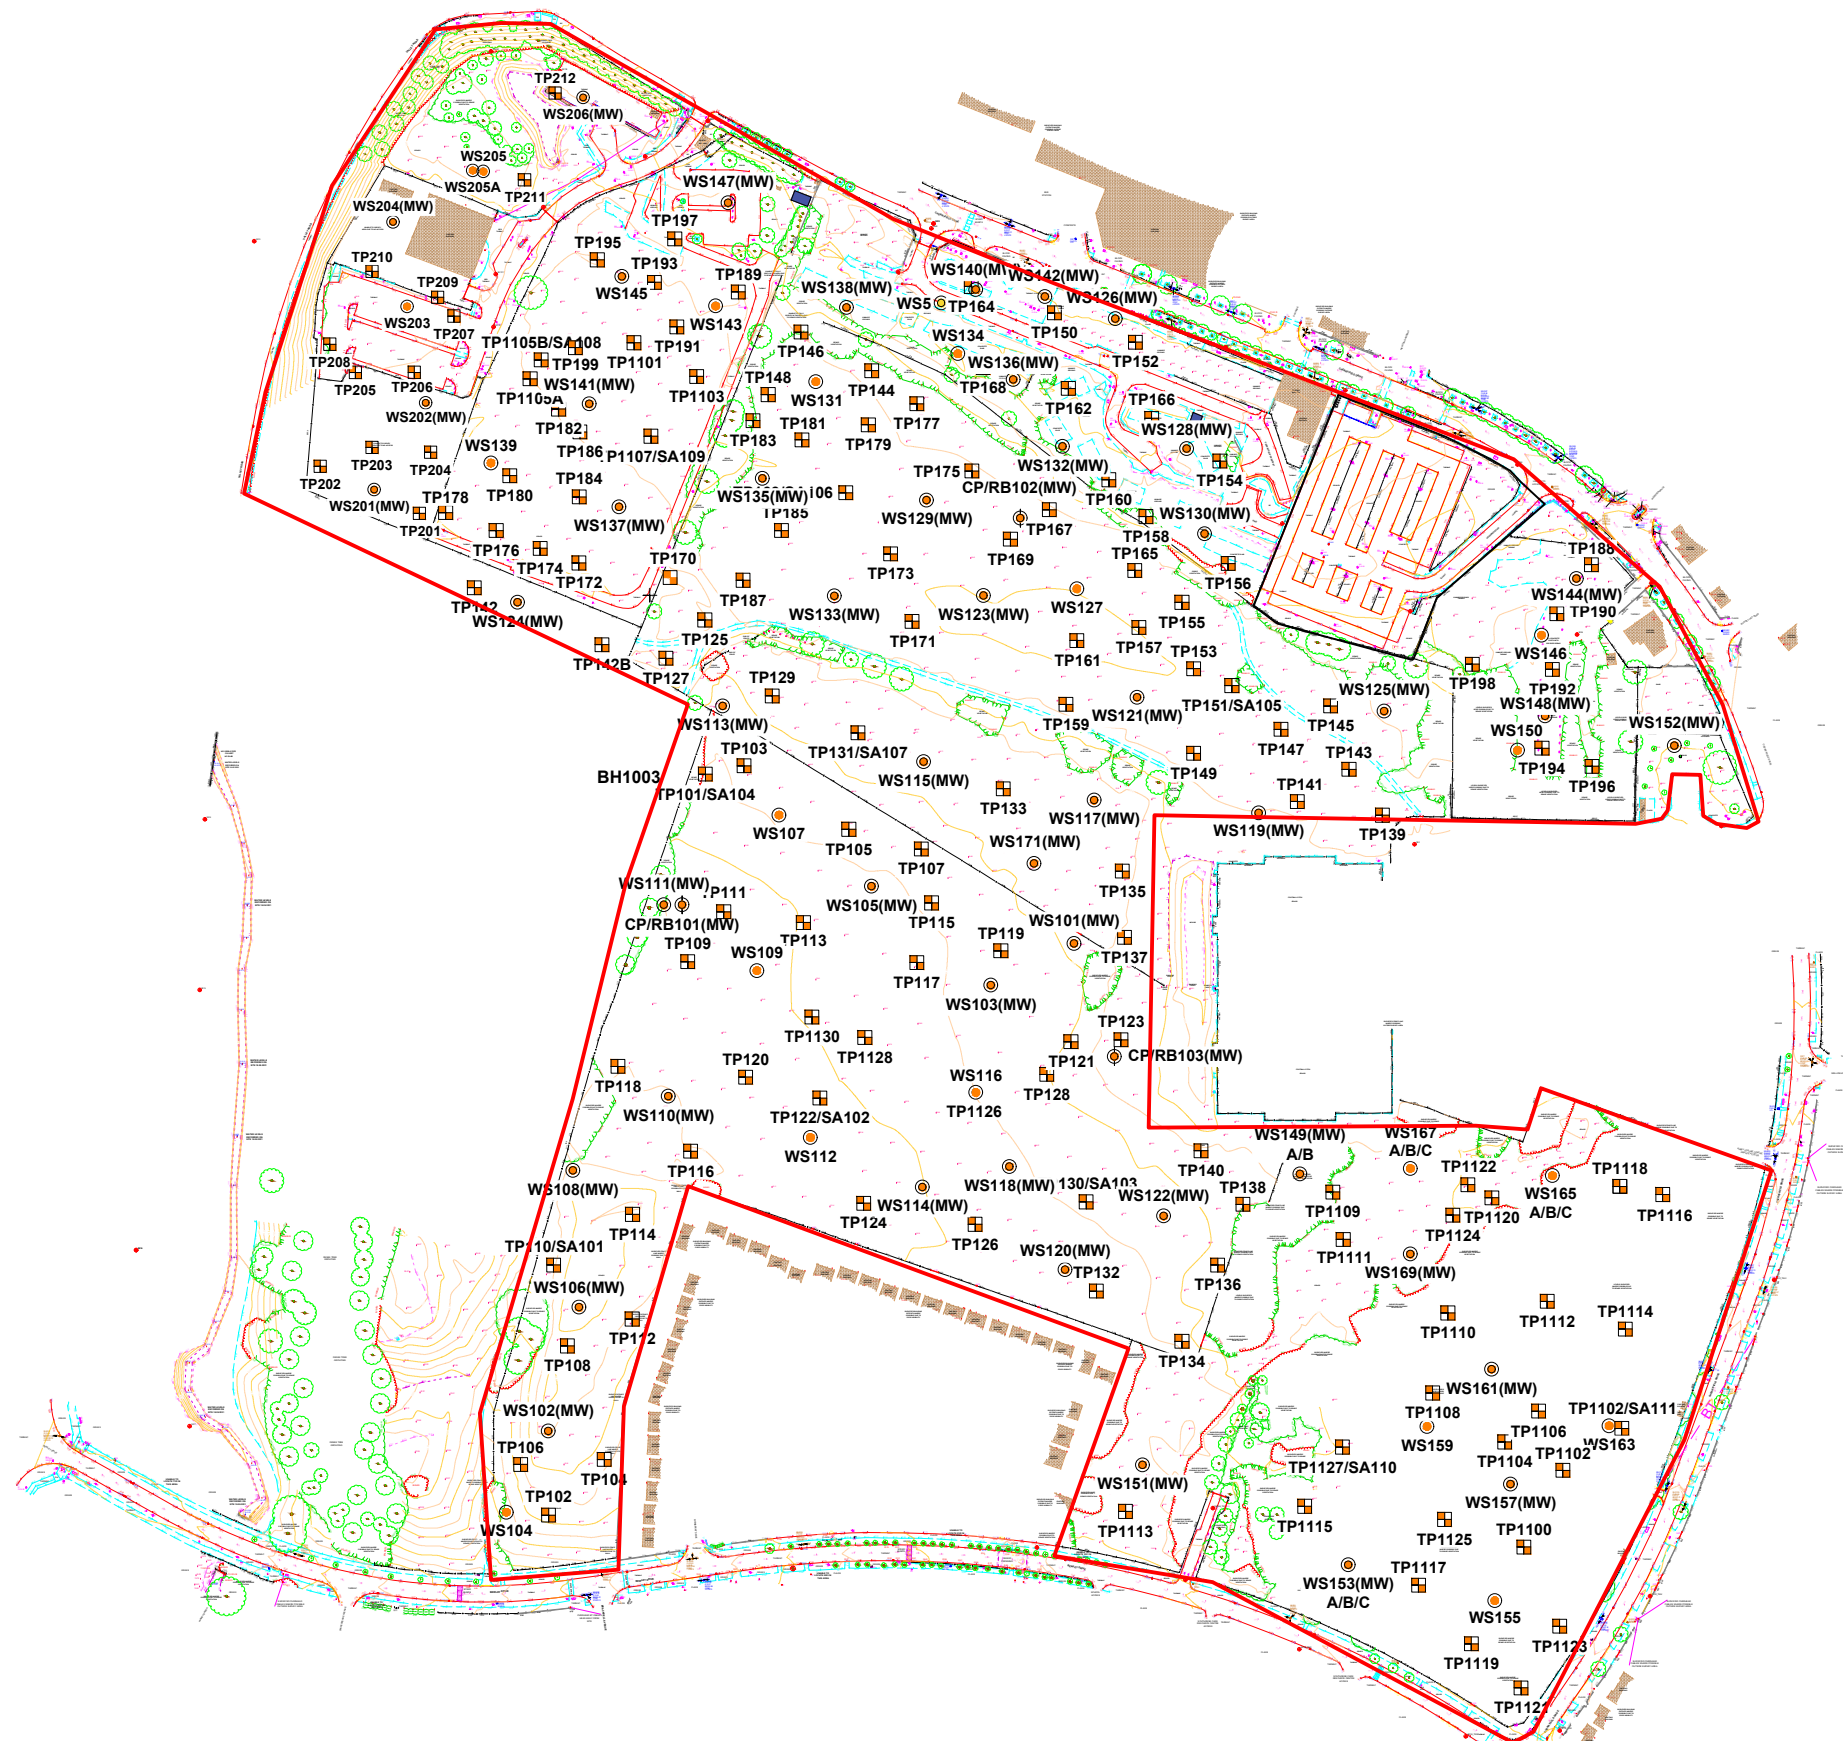
- Approximate Window Sample Probehole Location (E3P January 2022)
- Approximate Trial Pit Location (E3P January 2022)
- Approximate Rotary Borehole Location (E3P January 2022)
- Approximate Window Sample Probehole Location (E3P November 2023)
- Approximate Window Sample Probehole Location with Install (E3P November 2023)
- Approximate Trial Pit Location (E3P November 2023)

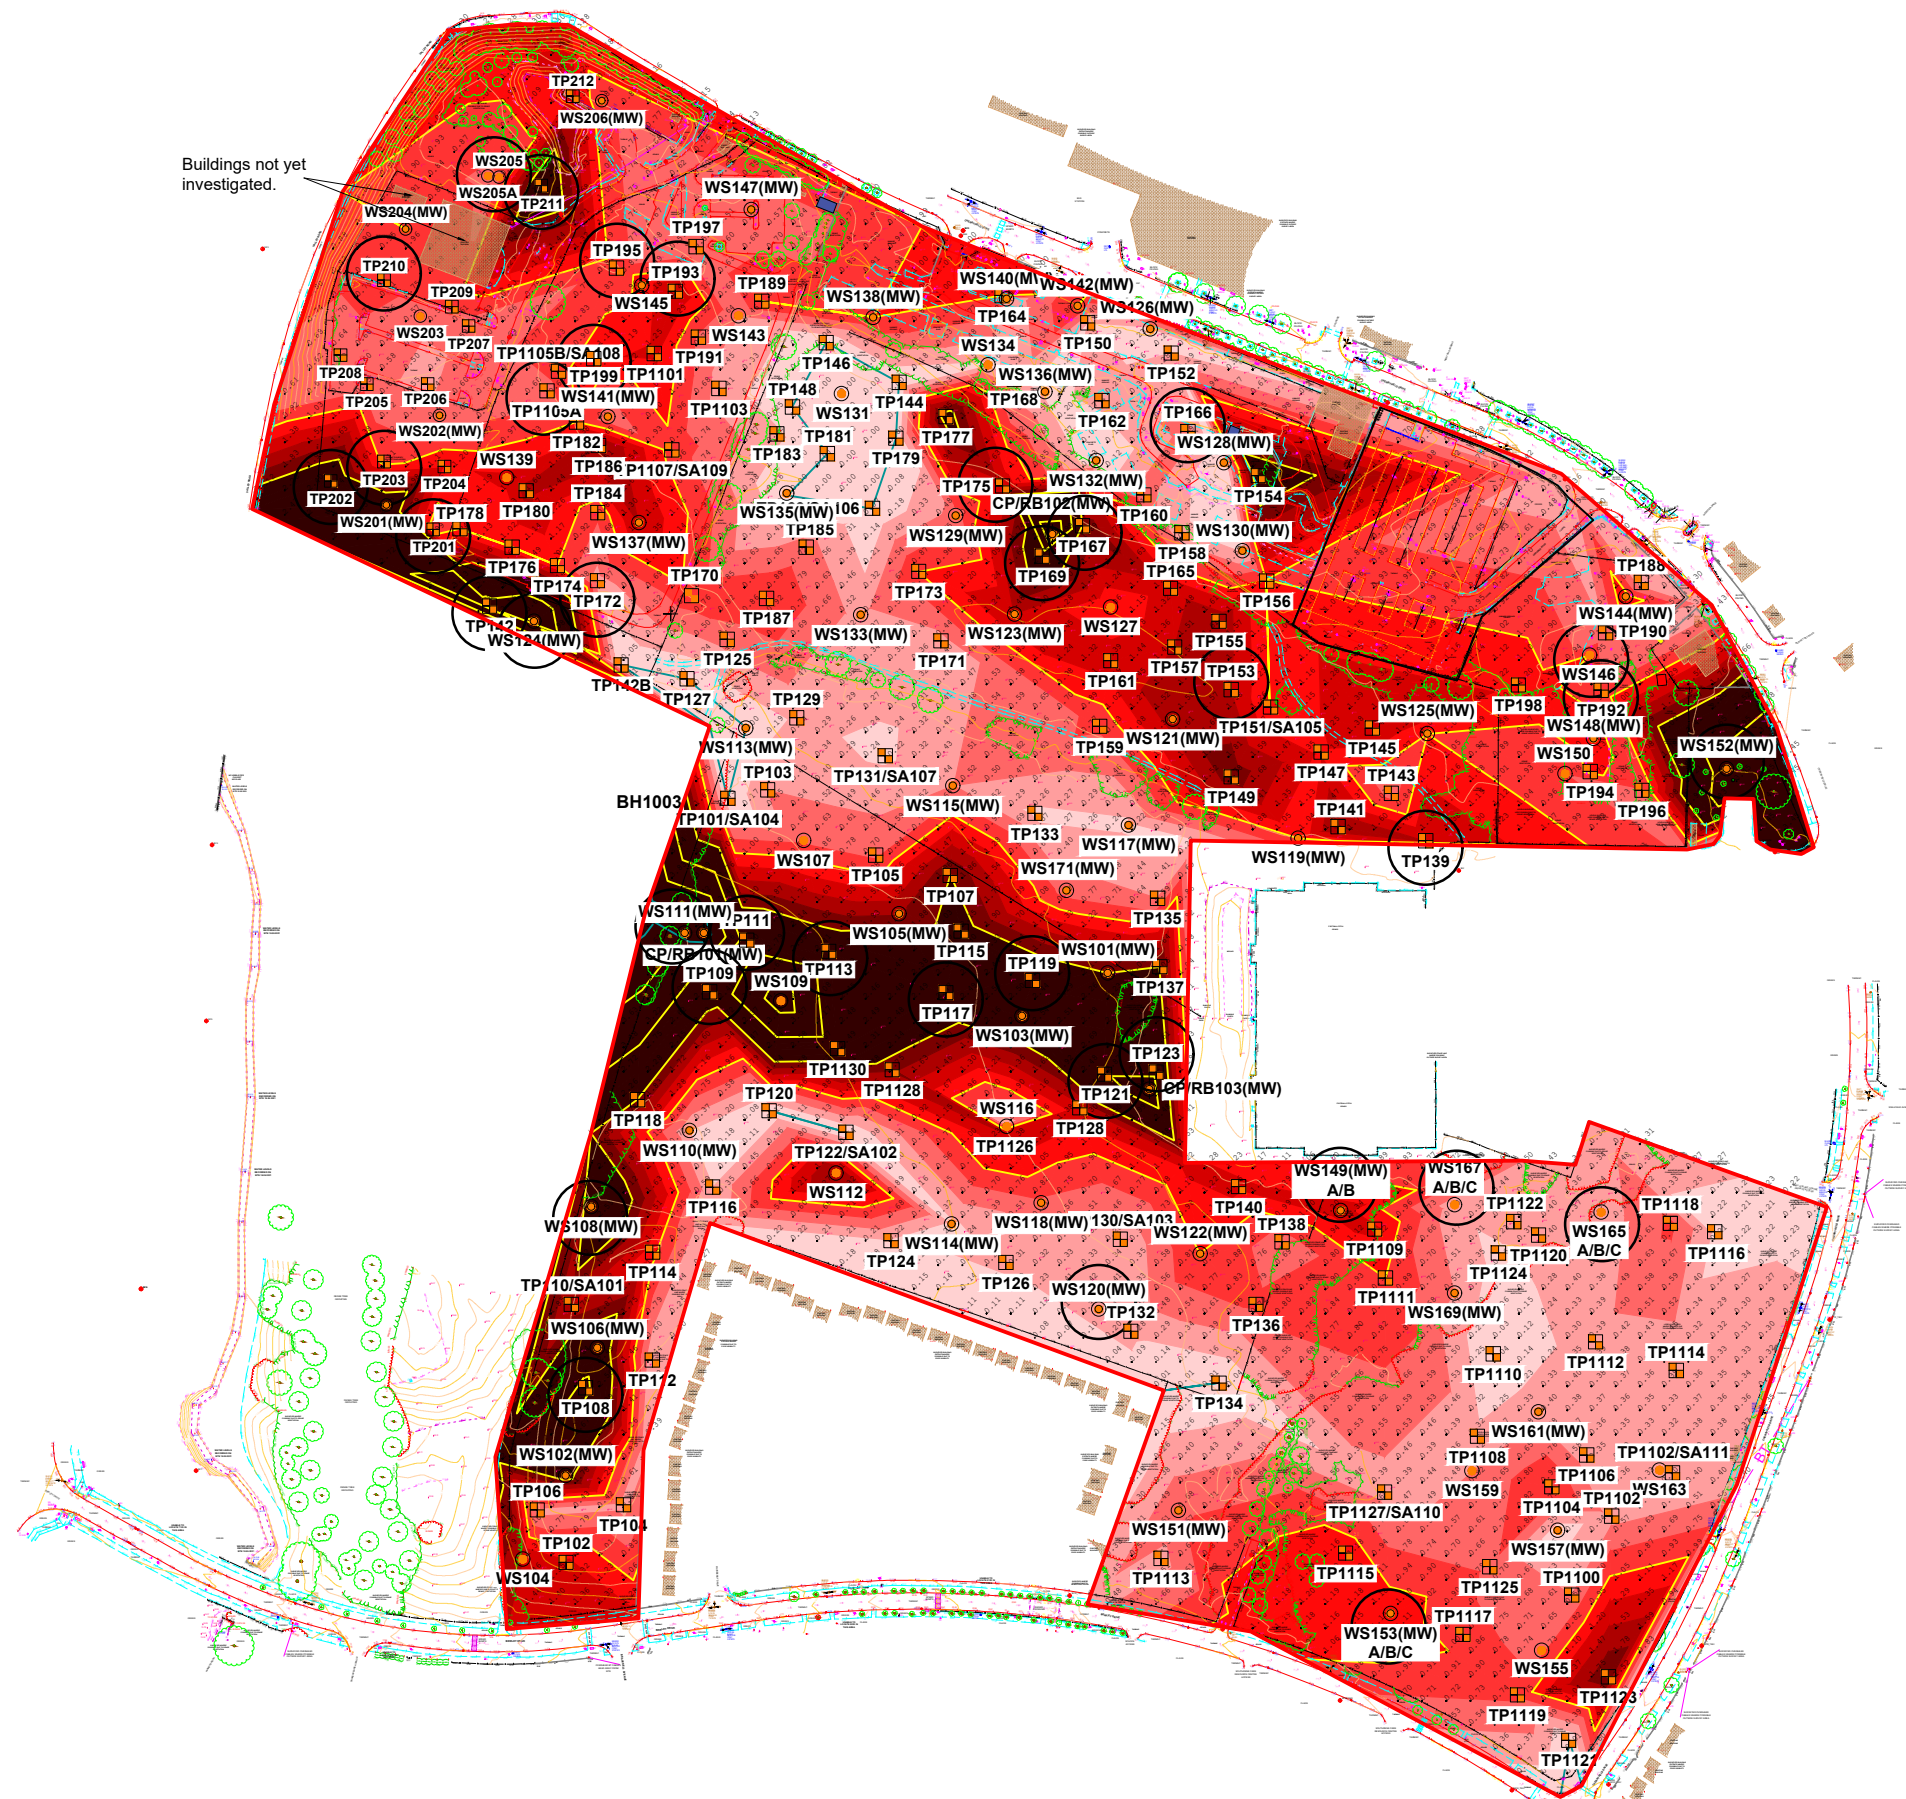
| 15-280-008 - Depth to Founding Strata Plan |

- Made Ground Depth (m)
- Depth of Made Ground 0.00
  - Depth of Made Ground 0.01 - 0.49m
  - Depth of Made Ground 0.50 - 0.99m
  - Depth of Made Ground 1.00 - 1.49m
  - Depth of Made Ground 1.50 - 1.99m
  - Depth of Made Ground 2.00 - 2.49m
  - Depth of Made Ground 2.50 - 2.99m
  - Depth of Made Ground 3.00 - 3.49m
  - Depth of Made Ground 3.50 - 3.99m
  - Depth of Made Ground 4.00 - 4.49m
  - Depth of Made Ground 4.50 - 4.99m
  - Depth of Made Ground >5.00m

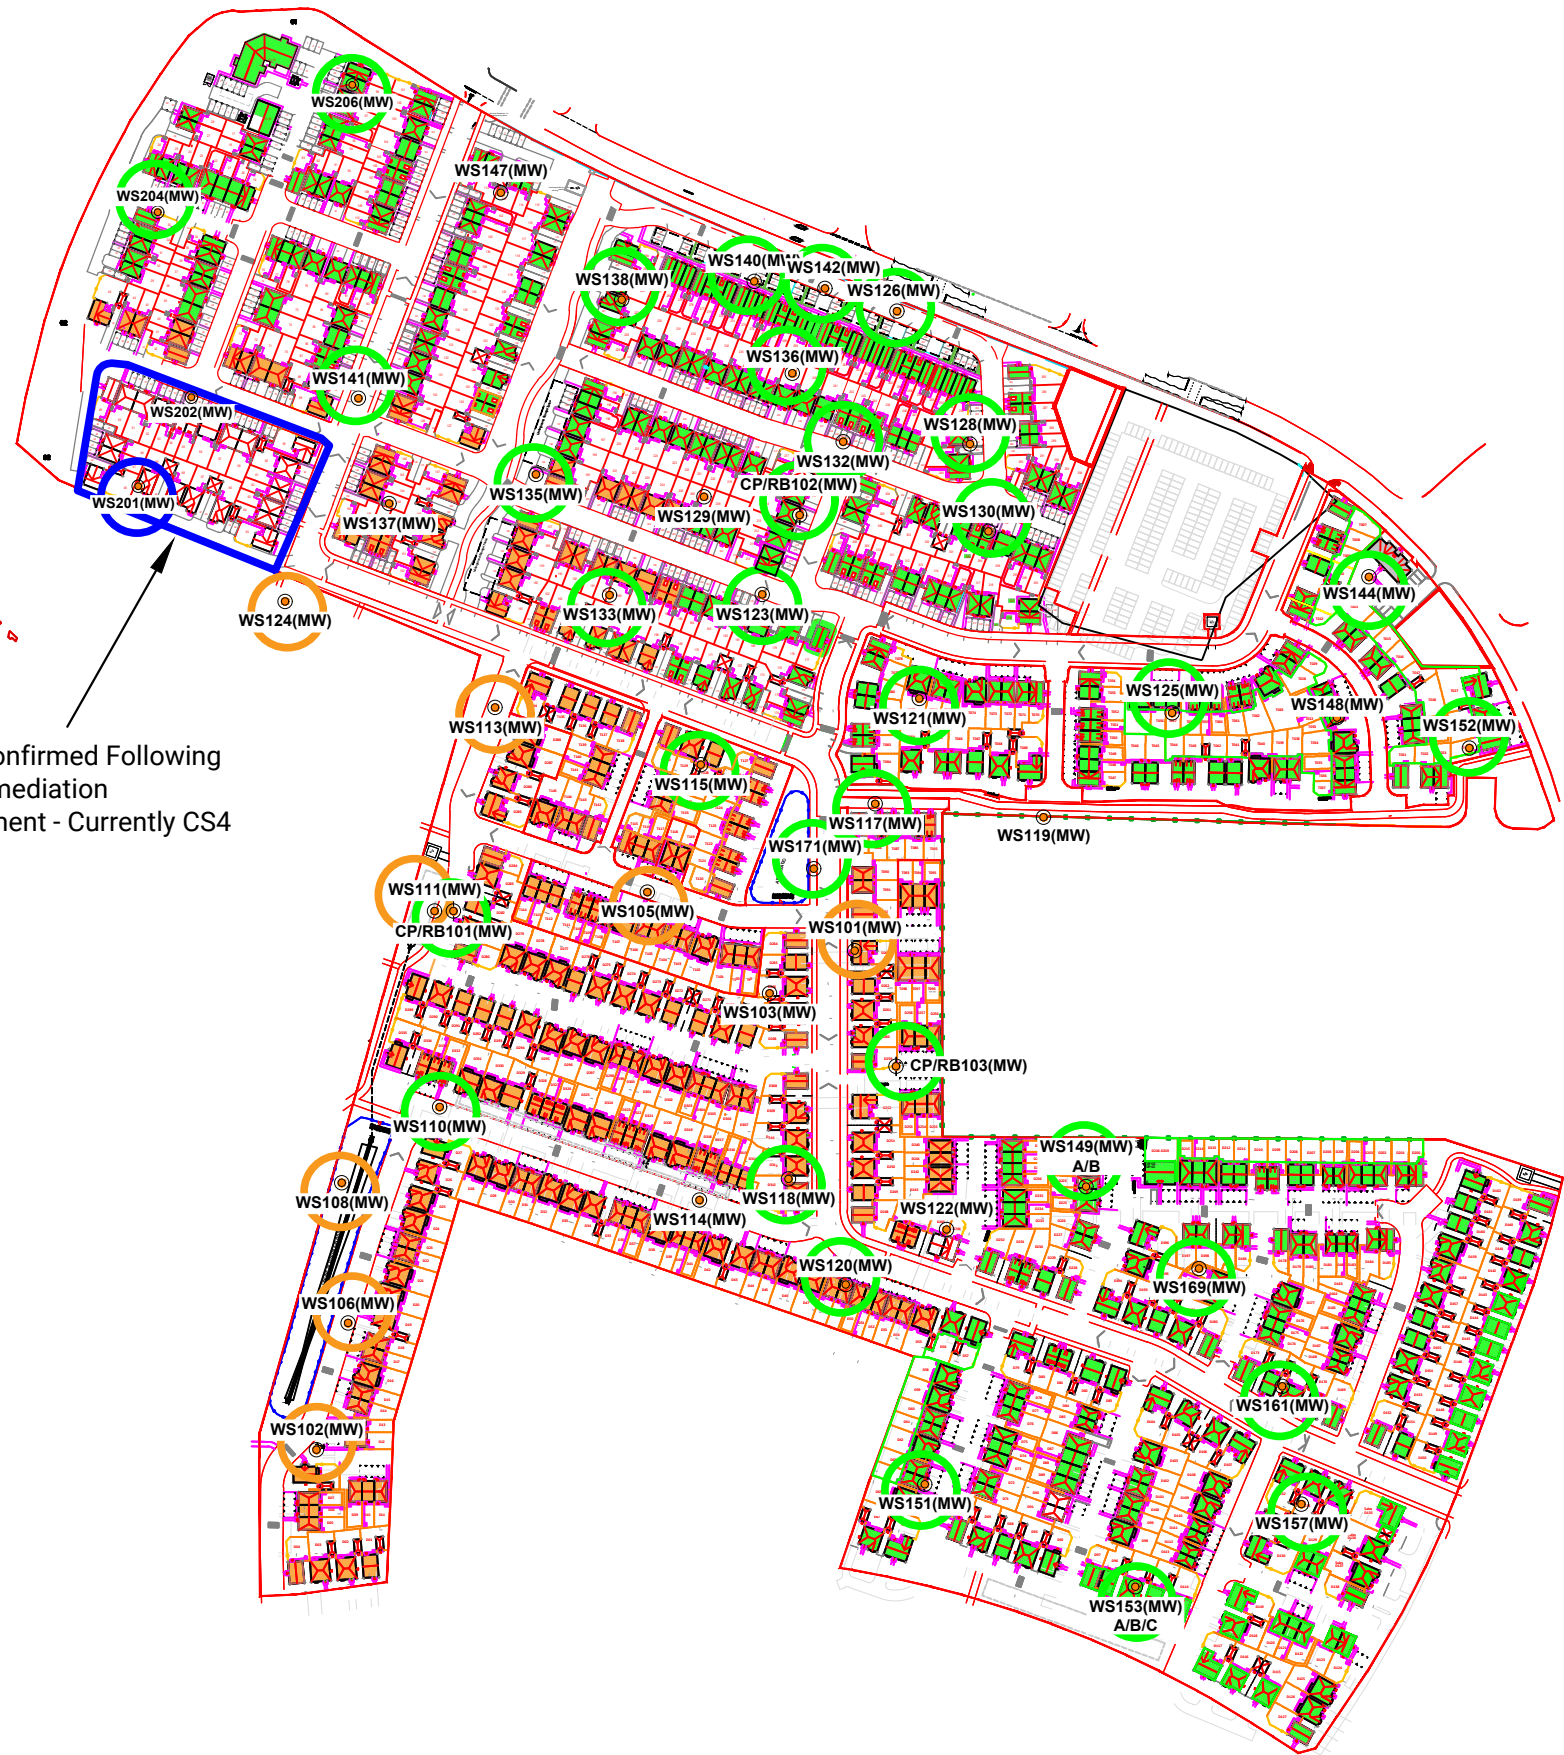
To Be Confirmed Following  
Post Remediation  
Assessment - Currently CS4

- Further post remediation assessment will be required in the location of WS201 to confirm the ground gas classification, given this location is currently classified as CS4 due to significantly elevated concentrations of methane and carbon dioxide. A flux box survey is recommended to quantify the methane emissions in this location.

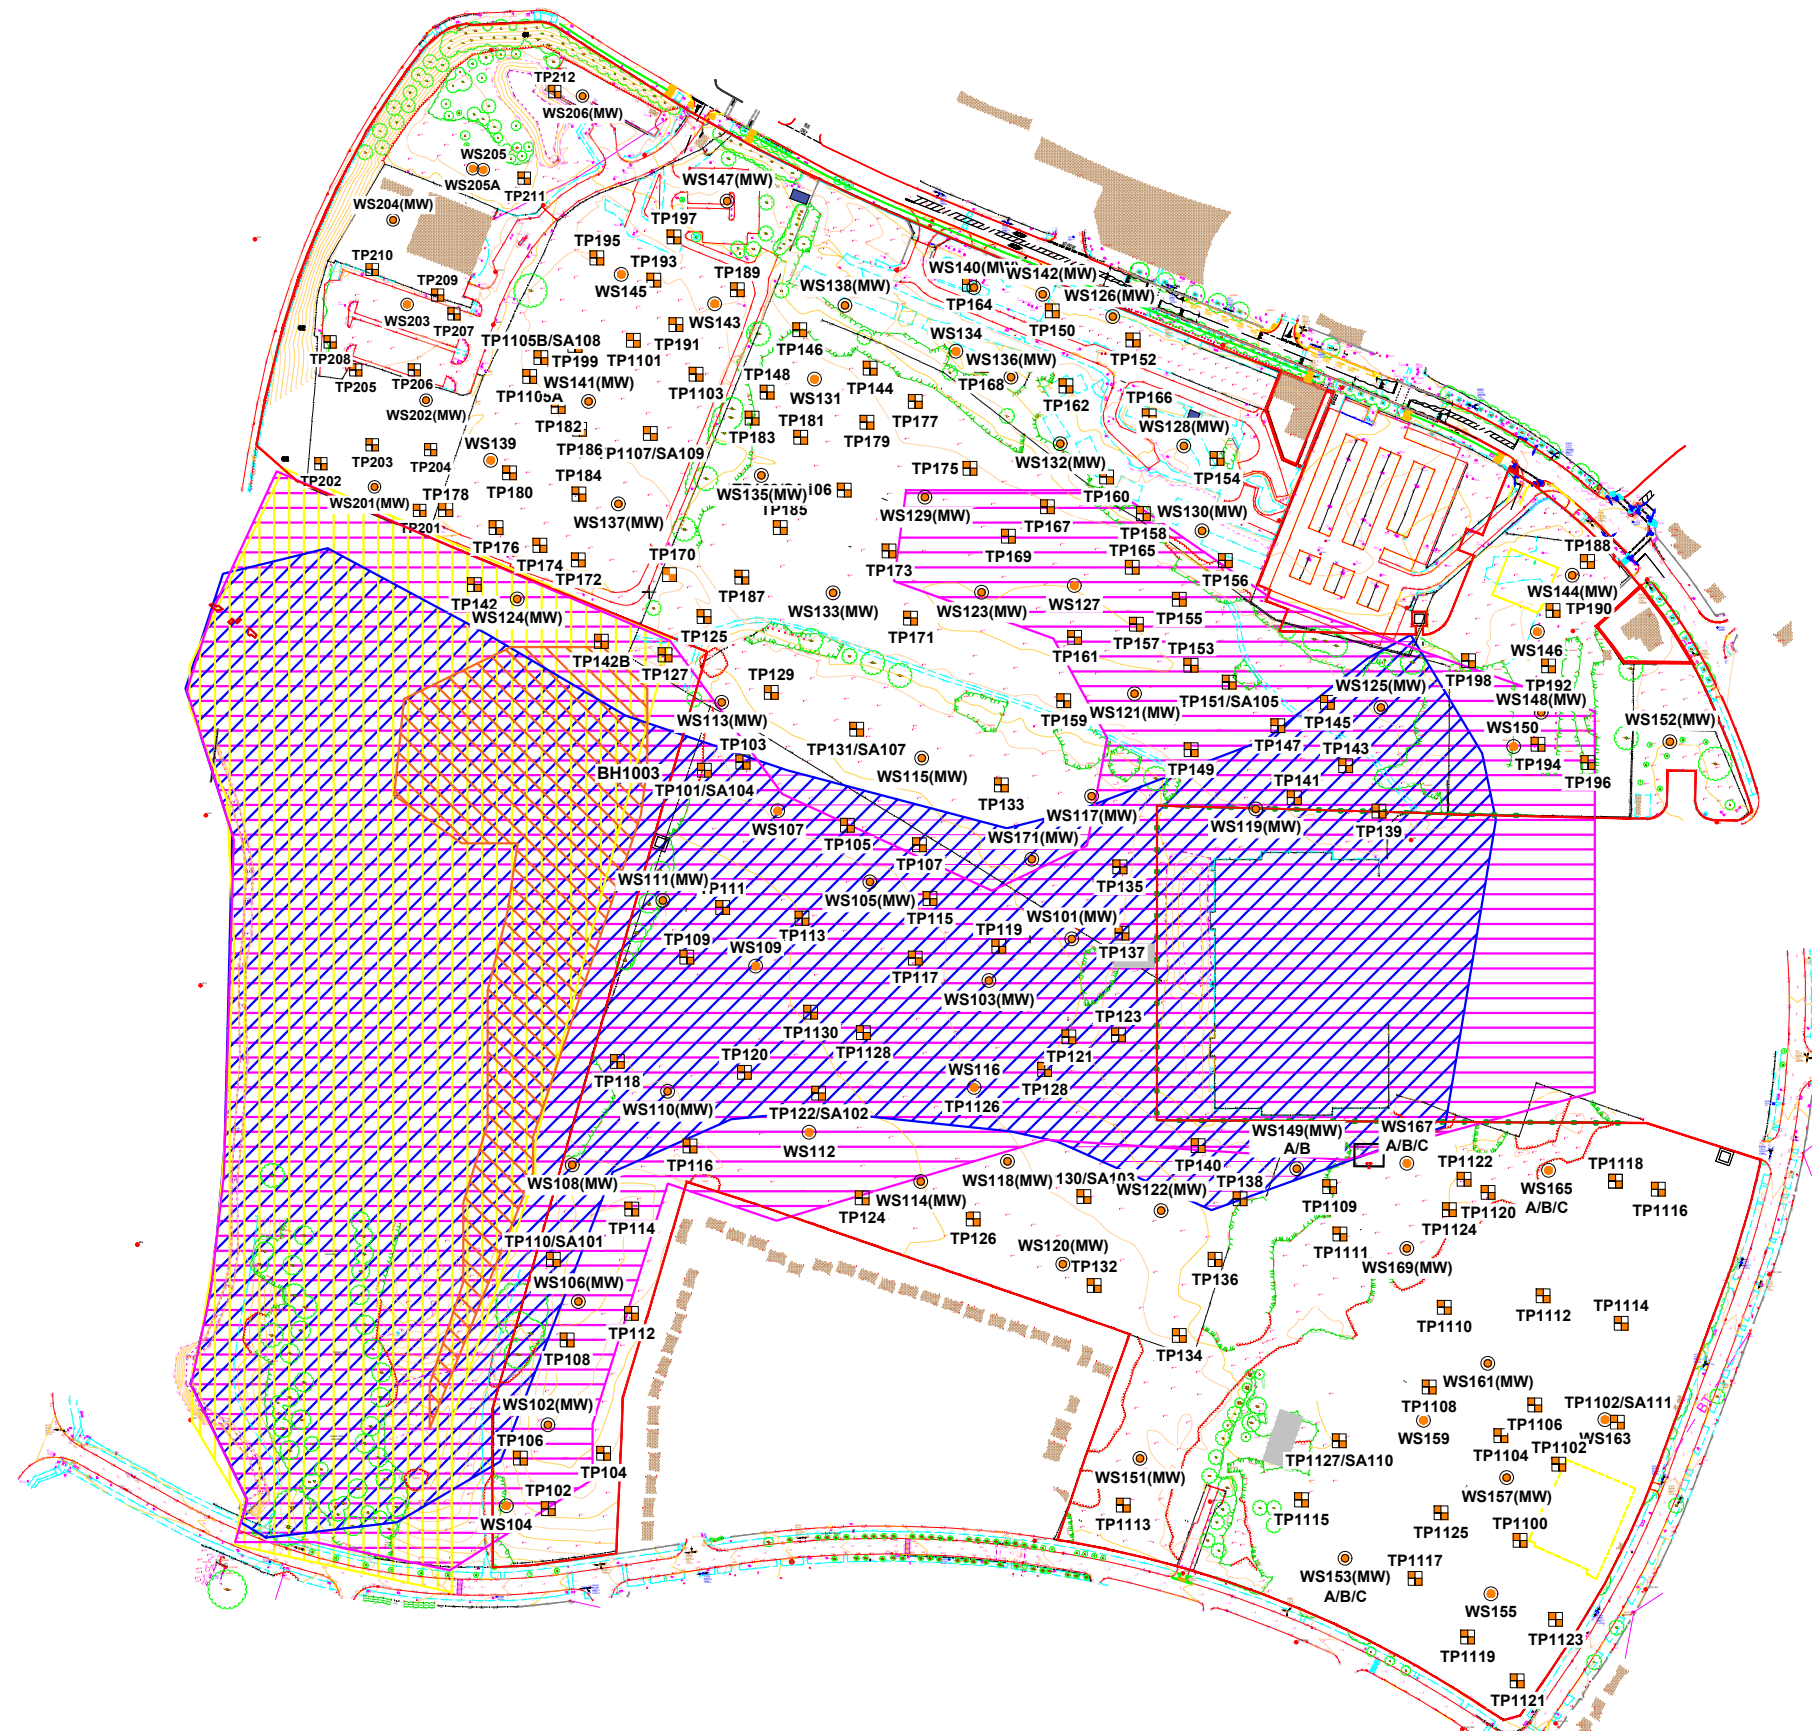
Possible Landfill  
Extent Plan

- Possible Extent of Landfill
- Former Sand / Gravel Pit
  - GDO205 Landfill Records
  - Buro Happold Landfill Delineation
  - WSP Landfill Delineation

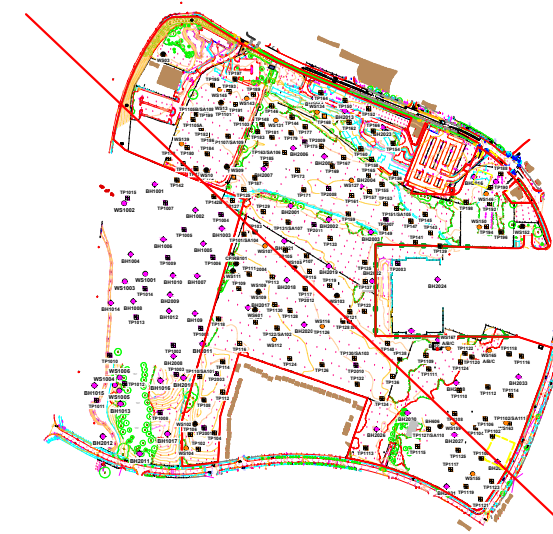
| <div>Geology Key</div> <div><div><div><div></div></div>Made Ground</div><div><div><div></div></div>Clay</div><div><div><div></div></div>Interbedded Clay &amp; Sand</div><div><div><div></div></div>Bedrock</div><div><div><div></div></div>Groundwater</div></div> | <div>Sources</div> <div><div><div>①</div>Landfill Gases (CO2 / Methane, Hydrogen Sulphide)</div><div><div>②</div>CO2 / Methane in Made Ground</div></div> | <div>Pathways</div> <div><div><div></div></div>Inhalation / Accumulation</div> | <div>Receptors</div> <div><div><div>①</div>Accumulation of Gases in Buildings (Future End Users)</div></div> | <div>Site Features</div> <div><div><div>A</div>Proposed Residential Development</div></div> | <div>Notes:</div> | <div>Client:</div> <div>DWH</div> | <div>Job No:</div> <div>15-280</div> <div>Drawing No:</div> <div>011</div> | <div>Date:</div> <div>11.03.2024</div> <div>Scale:</div> <div>NTS@ A3</div> | <div><div><div><div></div></div><div>e3p</div></div><div>Environmental Engineering Partnership Ltd<br/>Taylor Road, Trafford Park<br/>Urmston, Manchester, M41 7JQ<br/>Tel: 0161 707 9612<br/>E-mail: info@e3p.co.uk<br/>Website: www.e3p.co.uk</div></div> |

- ✳ Ground gas monitoring has been split into different sections based on the observed or theorised ground gas source, with the key sources identified as the adjacent landfill, the historically deposited landfill materials across the site, and the former petrol filling station.

- ✳ The key source of ground gas identified within the conceptual site model is the adjacent landfill at Bewley Road (Ref: EAHLD06985), which is noted to include household waste and was active from the 1950s to circa 1974.

- ✳ In addition, deep Made Ground has been encountered across the site, with the deepest deposits noted across the central region of the site associated with historical upfilling with landfill materials, as delineated in the Buro Happold report (Ref: 021706, dated November 2007).
