# ARBORICULTURAL METHOD STATEMENT

PROPOSED DEVELOPMENT

NORLANDS LANE  
CRONTON

Author: C. Salisbury  
Date: 05 August 2025  
Ref: TRE/NLC/Rev A

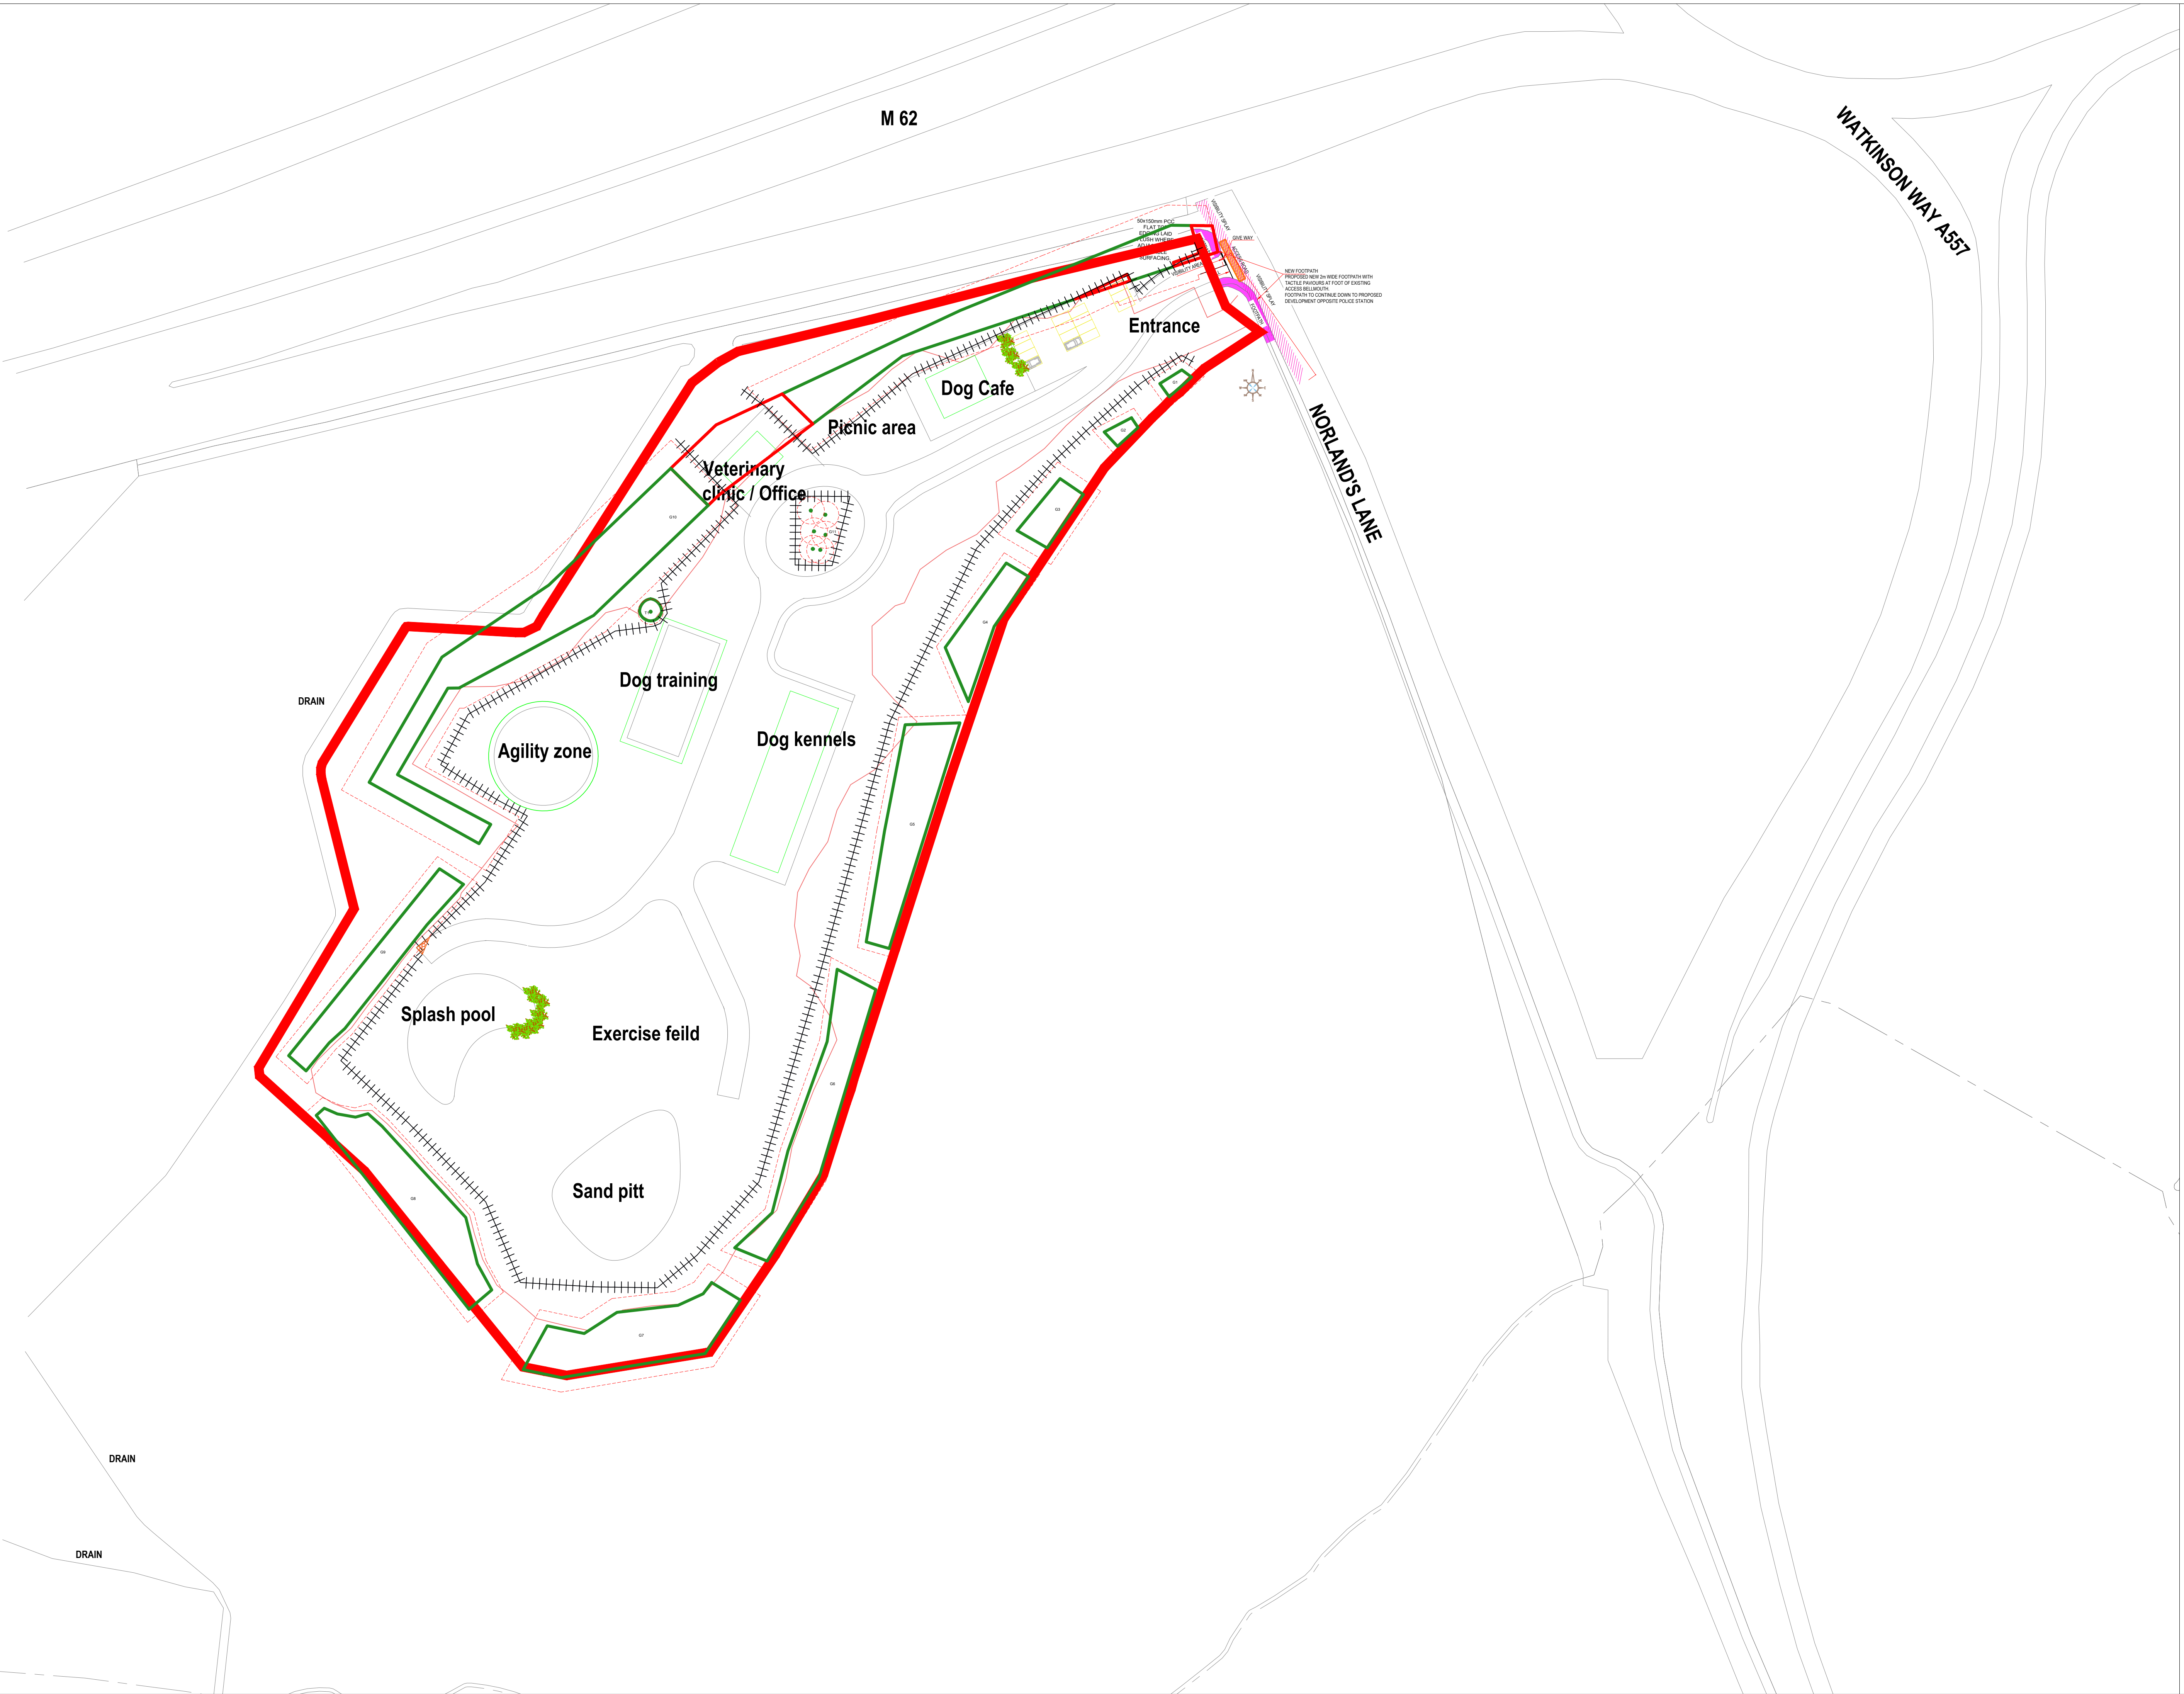
Drawing Title:  
Method Statement Plan

| Tree No. | Proposed Works |
|---|---|
| G10 | Fell 3 sections as shown on the enclosed plan |

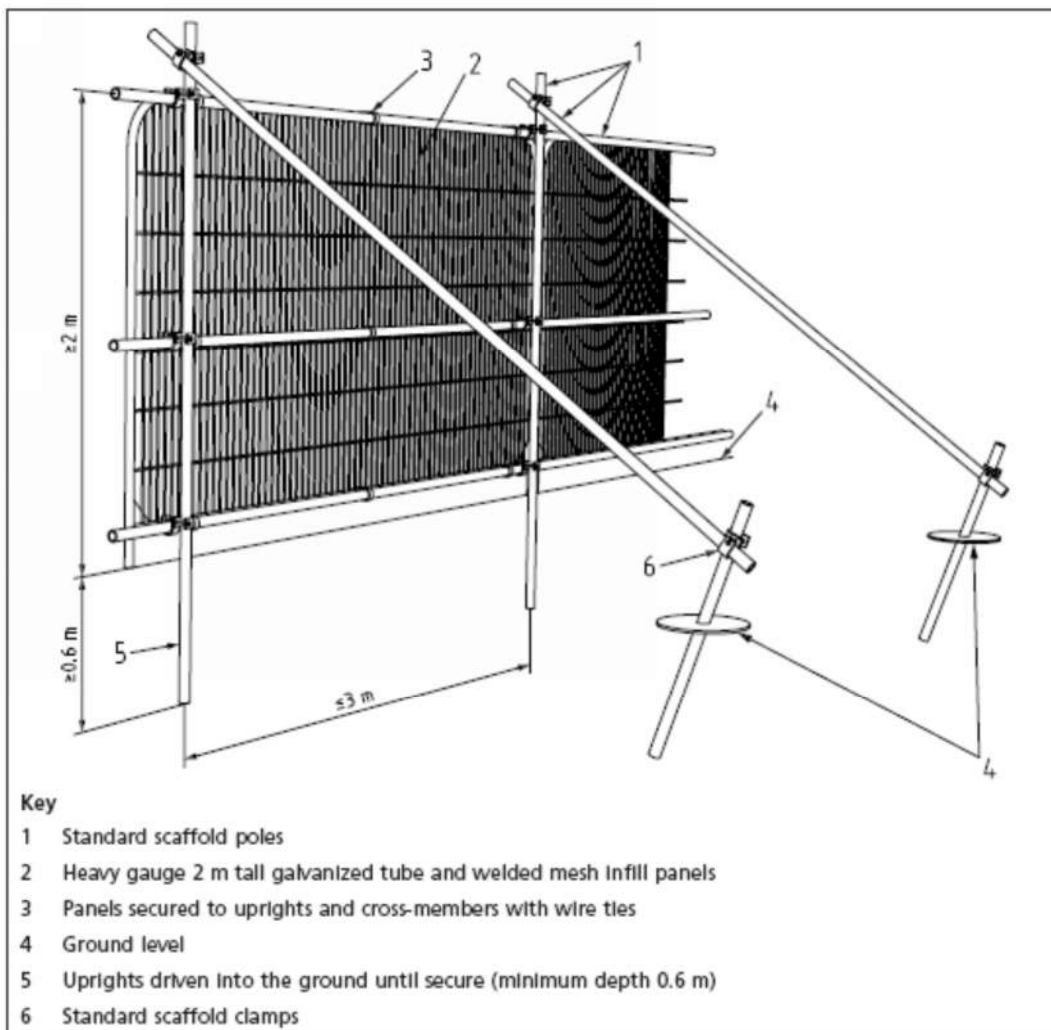
## Tree Protection Fencing (BS5837: 2012)

- 2.2.1 The fencing should be strong and suitable for local conditions. It should also take into account the degree of construction activity on the site.
- 2.2.2 The fencing should be at least 2.3m in height and should be erected with both a vertical and horizontal scaffolding framework capable of withstanding impact, with vertical tubes spaced at a maximum of 3 m. This should support either weldmesh panels which should be securely fixed with wire or scaffold clamps.
- 2.2.3 Notices should also be erected on the fencing stating ‘Protected Area - No operations within fenced area’.
- 2.2.4 The positioning of the protective fencing is also very important and should be erected in the proposed location identified in Appendix One. Once the fence has been erected it should never be crossed and particular care should be taken not to store any materials or soil within the protected area.

All fencing used on the site should fully comply with BS 5837:2012 (Trees in Relation to Construction – Recommendations).
