261-01

The Hovels,  
Tarbock Hall Lodge  
Ox Lane  
Prescot  
L35 1QA

Design and Heritage statement

Rev B

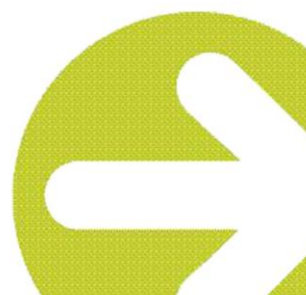
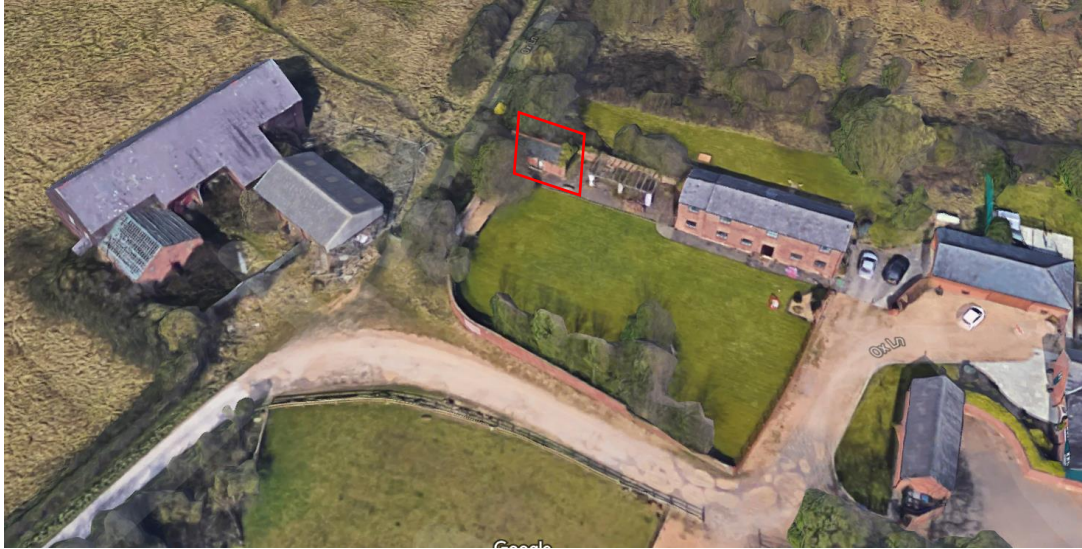
The building sits within the corner of the garden. The side wall forms part of the Tarbock Hall Lodge site boundary. This boundary is then adjacent to a maintenance strip of land within the same ownership.

There is an existing timber pergola that runs between The Hovels and The Lodge, forming a strong visual link between each structure.

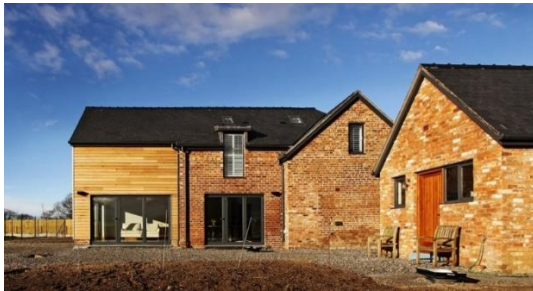
*Example of Timber extension to brick building with Aluminium windows.*

Timber cladding will be used for the extension. This cladding will form a contrast with the existing building and will also soften with time, helping the building settle into the existing landscape.

The windows and glazed doors will be a grey powder coated aluminium. This material is chosen due to its robustness and appearance. The grey frames will complement the proposed roof covering whilst the slim frame profile will be visually unobtrusive.
