Arboricultural  
Impact Assessment  
with  
Arboricultural Method Statement

**18 Keats Avenue  
Whiston  
L35 2XR**

Project No. AIA.13679.01

27<sup>th</sup> July 2023

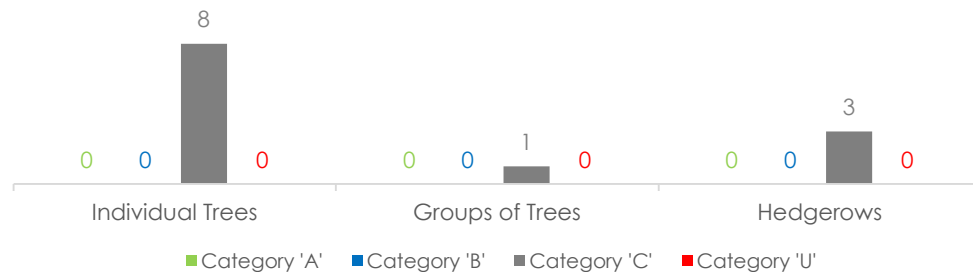
2.1.1. Eight individual trees, one group of trees and three hedges were recorded. In accordance with *BS5837:2012 Trees in relation to design, demolition and construction* all of the trees were recorded as retention category 'C'.

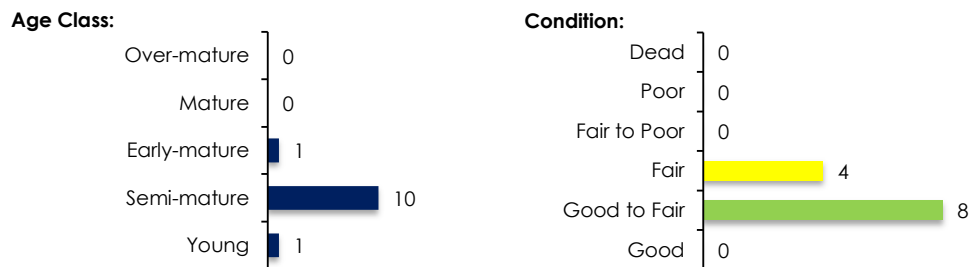
(Includes group and hedgerows as a single entity.)

2.2.1. Please see *Appendix 1* for the detailed list on existing species, age class, dimensions and condition of trees within the site, and *Appendix 2* for an explanation of retention category criteria. Tree locations can be seen on the *Tree Constraints Plan* at the rear of this report (*Drawing 1*).

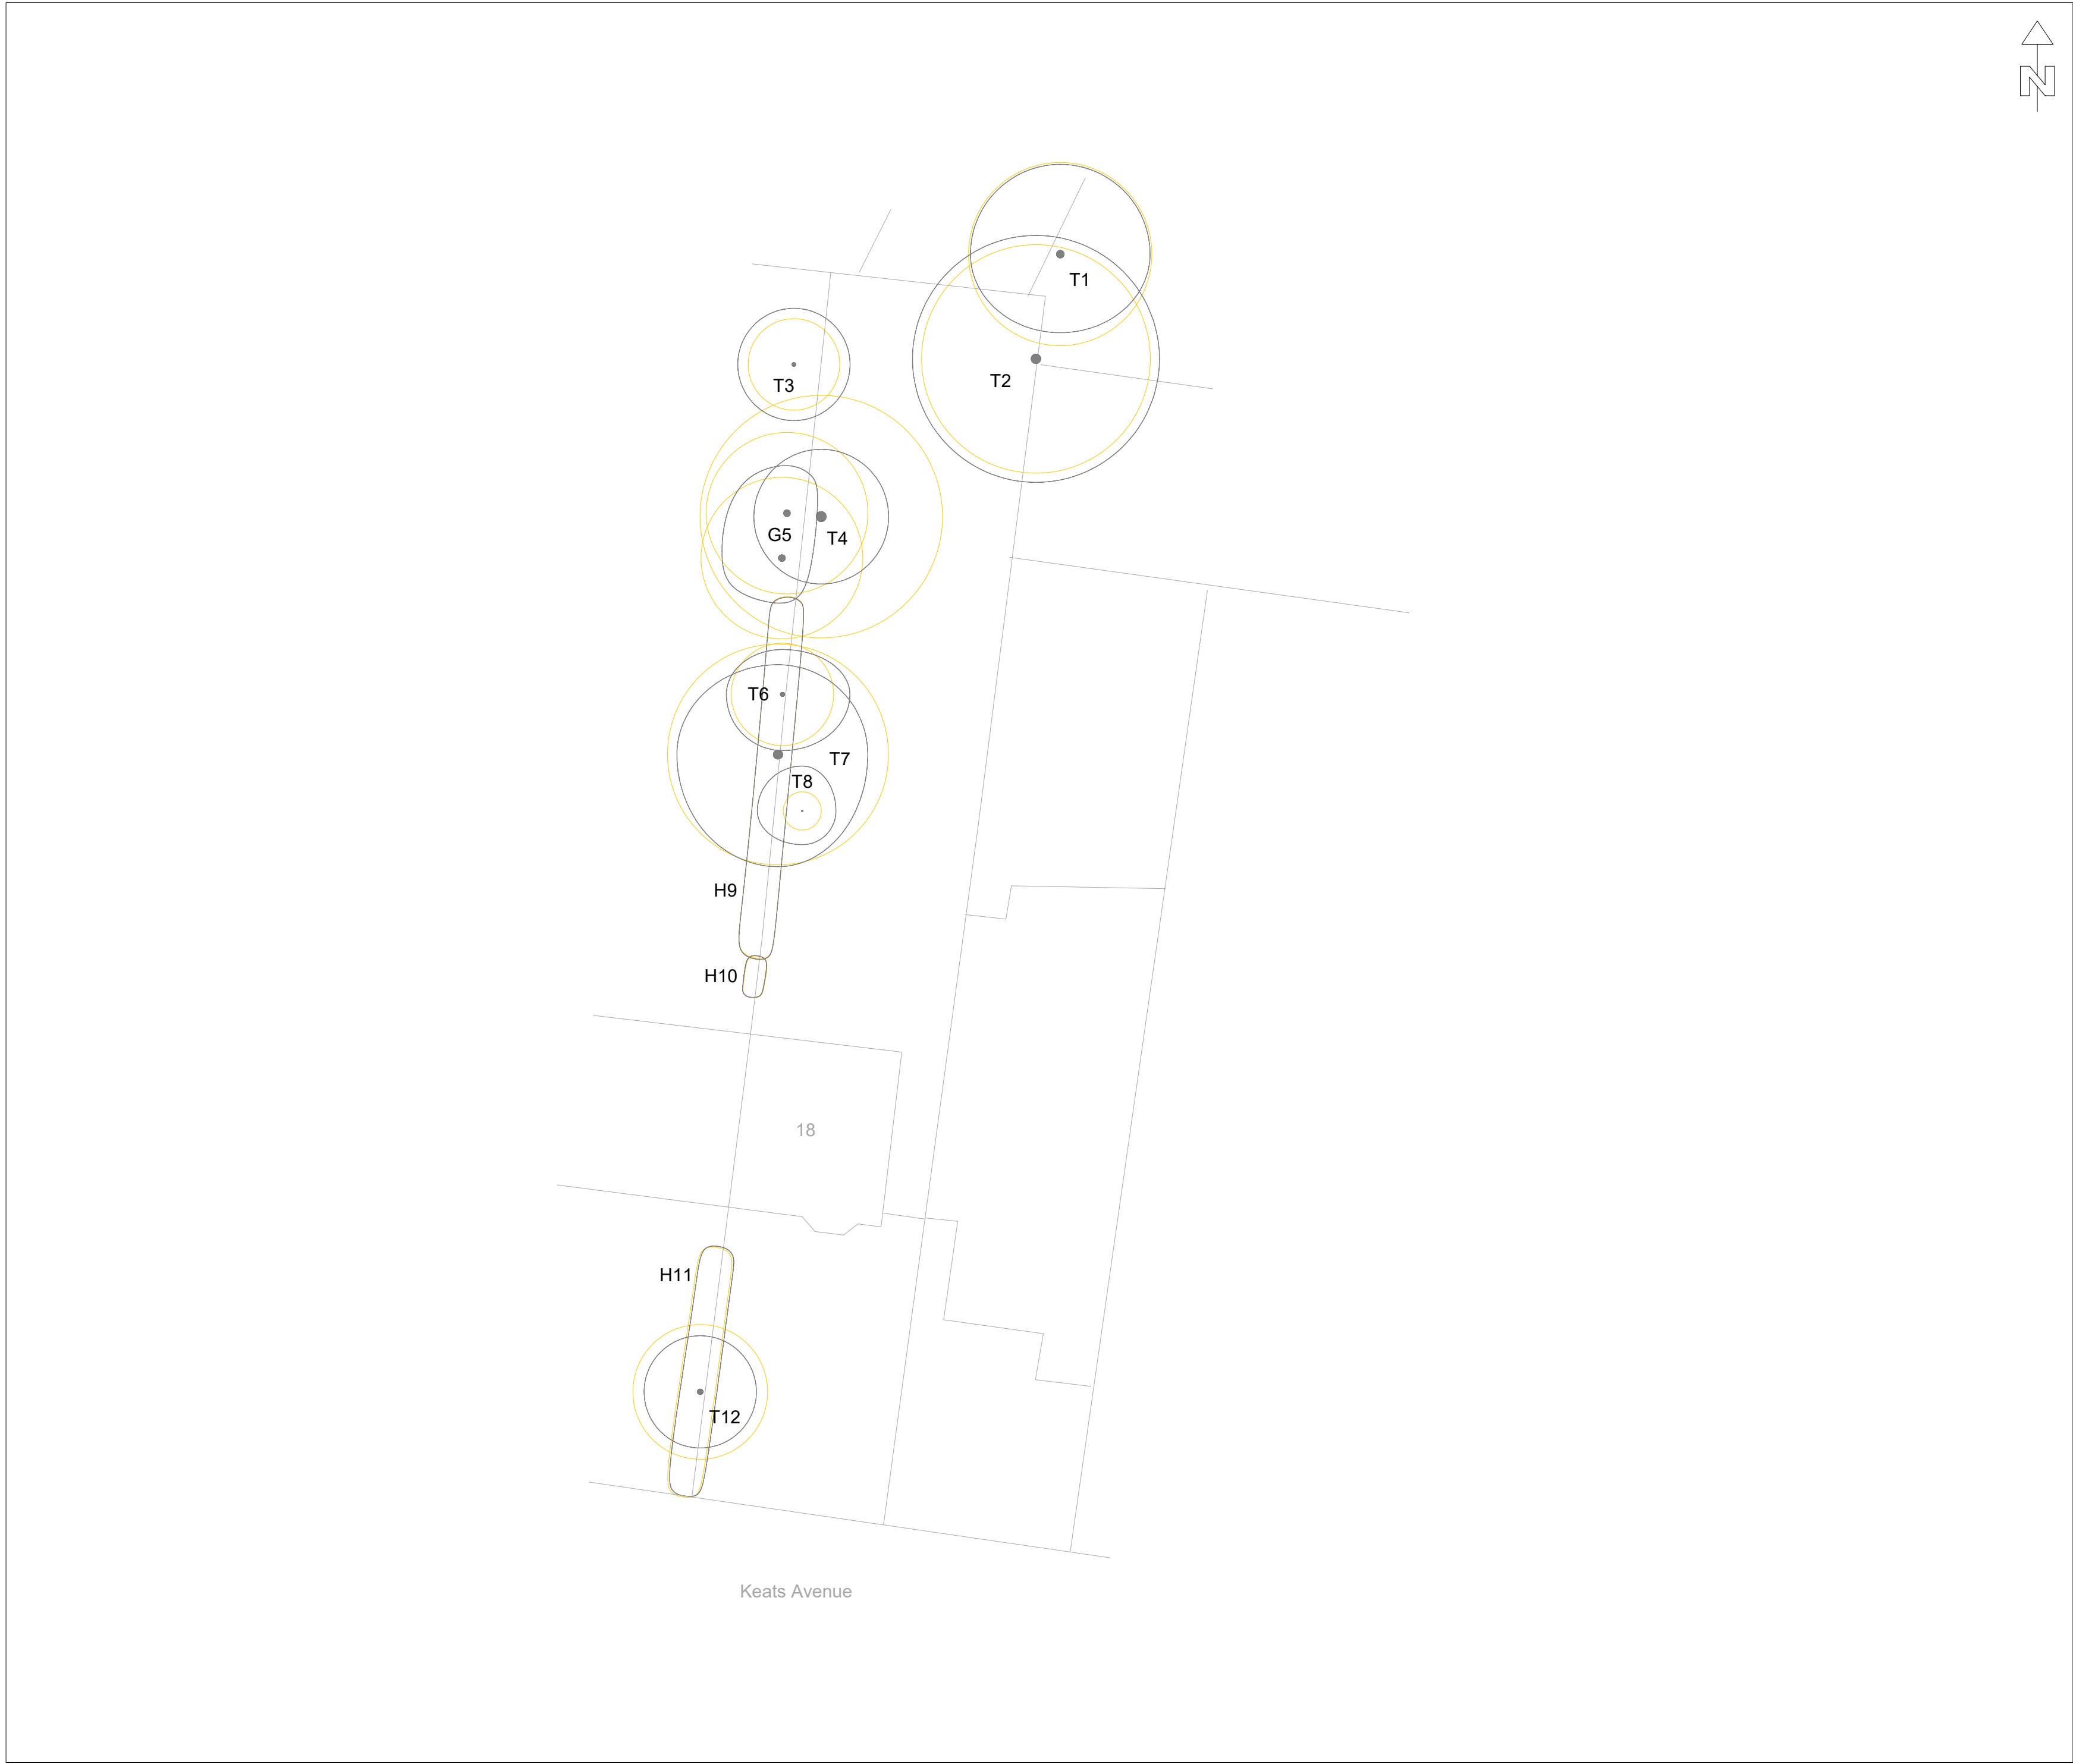
## Drawing 1. Tree Constraints Plan

The Root Protection Area (RPA) is a layout design tool highlighting the underground tree constraints.  
Along with the tree stem and branches the RPA must be considered prior to and during development.

- 2.3.1. The tree Root Protection Area (RPA) is a layout design tool indicating the area around a tree that, along with the tree stem and branches, must be considered during development. The protection of the roots and soil structure within the RPA should be treated as a priority. The RPA of each tree or group is marked on the *Tree Constraints Plan* at the rear of this report.

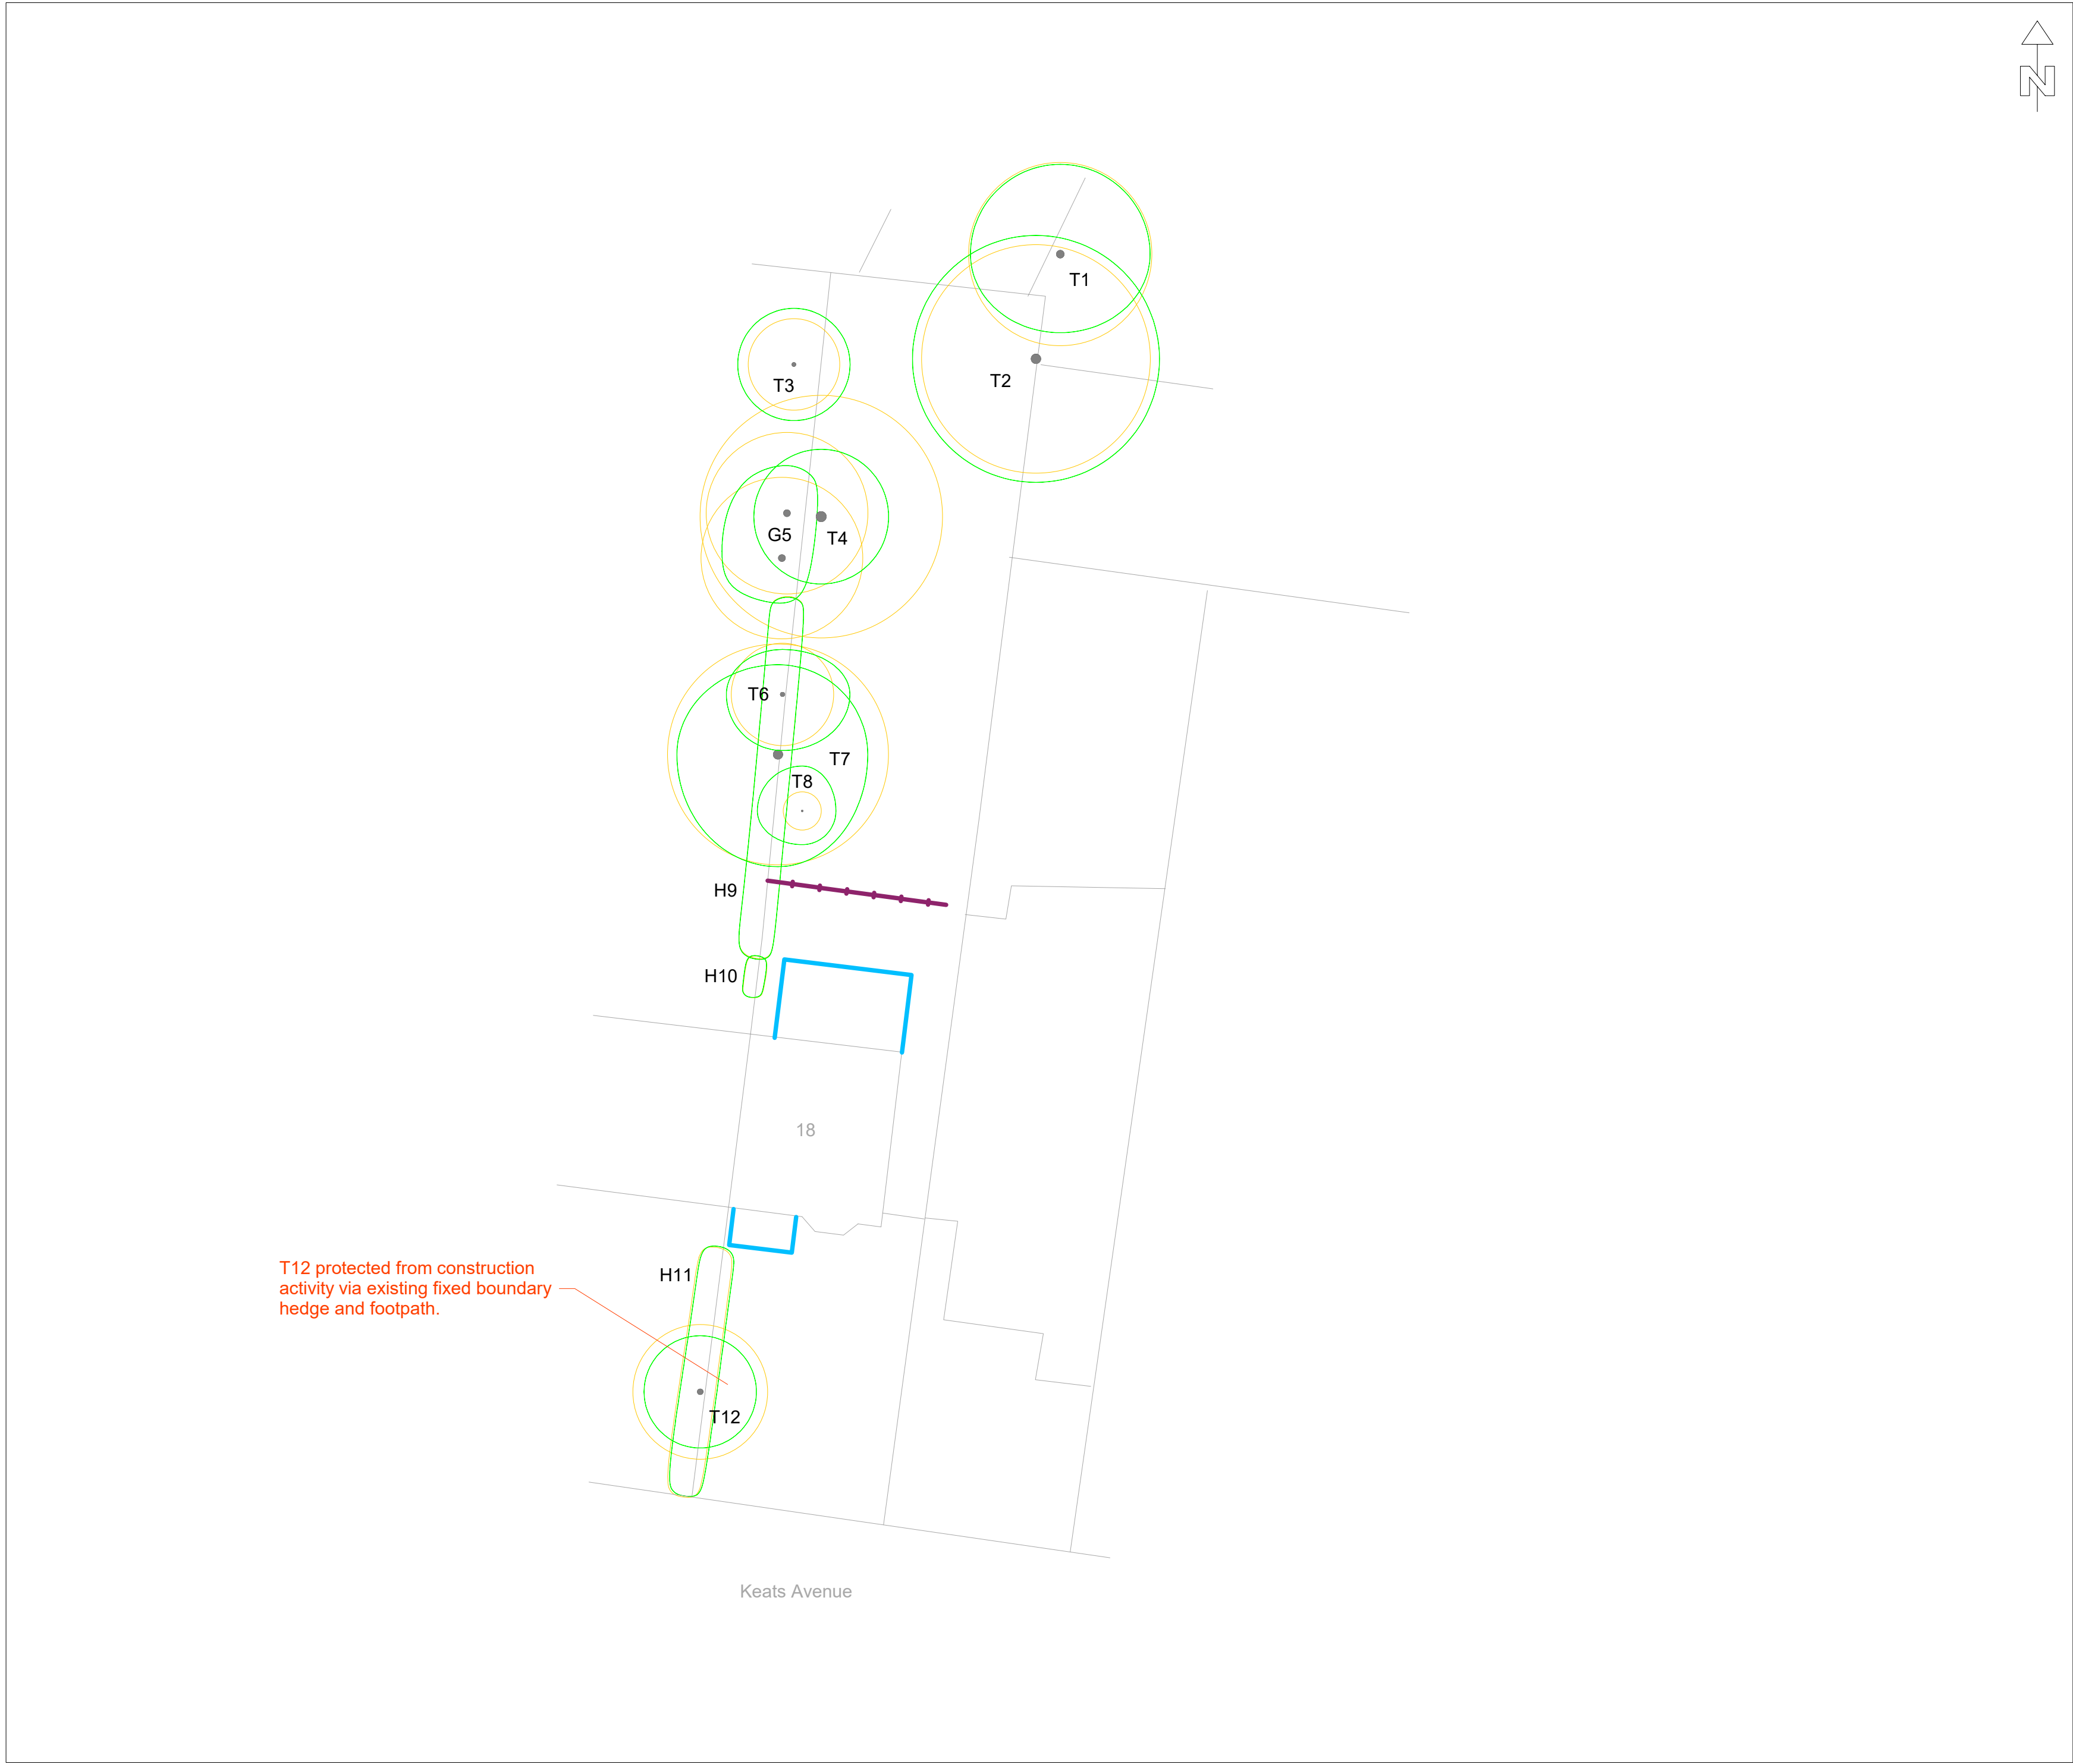
## Drawing 2. Tree Protection Plan

| | TEMPORARY PROTECTIVE BARRIER<br>Refer to Appendix 4 of the Arboricultural Impact Assessment for specification details. |

- 3.1.1. A single storey rear extension and front porch are proposed. The proposed layout drawing can be seen within the *Tree Protection Plan* to the rear of this report. This drawing has been used to assess the potential direct and indirect arboricultural impacts.

- 4.1.3. Please see *Appendix 4* for suggested barrier construction detail. It is recommended that in this instance the protective barrier shown in *Figure 2* would be appropriate. The suggested location for protective fencing is shown on the *Tree Protection Plan (Drawing 2)*.

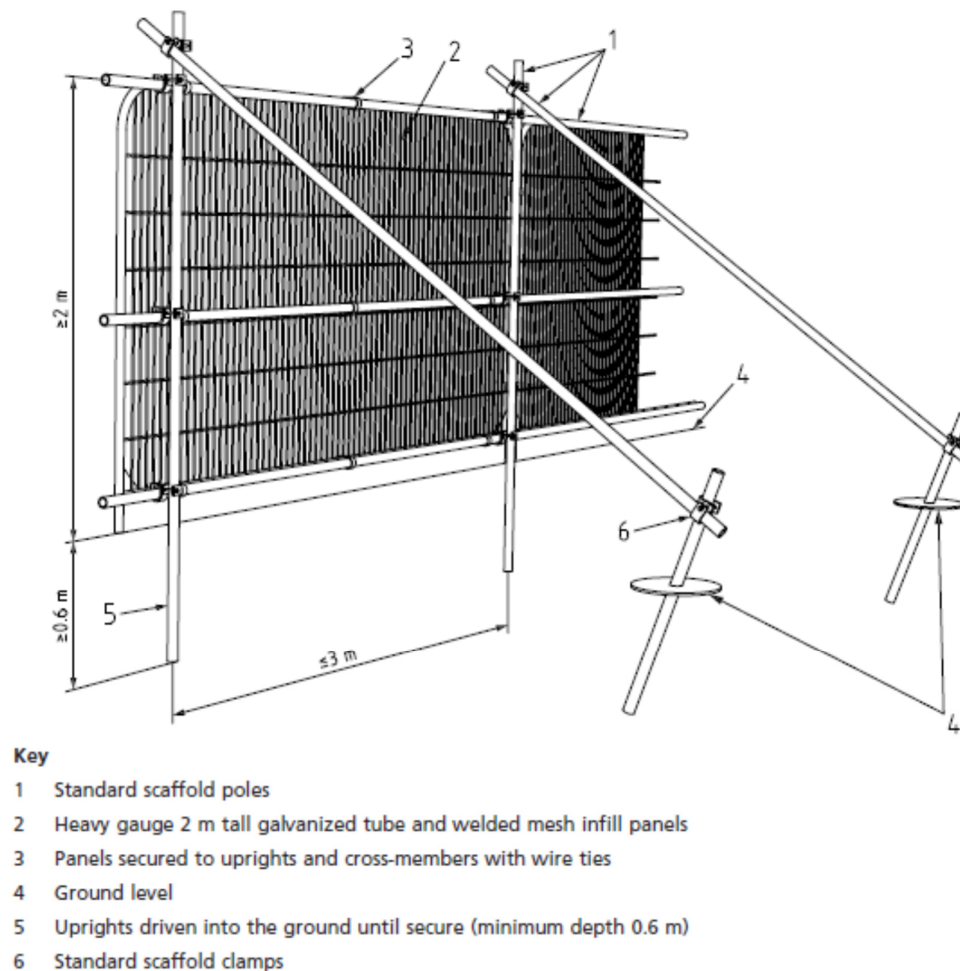
Figure 1. Default protective fencing barrier as detailed in BS 5837: 2012.

- A4.1 The default specification for protective barriers should consist of a vertical and horizontal scaffold framework, well braced to resist impacts, as illustrated below. The vertical tubes should be spaced at a *maximum* interval of 3 m and driven securely into the ground. Onto this framework, welded mesh panels should be securely fixed. Care should be exercised when locating the vertical poles to avoid underground services and, in the case of the bracing poles, also to avoid contact with structural roots.

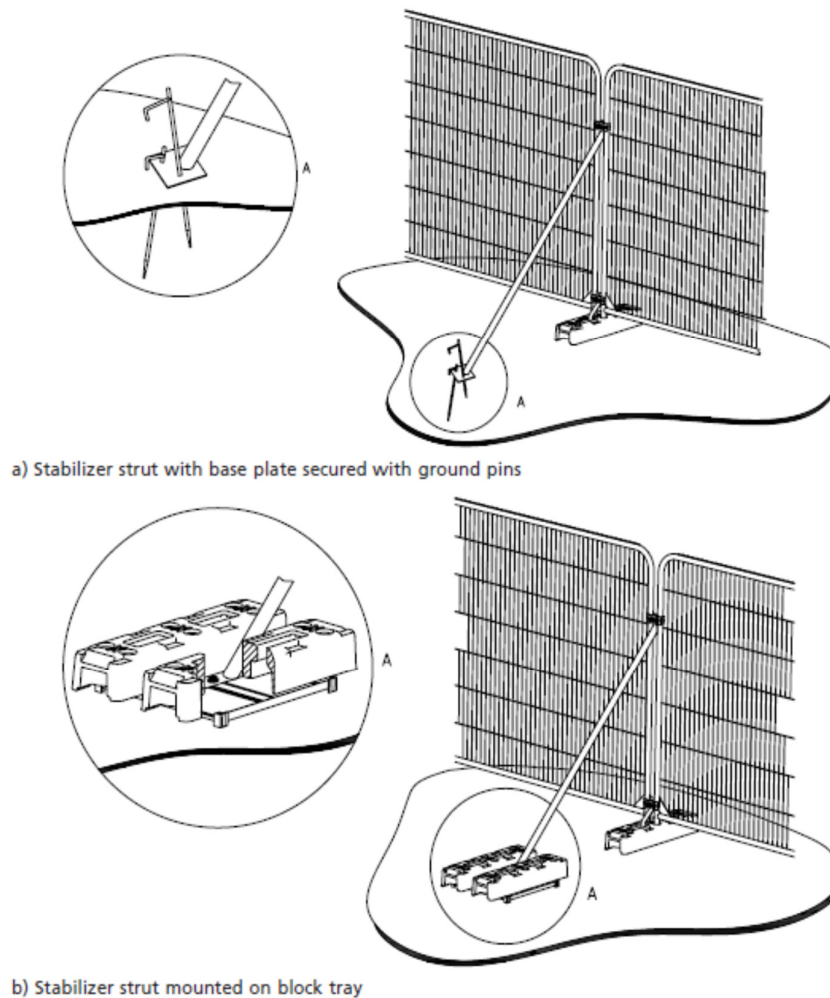
Figure 2. Examples of above-ground stabilizing systems

- A4.2 Where the site circumstances and associated risk of damaging incursion into the RPA do not necessitate the default level of protection, an alternative specification may be adopted. This system includes 2 m tall welded mesh panels on rubber or concrete feet, secure enough to provide an adequate level of protection from cars, vans, pedestrians and manually operated plant. In such cases, the fence panels should be joined together using a minimum of two anti-tamper couplers, installed so that they can only be removed from inside the fence. The distance between the fence couplers should be at least 1 m and should be uniform throughout the fence. The panels should be supported on the inner side by stabilizer struts, which should normally be attached to a base plate secured with ground pins (Figure 2a). Where the fencing is to be erected on retained hard surfacing or it is otherwise unfeasible to use ground pins, e.g. due to the presence of underground services, the stabilizer struts should be mounted on a block tray (Figure 2b).
