## ARBORICULTURAL IMPLICATIONS ASSESSMENT

LAND AT LYNTON  
MOOR LAND  
FAZAKERLEY

DECEMBER 2017

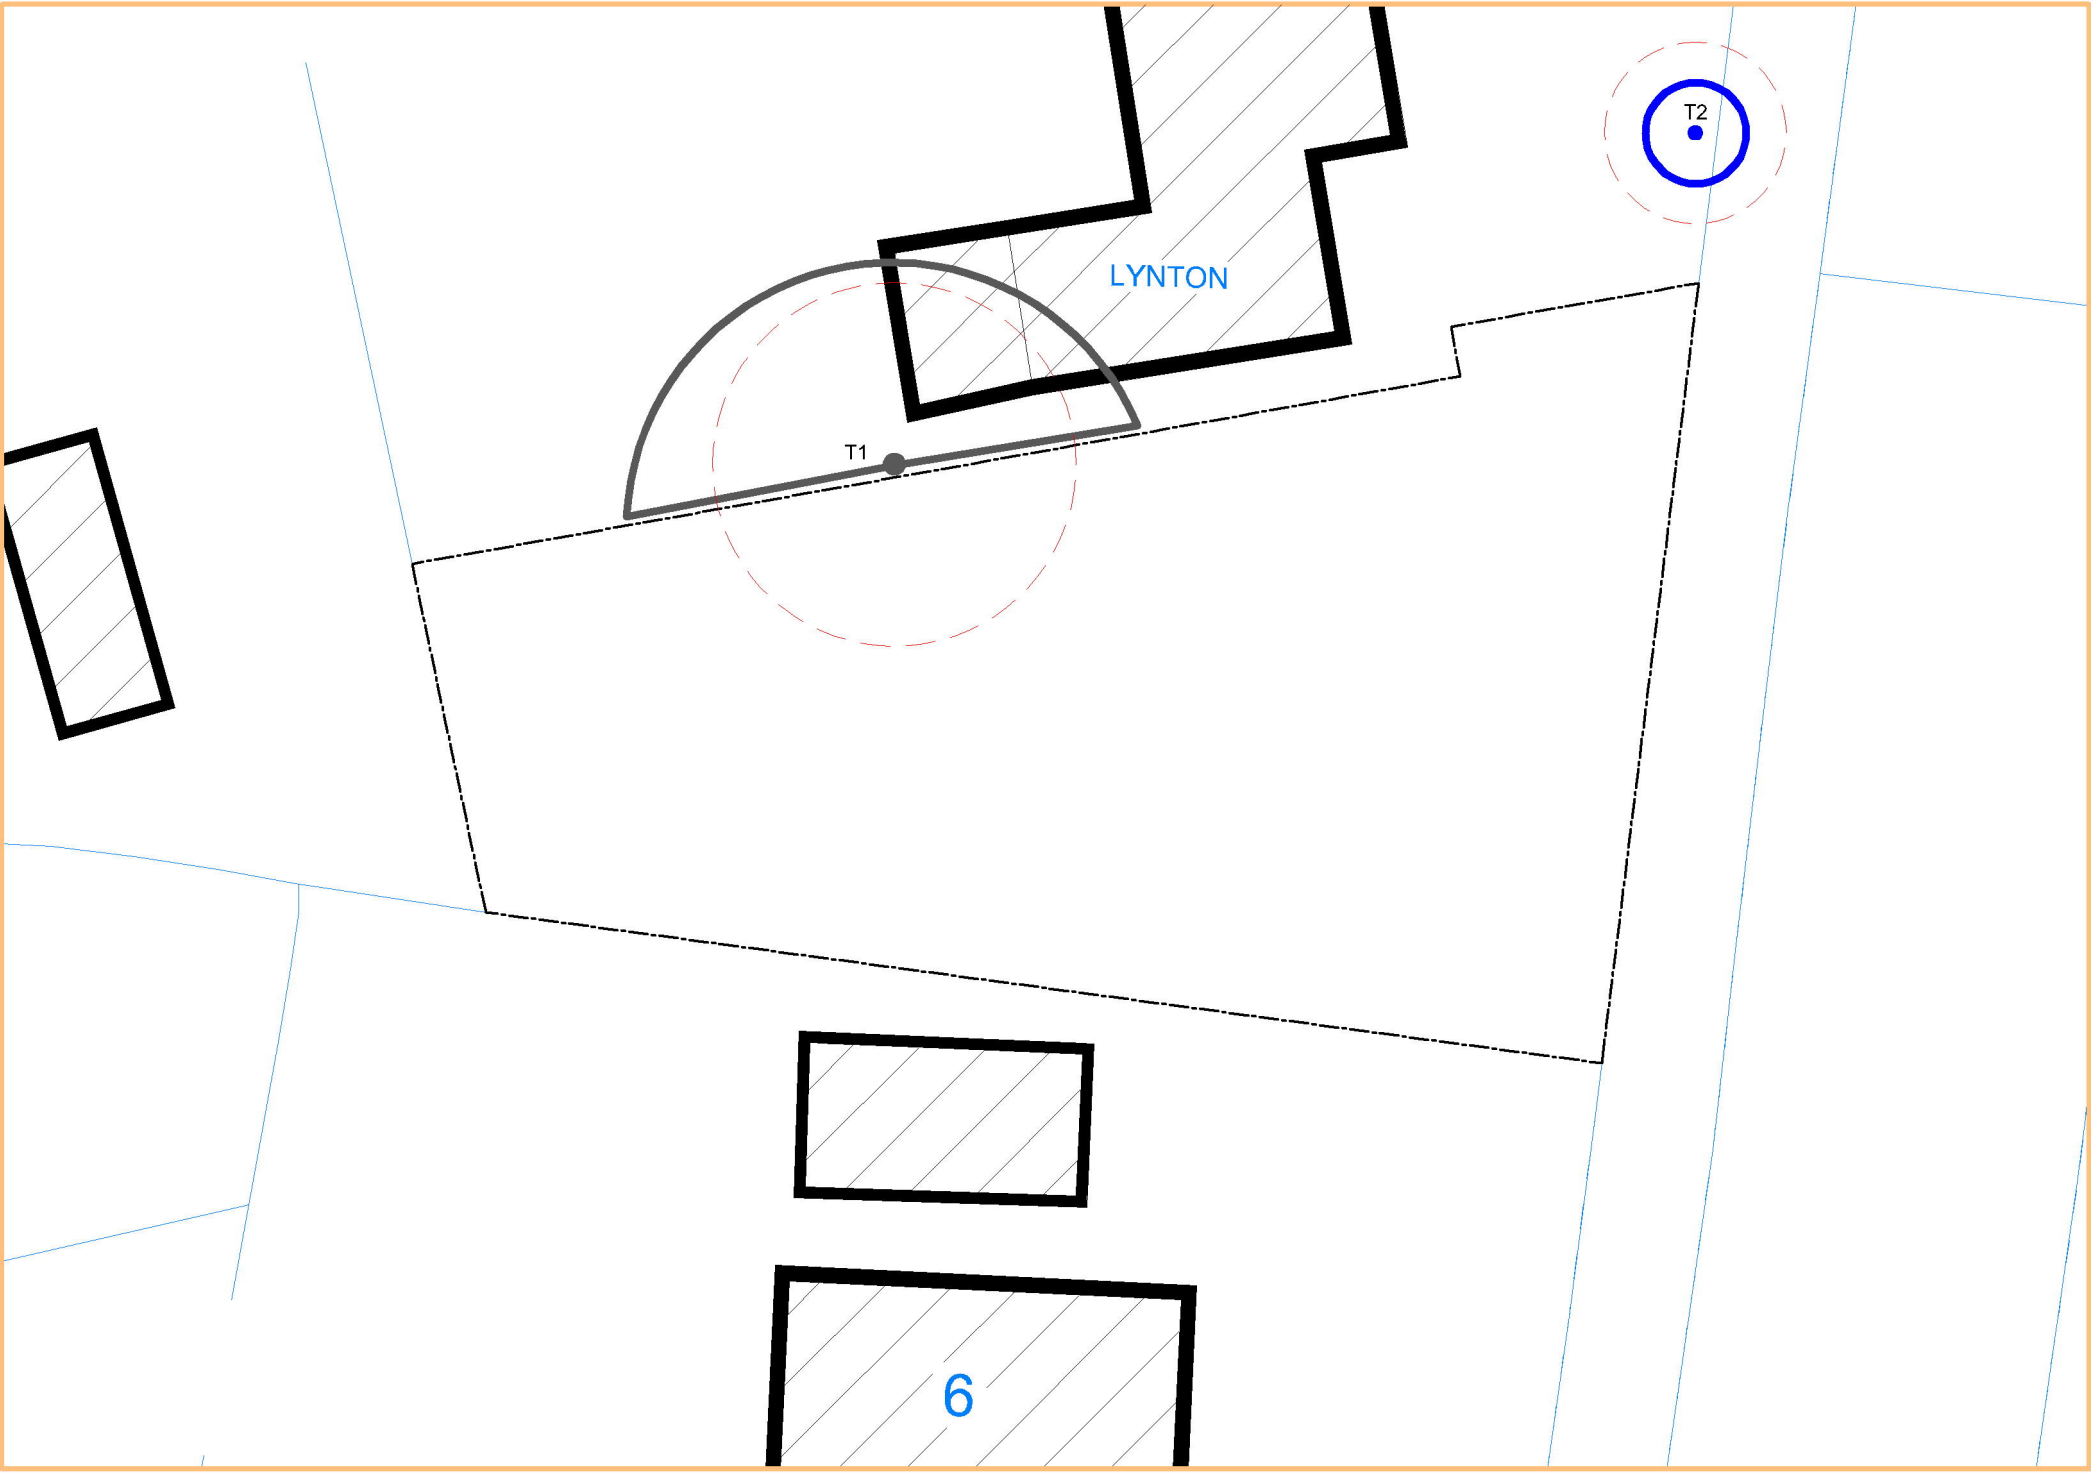
| Drawing Title:<br>BS5837 Plan | Drawing No:<br>17/00032 |

- 3.1 The site layout plan within appendix three identifies the trees in relation to the proposed car park alteration.
- 3.2 In order to fully assess the impact of the proposals an Impact Table (**Table 3.1**) has been created detailing each tree, which shows the proximity of the associated works to the tree.
- 3.3 This can then be assessed in accordance with BS 5837:2012 to determine whether proposals will have a detrimental impact on the health of each tree. Once this has been determined remedial measures can be detailed to reduce the impact the proposals will have on the treescape.

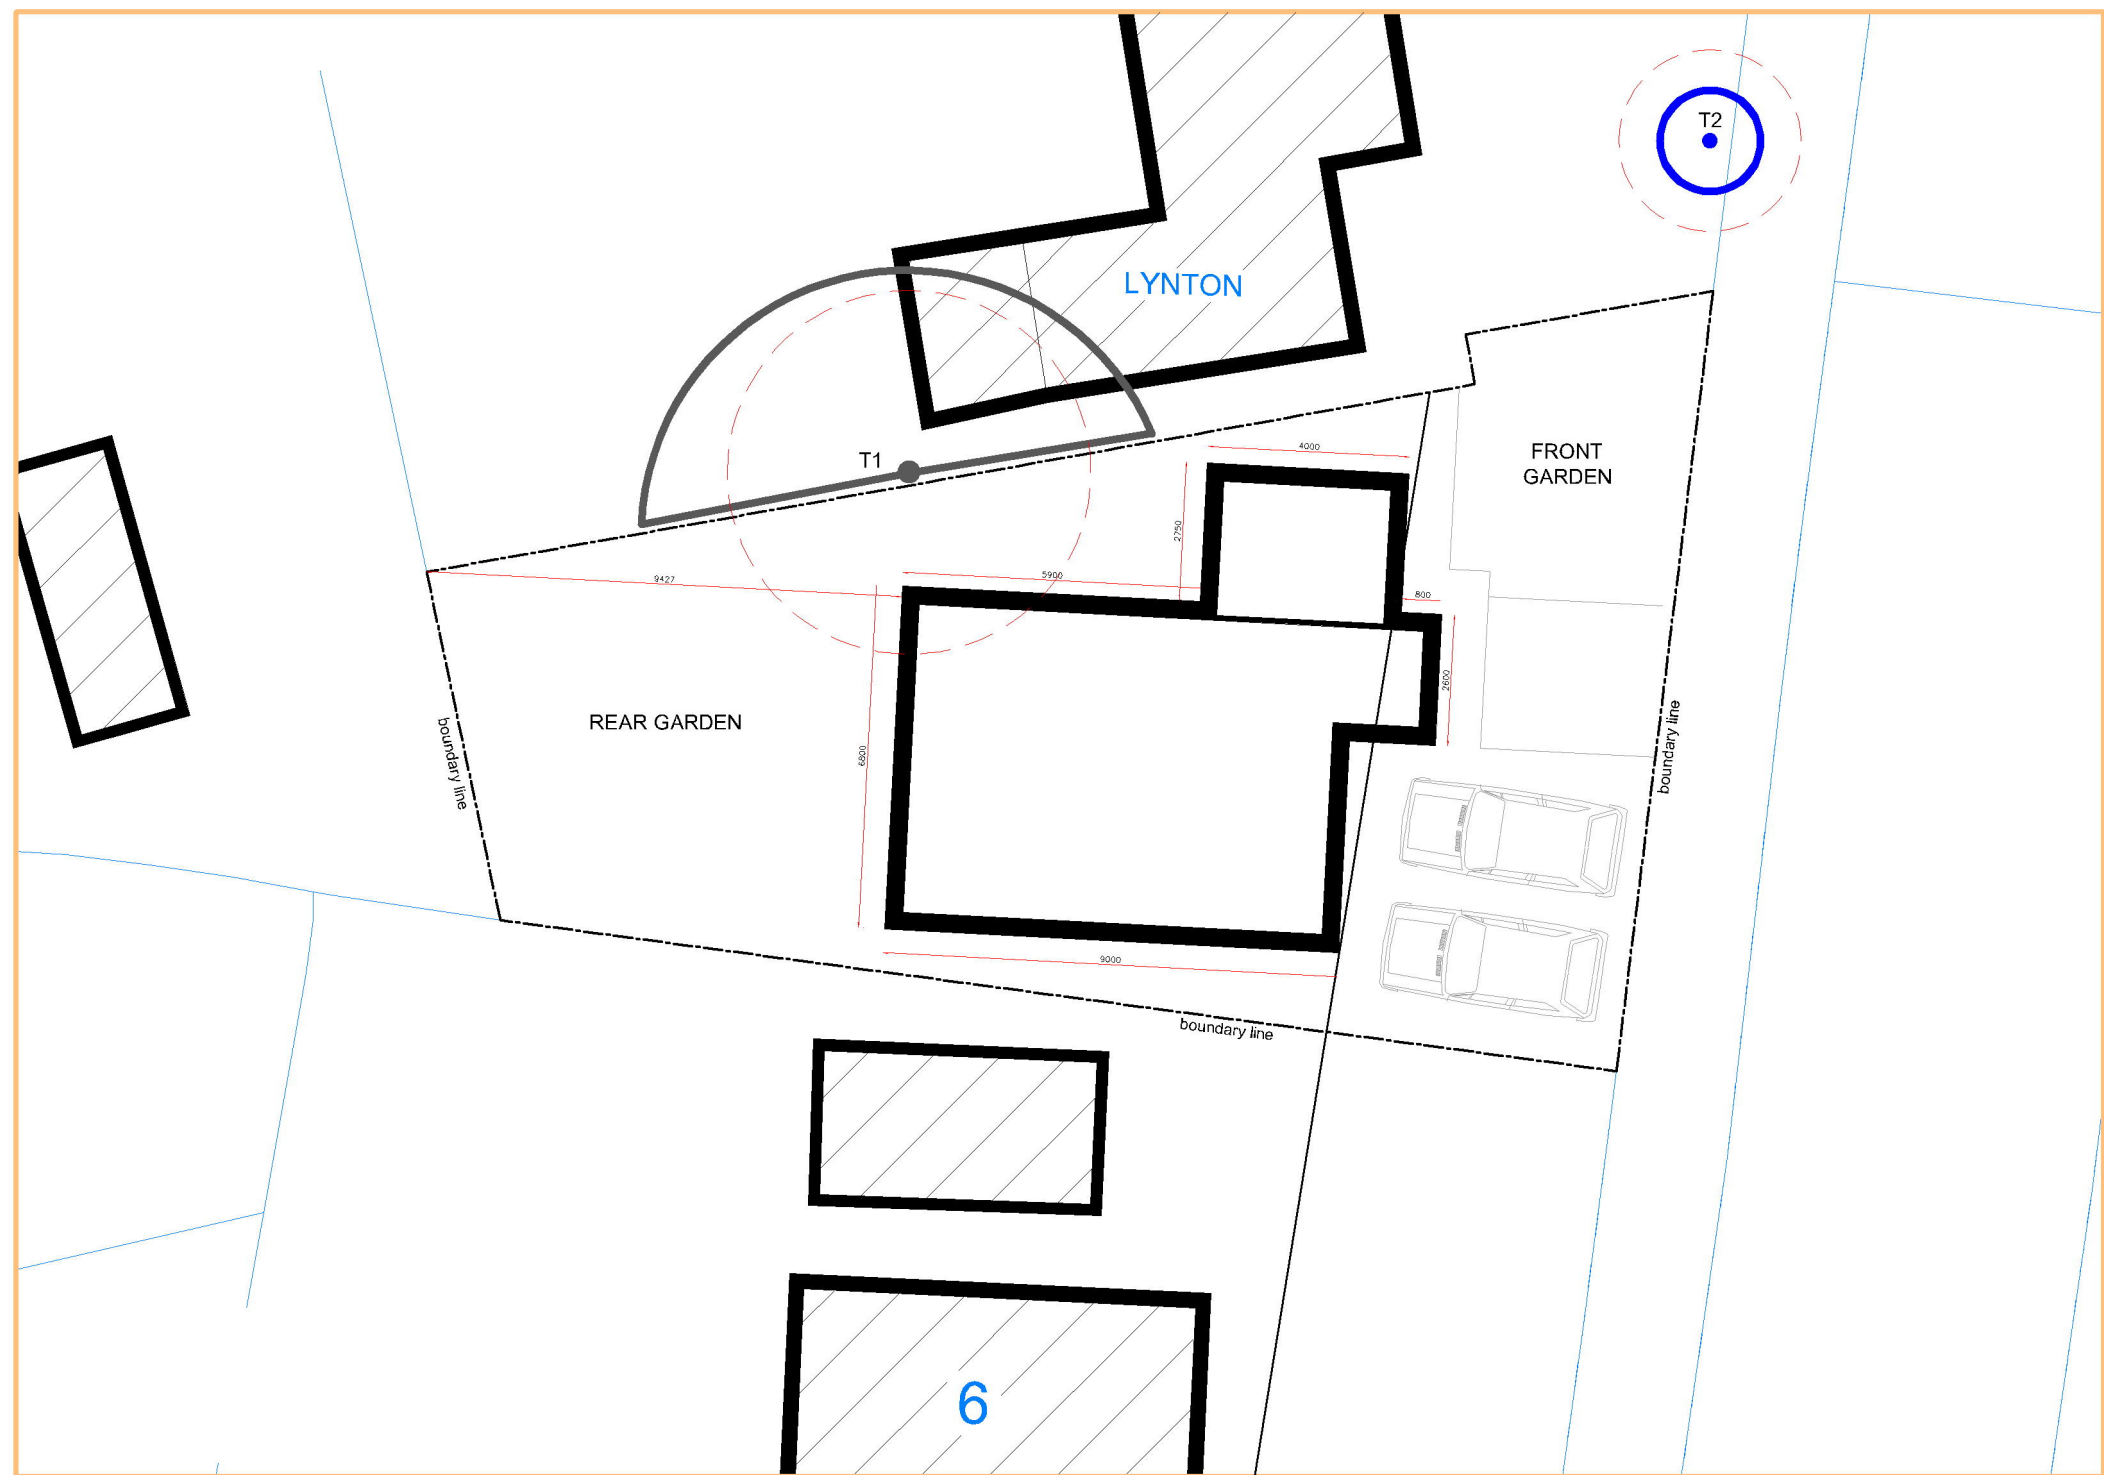
| Drawing Title:<br>AIA Plan | Drawing No:<br>17/00032 |

- 3.4 The works encroach into the root protection area (RPA) of T1. The works are minimal and at the extremity of the trees' RPA's. It is therefore considered that the long term health of the trees will not be impacted by the proposal.
