**SUPPLEMENTARY GROUND  
INVESTIGATION REPORT  
SYMMETRY PARK, MERSEYSIDE -  
UNITS 03 & 04**

**TE1163-TE-00-XX-RP-GE-001-V01**

**14 FEBRUARY 2024**

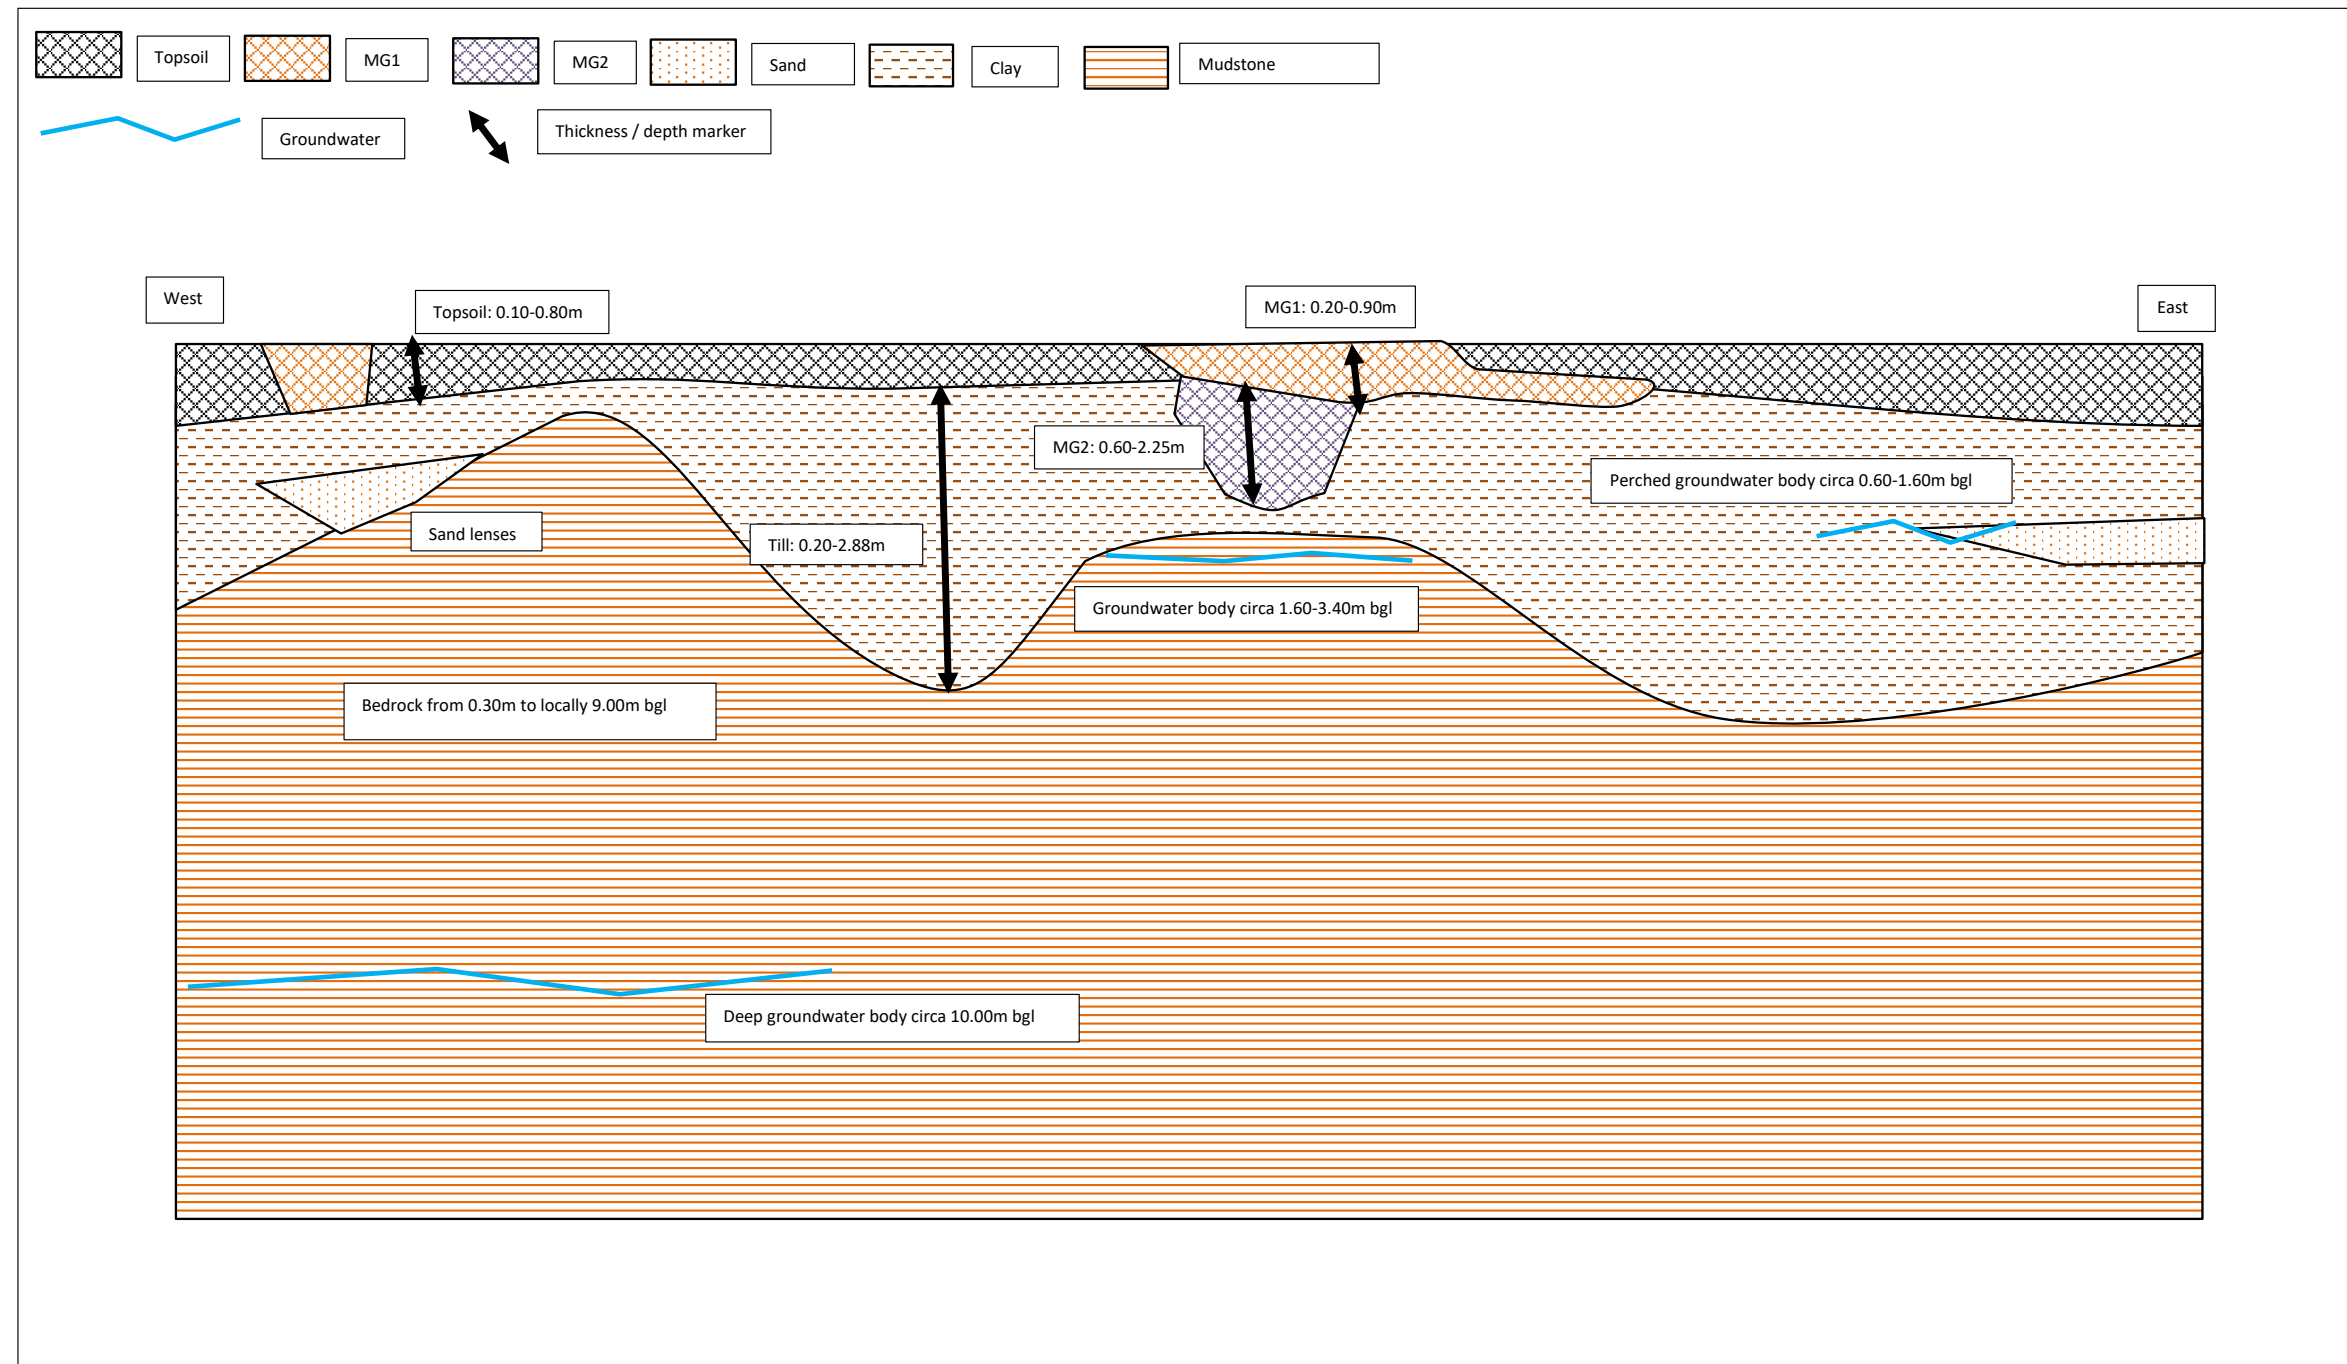
Figure 6.1 Schematic Drawing of Ground Conditions

Figure 6.1 presented below provide a schematic summary of the ground conditions beneath the site. The distinct populations of strata identified have been numbered and correspond with the more detailed descriptions below.

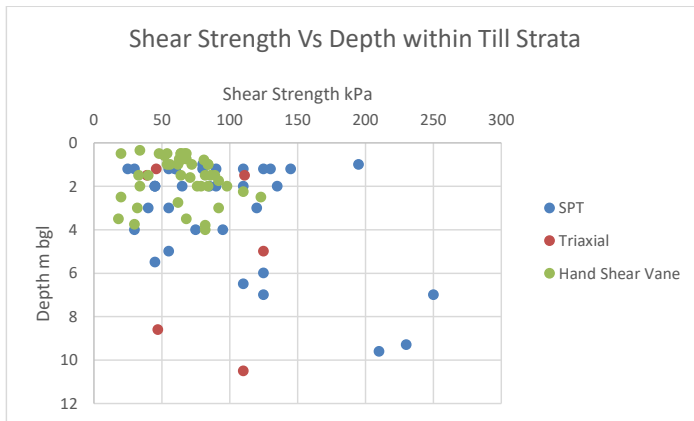
Figure 7-1 Shear Strength Vs Depth in Till Strata

The results of shear strength values derived from *in situ* standard penetration tests, hand shear vanes and triaxial tests for the natural clay unit are plotted in Figure 7.4 below.

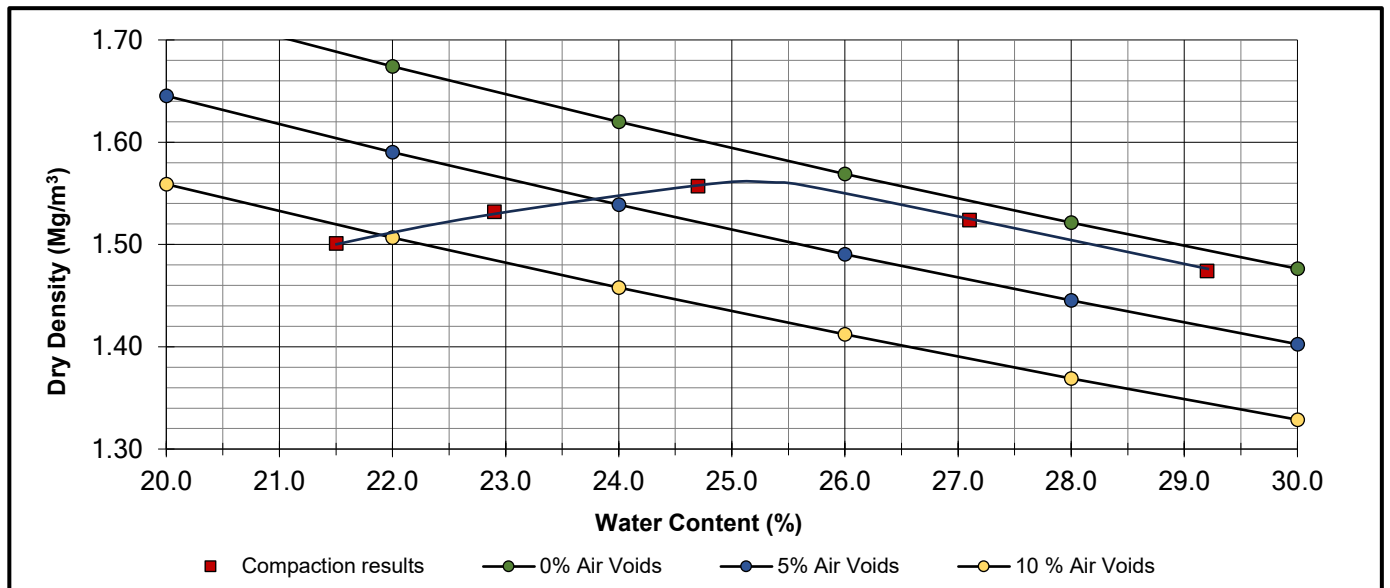
| OPTIMUM WATER CONTENT | 25 | (%) |
| MAXIMUM DRY DENSITY | 1.56 | (Mg/m <sup>3</sup> ) |

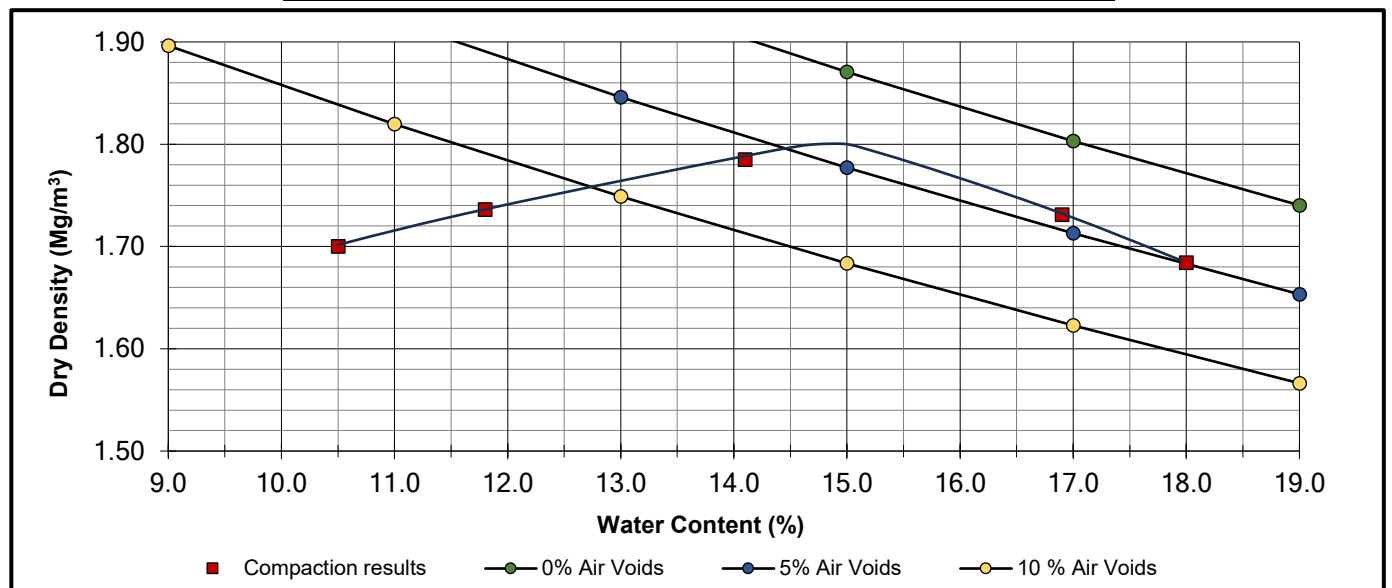
| OPTIMUM WATER CONTENT | 15 (%) |
| MAXIMUM DRY DENSITY | 1.80 (Mg/m <sup>3</sup> ) |

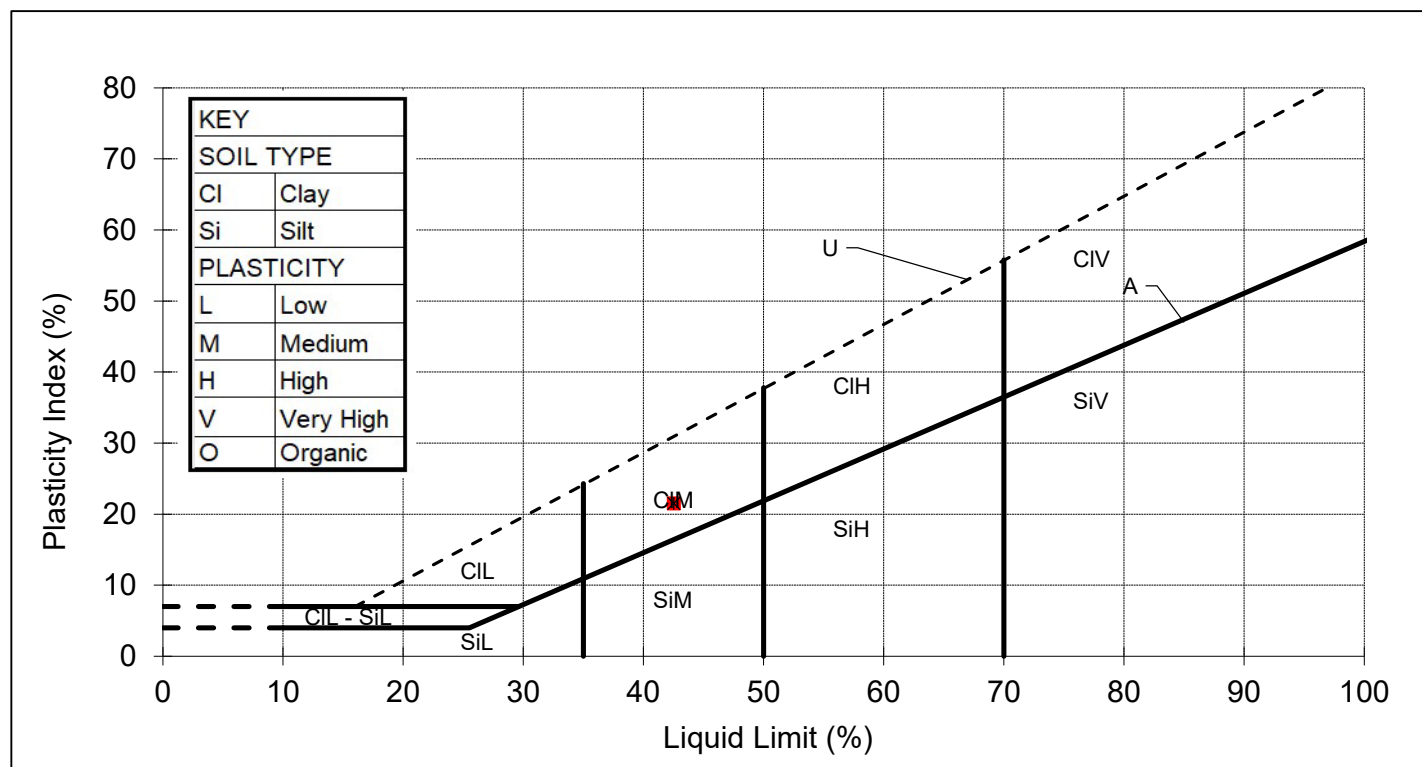
| Natural Moisture Content (%) | Liquid Limit (%) | Plastic Limit (%) | Plasticity Index (%) | Passing 425 micron (%) |
| 23.3 | 43 | 21 | 22 | 98 |

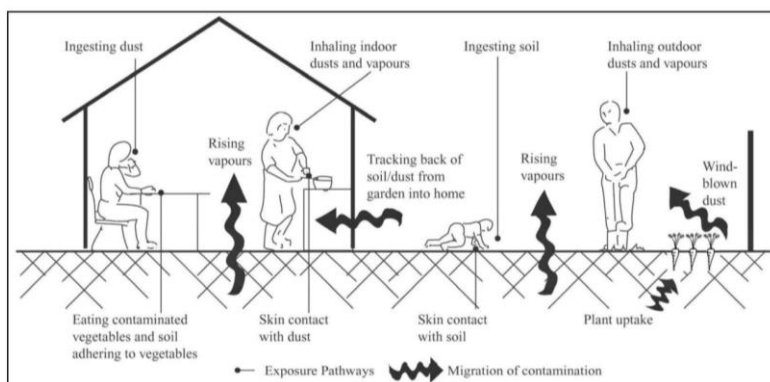
The CLEA model and associated guidance was developed to calculate an estimated tolerable daily intake (TDI) of contaminants for site users given a set of ‘typical’ human health exposure pathways which are detailed in “SR3: Updated technical background to the CLEA model”

(Science Report SC050021/SR3, EA, 2009) and reproduced below.

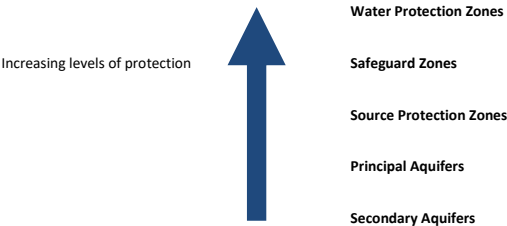
The Environment Agency has a tiered risk based approach to drinking water protection as summarised below:
