**LAND AT ACORNFIELD  
ROAD, KNOWSLEY**  
REMEDIATION STRATEGY

S2405/03, FEB 2026  
ISSUE 1.0

**SPIRE**  
**GEOTECHNICAL**  
Geologists &  
Site Investigation Specialists

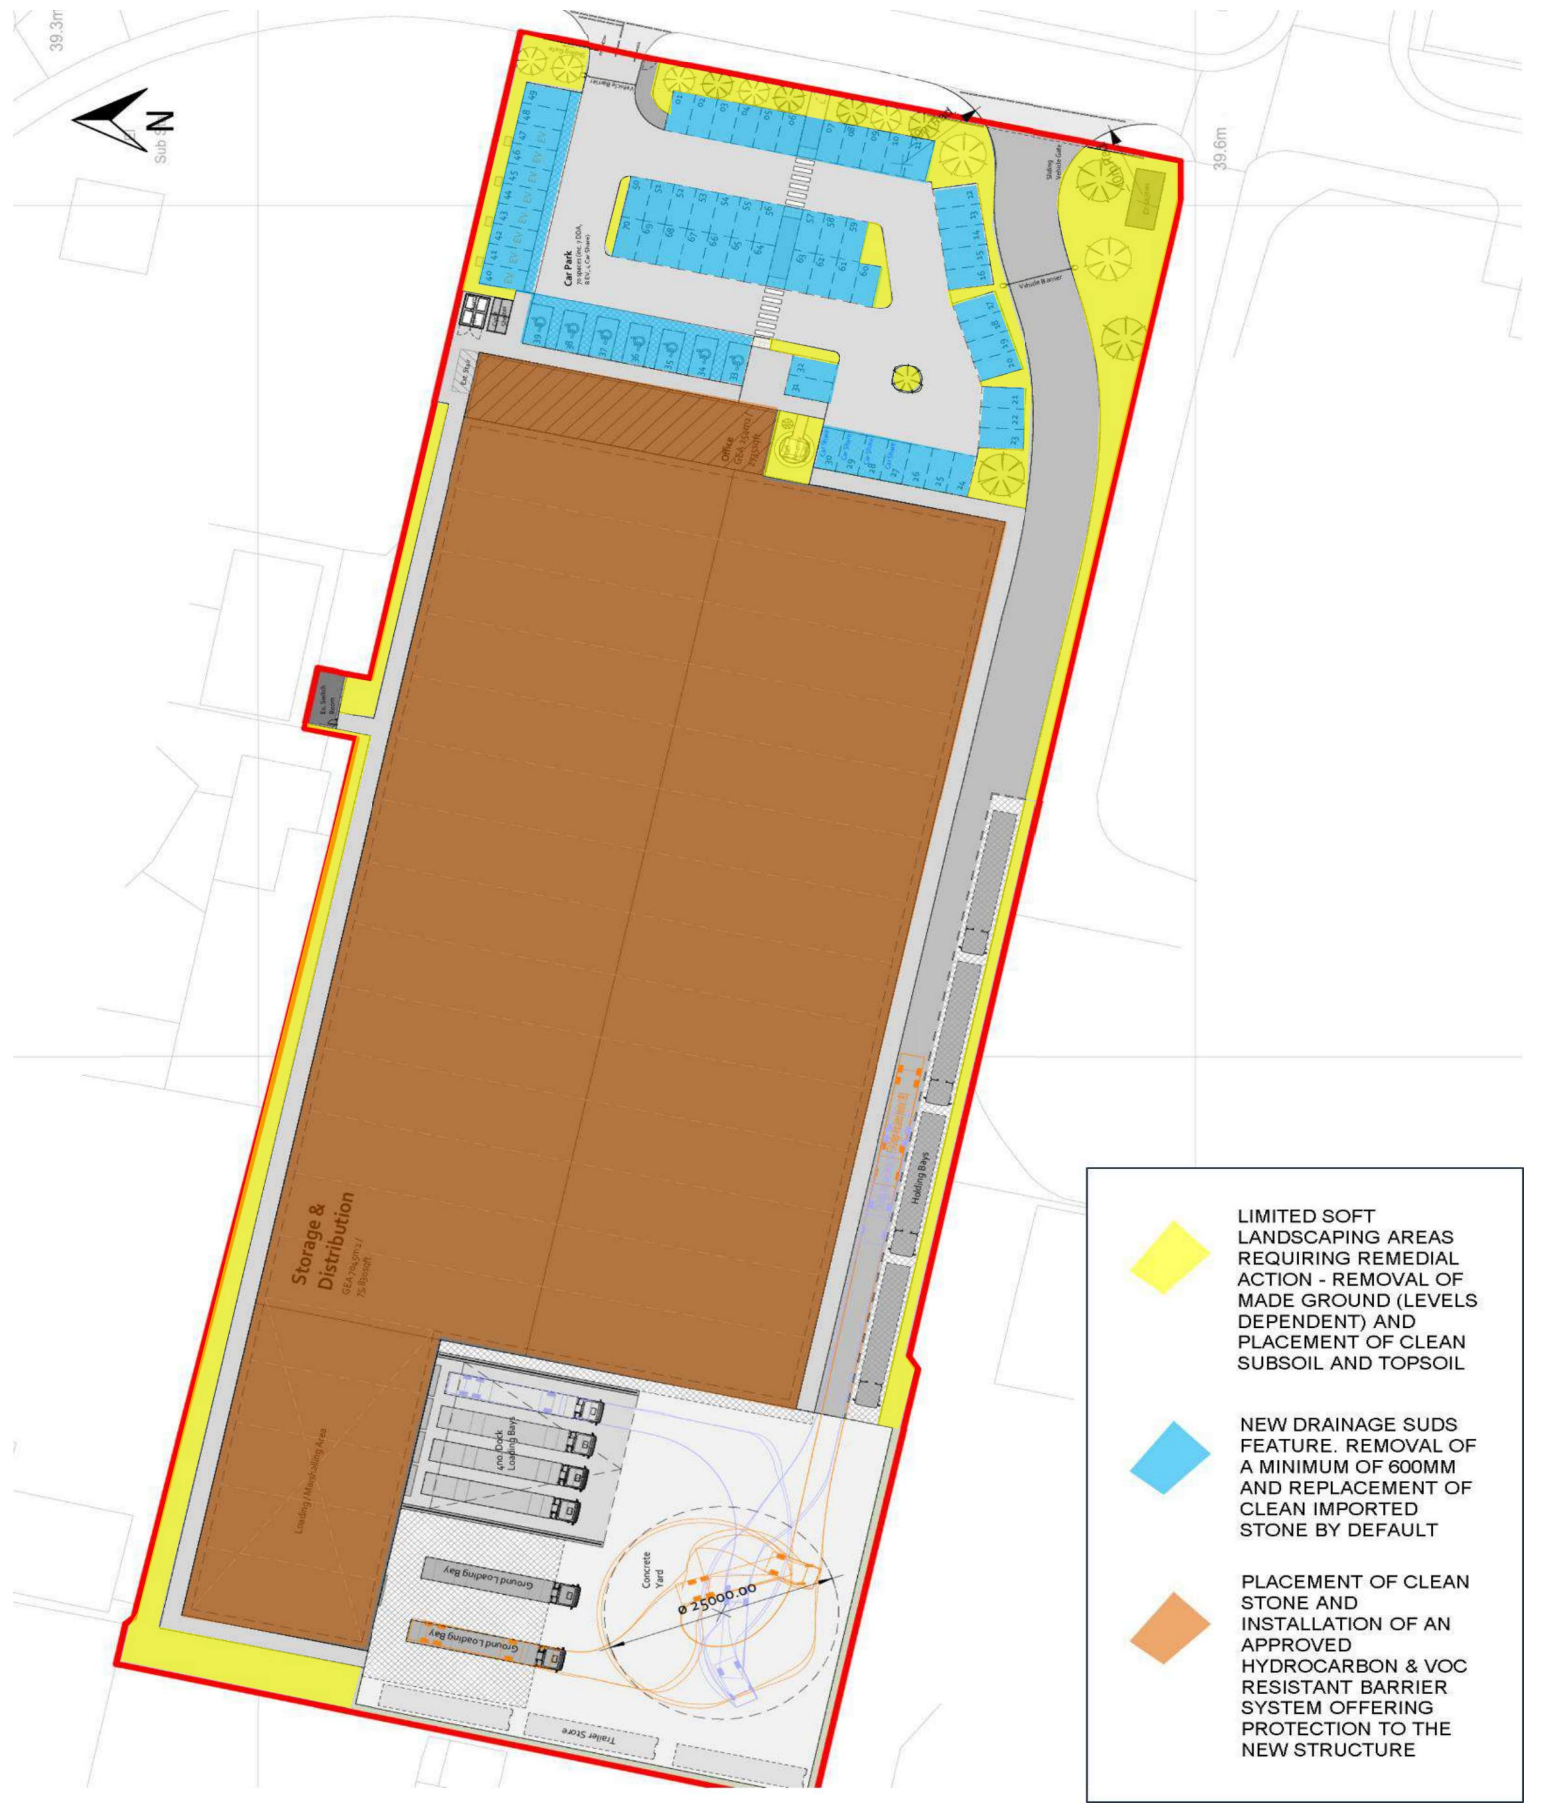
NEW DRAINAGE SUDS FEATURE. REMOVAL OF A MINIMUM OF 600MM AND REPLACEMENT OF CLEAN IMPORTED STONE BY DEFAULT
-

PLACEMENT OF CLEAN STONE AND INSTALLATION OF AN APPROVED HYDROCARBON & VOC RESISTANT BARRIER SYSTEM OFFERING PROTECTION TO THE NEW STRUCTURE

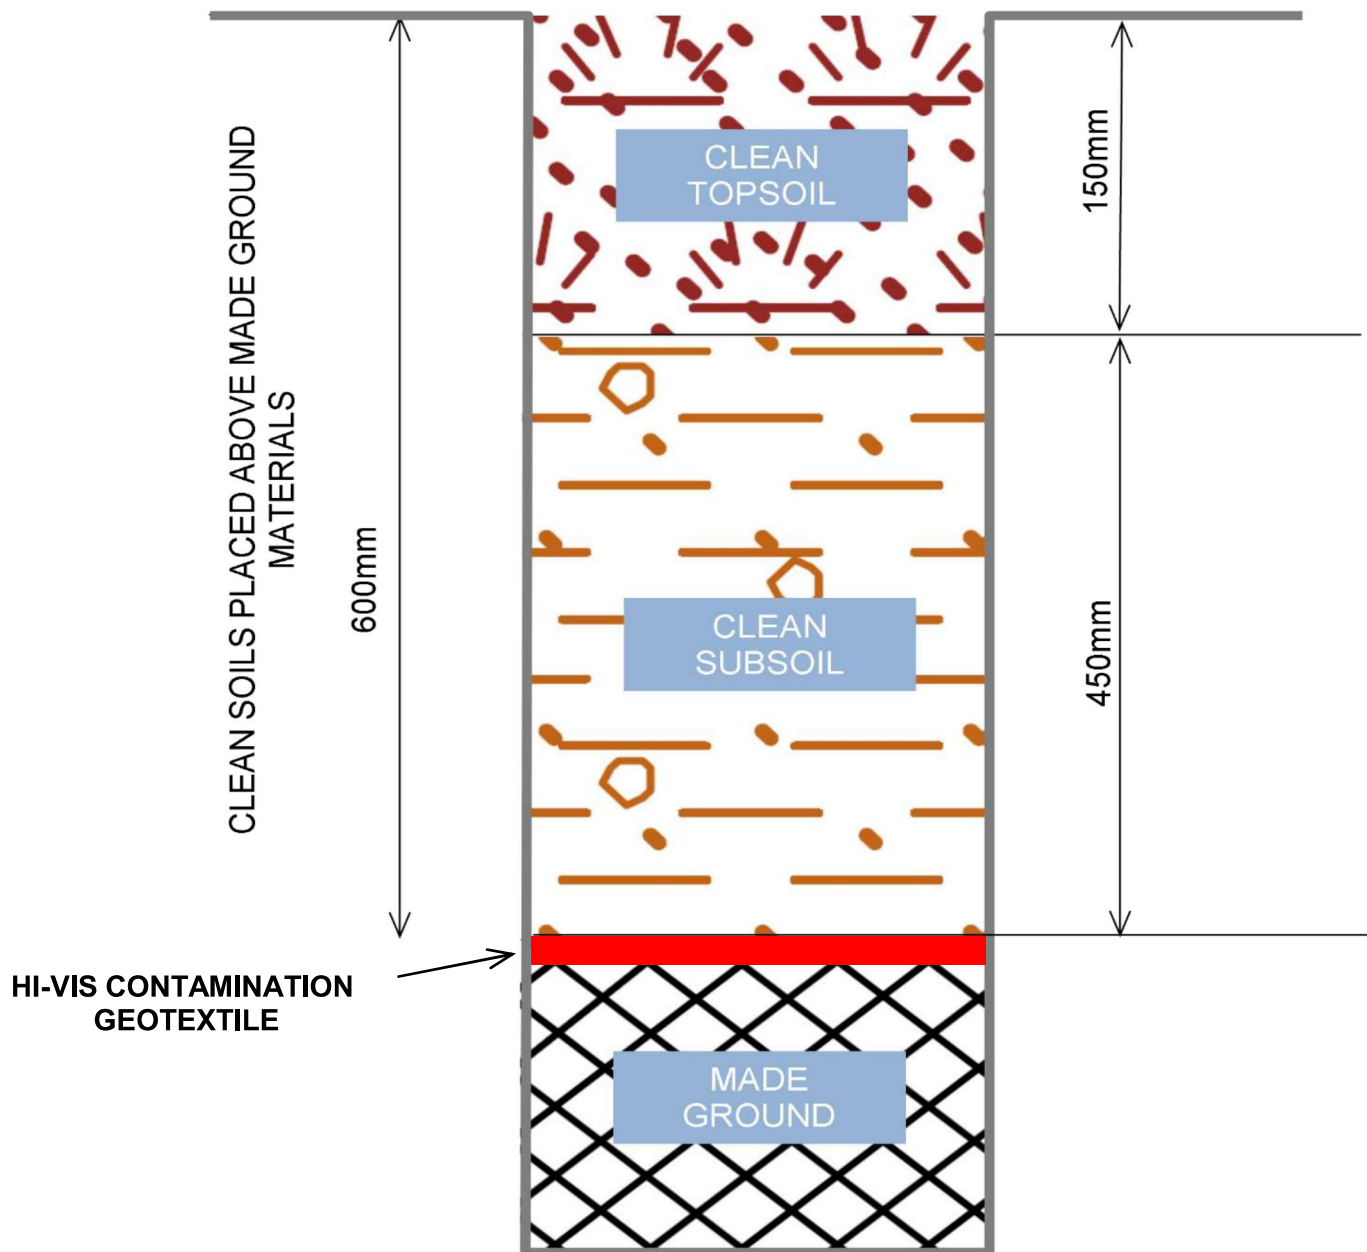
## SECTION THROUGH PLACED CLEAN SOILS

THE ABOVE THICKNESSES ARE DEPENDENT ON FINISHED EXTERNAL GROUND LEVELS. MADE GROUND OF 600MM THICKNESS OR LESS WHERE REMOVED SHALL BE REPLACED WITH CLEAN SUBSOIL AND CLEAN TOPSOIL. PRIOR TO THE PLACEMENT OF CLEAN MATERIALS, A HI-VIS CONTAMINATION GEOTEXTILE SHALL BE PLACED ABOVE RESIDUAL MADE GROUND REMAINING AT DEPTH.

CLEAN SUBSOIL MAY CONSTITUTE SITE-WON MATERIAL OF NATURAL GLACIAL TILL MATERIAL. CLEAN TOPSOIL WILL REQUIRE IMPORTING TO SITE.

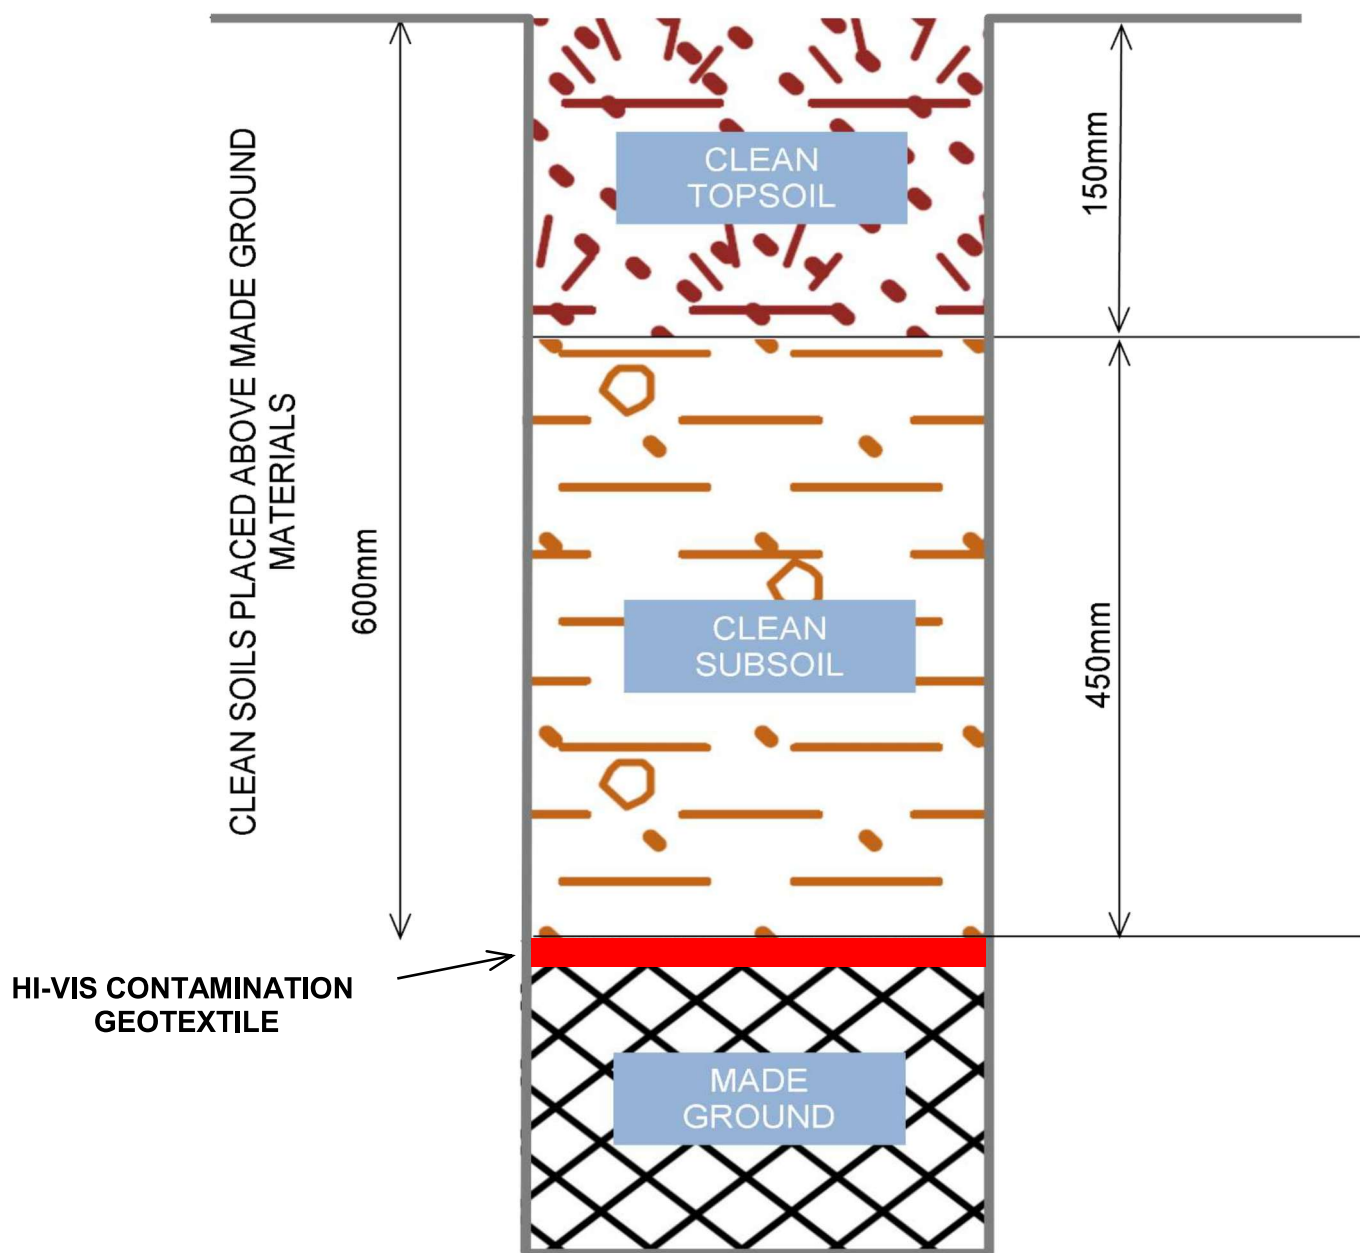
## SECTION THROUGH PLACED CLEAN SOILS

THE ABOVE THICKNESSES ARE DEPENDENT ON FINISHED EXTERNAL GROUND LEVELS. MADE GROUND OF 600MM THICKNESS OR LESS WHERE REMOVED SHALL BE REPLACED WITH CLEAN SUBSOIL AND CLEAN TOPSOIL. PRIOR TO THE PLACEMENT OF CLEAN MATERIALS, A HI-VIS CONTAMINATION GEOTEXTILE SHALL BE PLACED ABOVE RESIDUAL MADE GROUND REMAINING AT DEPTH.

CLEAN SUBSOIL MAY CONSTITUTE SITE-WON MATERIAL OF NATURAL GLACIAL TILL MATERIAL. CLEAN TOPSOIL WILL REQUIRE IMPORTING TO SITE.
