# ARBORICULTURAL IMPLICATIONS ASSESSMENT

PROPOSED DEVELOPMENT

ST ANDREW THE APOSTLE CPS  
HALEWOOD

Ref: TRE/SATACPSH/Rev A

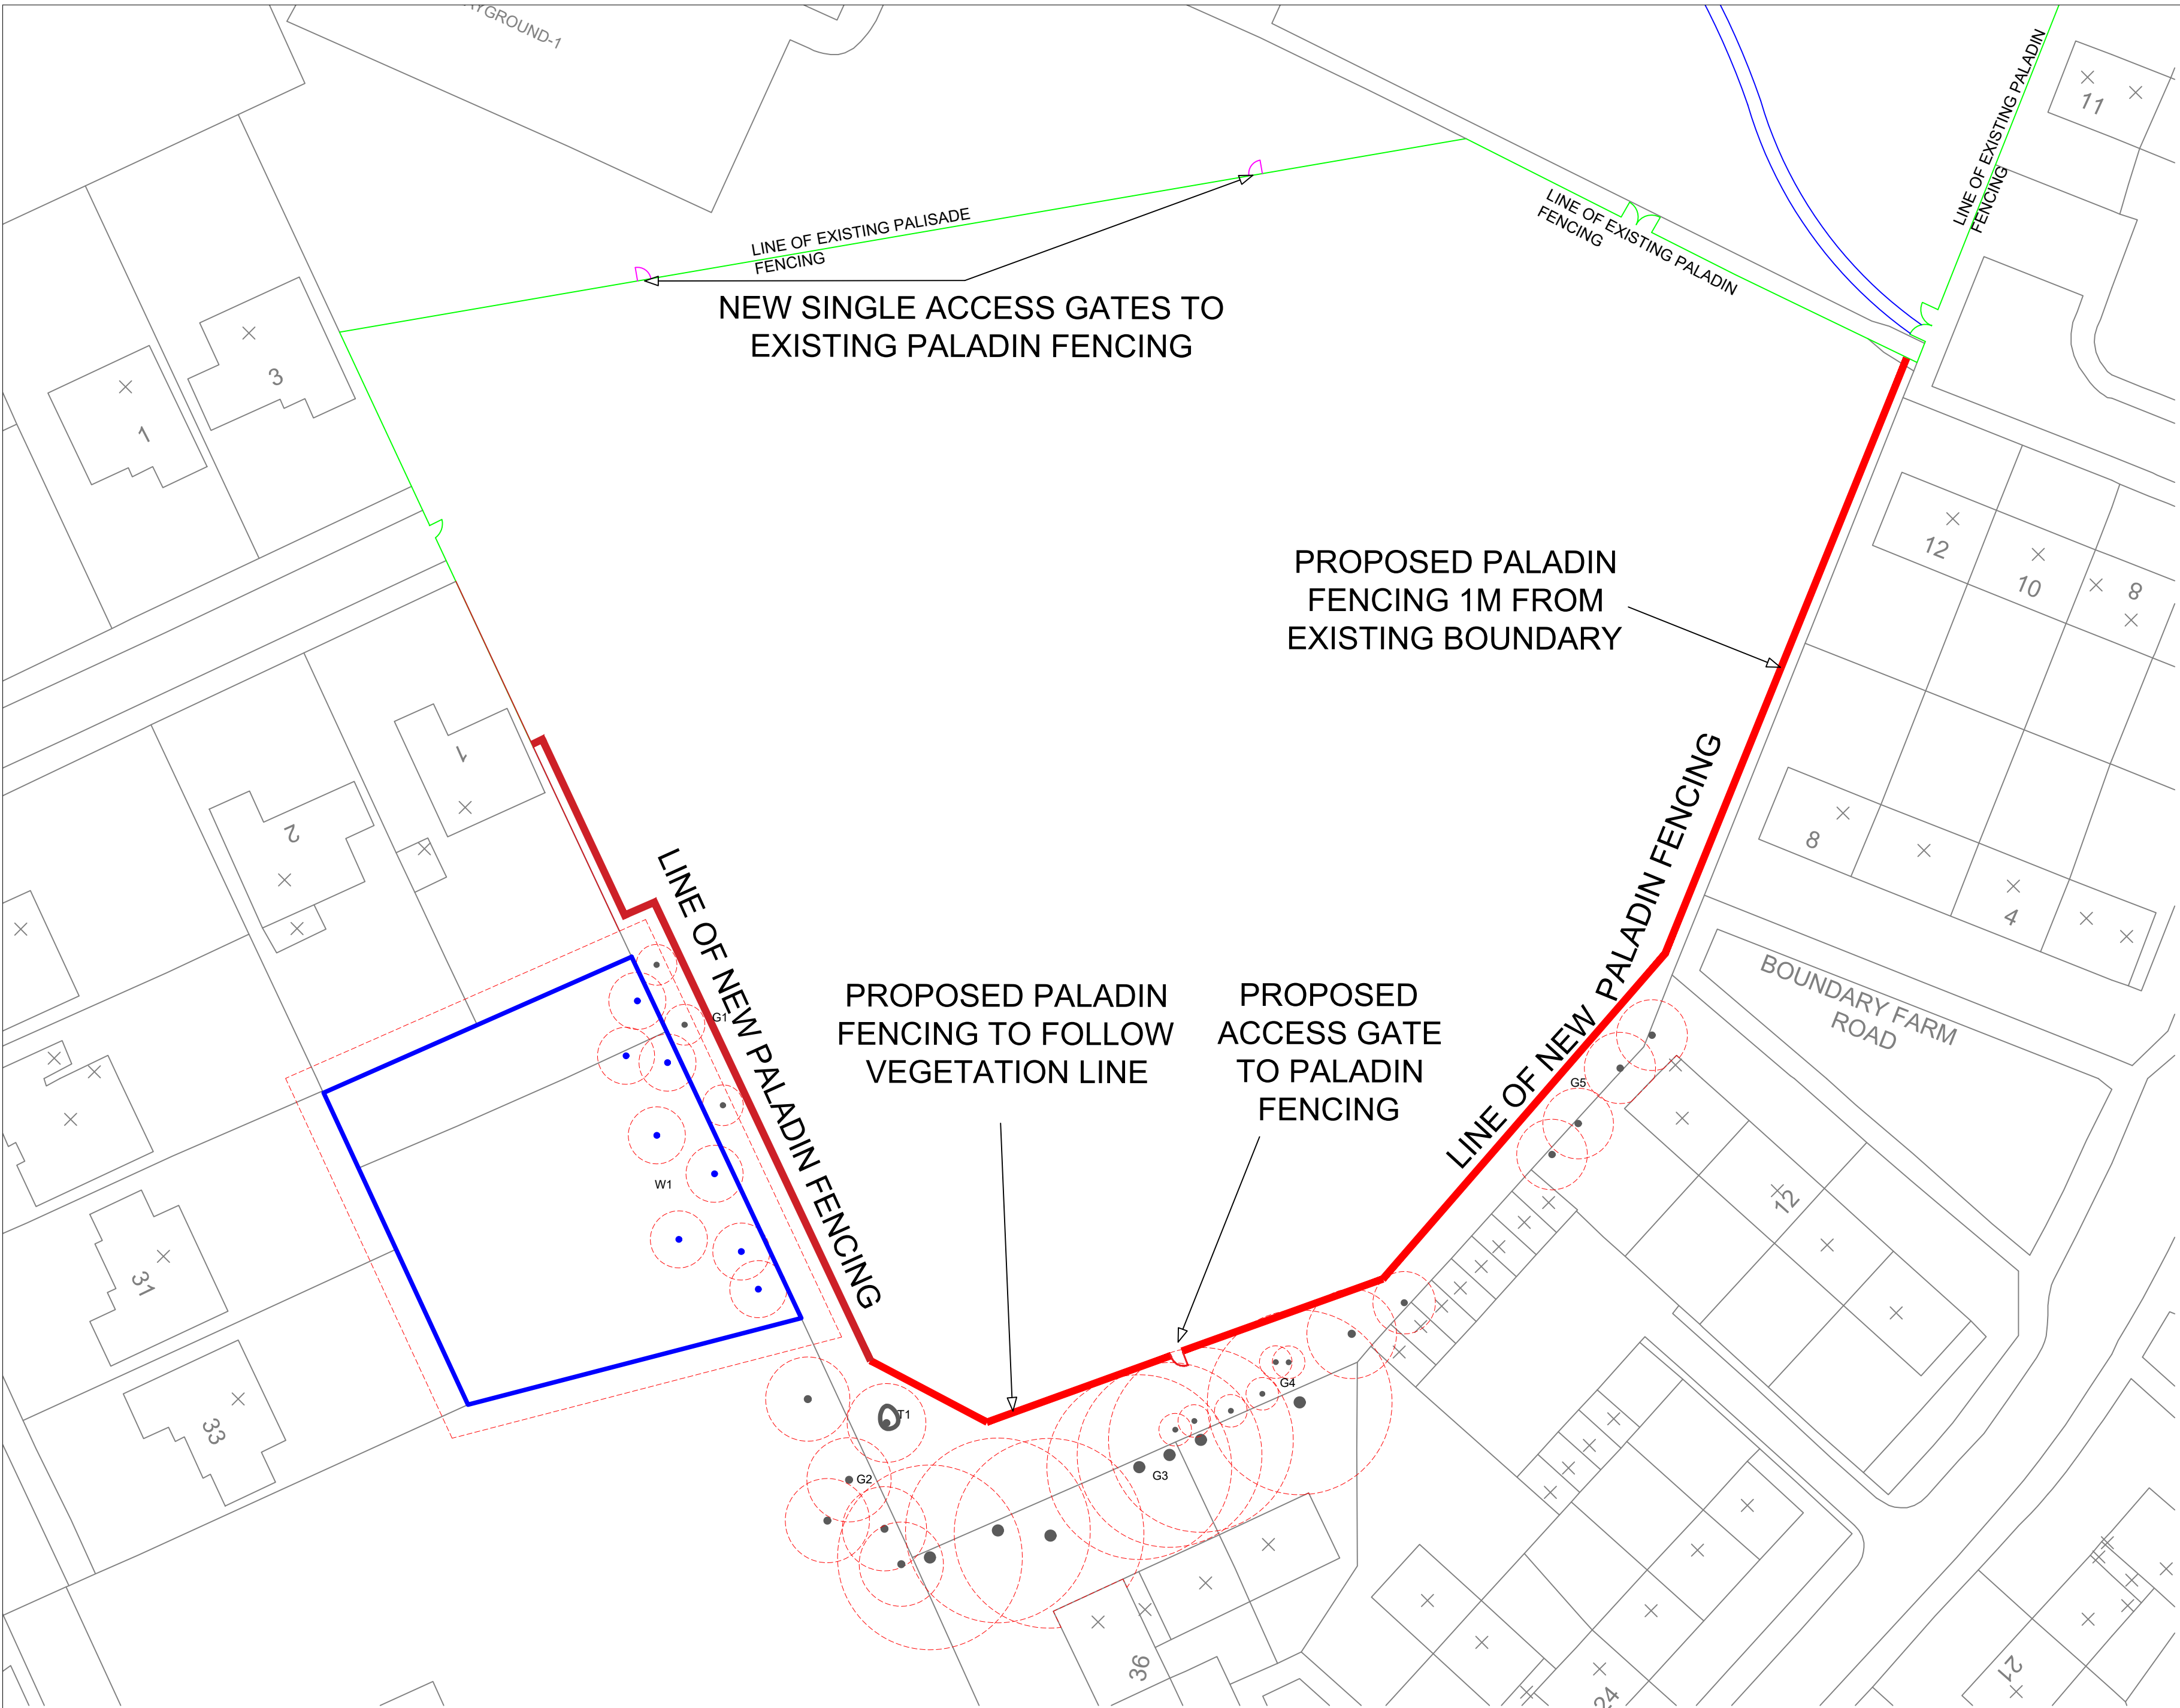
Drawing Title:  
AIS Plan

Drawing No:  
SACPSH/AIS/01 Rev A

- 3.1 Due to the proposed development and its associated infrastructure there are a number of locations where the proposals are in close proximity to the trees surveyed. The Site Layout Plan within appendix three identifies the trees in relation to the proposed development.
- 3.2 In order to fully assess the impact of the proposals an Impact Table has been created detailing each tree, which shows the proximity of the associated works to the tree.
- 3.3 This can then be assessed in accordance with BS 5837:2012 to determine whether the development will have a detrimental impact on the health of each tree. Once this has been determined remedial measures can be detailed to reduce the impact the proposals will have on the treescape.
