# **Arboricultural Constraints Appraisal**

in Respect of Proposal to Construct Three Building Extensions at

**ASET Hospital, 1 Sandstone Drive,  
Whiston, Merseyside, L35 7LS**

January 2021

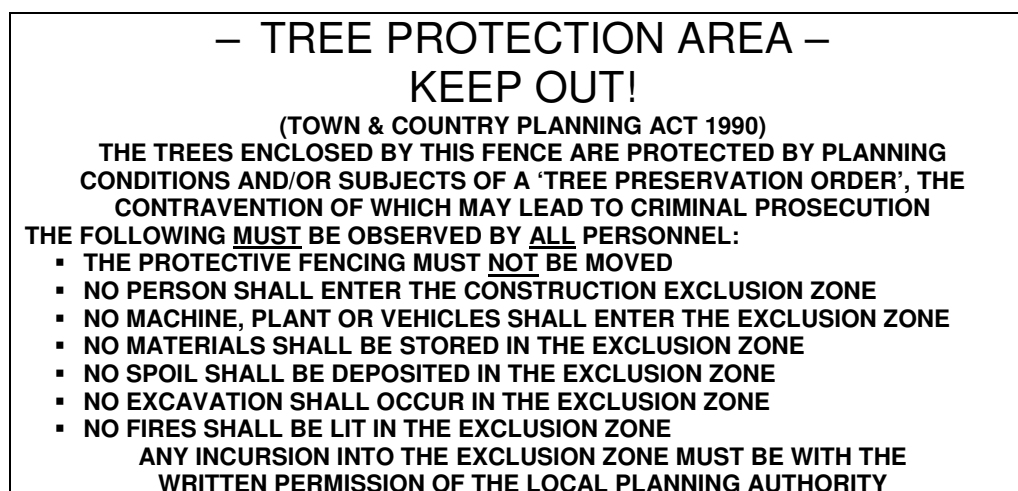
Figure 1: CEZ Warning Sign

6. No fixing shall be made to any tree and all possible precautions shall be taken to prevent damage to tree roots when locating posts.
7. A 600mm x 300mm warning sign reading "TREE PROTECTION AREA KEEP OUT" (see Figure 1, below) shall be fixed to every 10.0 metre length of protective fencing.

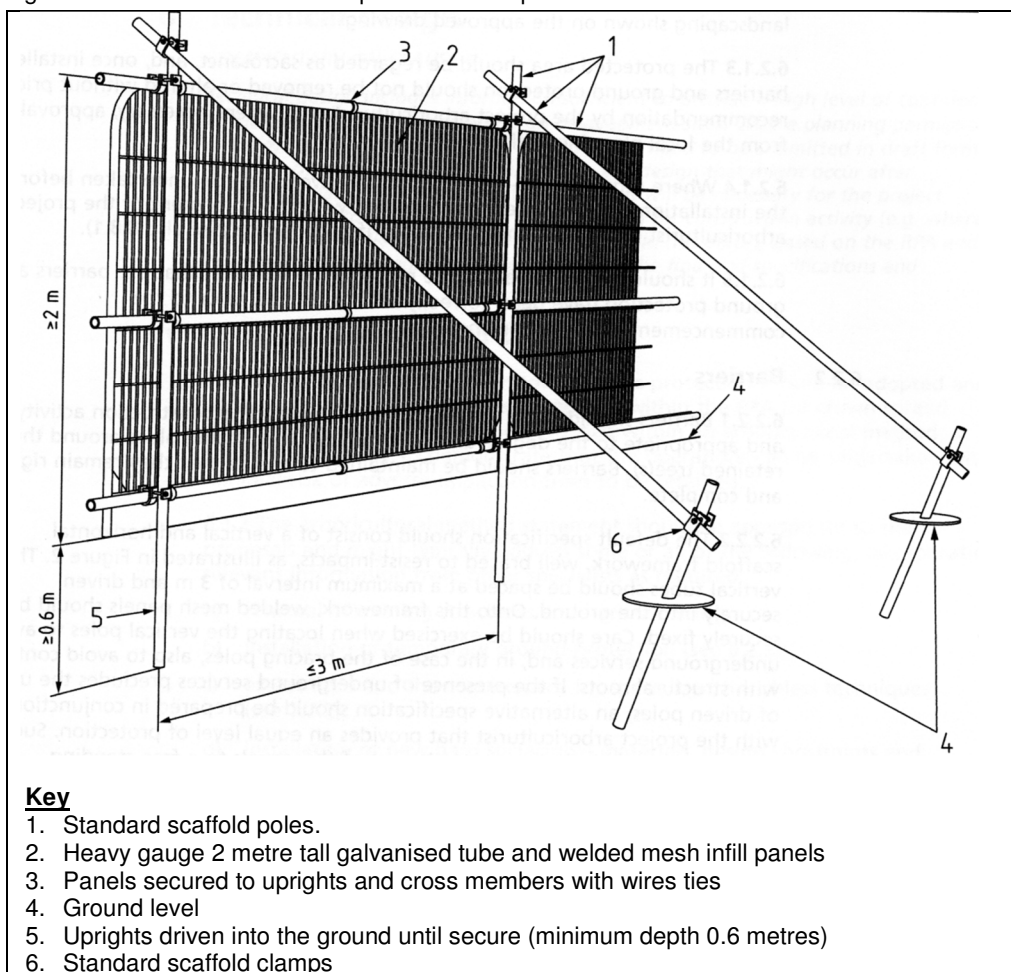
Figure 2: BS5837:2012 Default specification for protective barrier

1. Temporary protective fencing panels shall be weldmesh "Heras" panels of at least 2.0 metres in height.
2. The panels shall butt together and be securely fixed to a scaffold framework, as per 3 to 5 below.

3. The scaffold framework shall comprise of upright poles of at least 3.0 metres in length driven no less than 0.6 metres into the ground at maximum 3.0 metre centres with horizontal and diagonal poles fixed to the uprights, as per 4 to 5 below.

4. The two horizontal rail poles shall be attached to the uprights at heights of 0.6 and 1.8 metres with 3 no. clamps to each joint.
5. The diagonal scaffold pole struts be clamped to the top rail of the scaffold framework at a 45° angle and extend back into the CEZ and clamped to a 0.7 metre length of scaffold tube that shall be driven no less than 0.5m into the ground.

1. be retained in place throughout the development process, as specified in the 'Temporary Protective Fencing Construction' section below and detailed in BS5837:2012 Figure 2 (overleaf);

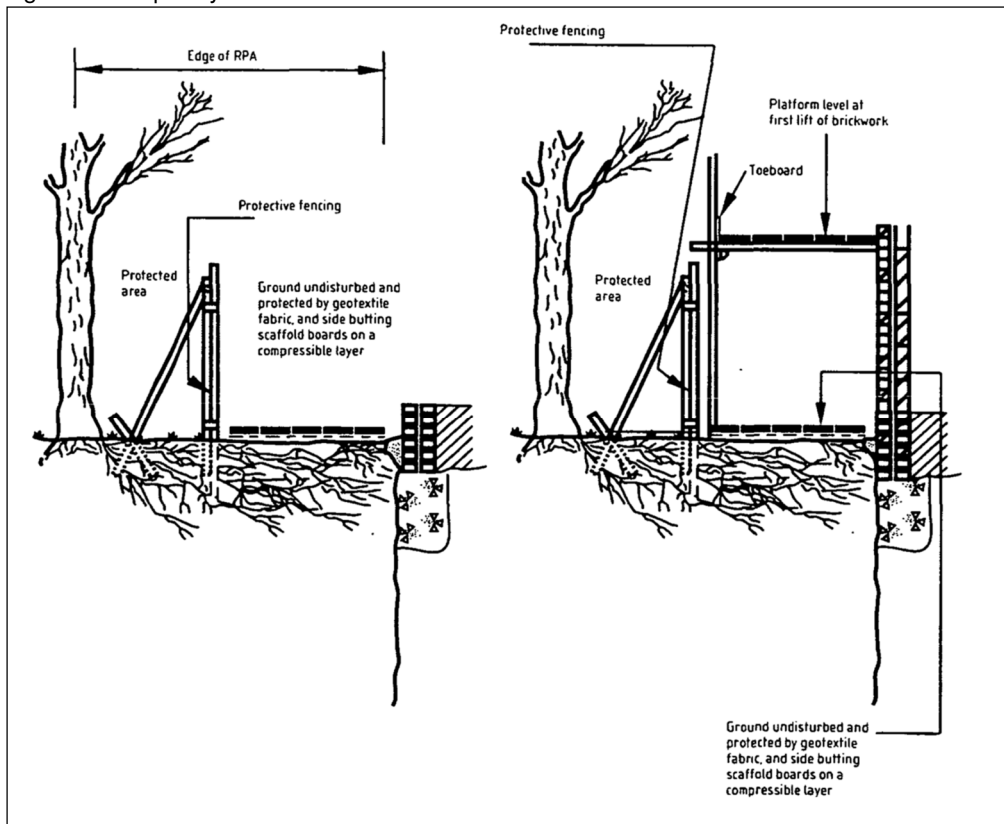
Figure 3: Temporary Ground Protection – Recommended Construction

1. Any necessary Temporary Ground Protection areas shall conform to Figure 3, below, unless otherwise agreed with the LPA.
2. The Ground Protection Area shall be left undisturbed and covered by a semi-permeable geotextile membrane which shall, in turn, be covered by a compressible layer consisting of a material such as woodchip.
3. Side-butting scaffold boards shall then be fitted to cover the Ground Protection Area.
4. On completion of installation, and prior to any demolition or construction works, site preparation, excavation or delivery of plant and materials, the Consulting Arboriculturist or the LPA Tree Officer, as agreed, shall inspect the Temporary Ground Protection.
5. The Temporary Ground Protection shall remain in place until completion of the project and only removed following receipt of written permission from the LPA.

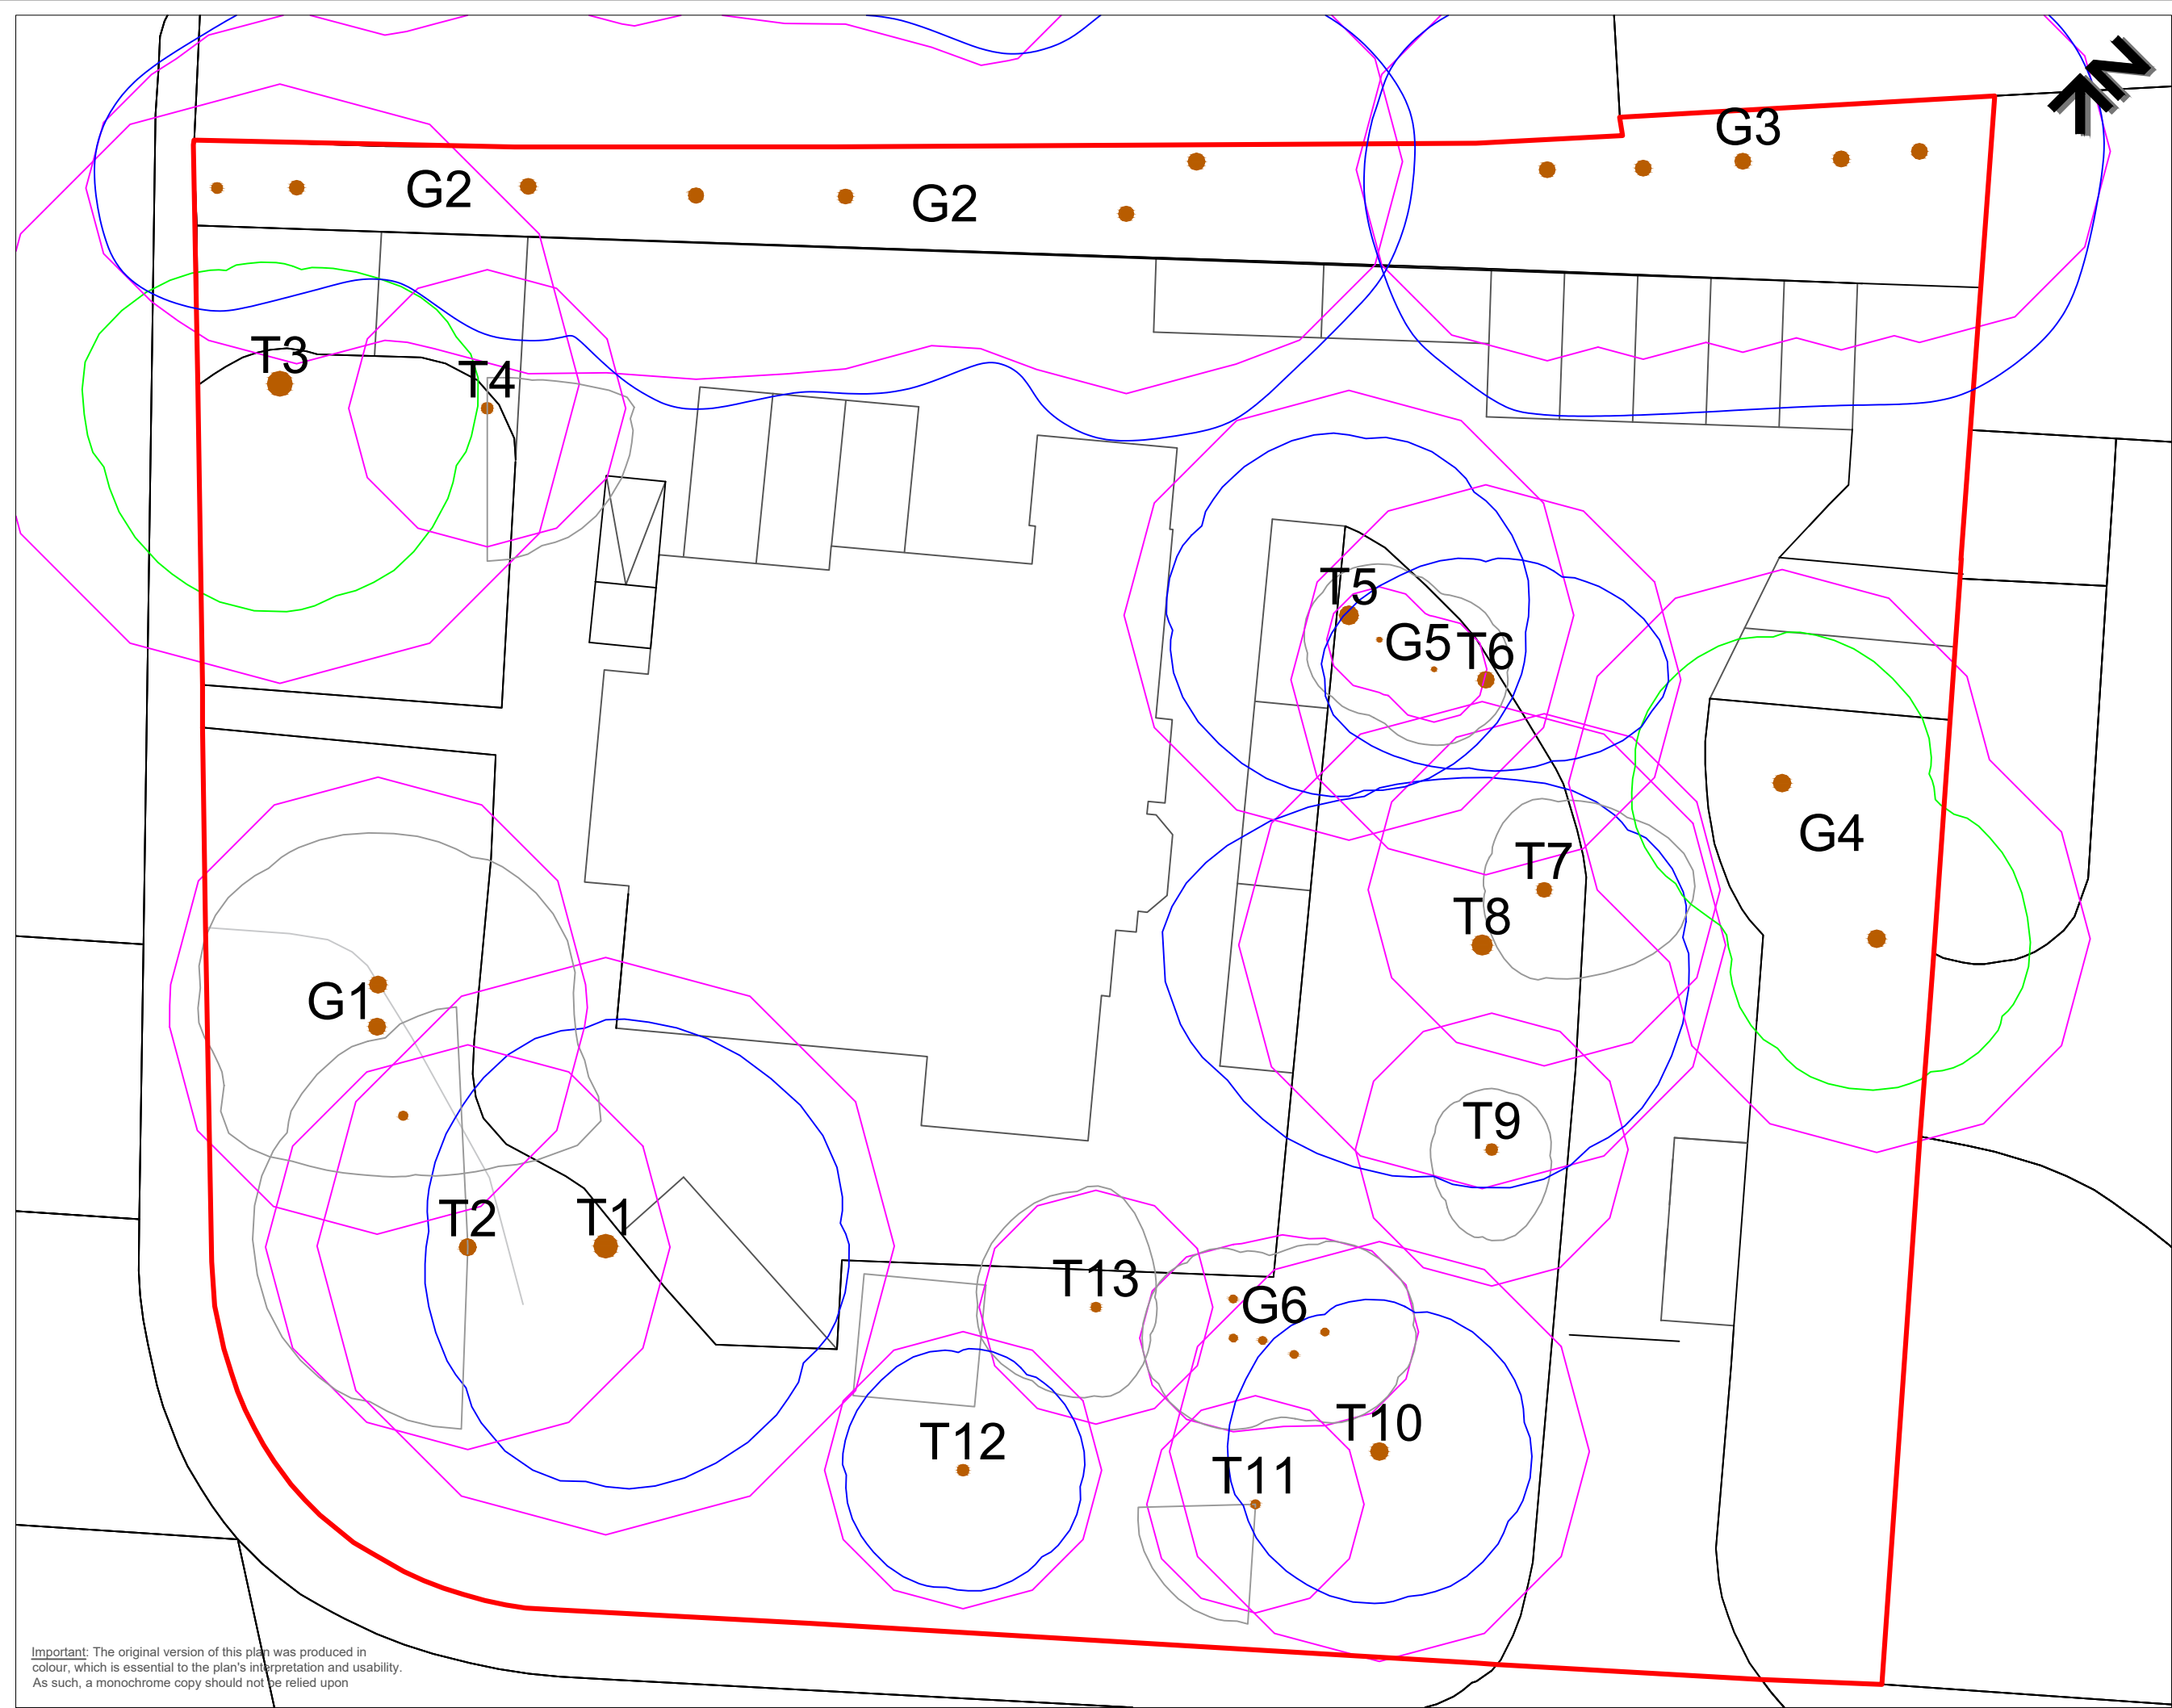
**Title:**  
**TREE CONSTRAINTS PLAN**  
in Respect of Proposal to Construct Three Building Extensions

Note: The locations of the trees and the locations and full extents of the groups were not included on the site plan provided, and were subsequently plotted by the arboriculturist at the time of the survey using GPS and, where possible, measurement from existing site features. As such, the locations of the trees and the extents of the groups cannot therefore be considered to be entirely accurate

RPAs  
Area(s) of Ground Around Trees that Should be Protected Throughout Development Works with Protective Fencing to form a Construction Exclusion Zone - see Temporary Protective Fencing Specification

2. be sited in the area(s) defined by the Root Protection Areas or, if applicable, the Construction Exclusion Zones, as detailed on the associated Tree Plan;
