**CCG-C-21-12517-3**

**COAL MINE RISK ASSESSMENT  
FOR LAND AT THE FORMER  
PRESCOT POLICE STATION  
DERBY STREET  
PRESCOT  
MERSEYSIDE  
L34**

**SEPTEMBER 2021**

**CC GEOTECHNICAL LIMITED**

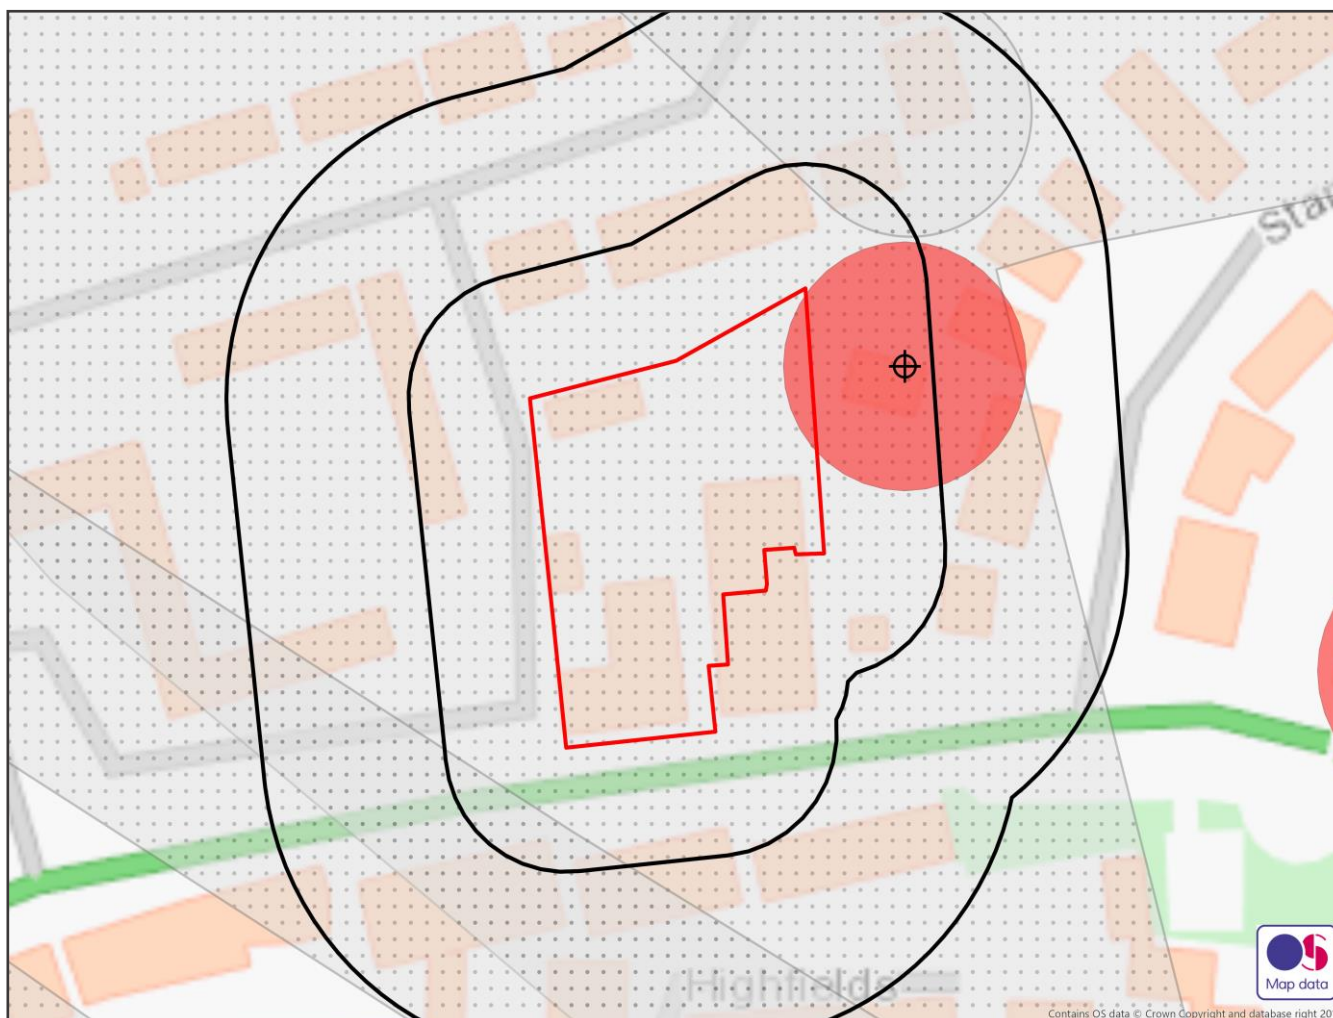
## Mining Hazard Map

The following mine entry has been identified within 20 metres of the Site and is shown on the Mining Hazard Map:
