Arboricultural  
Impact Assessment  
with  
Arboricultural Method Statement

**St. Helena's Residential Care Home  
Roby Road  
Liverpool  
L36 4HE**

Project No. AIA.13809.01

12<sup>th</sup> April 2024

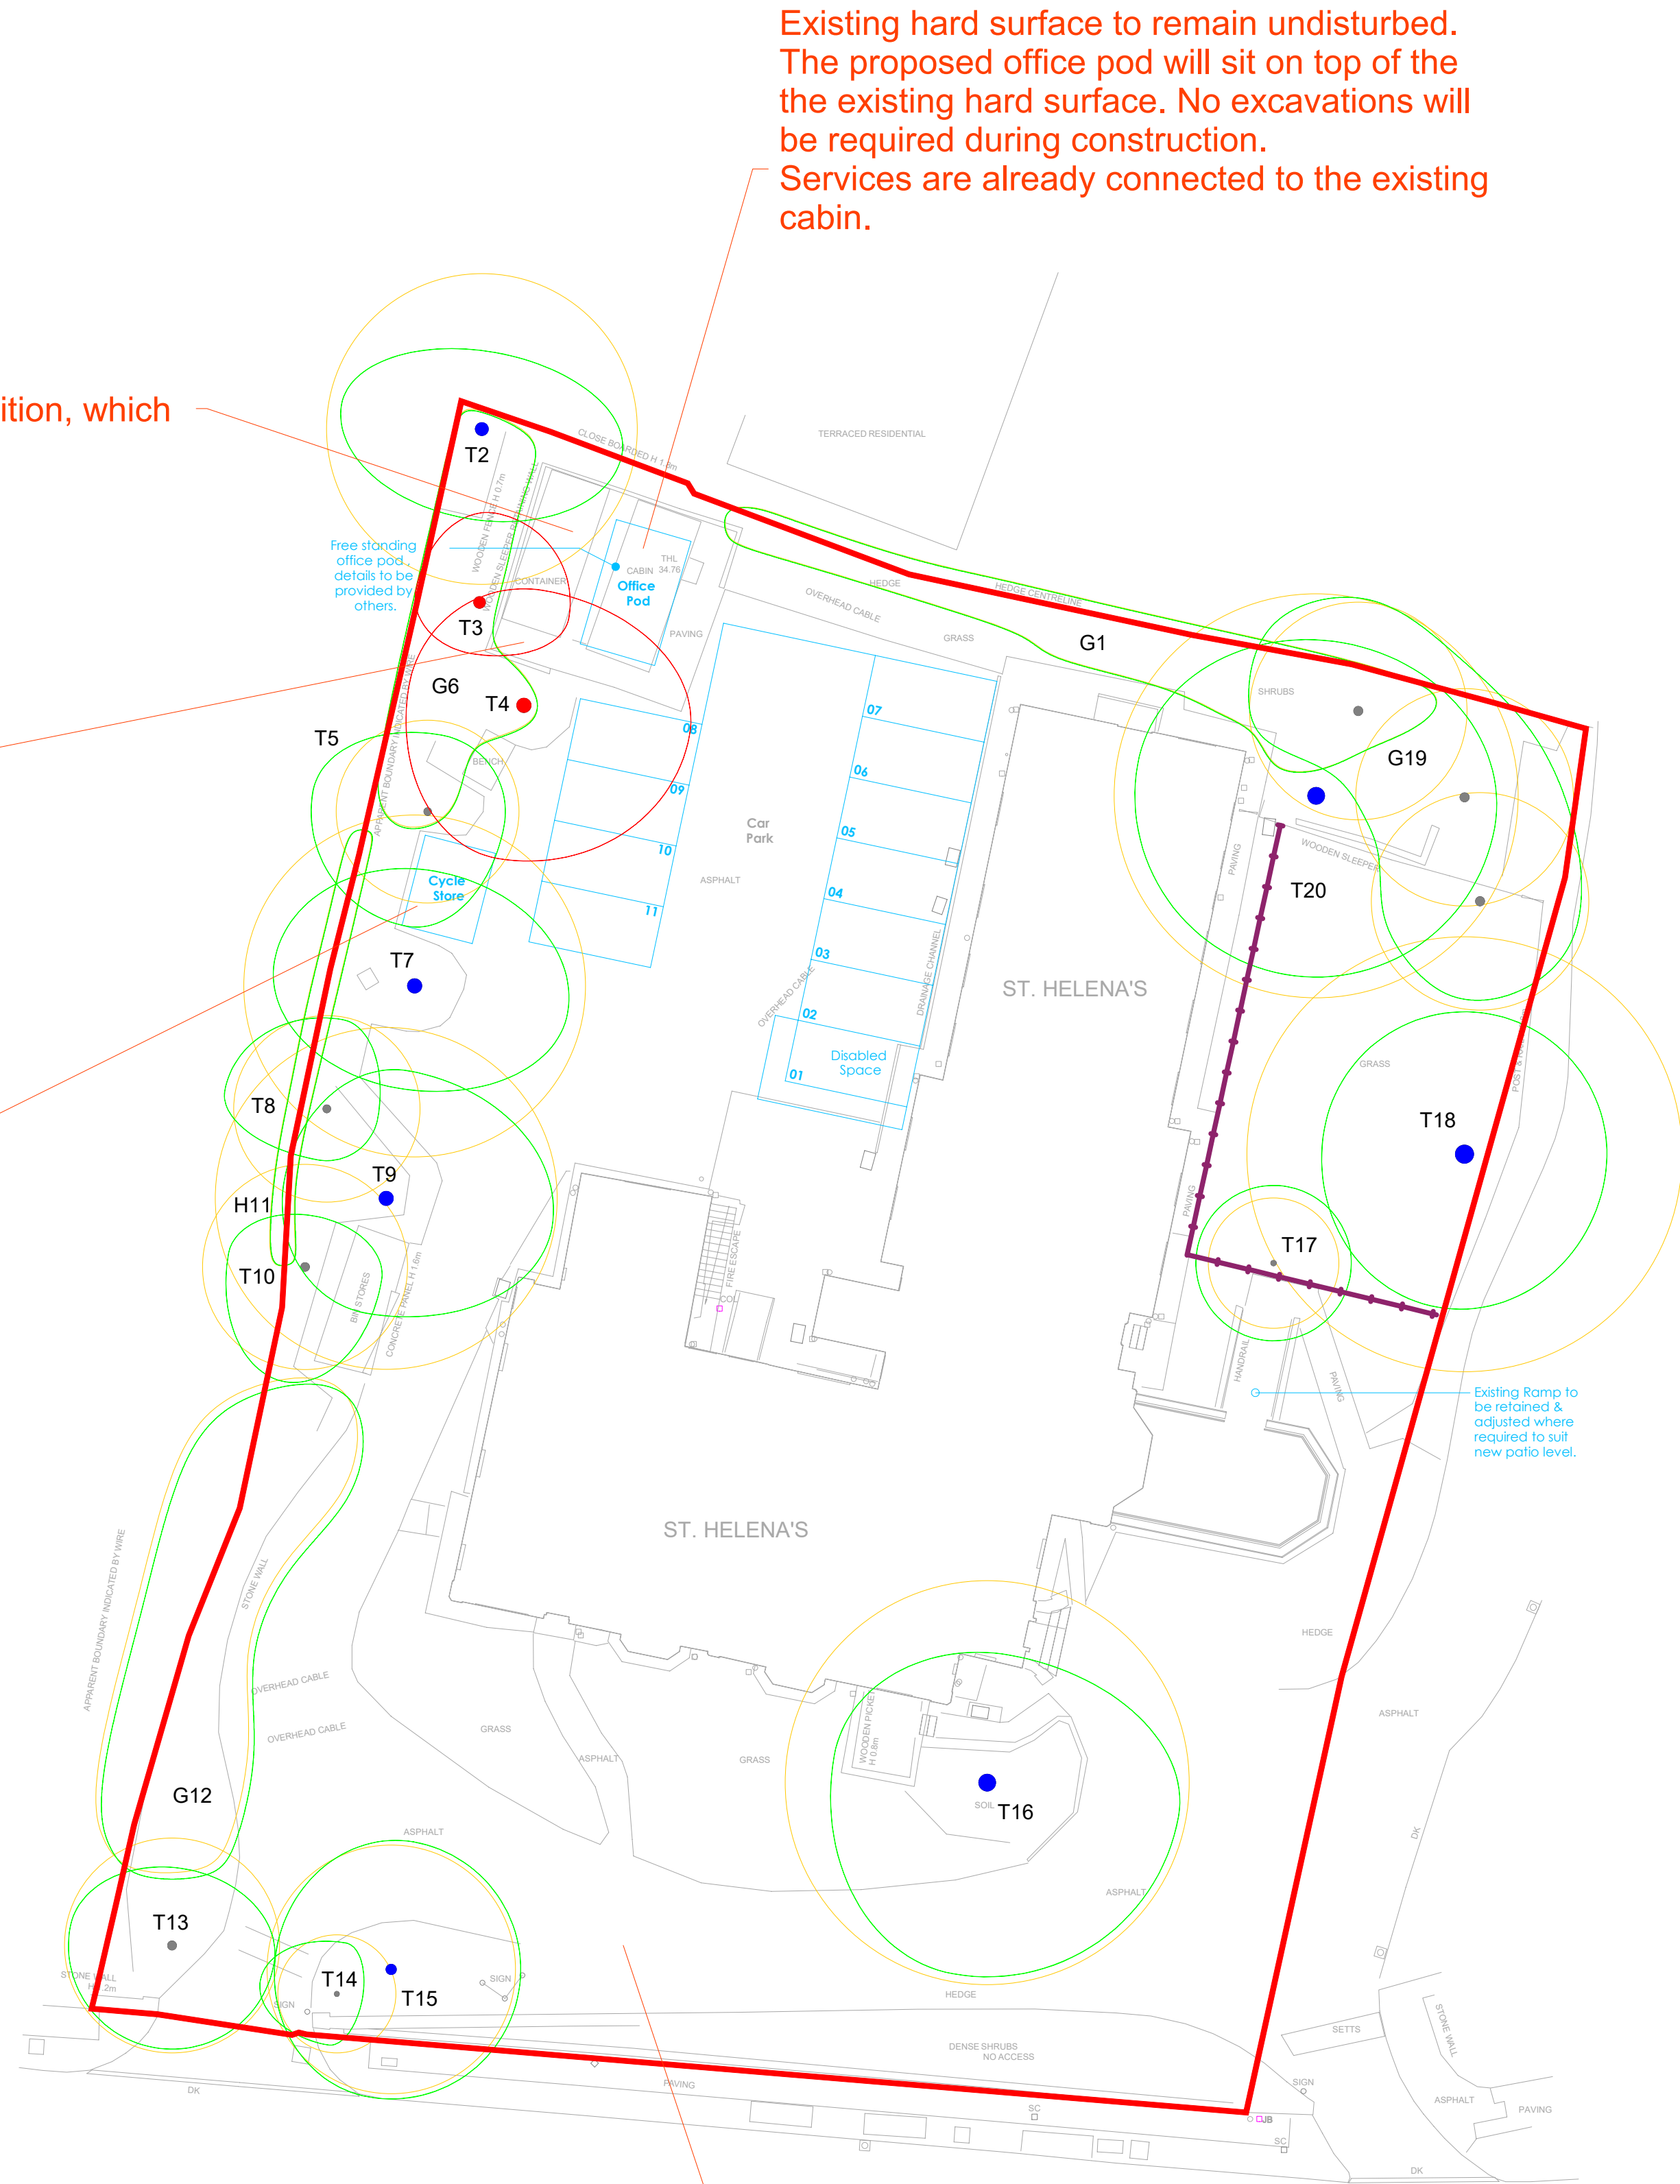
## Drawing 2. Tree Protection Plan

- 3.1.1. Renovations to the existing building are proposed. In addition, a replacement office pod for the existing cabin and a new cycle store are proposed. The proposed layout drawing can be seen within the *Tree Protection Plan* to the rear of this report. This drawing has been used to assess the potential direct and indirect arboricultural impacts.

- 3.2.1. No trees shall require removal to enable the construction of the proposed development.
- 3.2.2. Trees **T3** and **T4** could be retained during construction as the proposed works would not cause them any harm. However, both trees are recommended for removal due to their condition.

- 3.4.1. Sections of RPA from several retained trees extend into the proposed working area. However, it should be noted that these RPAs are currently located beneath an existing asphalt hard surface that would act to protect the RPAs from construction activity.

- 3.5.1. The existing cabin sits on top of a flagged area, which in turn sits on top of an asphalt hard surface. The proposed office will replace the existing cabin and will be a free-standing structure, positioned on top of the existing hard surface. The proposed office pod will not require foundation excavations to construct, and electrical services are already installed. Similarly, the proposed cycle store is comprised of a metal frame that will be fixed to the existing asphalt hard surface and will not require excavations to install.

- 4.2.3. Please see *Appendix 4* for suggested barrier construction detail. It is recommended that in this instance the protective barrier shown in *Figure 2* would be appropriate. The suggested location for protective fencing is shown on the *Tree Protection Plan (Drawing 2)*.

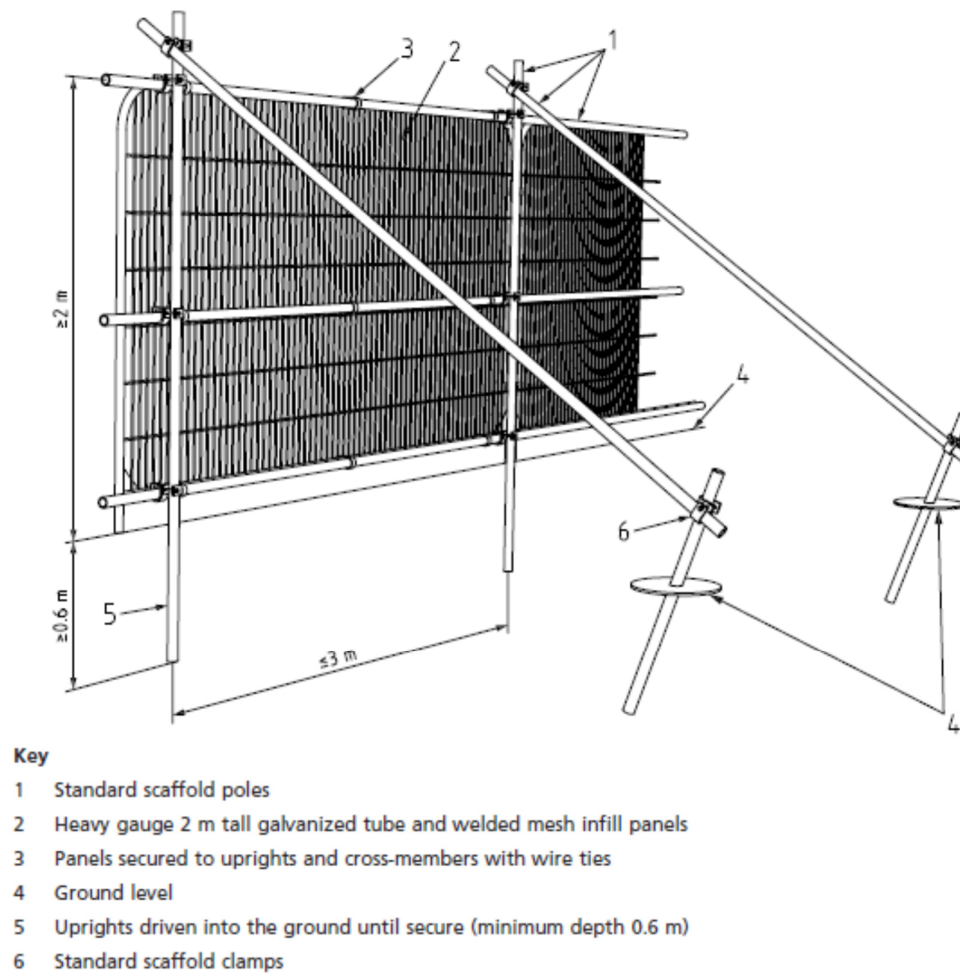
Figure 1. Default protective fencing barrier as detailed in BS 5837: 2012.

- A4.1 The default specification for protective barriers should consist of a vertical and horizontal scaffold framework, well-braced to resist impacts, as illustrated below. The vertical tubes should be spaced at a *maximum* interval of 3 m and driven securely into the ground. Onto this framework, welded mesh panels should be securely fixed. Care should be exercised when locating the vertical poles to avoid underground services and, in the case of the bracing poles, also to avoid contact with structural roots.
