CLIENT: JLR

PROJECT: EASTLANDS CAR PARK

TITLE: SITE STRIP EXCAVATIONS

DRAWING No: 5031818-RDG-XX-XX-D-C-110102

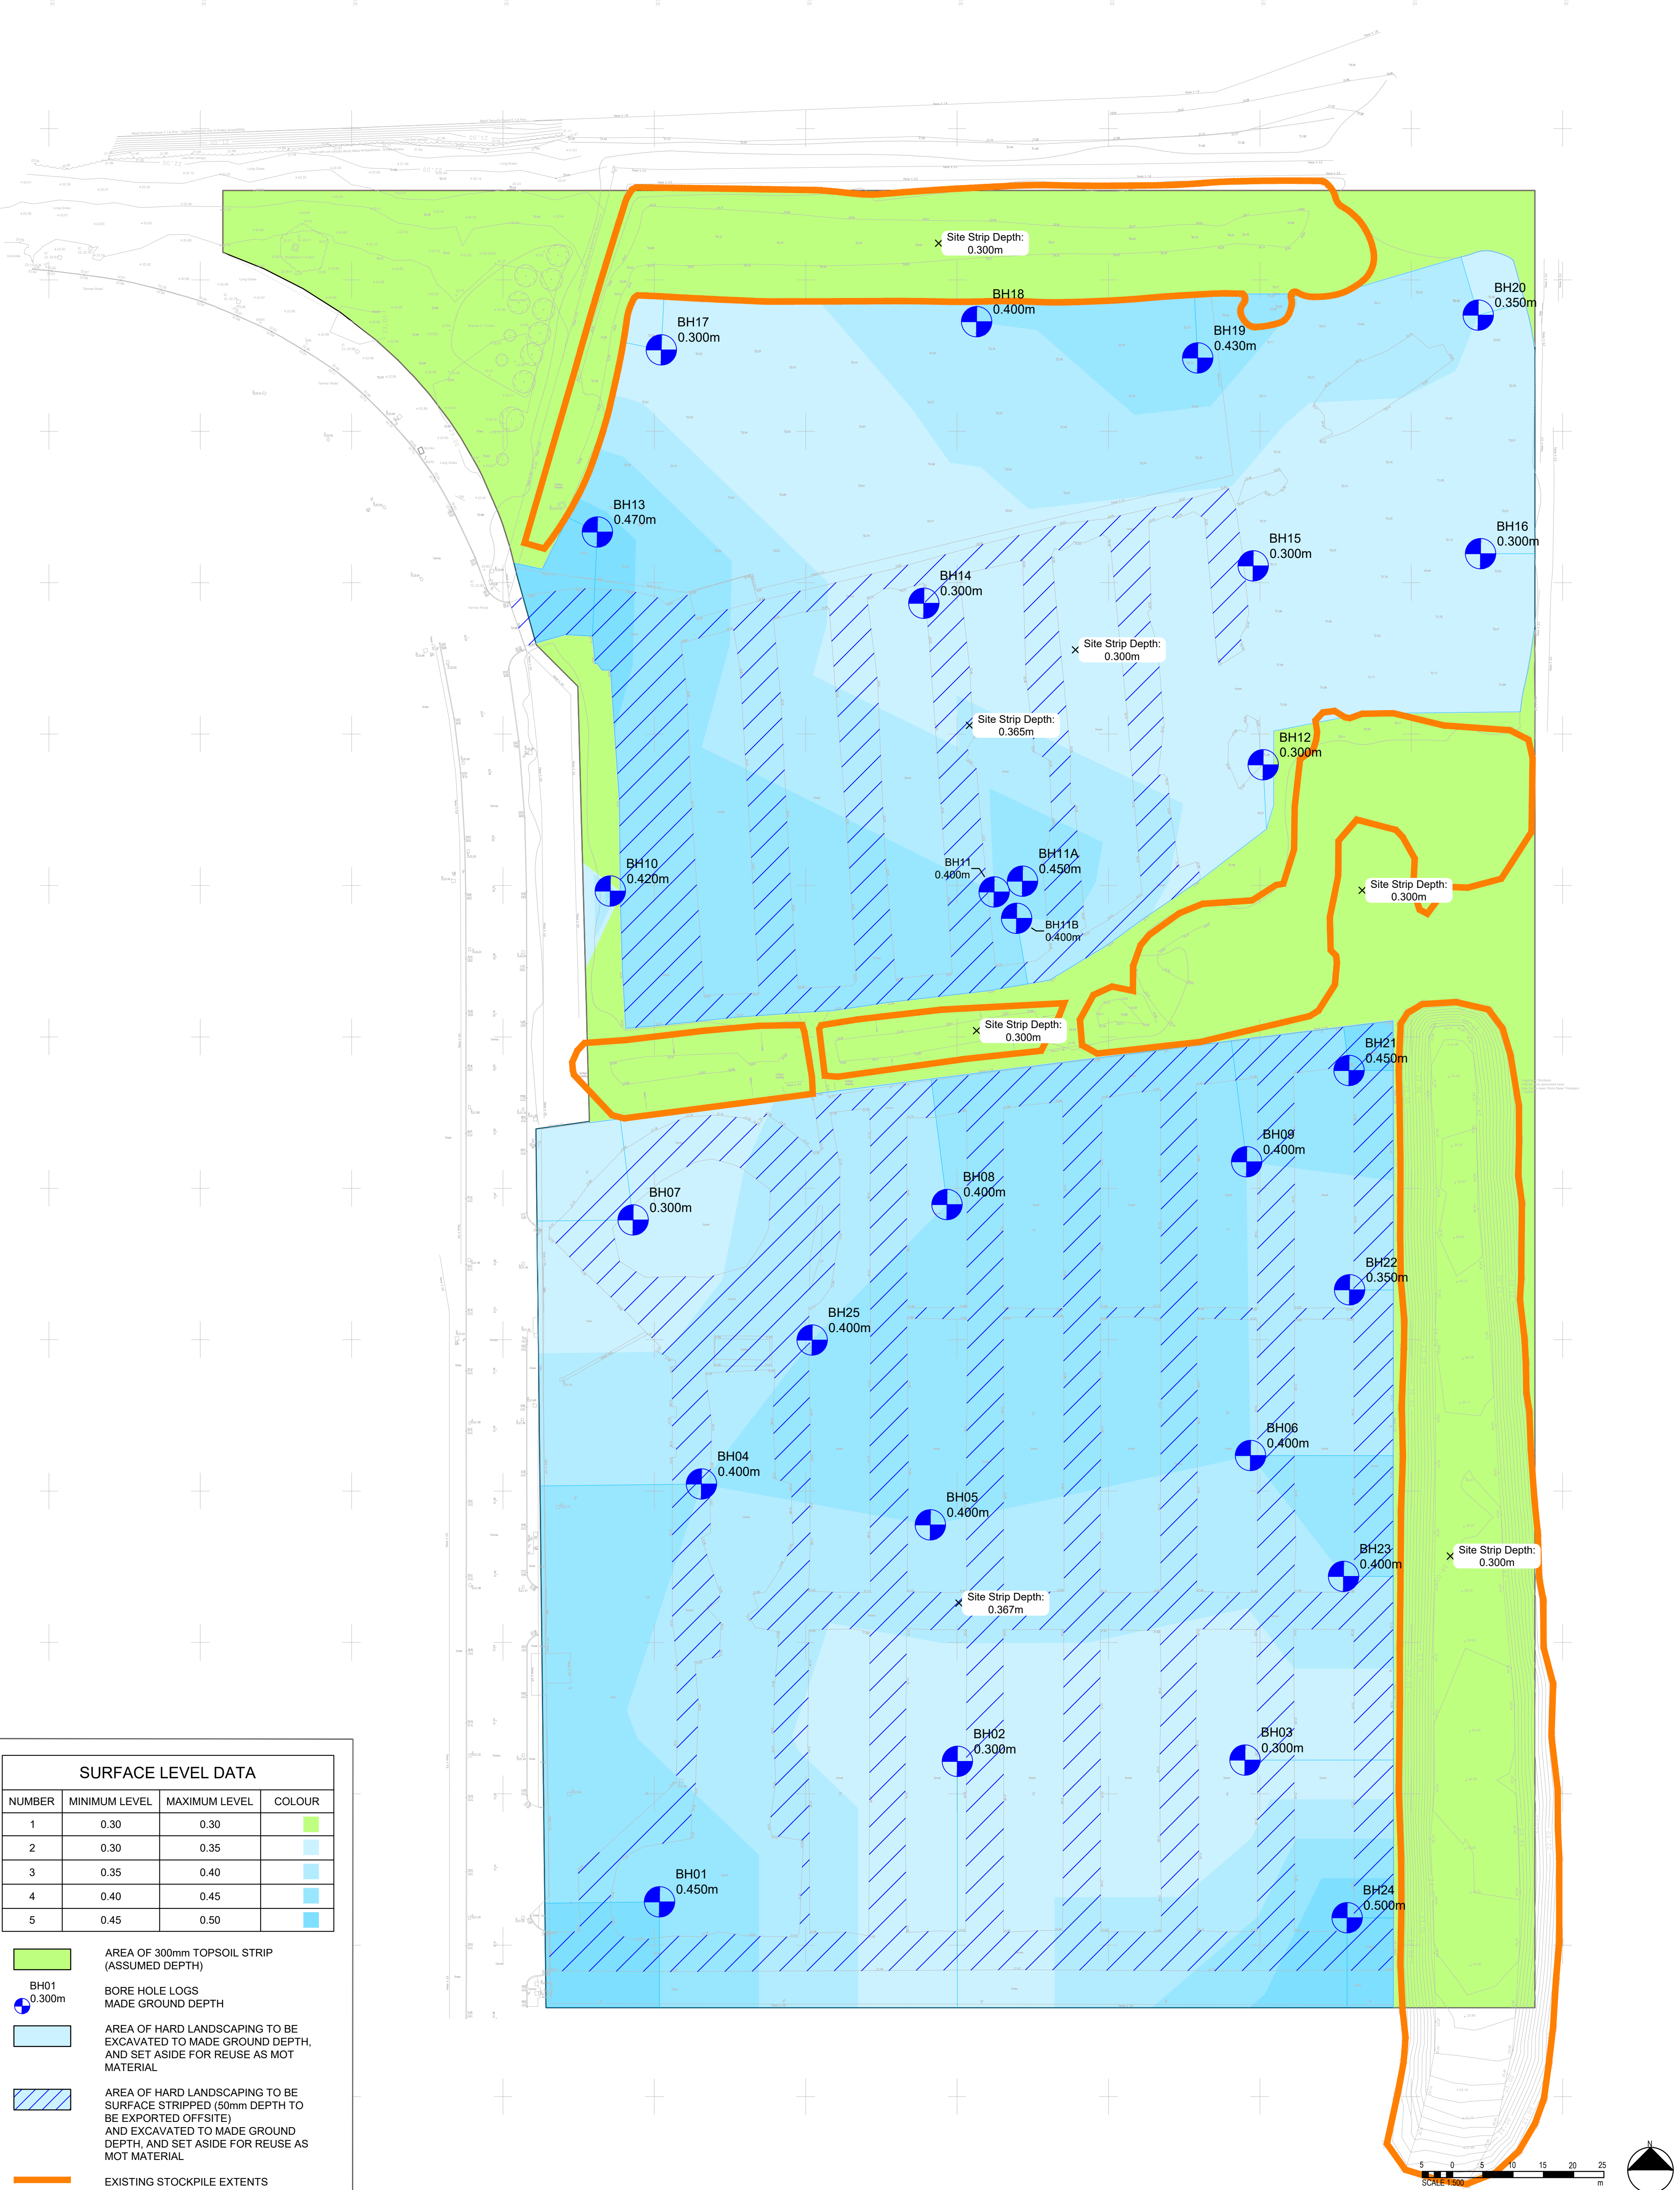
- AREA OF 300mm TOPSOIL STRIP (ASSUMED DEPTH)
- BH01 0.300m BORE HOLE LOGS MADE GROUND DEPTH
- AREA OF HARD LANDSCAPING TO BE EXCAVATED TO MADE GROUND DEPTH, AND SET ASIDE FOR REUSE AS MOT MATERIAL
- AREA OF HARD LANDSCAPING TO BE SURFACE STRIPPED (50mm DEPTH TO BE EXPORTED OFFSITE) AND EXCAVATED TO MADE GROUND DEPTH, AND SET ASIDE FOR REUSE AS MOT MATERIAL
- EXISTING STOCKPILE EXTENTS
