# Heritage Statement

The Clock Face, Derby Street, Prescott

Daniel Thwaites PLC

DECEMBER 2023

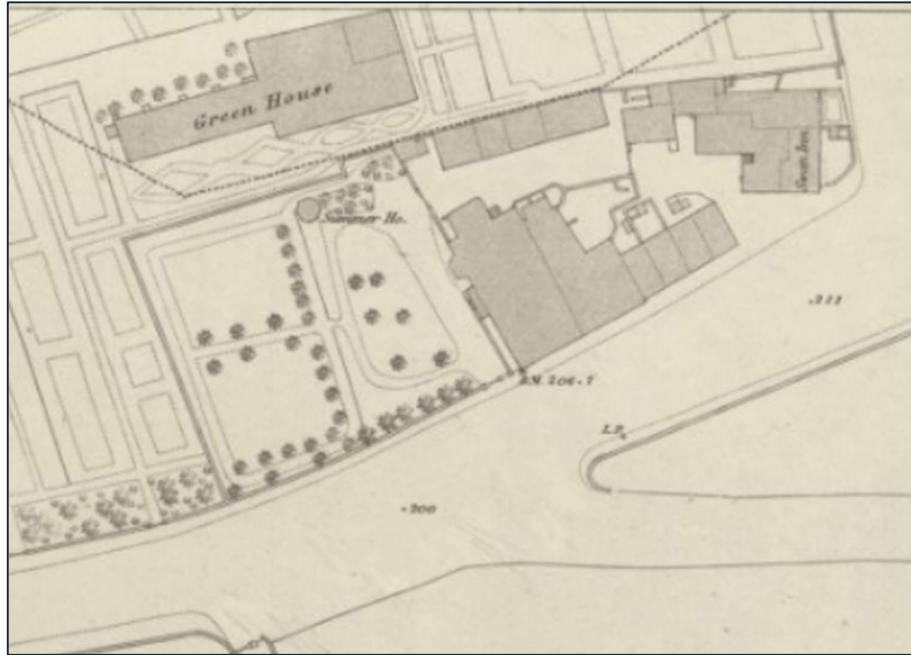
Map 1 – Extract of the Prescott Town Plan (sheet 3) surveyed 1848 (Reproduced with the permission of the National Library of Scotland)

- 3.11 The earliest available mapping which depicts the building is the 1848 Town Plan for Prescott (See Appendix I, Map 1) although Greenwood's map of 1818<sup>1</sup> indicates buildings to be present upon the Site at this date. Both the canted bay and projecting porch are shown to be present on the 1848 plan. The arrangement of the wider site is depicted largely as extant; the rear yard and stable range are present with the gated access clearly shown. The enclosing walls to the carpark are also shown to be present however the carpark is laid out as a garden with formal paths. A circular or octagonal summer house is depicted to the west of the house.

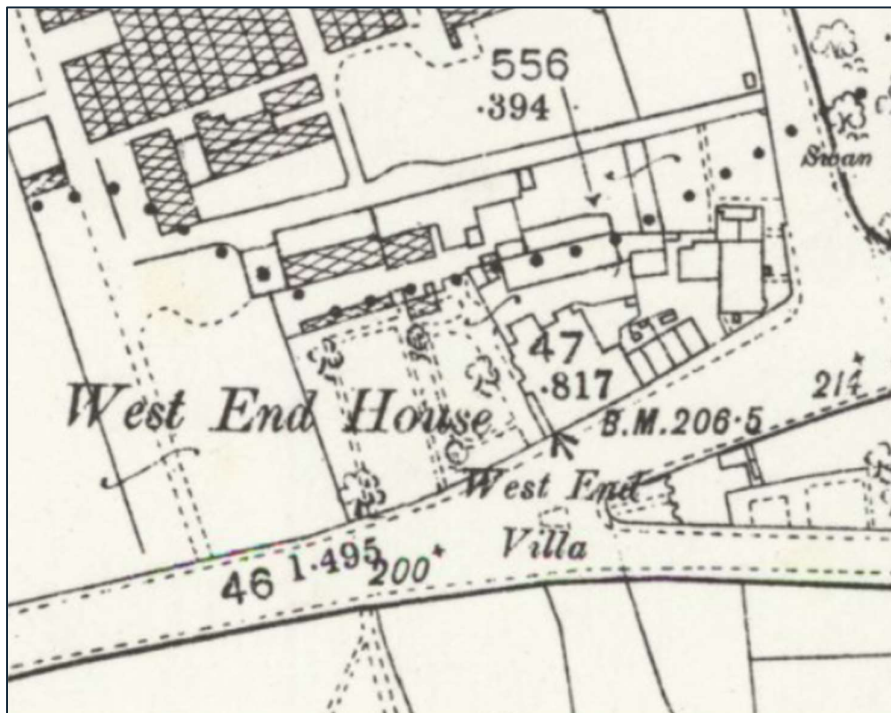
Map2 – Extract of the 1890 – 1891 Ordnance Survey Plan for Lancashire (CV11.7) (Reproduced with the permission of the National Library of Scotland)

- 3.12 Little change is shown to have occurred to the property footprint or the surrounding grounds during the second half of the 19<sup>th</sup> century with Map 2 depicting the property in the early 1890s. This map identifies the property as 'West End House' and suggests that number 52 and 54 possibly formed part of a single, larger property. Later mapping (Maps 2 and 3) depicts the properties as being separate in the early 20<sup>th</sup> century.

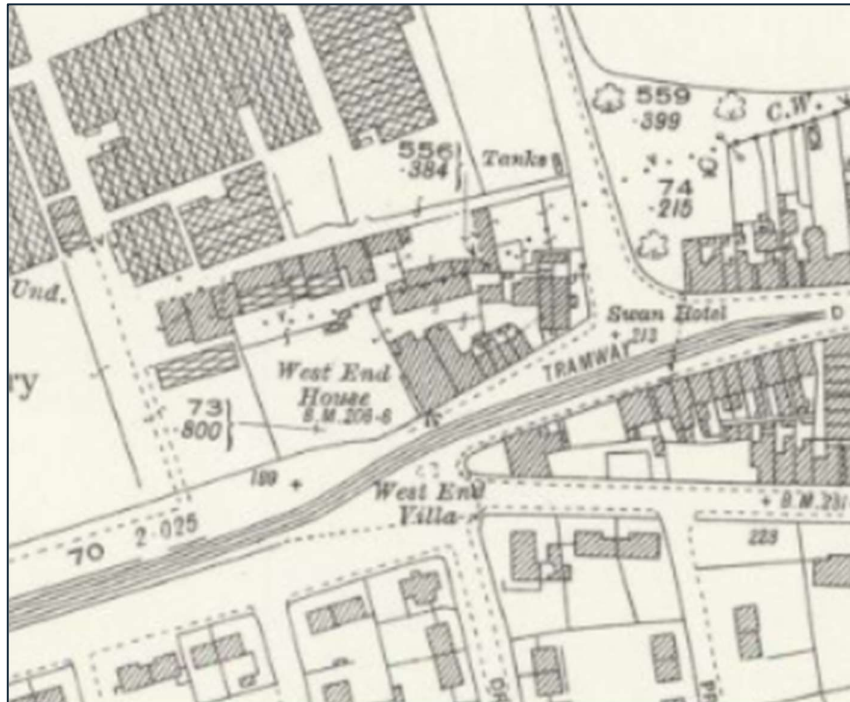
Map 3 – Extract of the 1925 (published 1927) Ordnance Survey Plan for Lancashire (CVI 1.7)  
(Reproduced with the permission of the National Library of Scotland)

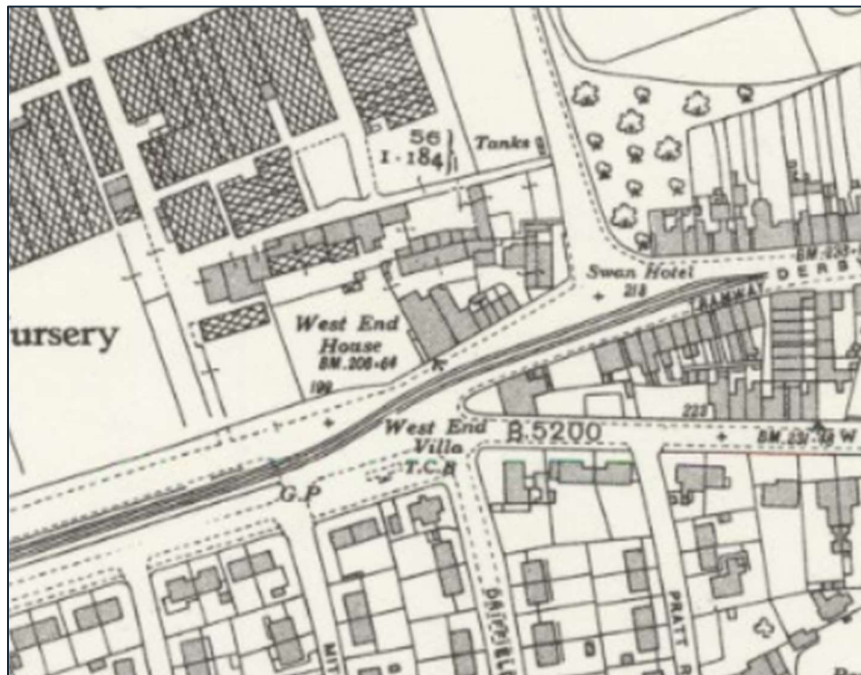
Map 4 – Extract of the Revised 1937 (published 1939) Ordnance Survey Plan for Lancashire  
(CVI 1.7) (Reproduced with the permission of the National Library of Scotland)

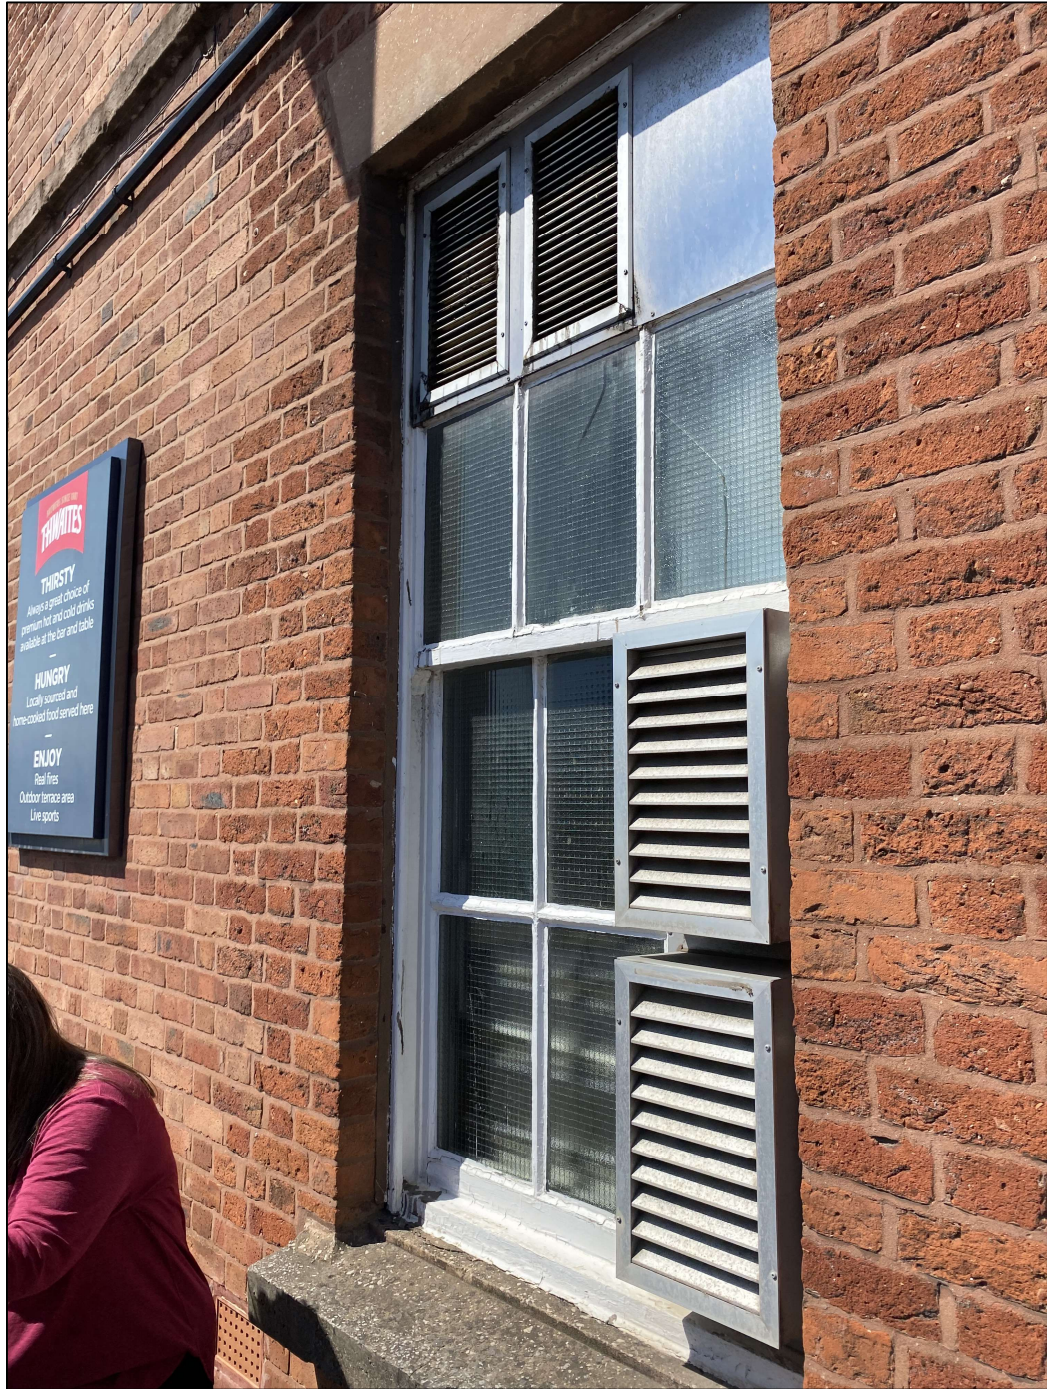
Plate 1 – Window as existing

4.4 The proposed works are limited to the right side, ground floor window opening on the southeast (Derby Street) elevation and comprise the following:

- Replacement of 2 x glass panes to the right-hand side of the bottom sash and retention of 2 x steel intake vents installed in place.
- Installation and retention of 2 x vent grilles to the top left and top central panes of the top sash.
- Paint the steel intake and extract vents and grilles in RAL 7000 grey.
- Removal of existing flush fitting steel cover to the top right pane of the top sash window and replacement with safety glass panes to match existing.

- Localised repair of the timber windowsills, bottom rails and glazing bars where required.
- 4.5 As part of the compliant operation of the kitchen extract system it is necessary to install air intake vents within an external elevation. The kitchen is located within the northeast corner of the ground floor, directly behind the window and the adjacent door. Due to the internal layout of the ground floor accommodation and the terraced nature of the building, it is not possible to install air intake vents within an alternative external elevation. Furthermore, due to the nature of the first-floor arrangement it is not possible to install intake vents via the roof covering. It has therefore been necessary to modify the existing sash window within the window opening to accommodate the necessary ventilation.

- 4.6 The new intake system has already been installed. Installation has necessitated the removal of 2 x panes of modern safety glass. The intake vents whilst projecting, do not project forwards of the window reveal.

- 4.7 Two existing ventilation grilles installed to the top left and centre panes of the top sash of the window are to be retained. The grilles form part of the air extract system installed to allow the compliant operation of the kitchen extract system. The vents have followed the proportions of the sash panes and are set flush within the sash casement.

- 4.8 The new intake vents and existing extract vent grilles are to receive a grey finish (RAL 7000) to assist with their assimilation into the window within general views of the elevations; grey considered to better match the finish of the safety of existing glass.

- 4.9 The scheme also proposes for the removal of the previous flush, fitting steel cover to the top right pane of the top sash and the replacement of a safety glass pane set within the existing frame / glazing bars which are present behind the cover. The new pane will match existing glass within the window. Prior to installation the rebate (in which the pane is to be secured) should be cleaned, dusted, and given a thin coat of primer, before new linseed-oil bedding putty is applied. The glass pane can then be pressed into place and fastened with fixings that replicate traditional methods / accord with the safety glass providers installation requirements.

- 4.11 The works will not affect an original window with photography evidencing the opening subject to this application was created in the latter part of the 20<sup>th</sup> century. As such the alterations will not result in the loss of historic fabric or affect a historic feature. However, the works will minimally alter a prominent elevation of the building and whilst not original, the opening has been detailed to replicate original window openings present on the elevation. Opportunities to insert the intake vents in an alternative location are not available. The intake vents and the extract grilles are necessary to ensure the commercial kitchen area is compliant with the necessary standards so that it can continue to function and support the food offer of the business. In order to minimise adverse visual effects to the elevation, the existing intake and extract vents are to receive a grey colour finished (RAL 7000). This is intended to assist in the assimilating the insertions. To balance against the limited, adverse visual impact of the works, the redundant steel cover is being replaced with a glass pane and the window is to be repaired where required. This element of the works will offer some small benefit to the building.

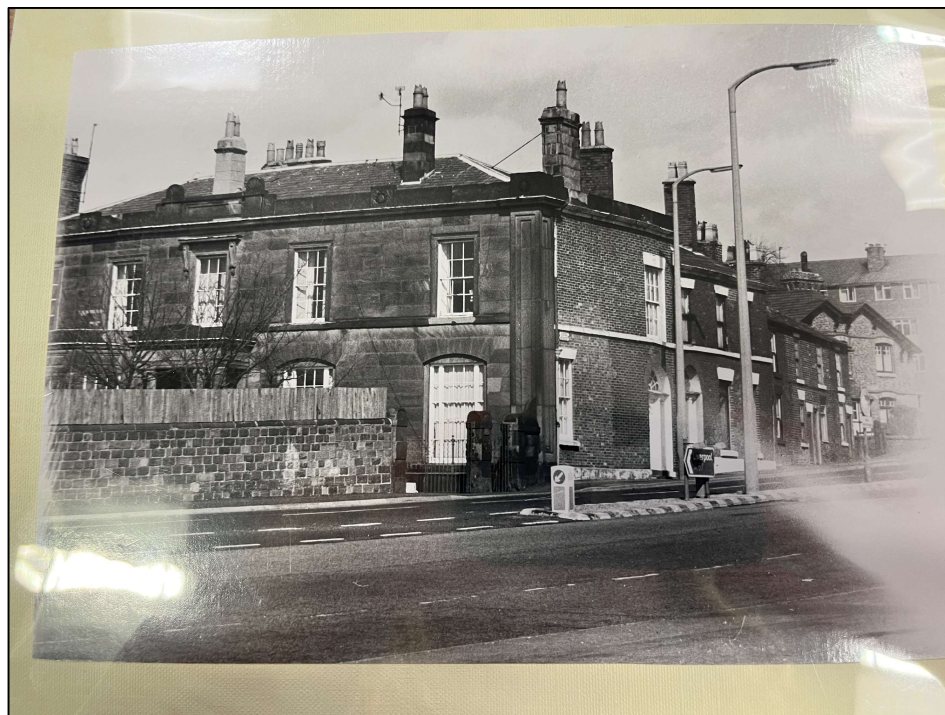
*Plate 2 – Image of the Clock Face in 1978 (Archive Reference GB1076.IMPT/1117/3)*

- 3.15 A later image of the Derby Street frontage held within Knowsley Archives (catalogue reference GB1076.IMPT/1/17/3) (see Appendix 2, plate 2) dated to 1978 indicates the window opening inserted to the left of the secondary entrance door and which is subject to this application is a recent insertion. This would offer some explanation as to why the windowsill is of concrete construction rather than of red sandstone to match the original window openings present to the elevation. In addition, a subtle change in brickwork texture to the area of wall between the two ground floor windows suggests it has been rebuilt.
