# Heritage Statement

The Clock Face, Derby Street, Prescott

Daniel Thwaites PLC

DECEMBER 2023

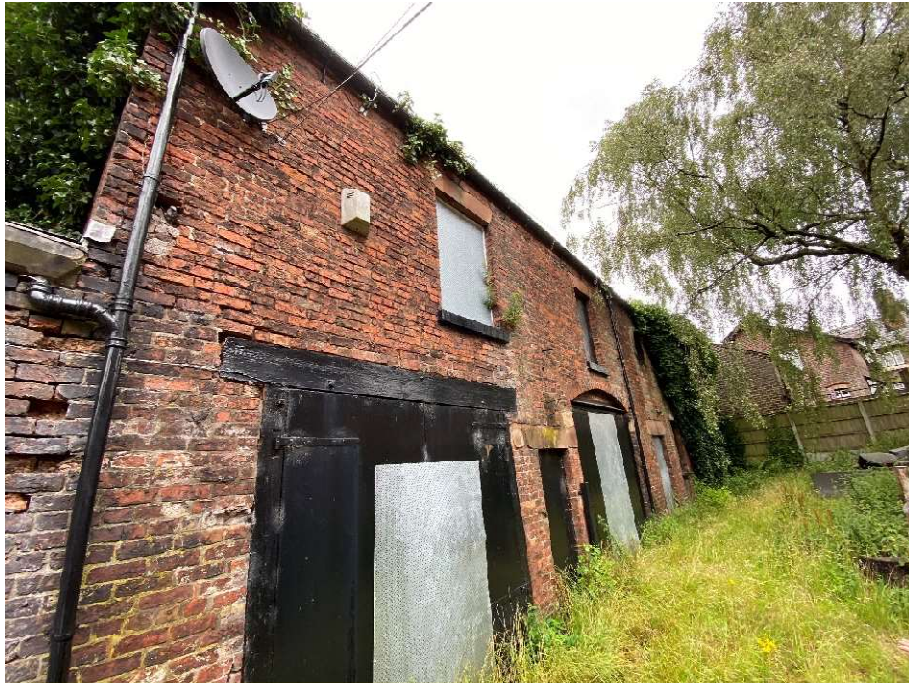
*Plate 1 – south elevation of the stable block with satellite dish to left and vegetation growth to the right (east) end.*

| <b>Proposed Works</b> | <b>Justification / Explanation for the Works</b> | <b>Assessment</b> | <b>Impact upon Significance</b> |
|---|---|---|---|
| Removal of Ivy from Stable block range | To prevent deterioration of fabric through growth in mortar joints, through vegetation holding moisture against fabric and through concealment of defects. | It is proposed that vegetation growth is removed from the exterior of the building by cutting the vegetation growth at the root initially prior to de-veg of the elevation. This will allow for any localised pointing and brickwork repairs and clearing and repair of the guttering and downpipes to be undertaken. | Beneficial impact upon the significance of the stable block.<br><br>Neutral impact to the significance of the Clock Face and Prescott Conservation Area. |

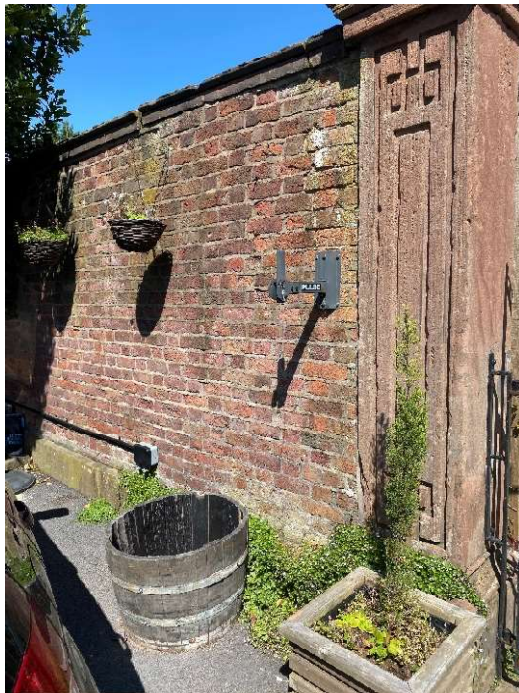
*Plate 7 – Tv bracket installed to the southwest elevation of the enclosing brickwork wall which is to be removed.*

| Decluttering of the external elevations of the stable block, Clock Face, and enclosing brick walls through removal of redundant cabling, alarm box and TV bracket etc. | To enhance the overall appearance of the buildings and its associated curtilage structures. | The removal of cabling from the stable block where found to be redundant alongside the removal of redundant equipment from the exterior of the buildings and the enclosing brick wall to the rear stable yard will enhance the overall appearance of the buildings. | Beneficial impact upon the significance of the stable block.<br><br>Neutral impact to the significance of the Clock Face and Prescott Conservation Area. |

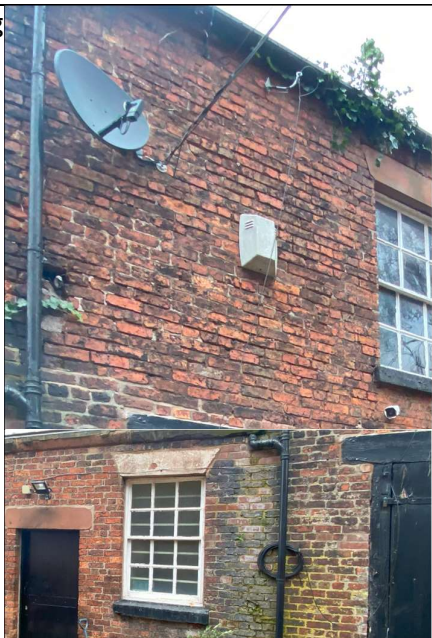
| External Cabling | South elevation of the outbuilding / stable range. | More than 4 years. | Removal of external cabling where it is found to be redundant and defunct. Retention of non-defunct cabling is included within the current LBC submission. | |
