# **Molyneux House 21 High Street Prescot**

**Window Schedule For  
Proposed Conversion Of  
Ground Floor Into 2 x Apartments**

**BPS  
DEVELOPMENTS LTD**

**September 2026**

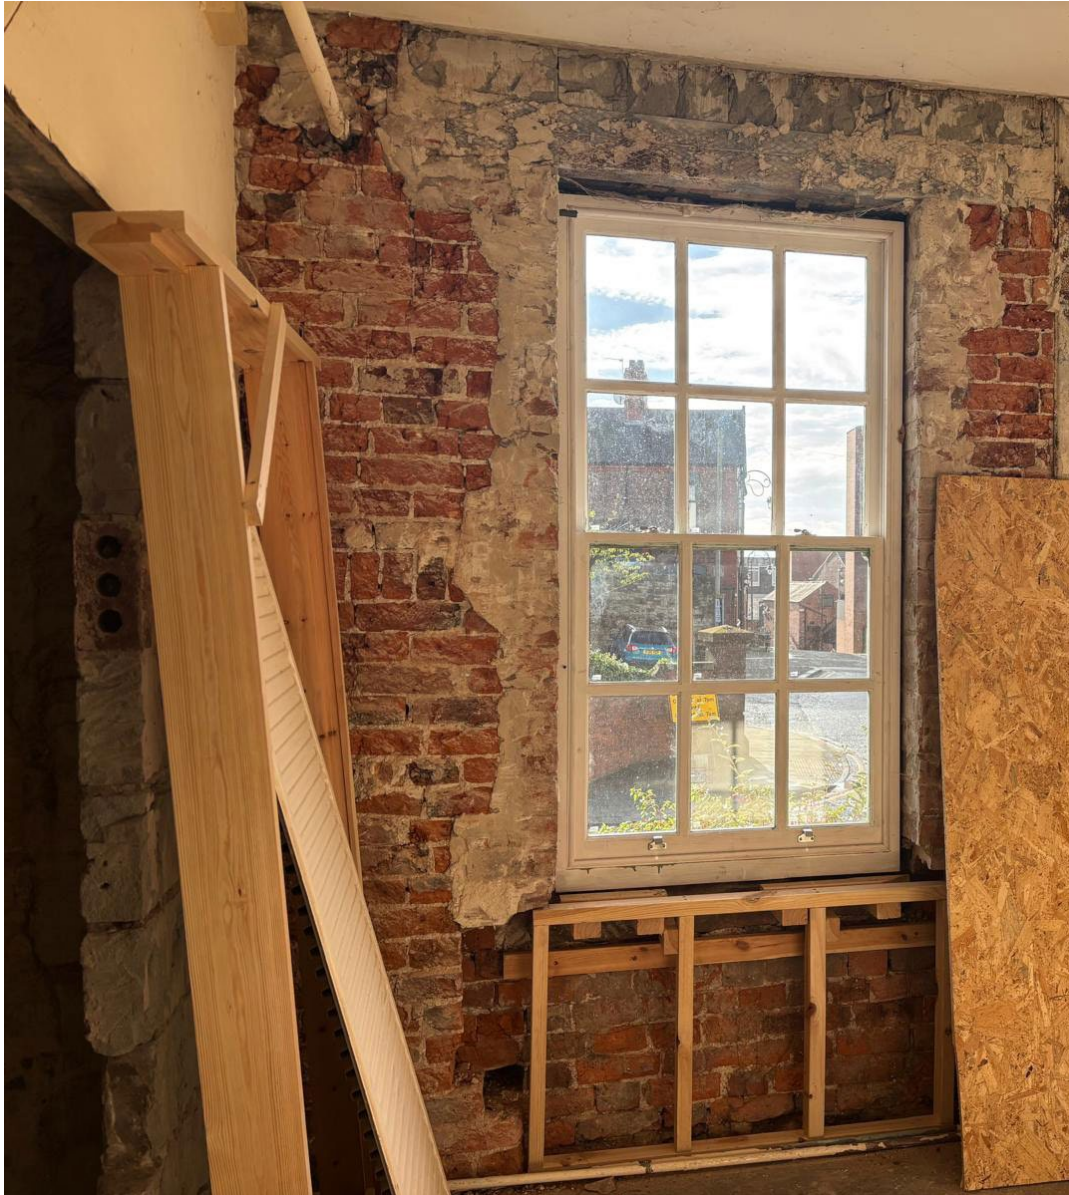
## Flat 1 Living Room Right Hand Frame From Front

Existing window was found to be affected by both dry rot and wet rot to sashes.

Window has been replaced with new timber sliding sash window. Cill board is to be replaced with new softwood cill board.

Timber stud beneath frame is to be removed and wall plastered.

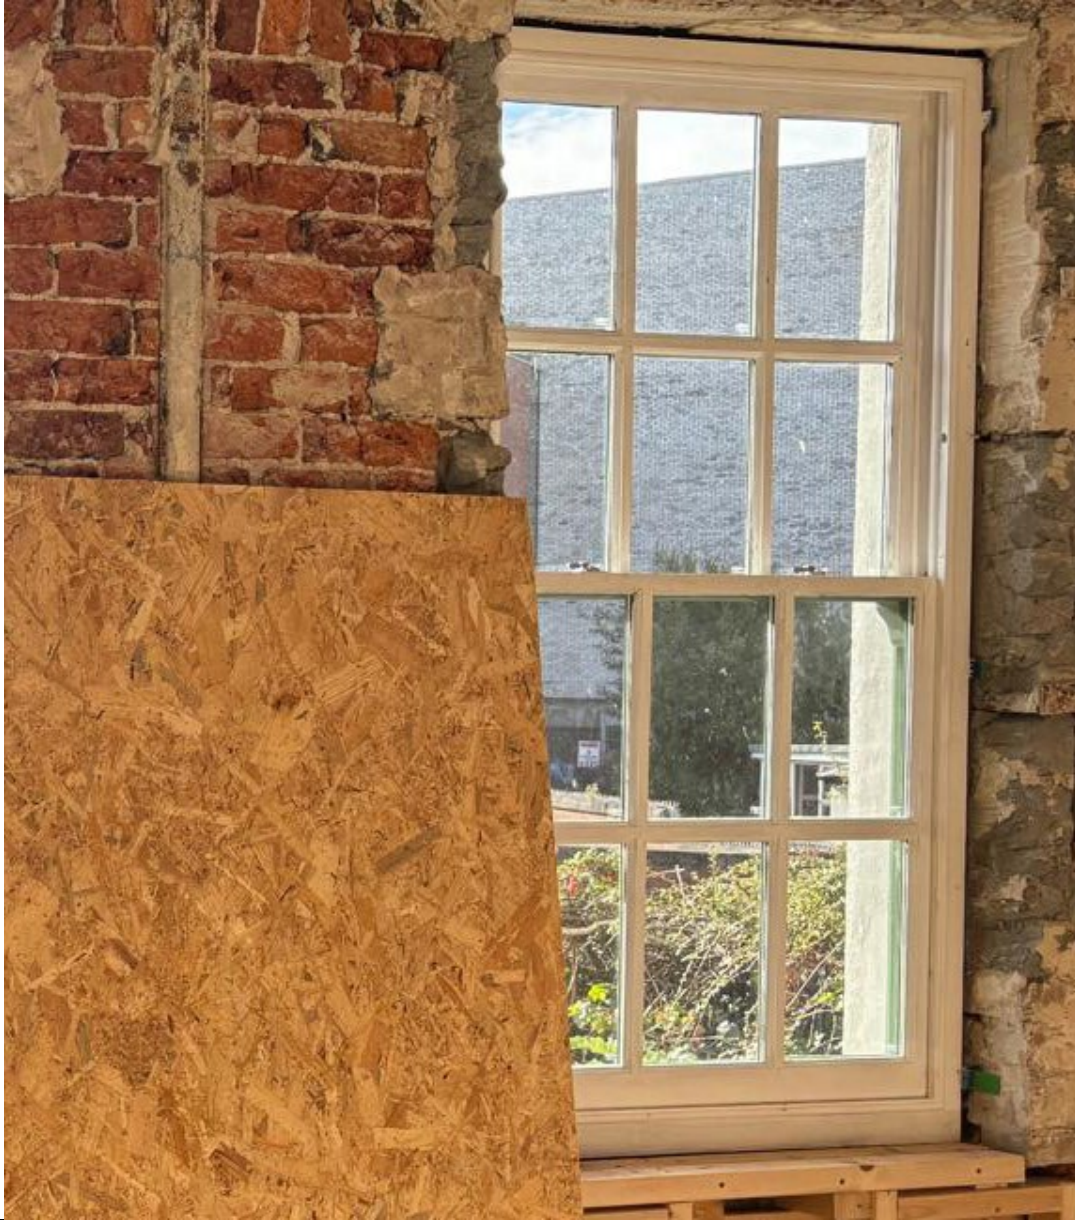
## Flat 1 Living Room Left Hand Frame From Front

Existing window was found to be affected by both dry rot and wet rot to sashes.

Window has been replaced with new timber sliding sash window. Cill board is to be replaced with new softwood cill board.

Timber stud beneath frame is to be removed and wall plastered.

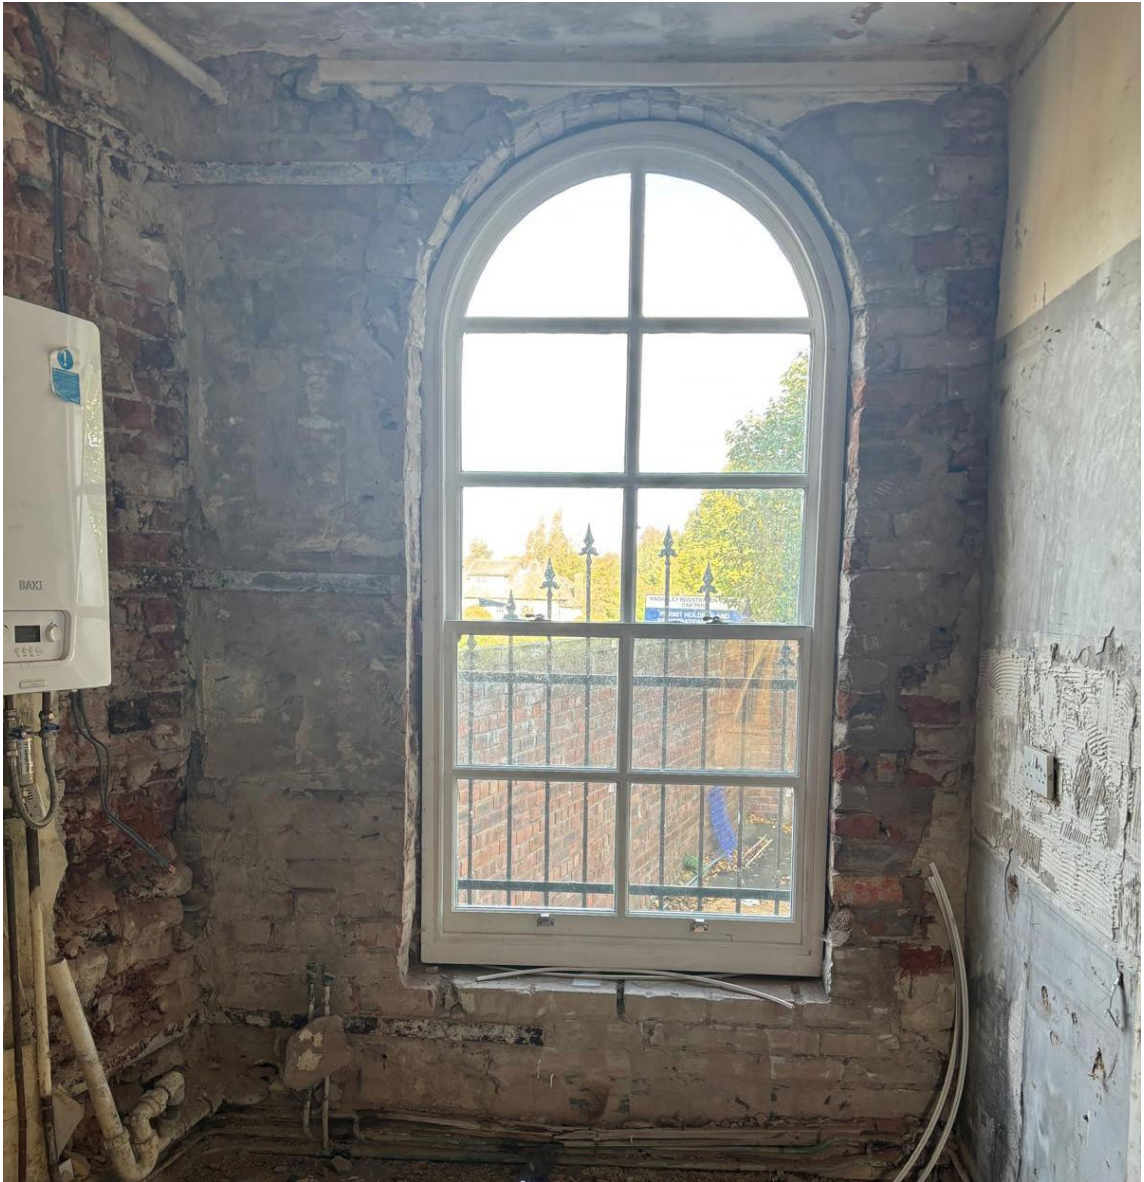
## Bedroom

Existing window was found to be affected by both dry rot and wet rot to sashes.

Window has been replaced with new timber sliding sash window. Cill board is to be replaced with new softwood cill board.

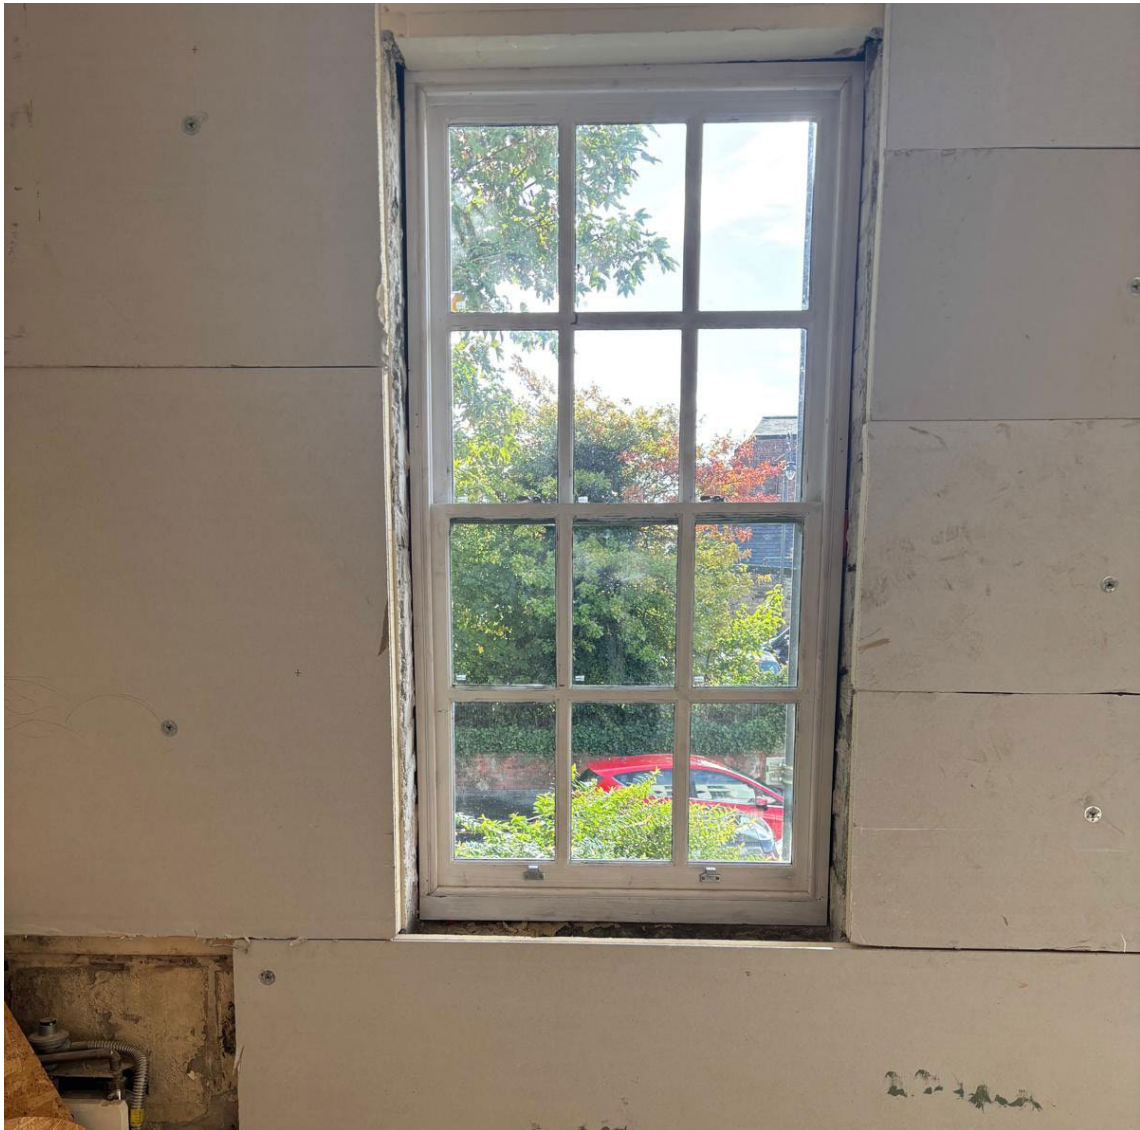
## Flat 2 Living Room Window (Right Hand Frame From Front)

Existing window was found to be affected by both dry rot and wet rot to sashes.

Window has been replaced with new timber sliding sash window. Cill board is to be replaced with new softwood cill board.

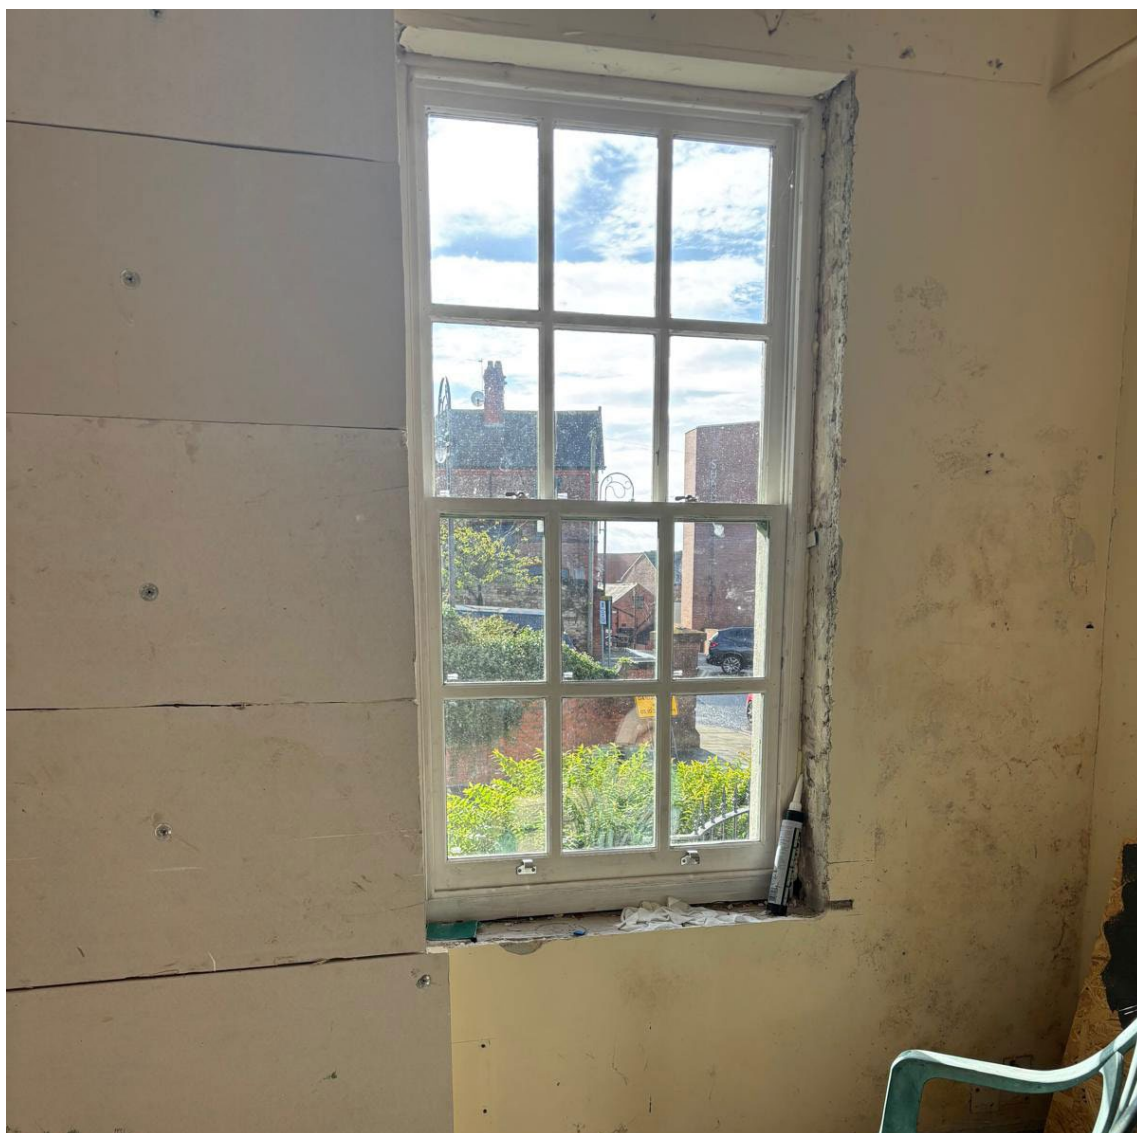
## Flat 2 Living Room Window (Left Hand Frame Front)

Existing window was found to be affected by both dry rot and wet rot to sashes.

Window has been replaced with new timber sliding sash window. Cill board is to be replaced with new softwood cill board.

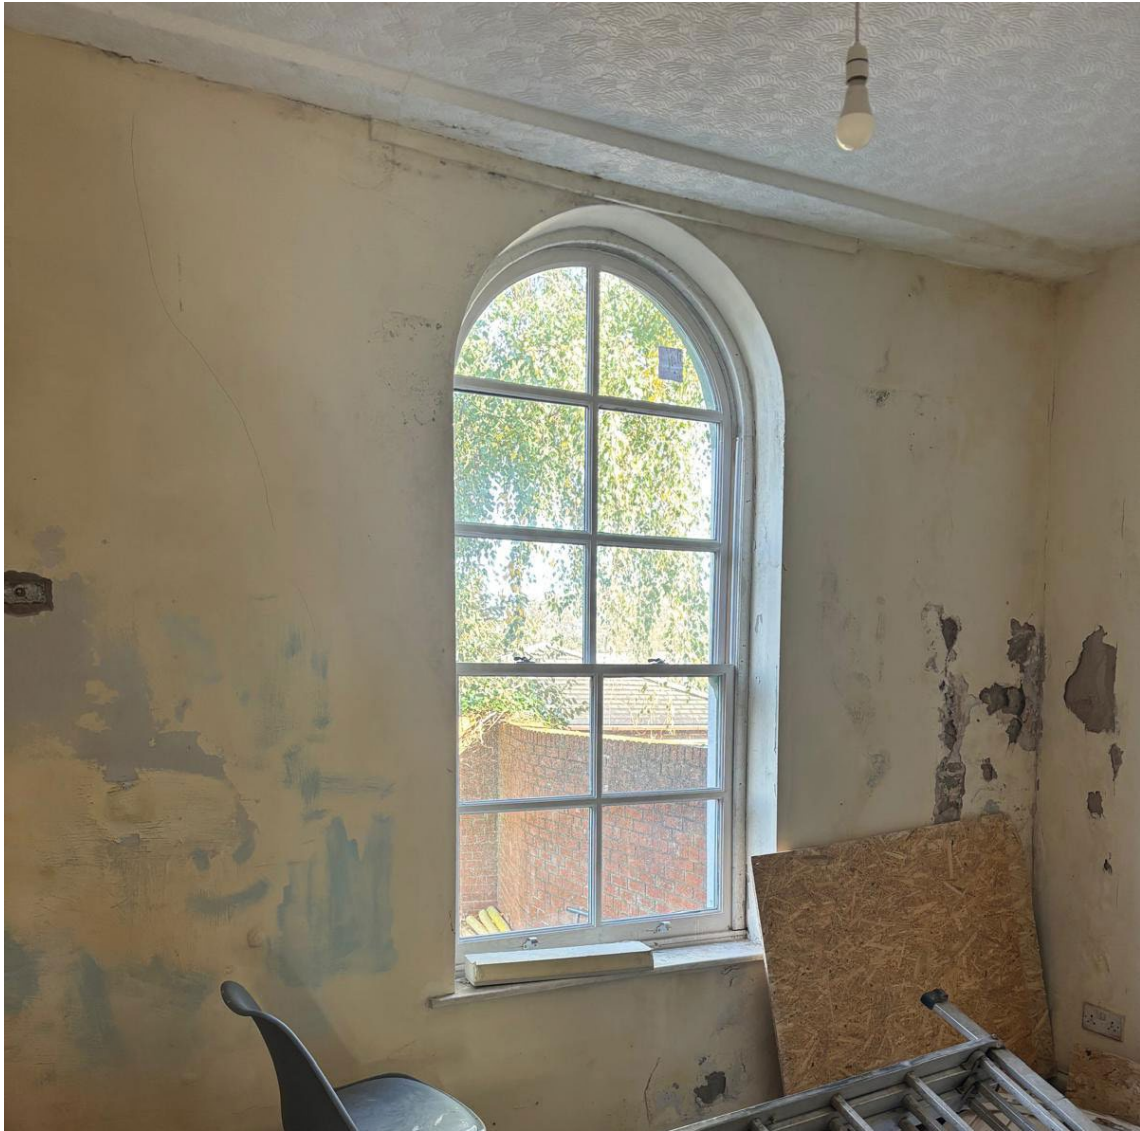
Window frame sliding sashes have been replaced with new softwood sliding sashes as originals were Found to be rotten and beyond repair.

Existing frame has been repaired and non original softwood cill has been retained.
