**Re: Jubilee Park, Liverpool – Infiltration Testing to Assist with Soakaway Design**

# INSITU SOAKAWAY TEST RESULTS

**Job No.: EAL.208.23**

**Site: Jubilee Park, Liverpool**

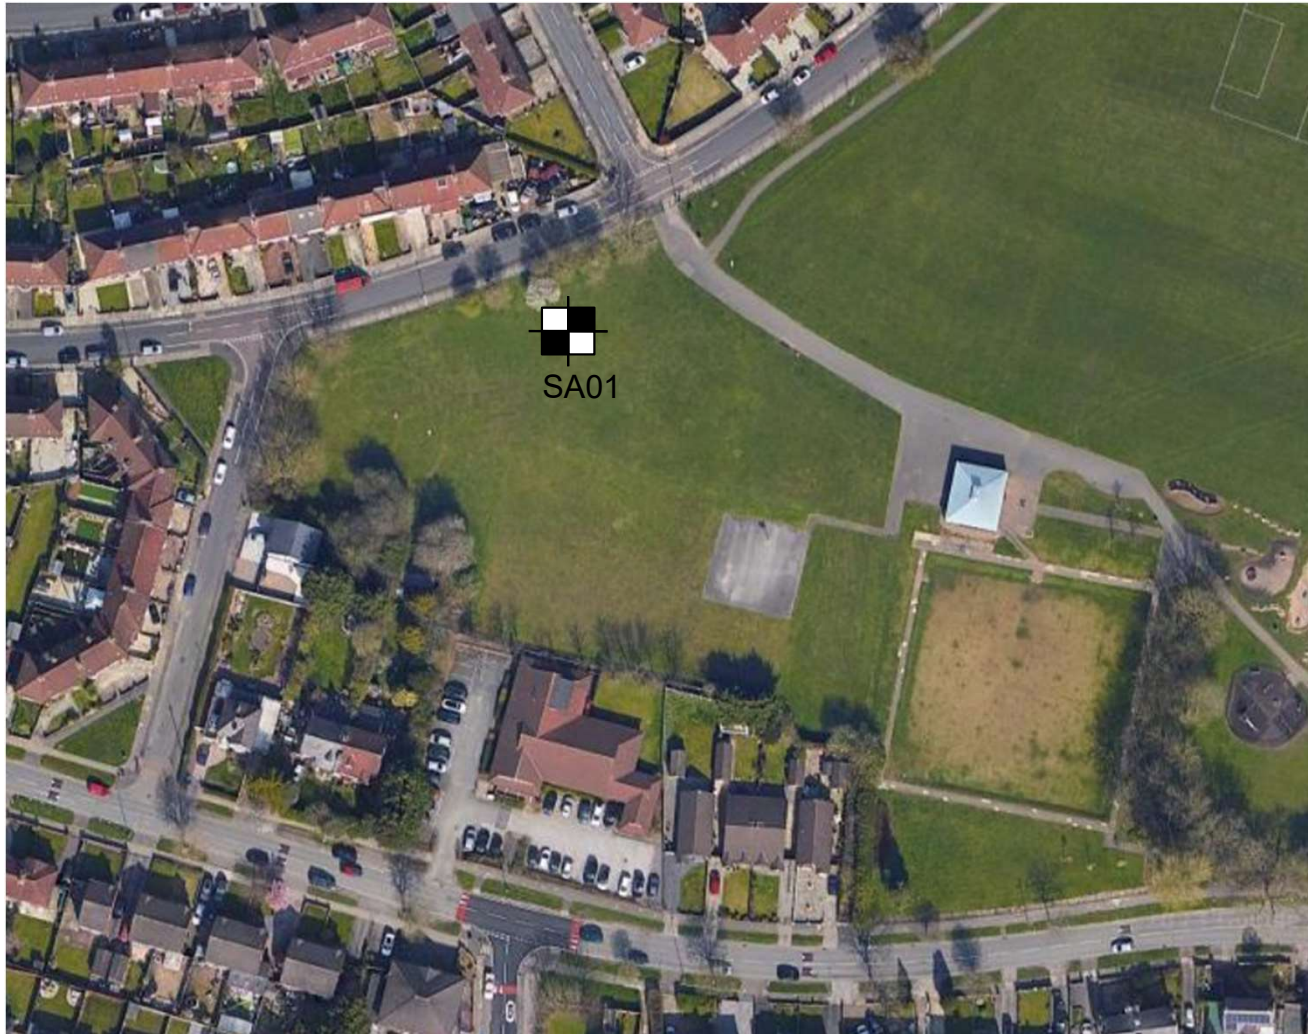
Figure 2

A soakaway test pit (SA01) was excavated in an area where a previous site investigation had identified a granular layer in which an incomplete infiltration test was undertaken. An exploratory hole location plan is enclosed in **Appendix A**.

Soakaway Location

Site Layout & Exploratory Hole Location

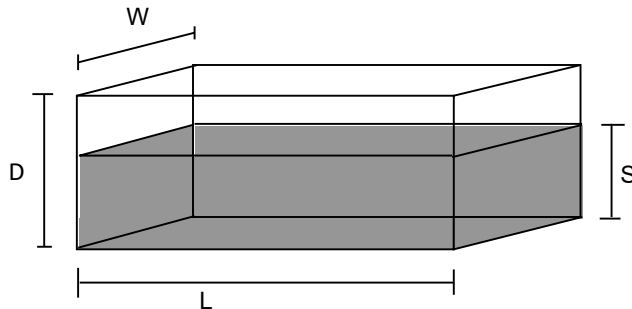
## Sketch plan of test zone

D = Depth of test pit = 1.05

W = Width of test pit = 0.40

L = Length of test pit = 0.40

S = Storage depth = 0.64

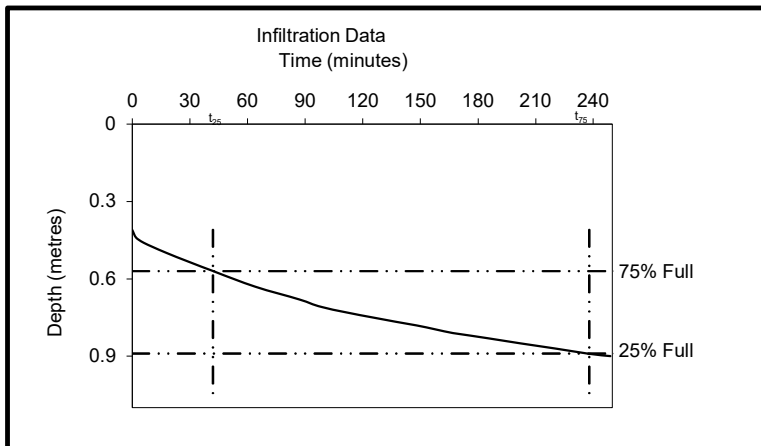
## Soakaway Test Run 1

From the above graph,

$$t_{p25} = 42 \quad (min) \quad t_{p75} = 238 \quad (min)$$

$$\text{Soil Infiltration Rate, } i = \frac{V_{p75-25} \times N}{a_{p50} \times t_{p75-25}} = 6.48E-06 \quad T_{run1} = 6.48 \times 10^{-6} \quad m/s$$

A single full infiltration test run was completed at the above with a calculated infiltration rate of 6.48 x 10<sup>-6</sup>m/s.
