# PROPOSED RESIDENTIAL DEVELOPMENT, LAND AT STONEY LANE, WHISTON – RESPONSE TO ACTIVE TRAVEL ENGLAND – MAY 2026

DRAWING TITLE:  
**PROPOSED UNCONTROLLED  
CROSSING PLAN**

DRAWING TITLE:  
**PEDESTRIAN WALKING ROUTE TO WHISTON**

DRAWING TITLE:  
**PEDESTRIAN WALKING ROUTE TO RAINHILL**

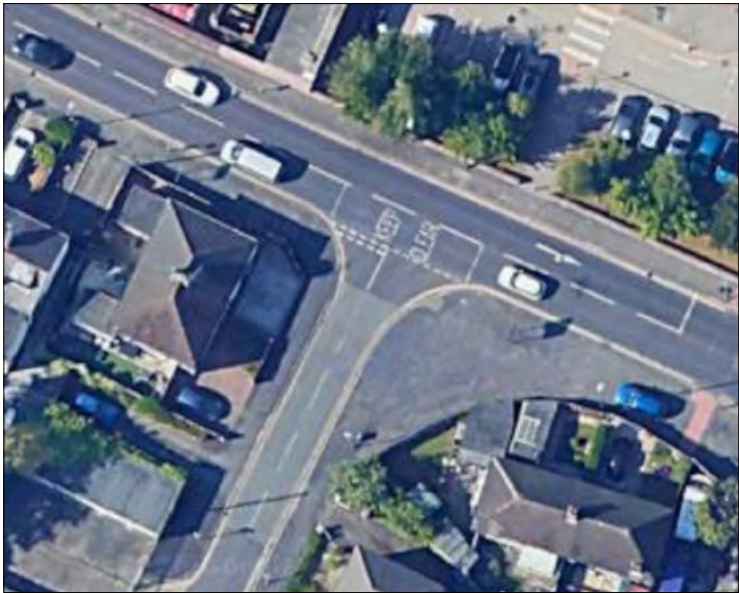
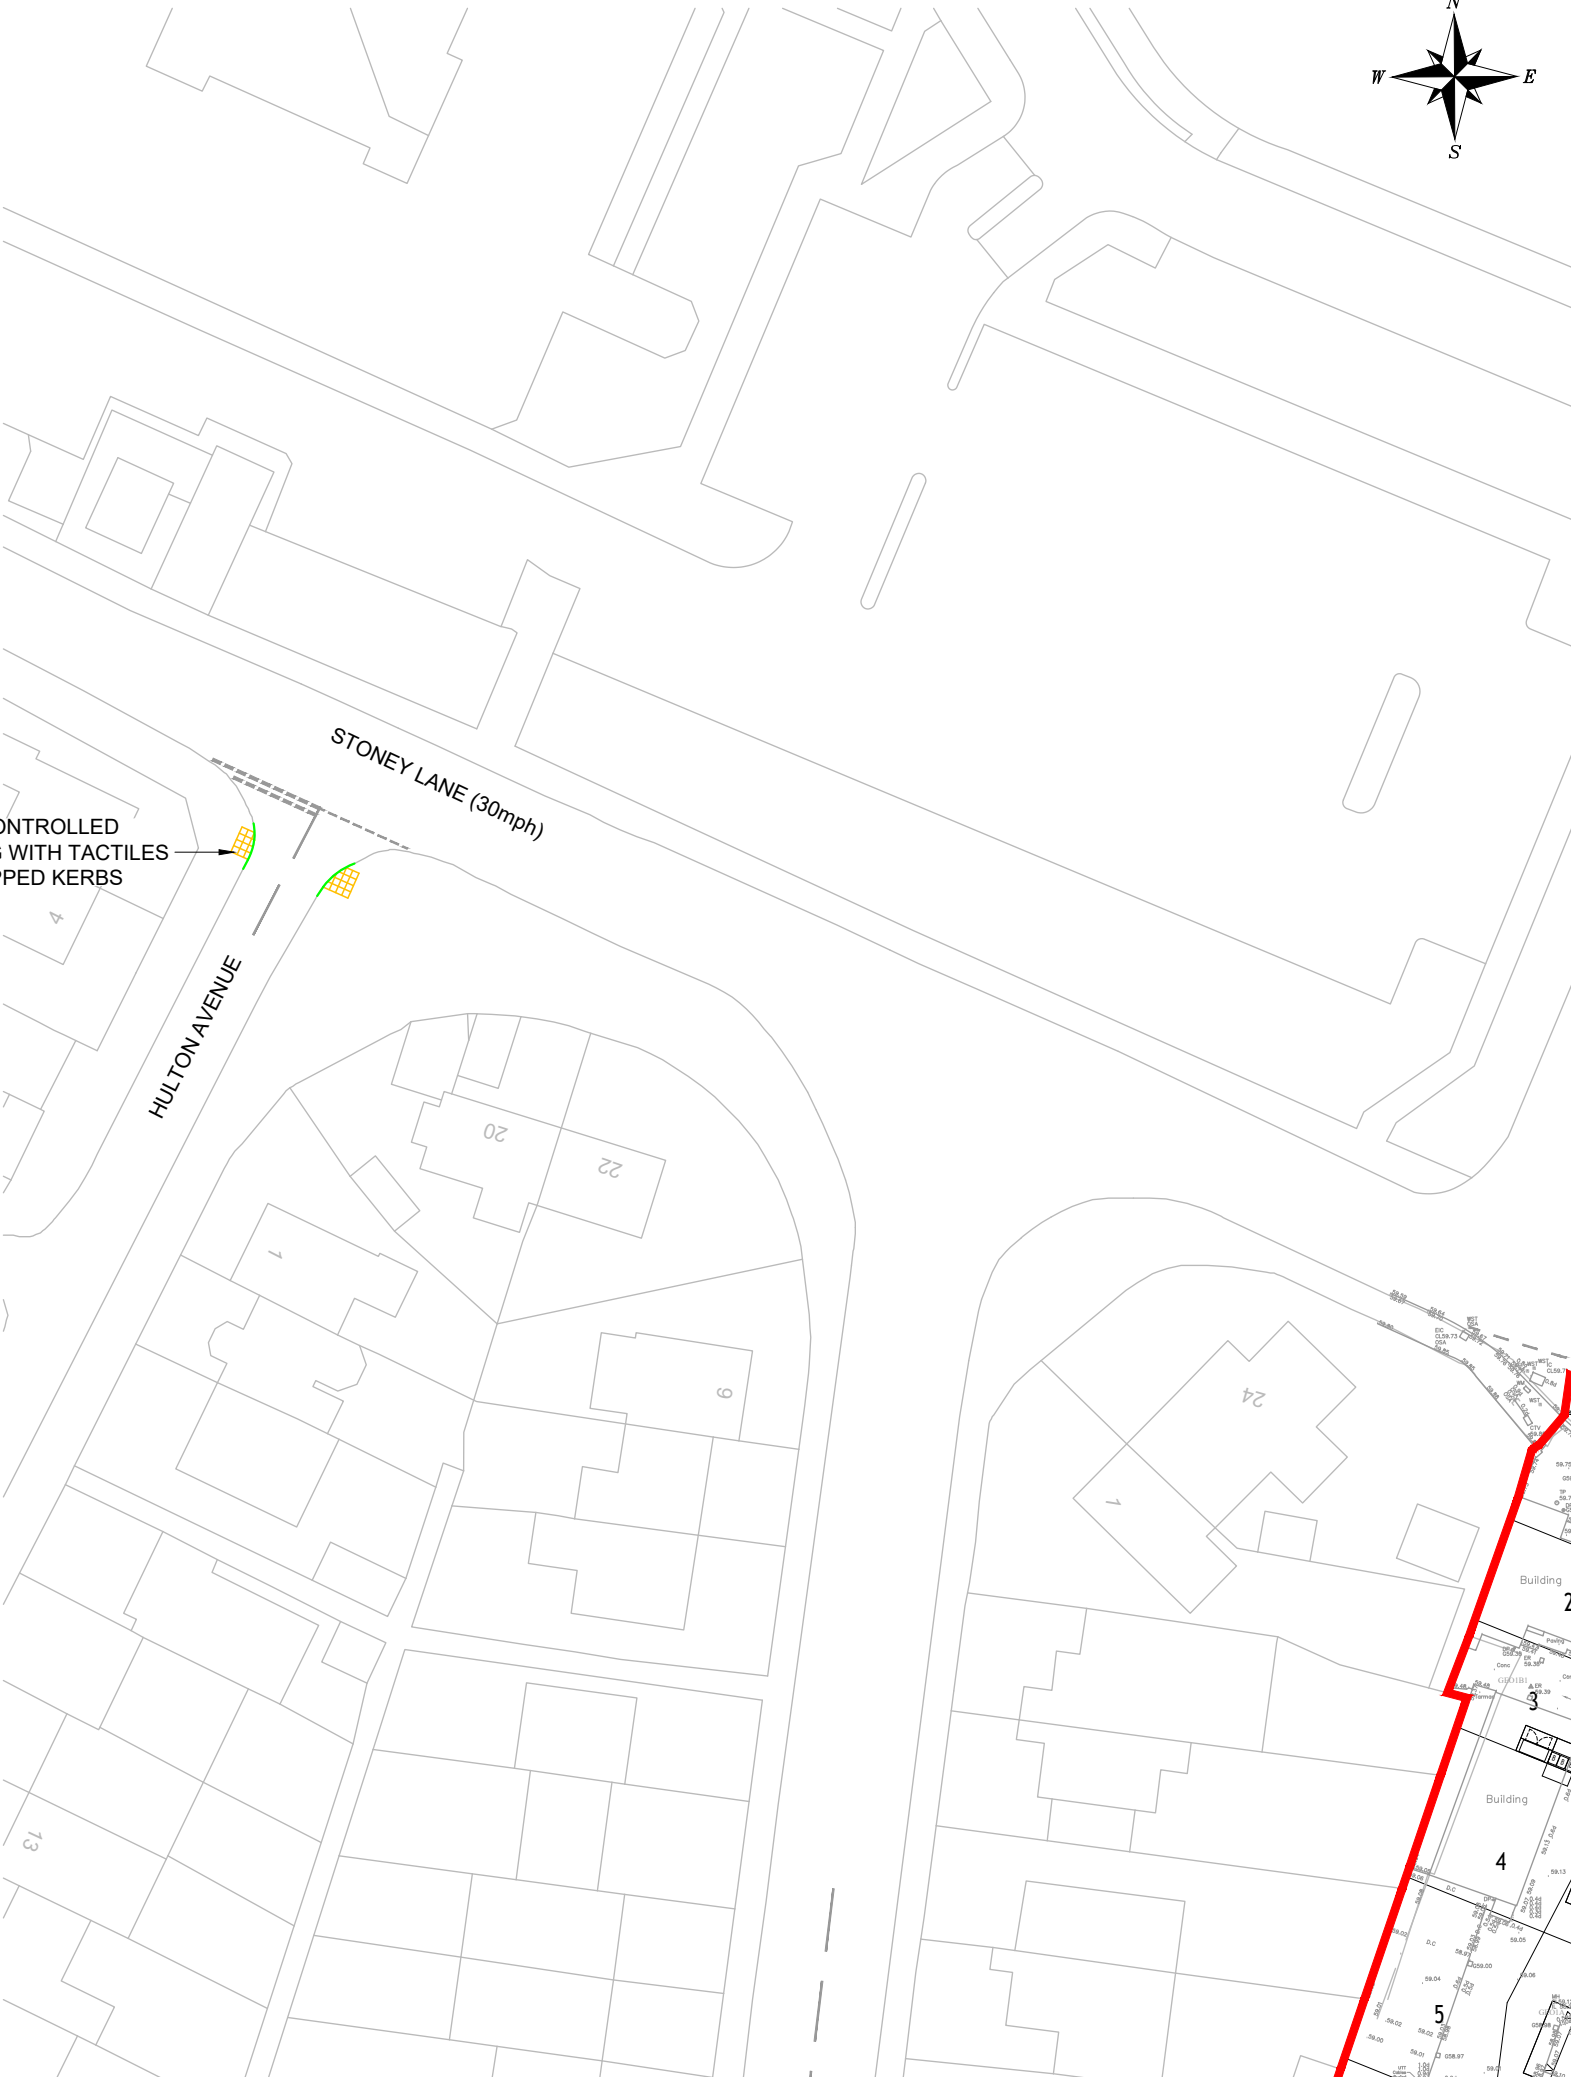
**Plan 1          Proposed Uncontrolled Crossing Plan**

- 9 Walking route audits to local destinations such as Whiston, Rainhill and Prescot have been undertaken. The audits assess the attractiveness, comfort, directness, safety and coherence, and identifies the potential improvements along the routes. Walking route plans have also been produced, including images of locations that could potentially be improved.
- 10 The walking route audits identified the potential improvements such as an uncontrolled pedestrian crossing with tactile paving and associated tactile paving across the Stoney Lane/Hulton Avenue priority junction.
- 11 The estimated costs for the improvement scheme at the Stoney Lane/Hulton Avenue priority junction would be between £10,000 and £15,000.
- 12 The walking route audit and associated walking route plans are provided in **Appendix 1**, whilst the proposed uncontrolled crossing plan is shown on **Plan 1**.

NEW UNCONTROLLED  
CROSSING WITH TACTILES  
AND DROPPED KERBS

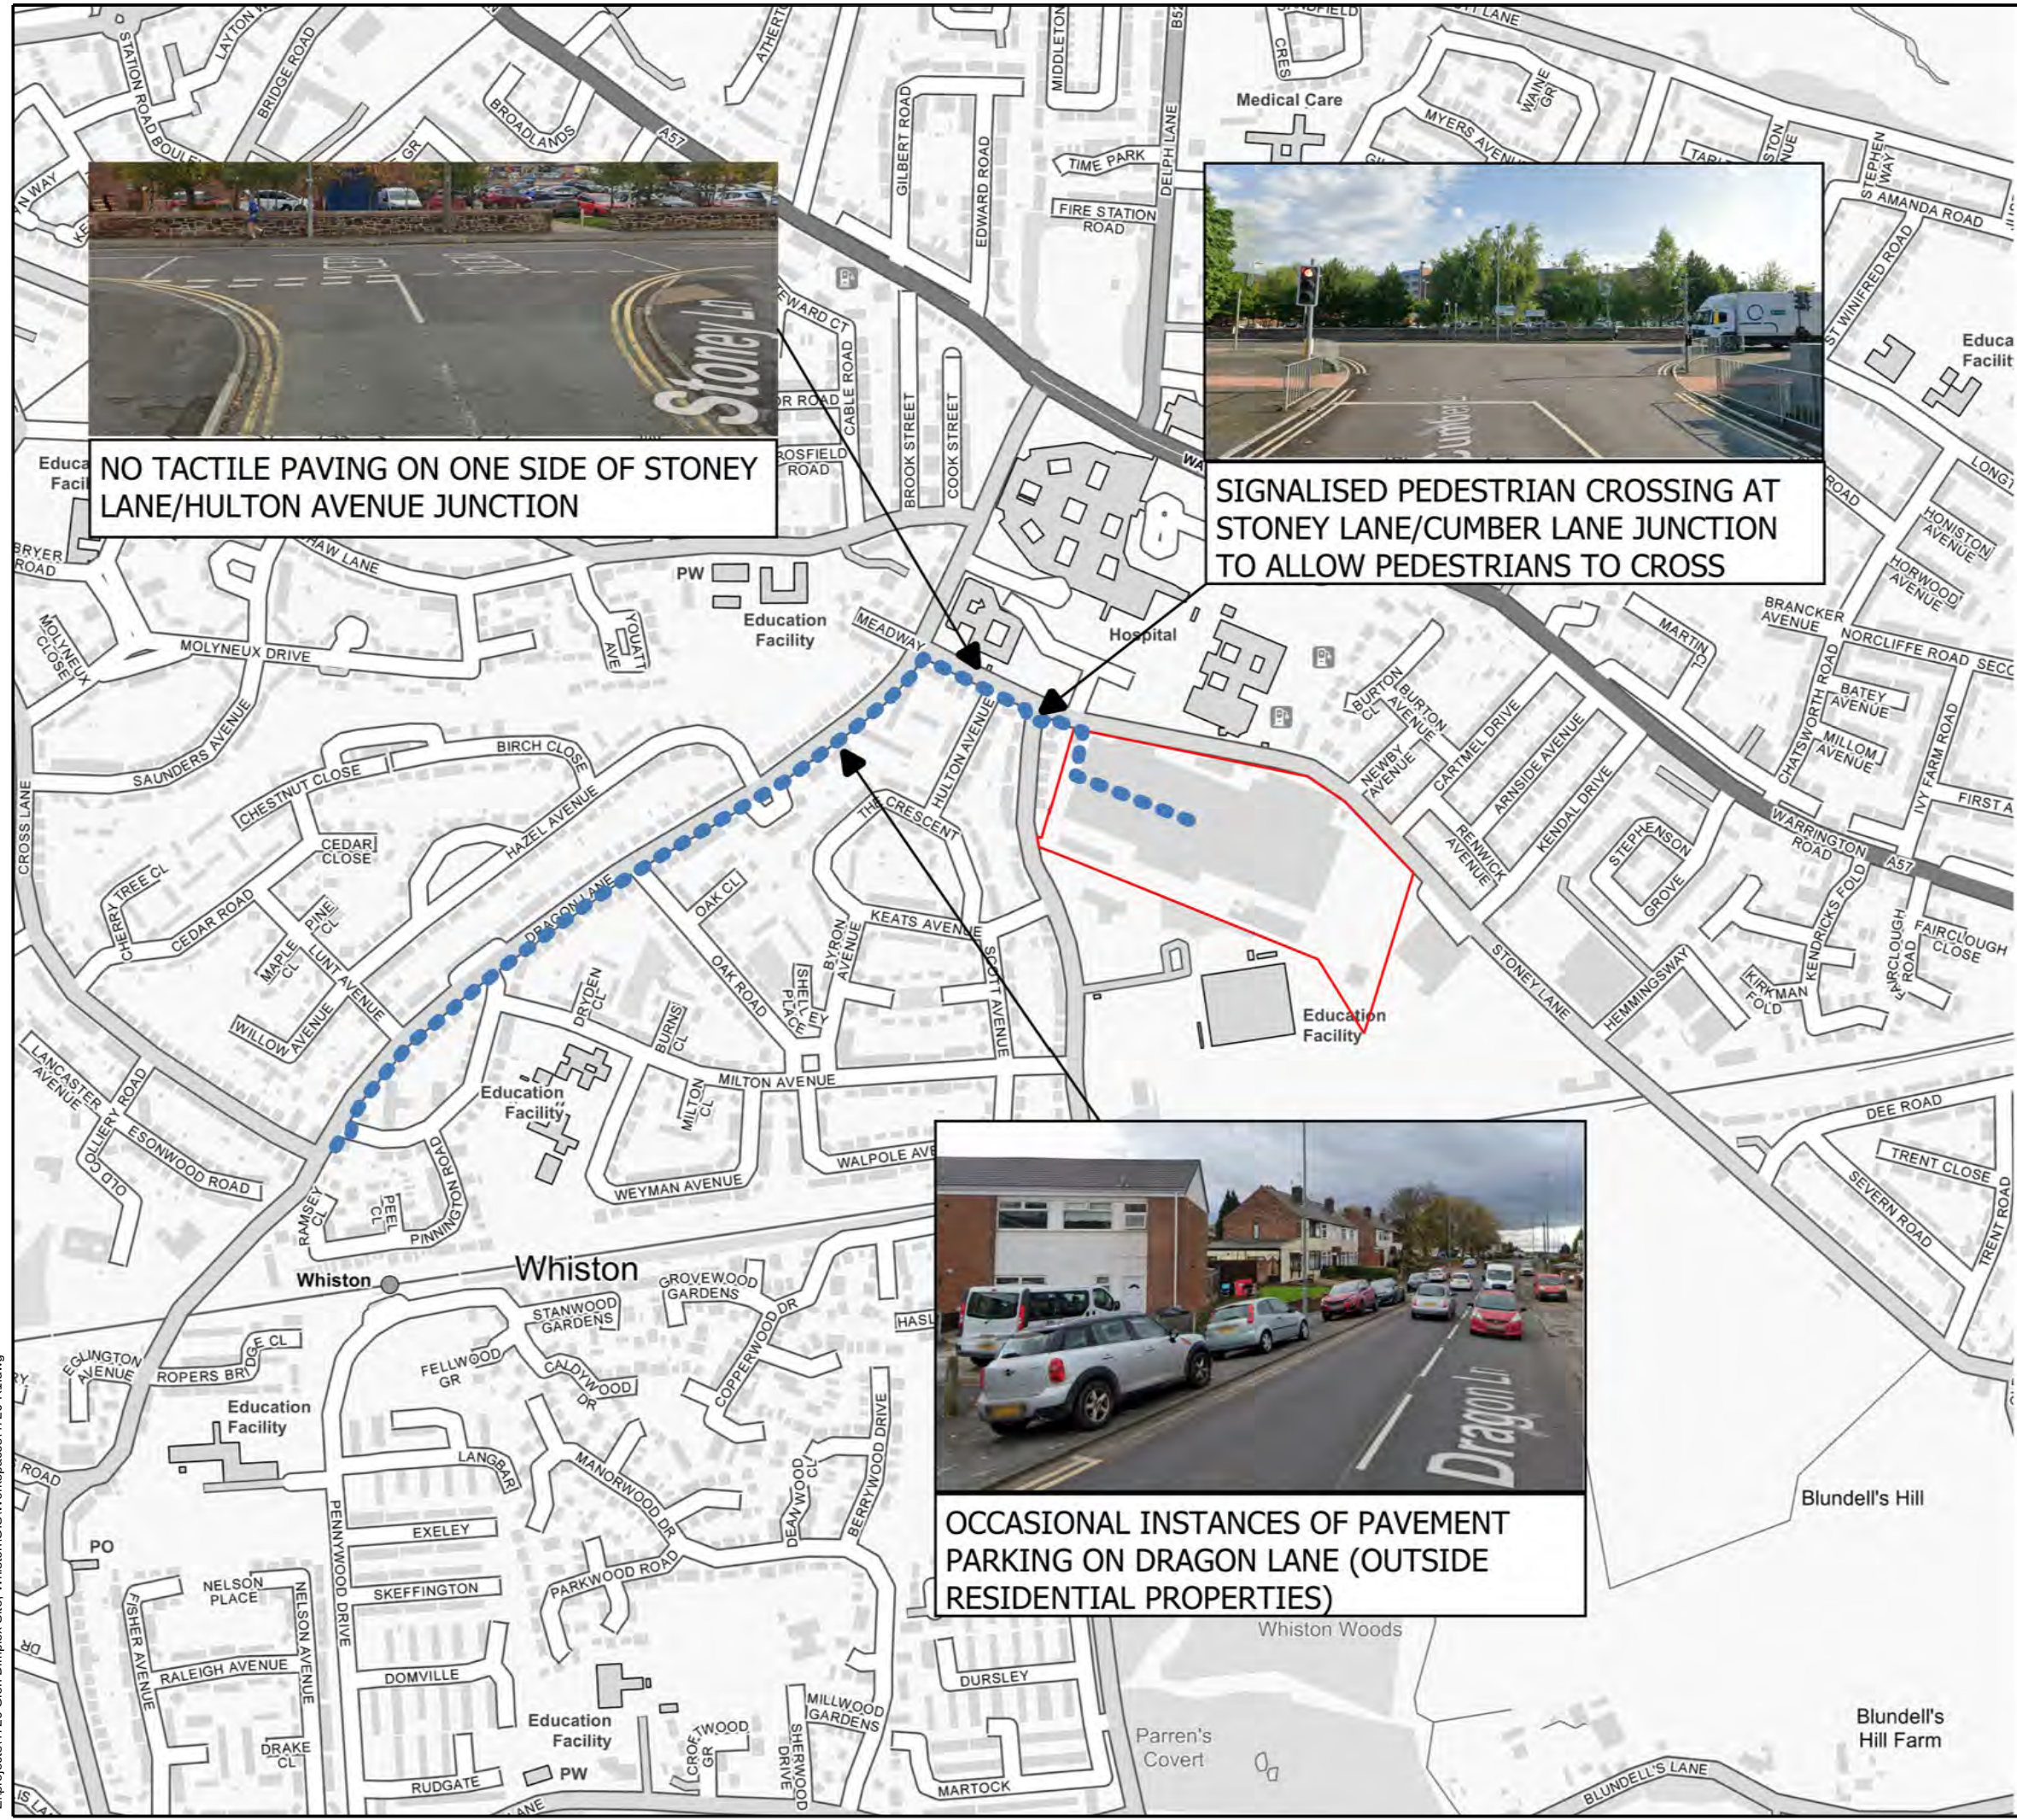
| Comments | Tactile paving could be improved at some minor - low trafficked roads along the route, however, these are not considered critical as the route is considered of a sufficient quality to encourage sustainable travel to and from the site |

| Actions | Potential off-site improvements are to be discussed with the Council Highways at a later stage of the planning application. |

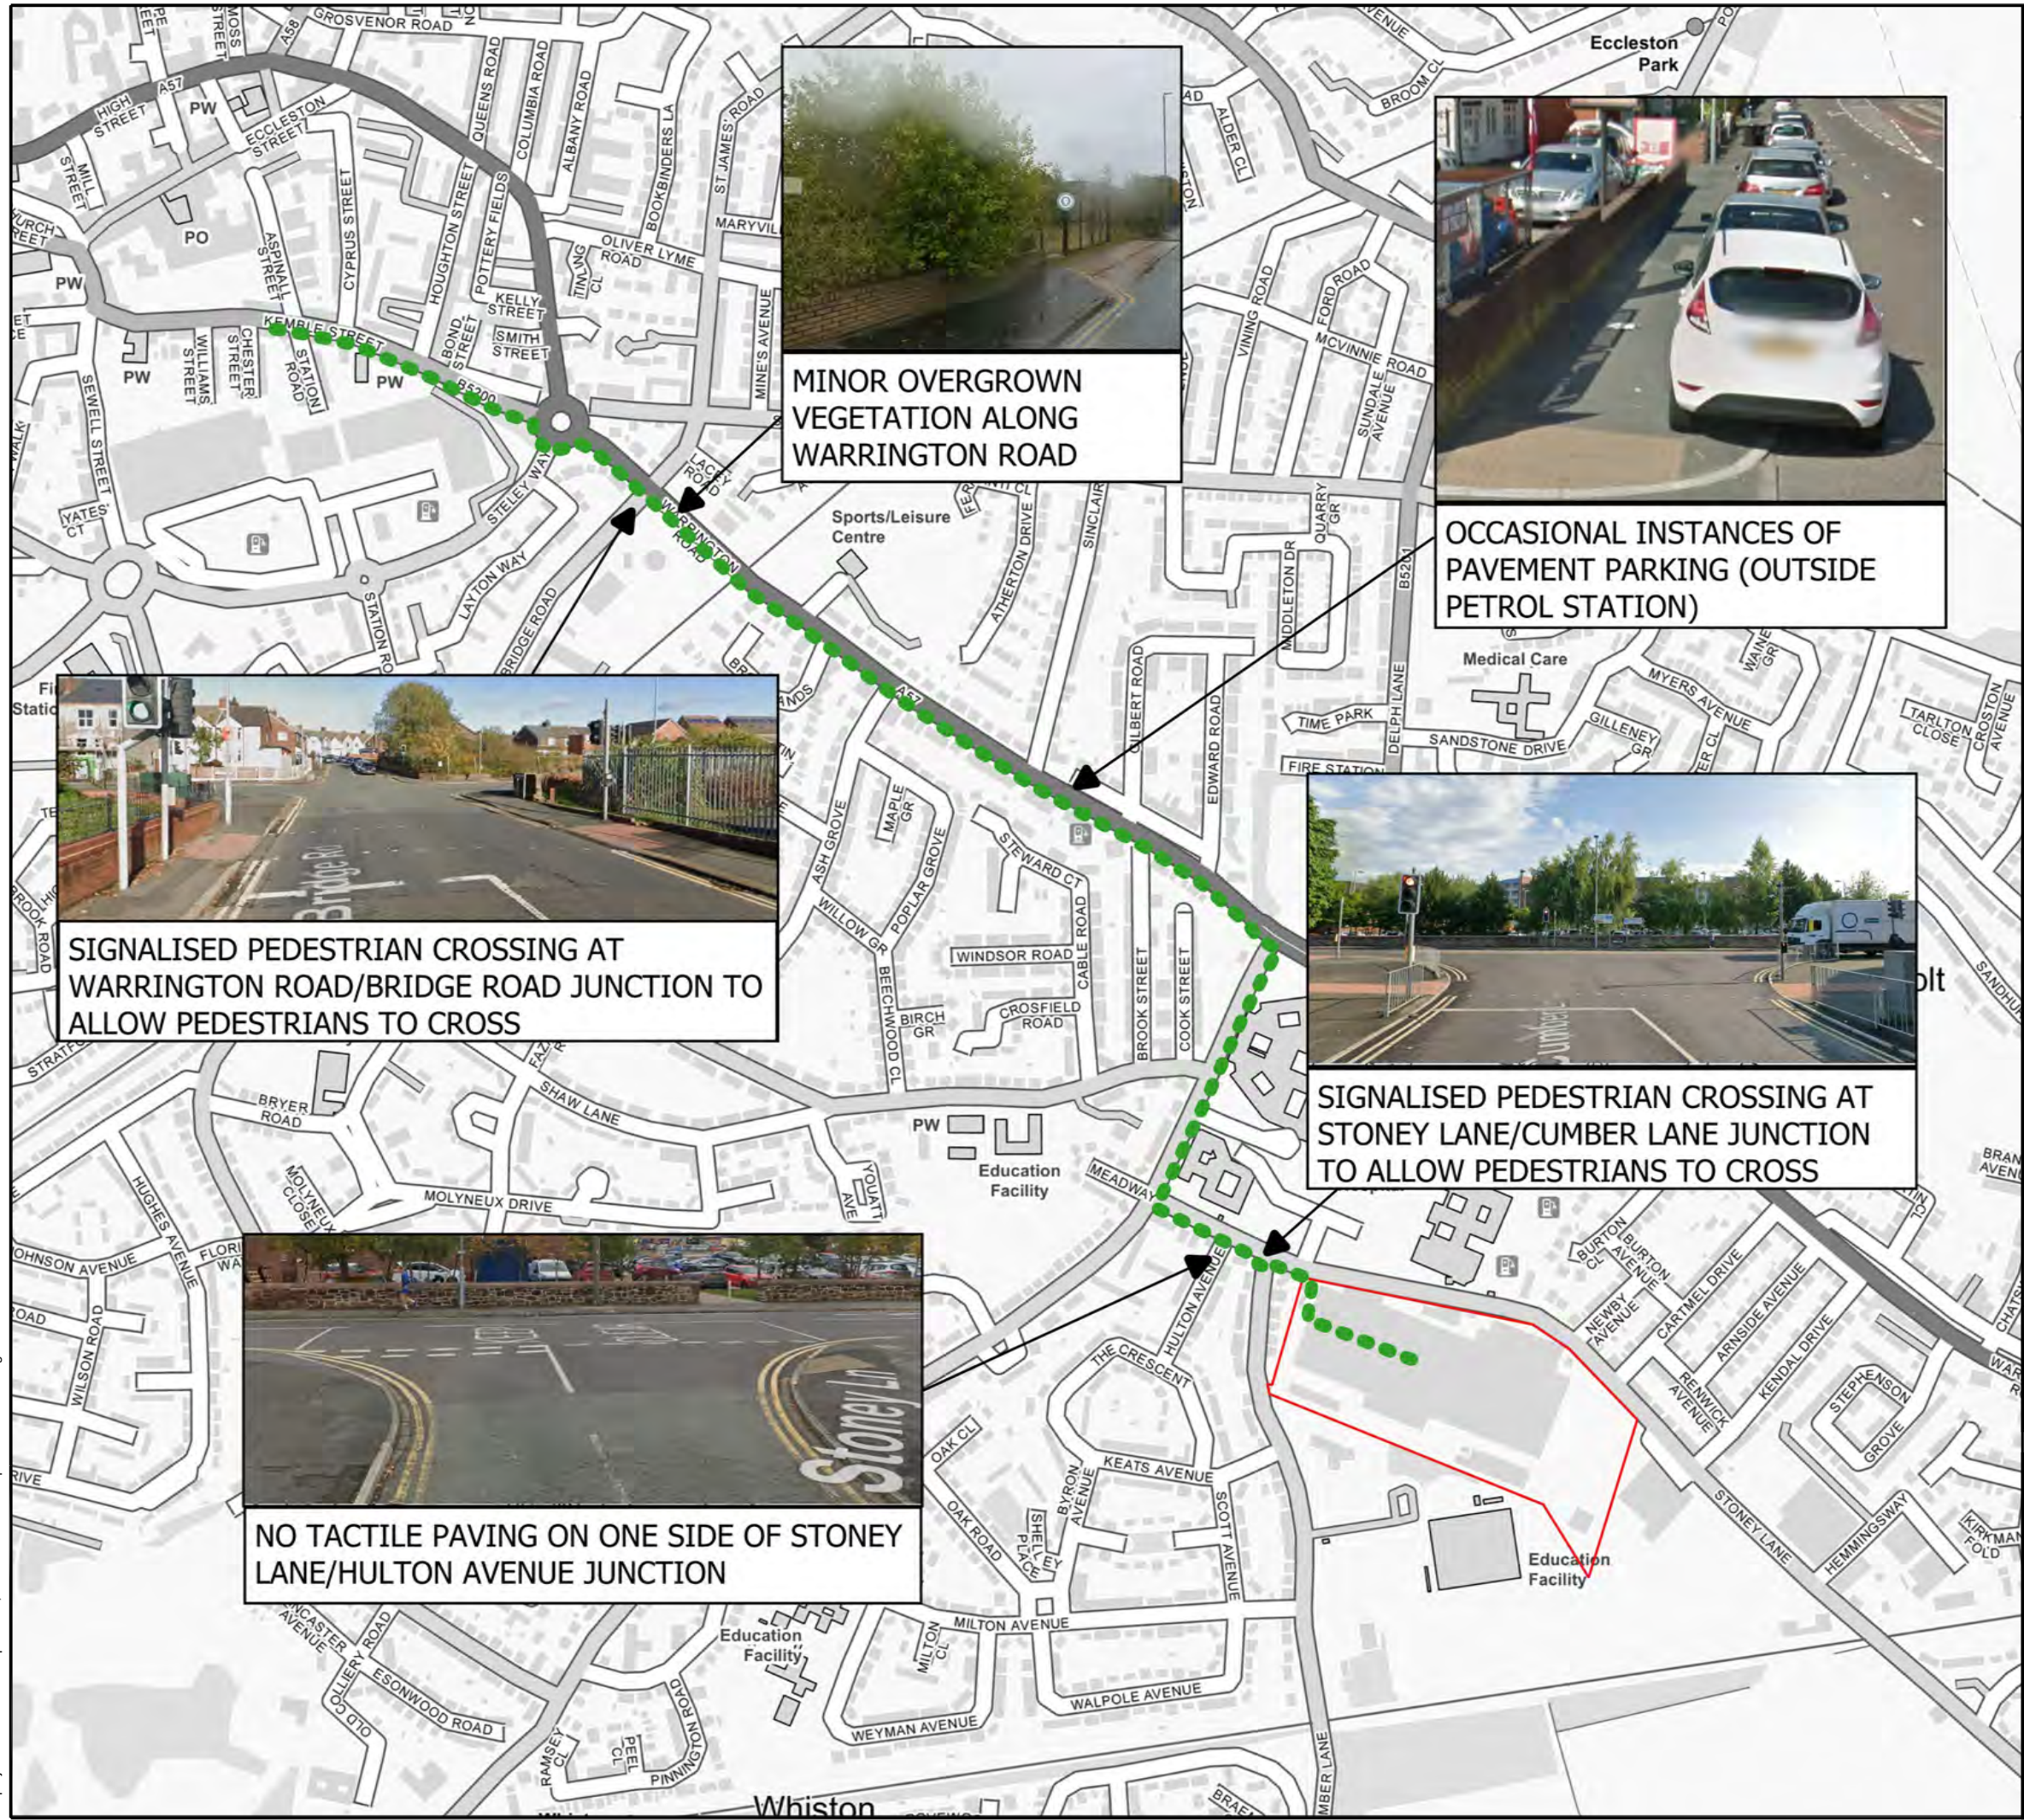
PEDESTRIAN WALKING ROUTE TO PRESCOT

| Comments | The route is generally direct and well connected, with good footway provision and crossing facilities. Whilst sections along the A57 Warrington Road experience moderate traffic and noise, this is typical of an urban environment and does not significantly impact the overall quality of the route. |

| Actions | No off-site improvements are proposed at this stage. |

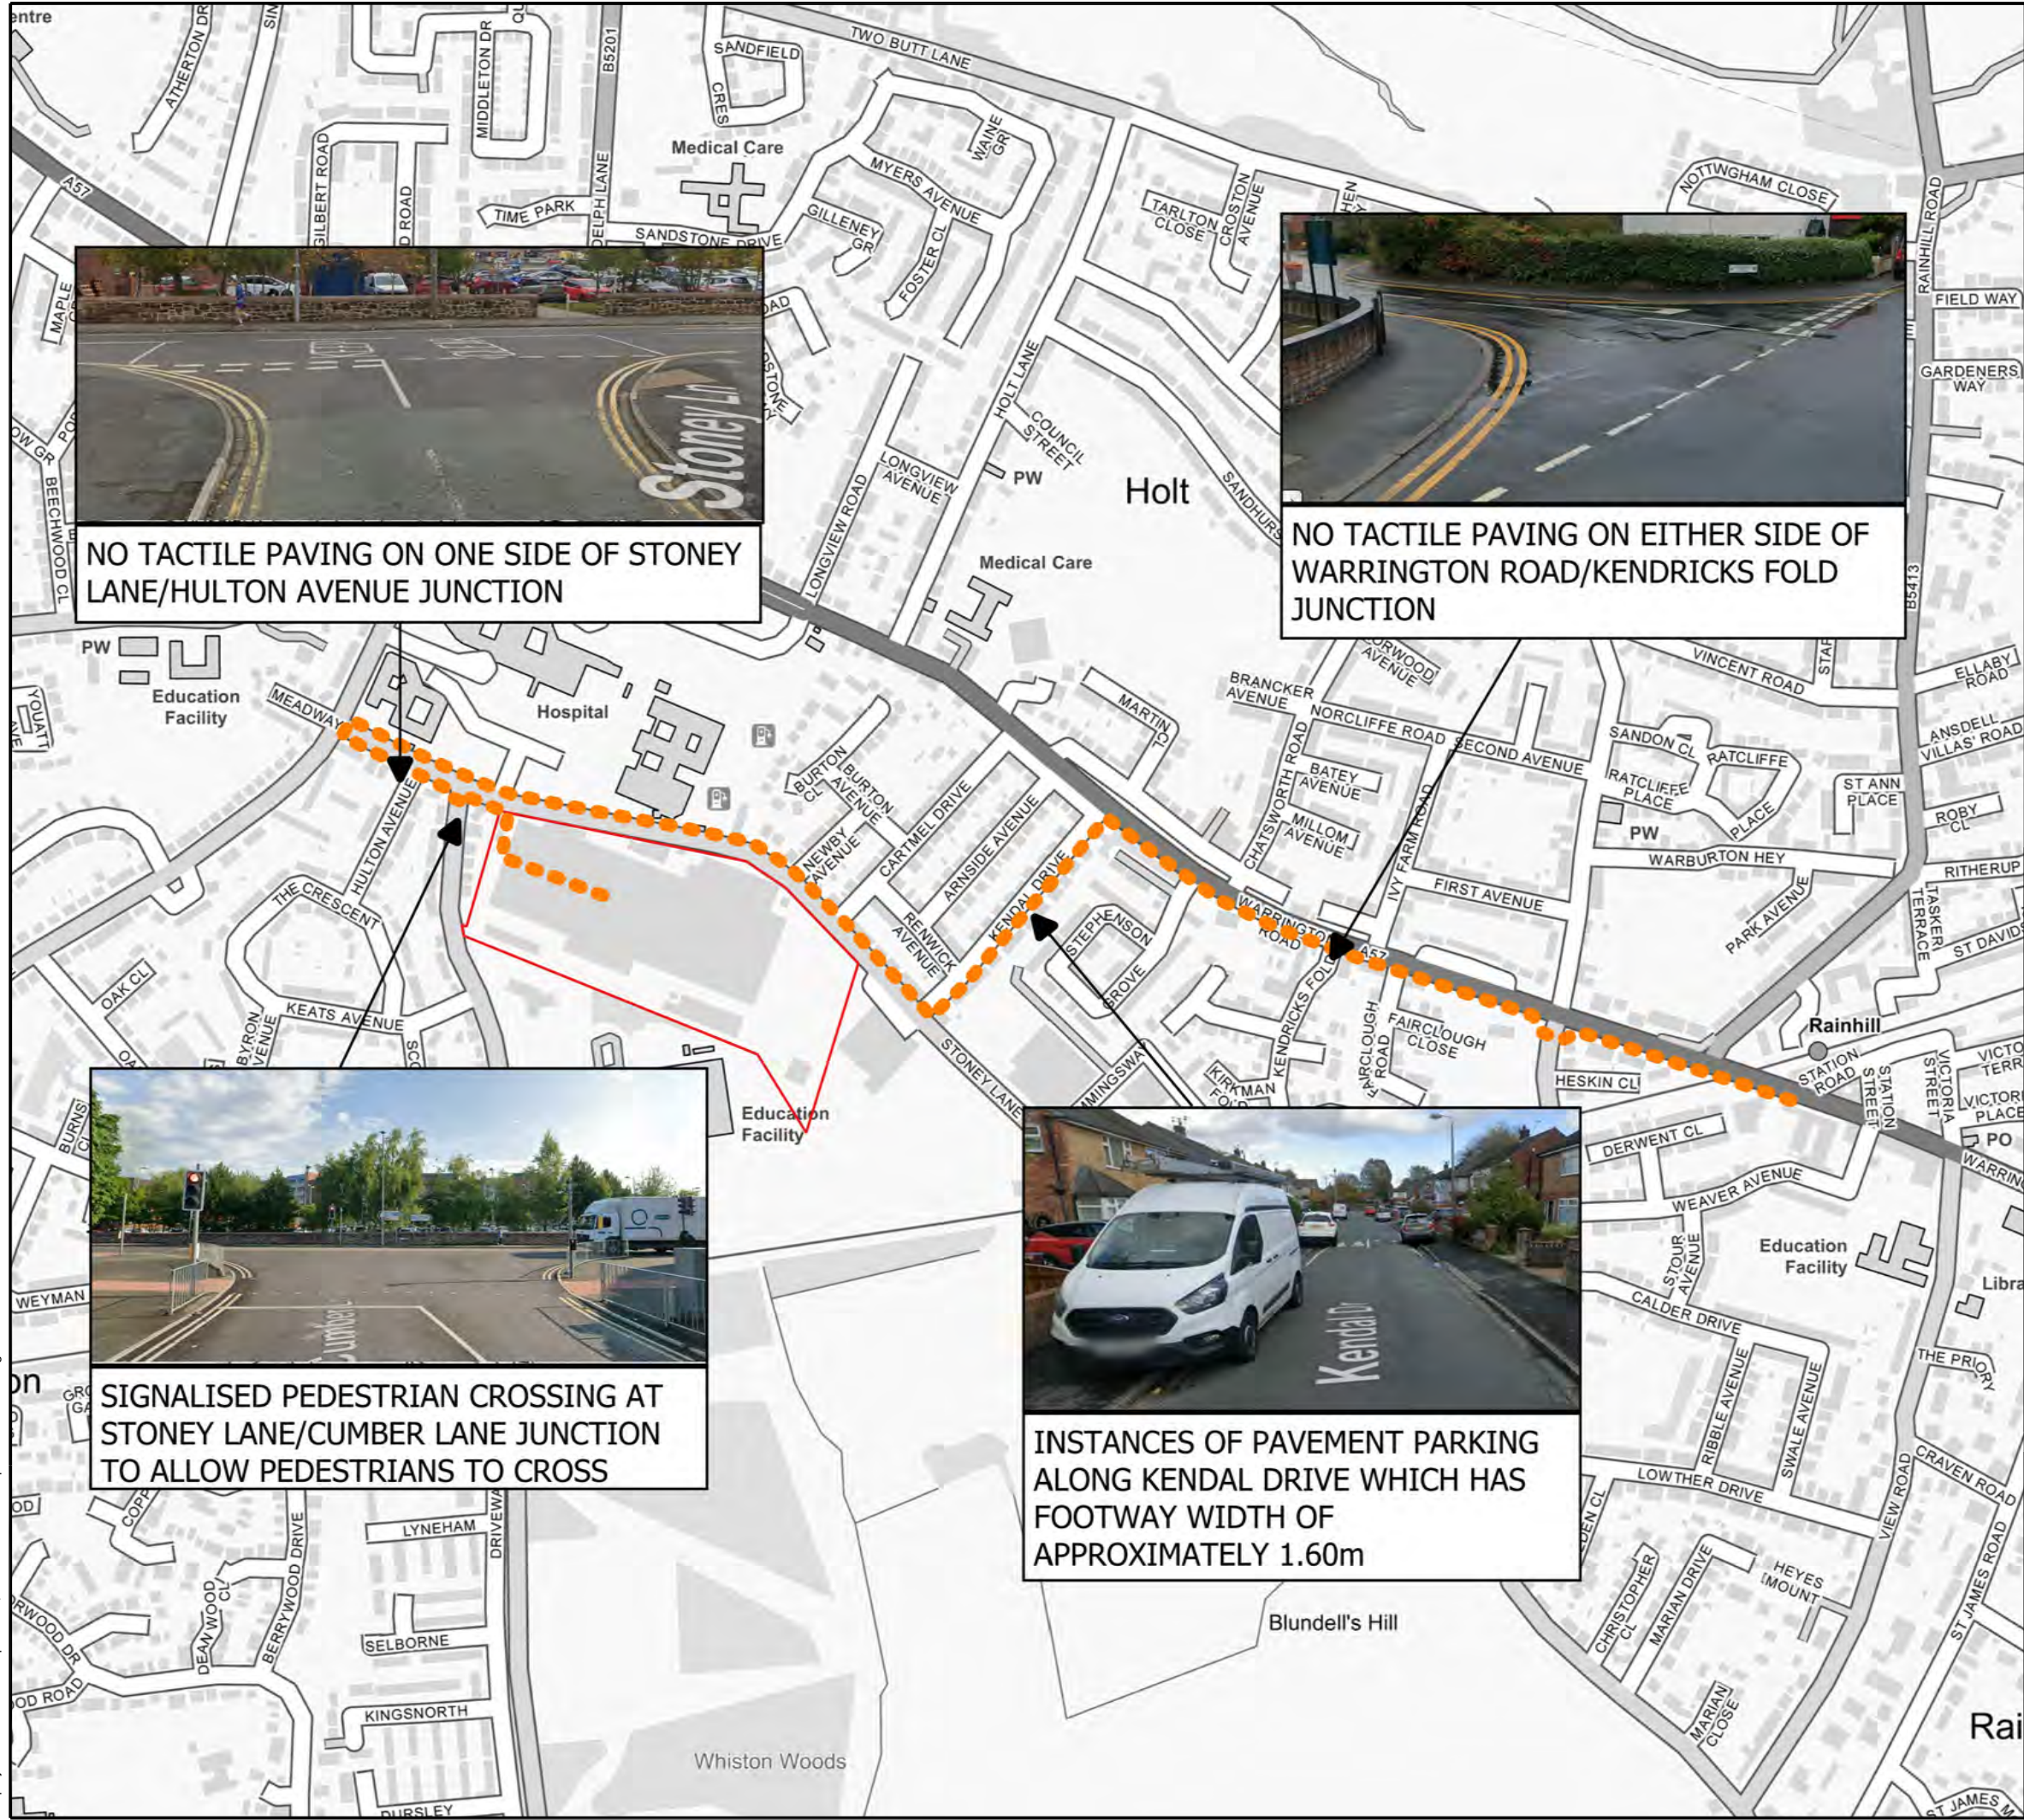
NO TACTILE PAVING ON ONE SIDE OF STONEY LANE/HULTON AVENUE JUNCTION

NO TACTILE PAVING ON EITHER SIDE OF WARRINGTON ROAD/KENDRICKS FOLD JUNCTION

SIGNALISED PEDESTRIAN CROSSING AT STONEY LANE/CUMBER LANE JUNCTION TO ALLOW PEDESTRIANS TO CROSS

INSTANCES OF PAVEMENT PARKING ALONG KENDAL DRIVE WHICH HAS FOOTWAY WIDTH OF APPROXIMATELY 1.60m

| <b>6. COMFORT</b><br>- footway width | Able to accommodate all users without 'give and take' between users or walking on roads. Footway widths generally in excess of 2m. | Footway widths of between approximately 1.5m and 2m. Occasional need for 'give and take' between users and walking on roads. | Footway widths of less than 1.5m (i.e. standard wheelchair width). Limited footway width requires users to 'give and take' frequently, walk on roads and/or results in crowding/delay. | <b>1</b> | Footway width of approximately 1.60m along Kendal Drive. | No action proposed. |
| <b>8. COMFORT</b><br>- footway parking | No instances of vehicles parking on footways noted. Clearance widths generally in excess of 2m between permanent obstructions. | Clearance widths between approximately 1.5m and 2m. Occasional need for 'give and take' between users and walking on roads due to footway parking. Footway parking causes some deviation from desire lines. | Clearance widths less than 1.5m. Footway parking requires users to 'give and take' frequently, walk on roads and/or results in crowding/delay. Footway parking causes significant deviation from desire lines. | <b>1</b> | Some instances of pavement parking, especially on Kendal Drive leading to the need of occasional 'give and take'. | No action proposed. |

| Actions | Potential off-site improvements are to be discussed with the Council as the application progresses. |
