# ARBORICULTURAL METHOD STATEMENT

Former Education Building, Huyton Hey Road

Ref: 23/00013/AMS  
Author: Jonathan Henderson  
Qualifications: B.Sc Hons, TechArborA

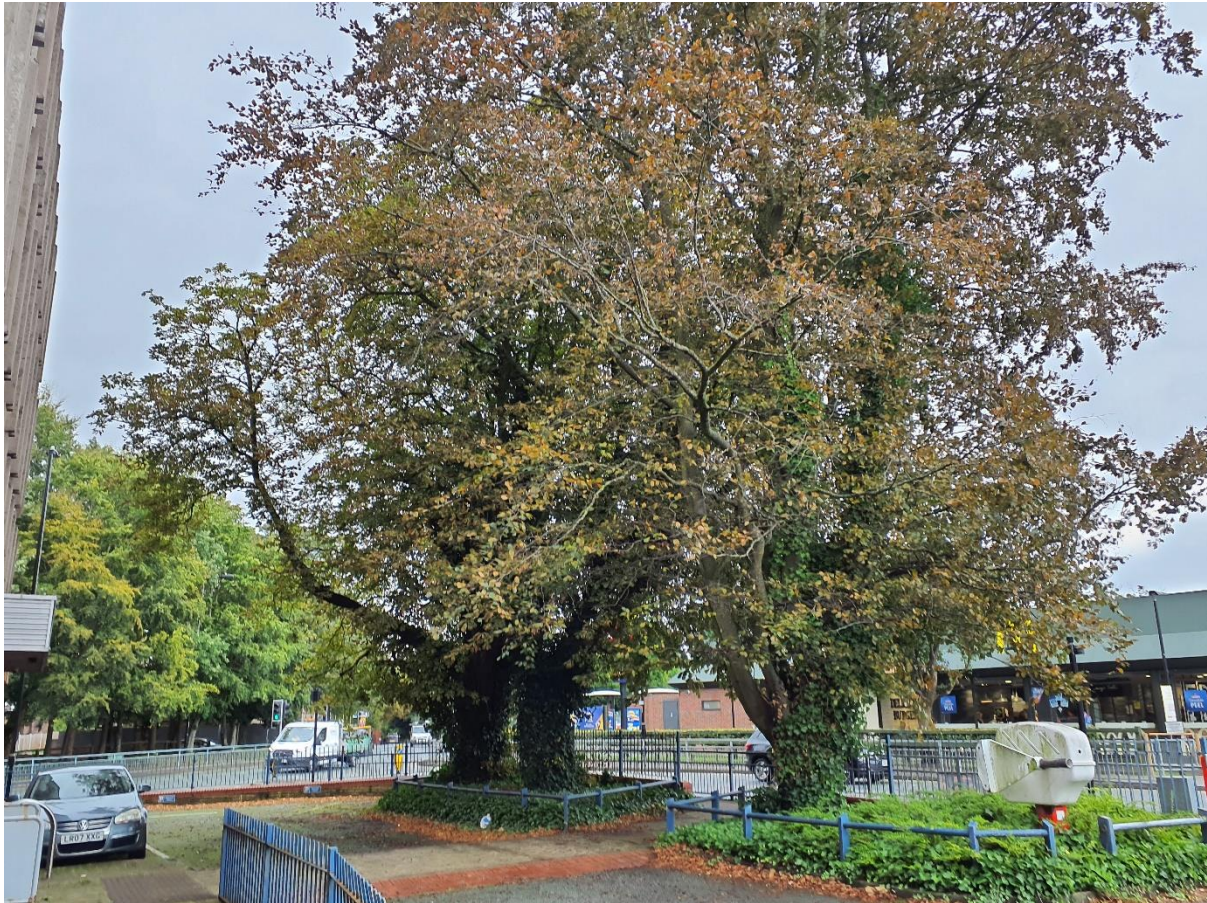
An image showing T4 (R), T5 and T6 (L).

| Tree No. | Proposed Works |
|---|---|
| T4, T5, T6 | Sever ivy from base to 2m |

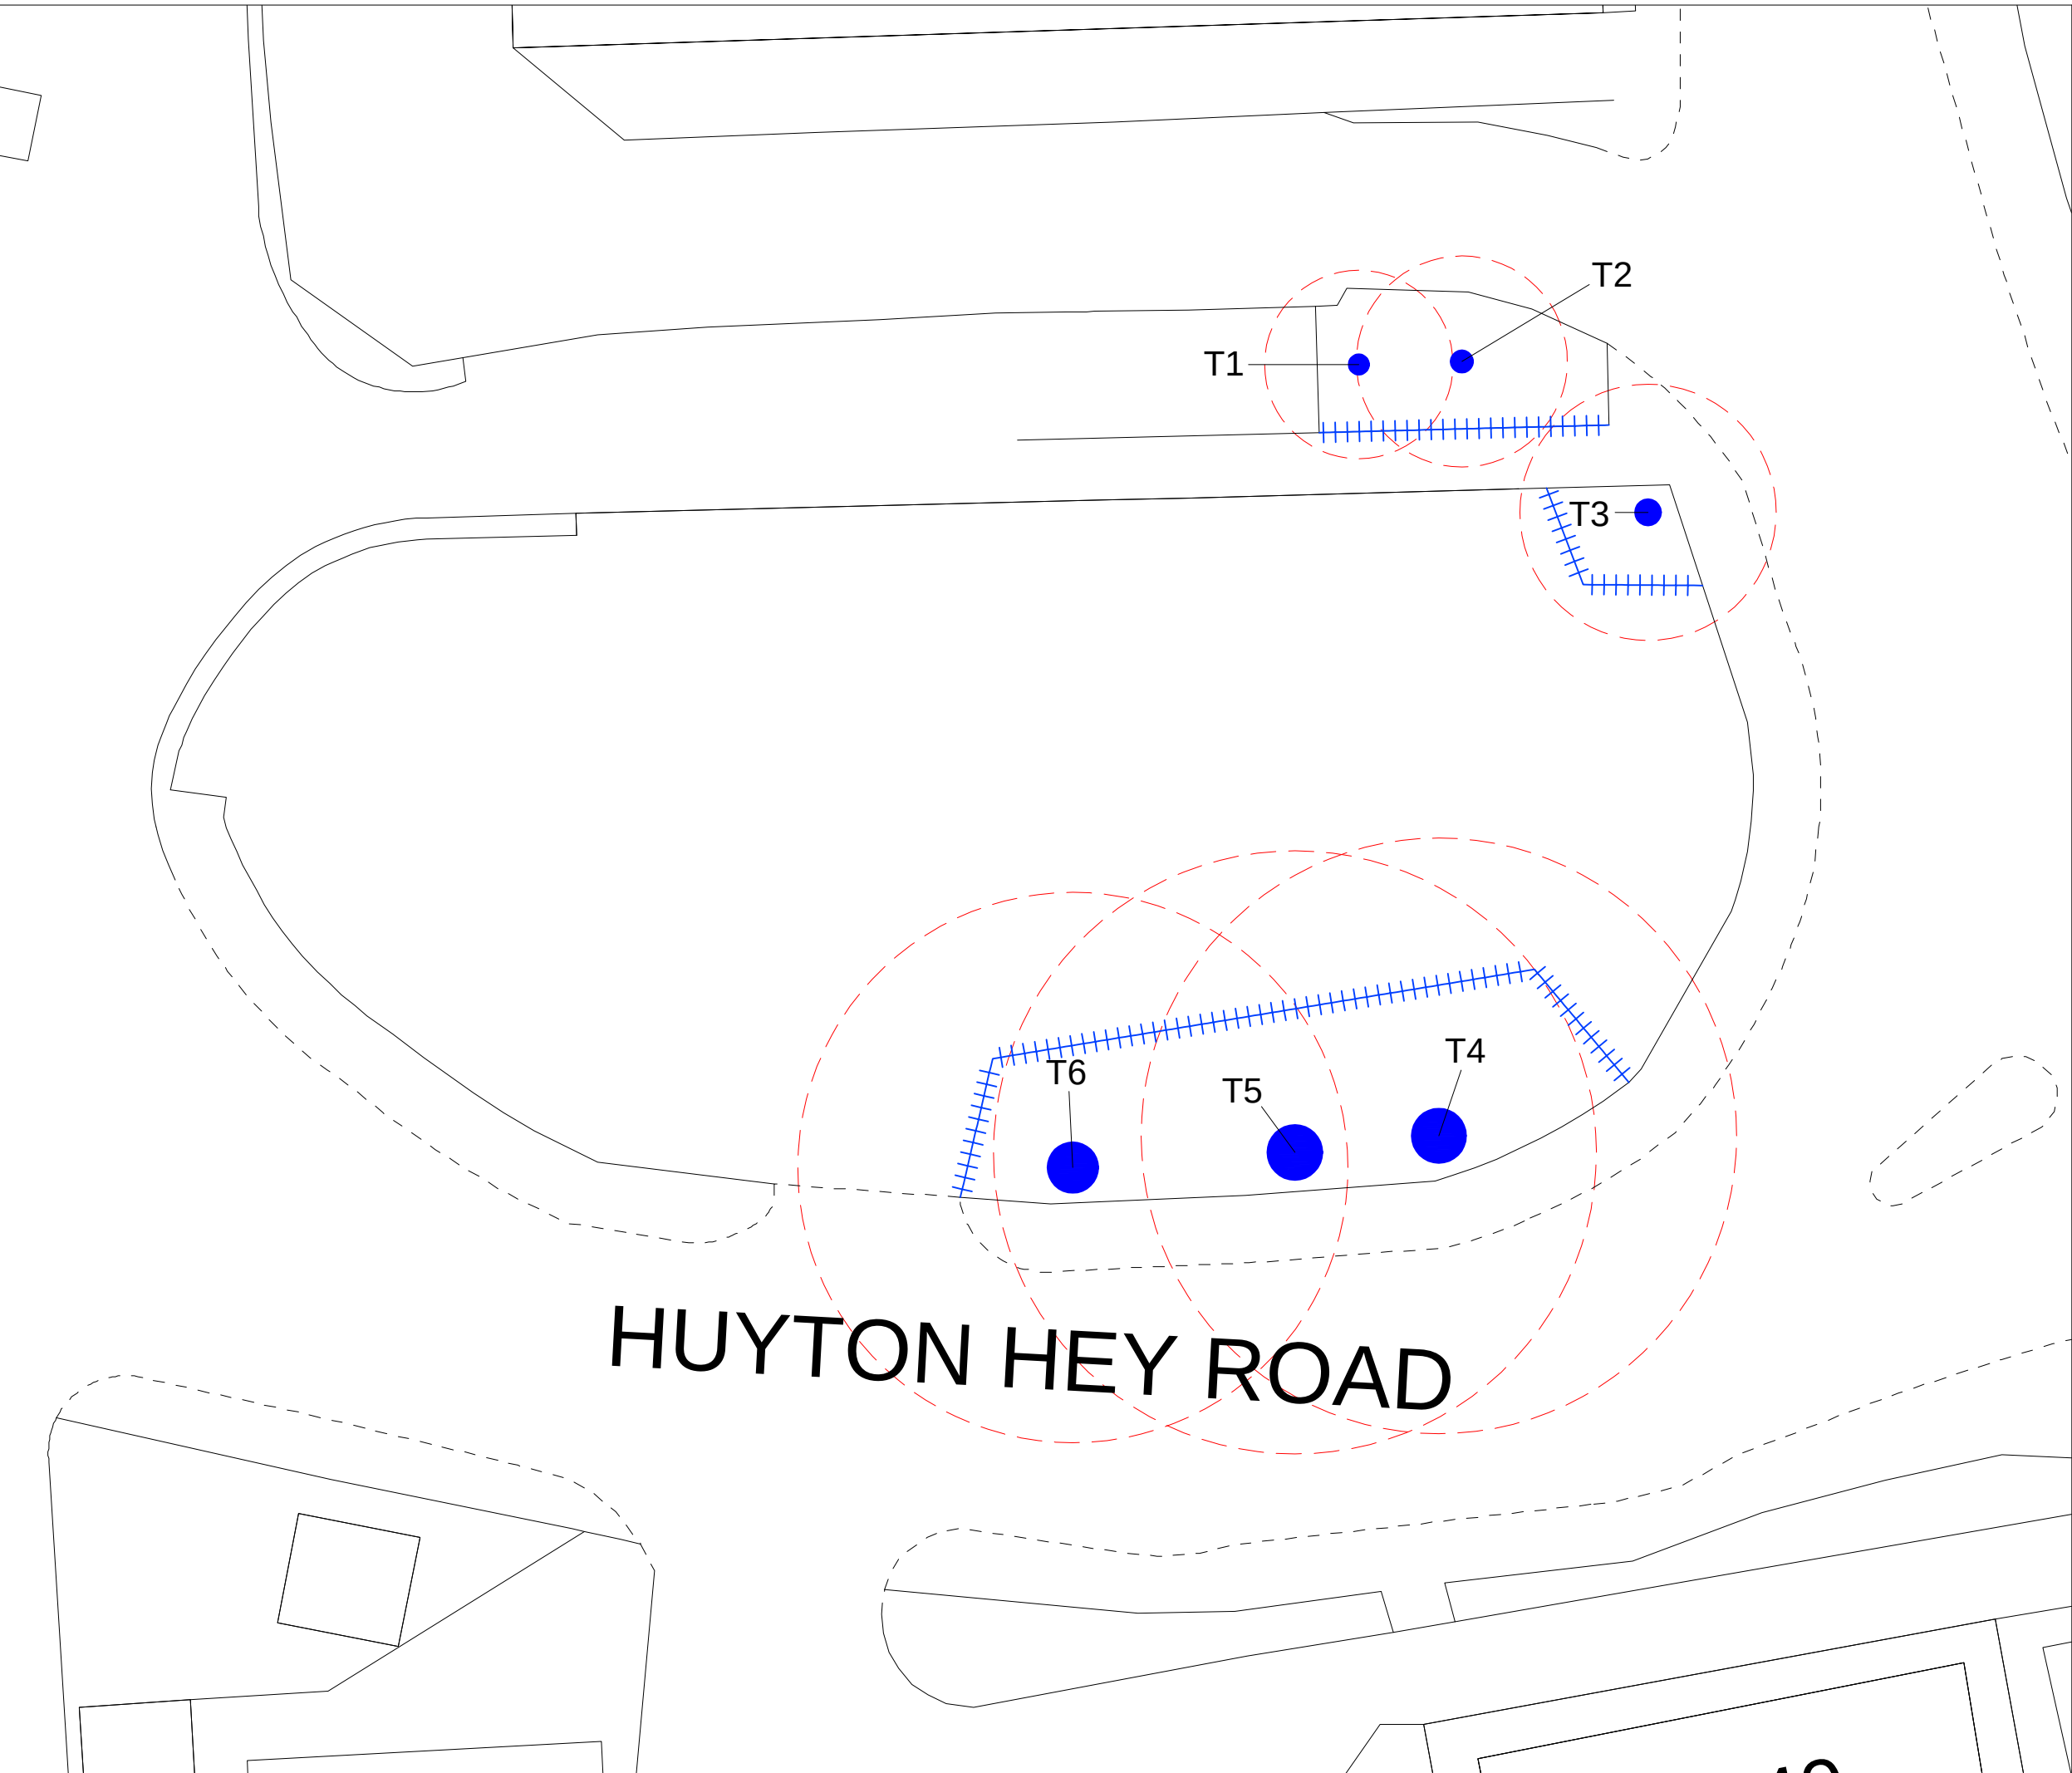
| Tree Protection Plan | 23/00013/TPP | |

Retained Trees
-

Trees to be Removed
-

Root protection area
-

Tree protection fencing

The positioning of the protective fencing is also very important and should be erected in the proposed location identified in Appendix 1.0. Once the fence has been erected it should never be crossed and particular care should be taken to store any materials or soil within the protected area.

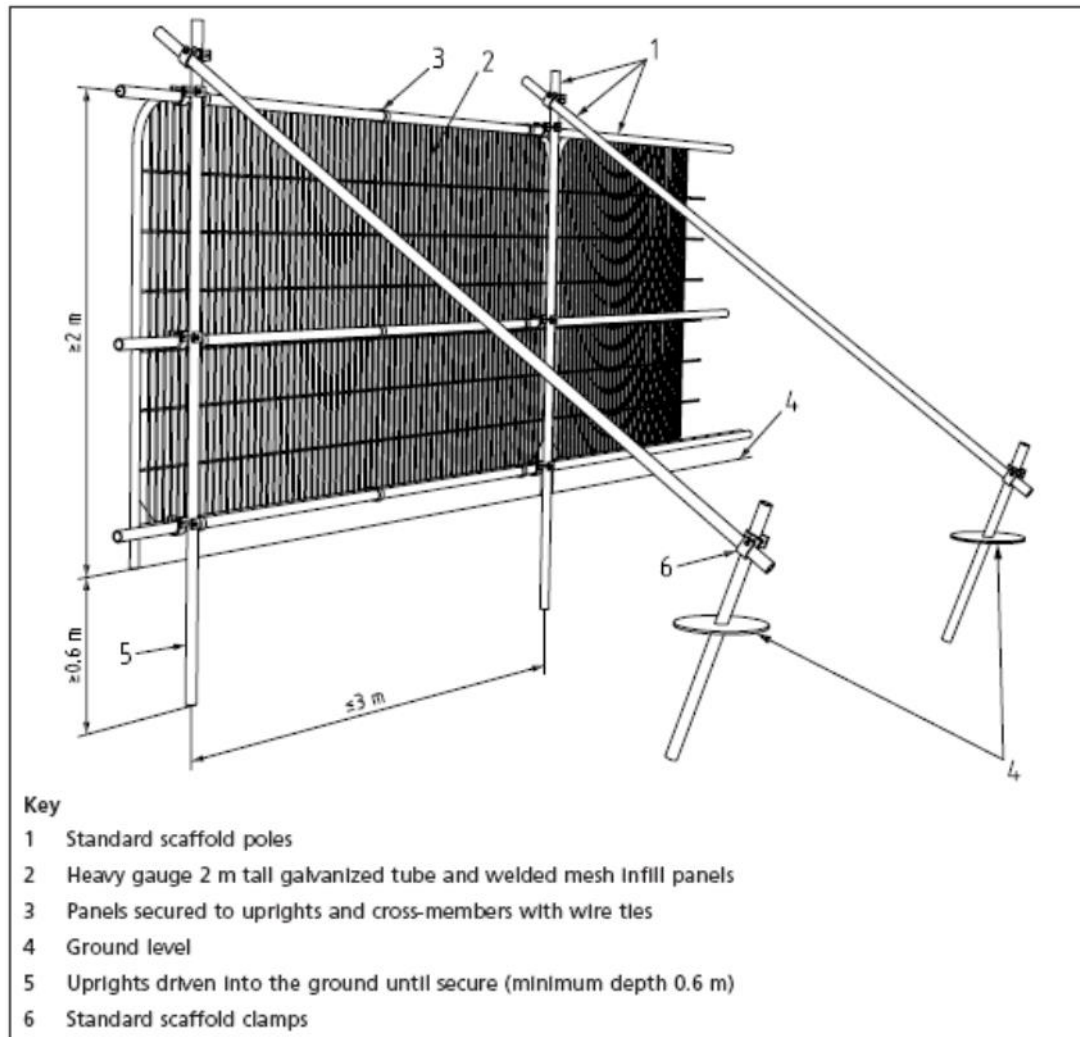
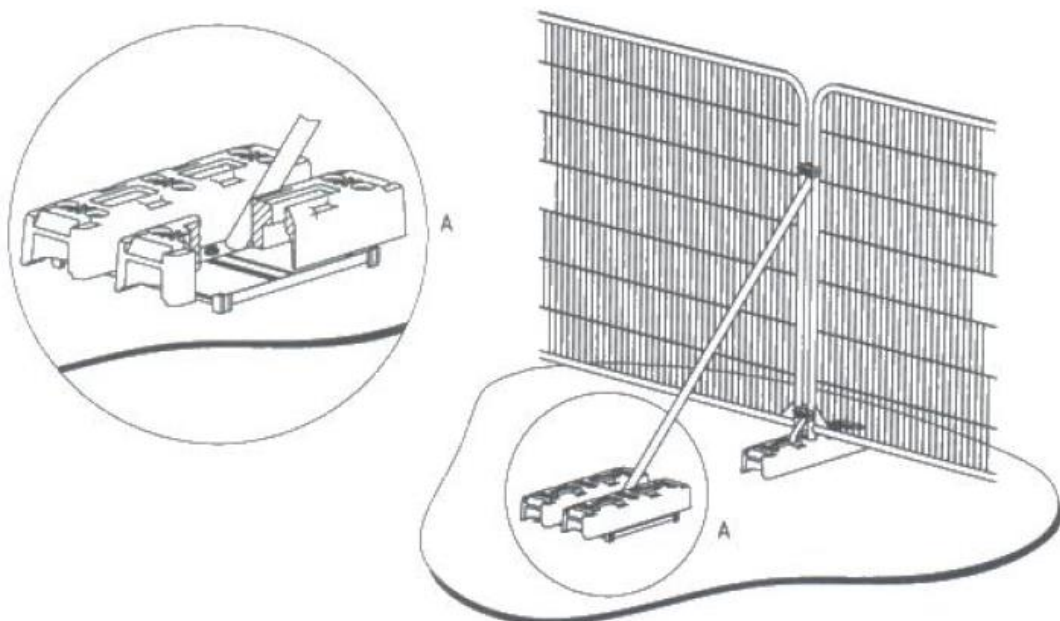
## **Appendix 2.0 Tree Fencing Specification**

b) Stabilizer strut mounted on block tray

The fencing should be at least 2.3m in height and should be erected with both a vertical and horizontal scaffolding framework capable of withstanding impact, with vertical tubes

spaced at a maximum of 3 m. This should support either weldmesh panels which should be securely fixed with wire or scaffold clamps.

Where it is demonstrated that there is a presence of underground services, an alternative arrangement is acceptable using boots to support the vertical sections of the fence and a stabilizer strut mounted on a block tray.
