# ARBORICULTURAL IMPLICATIONS ASSESSMENT

PROPOSED DEVELOPMENT

VINE COTTAGE  
NETHERLEY ROAD  
TARBOCK

Author: C. Salisbury  
Date: 12 May 2021  
Ref: TRE/VCNR

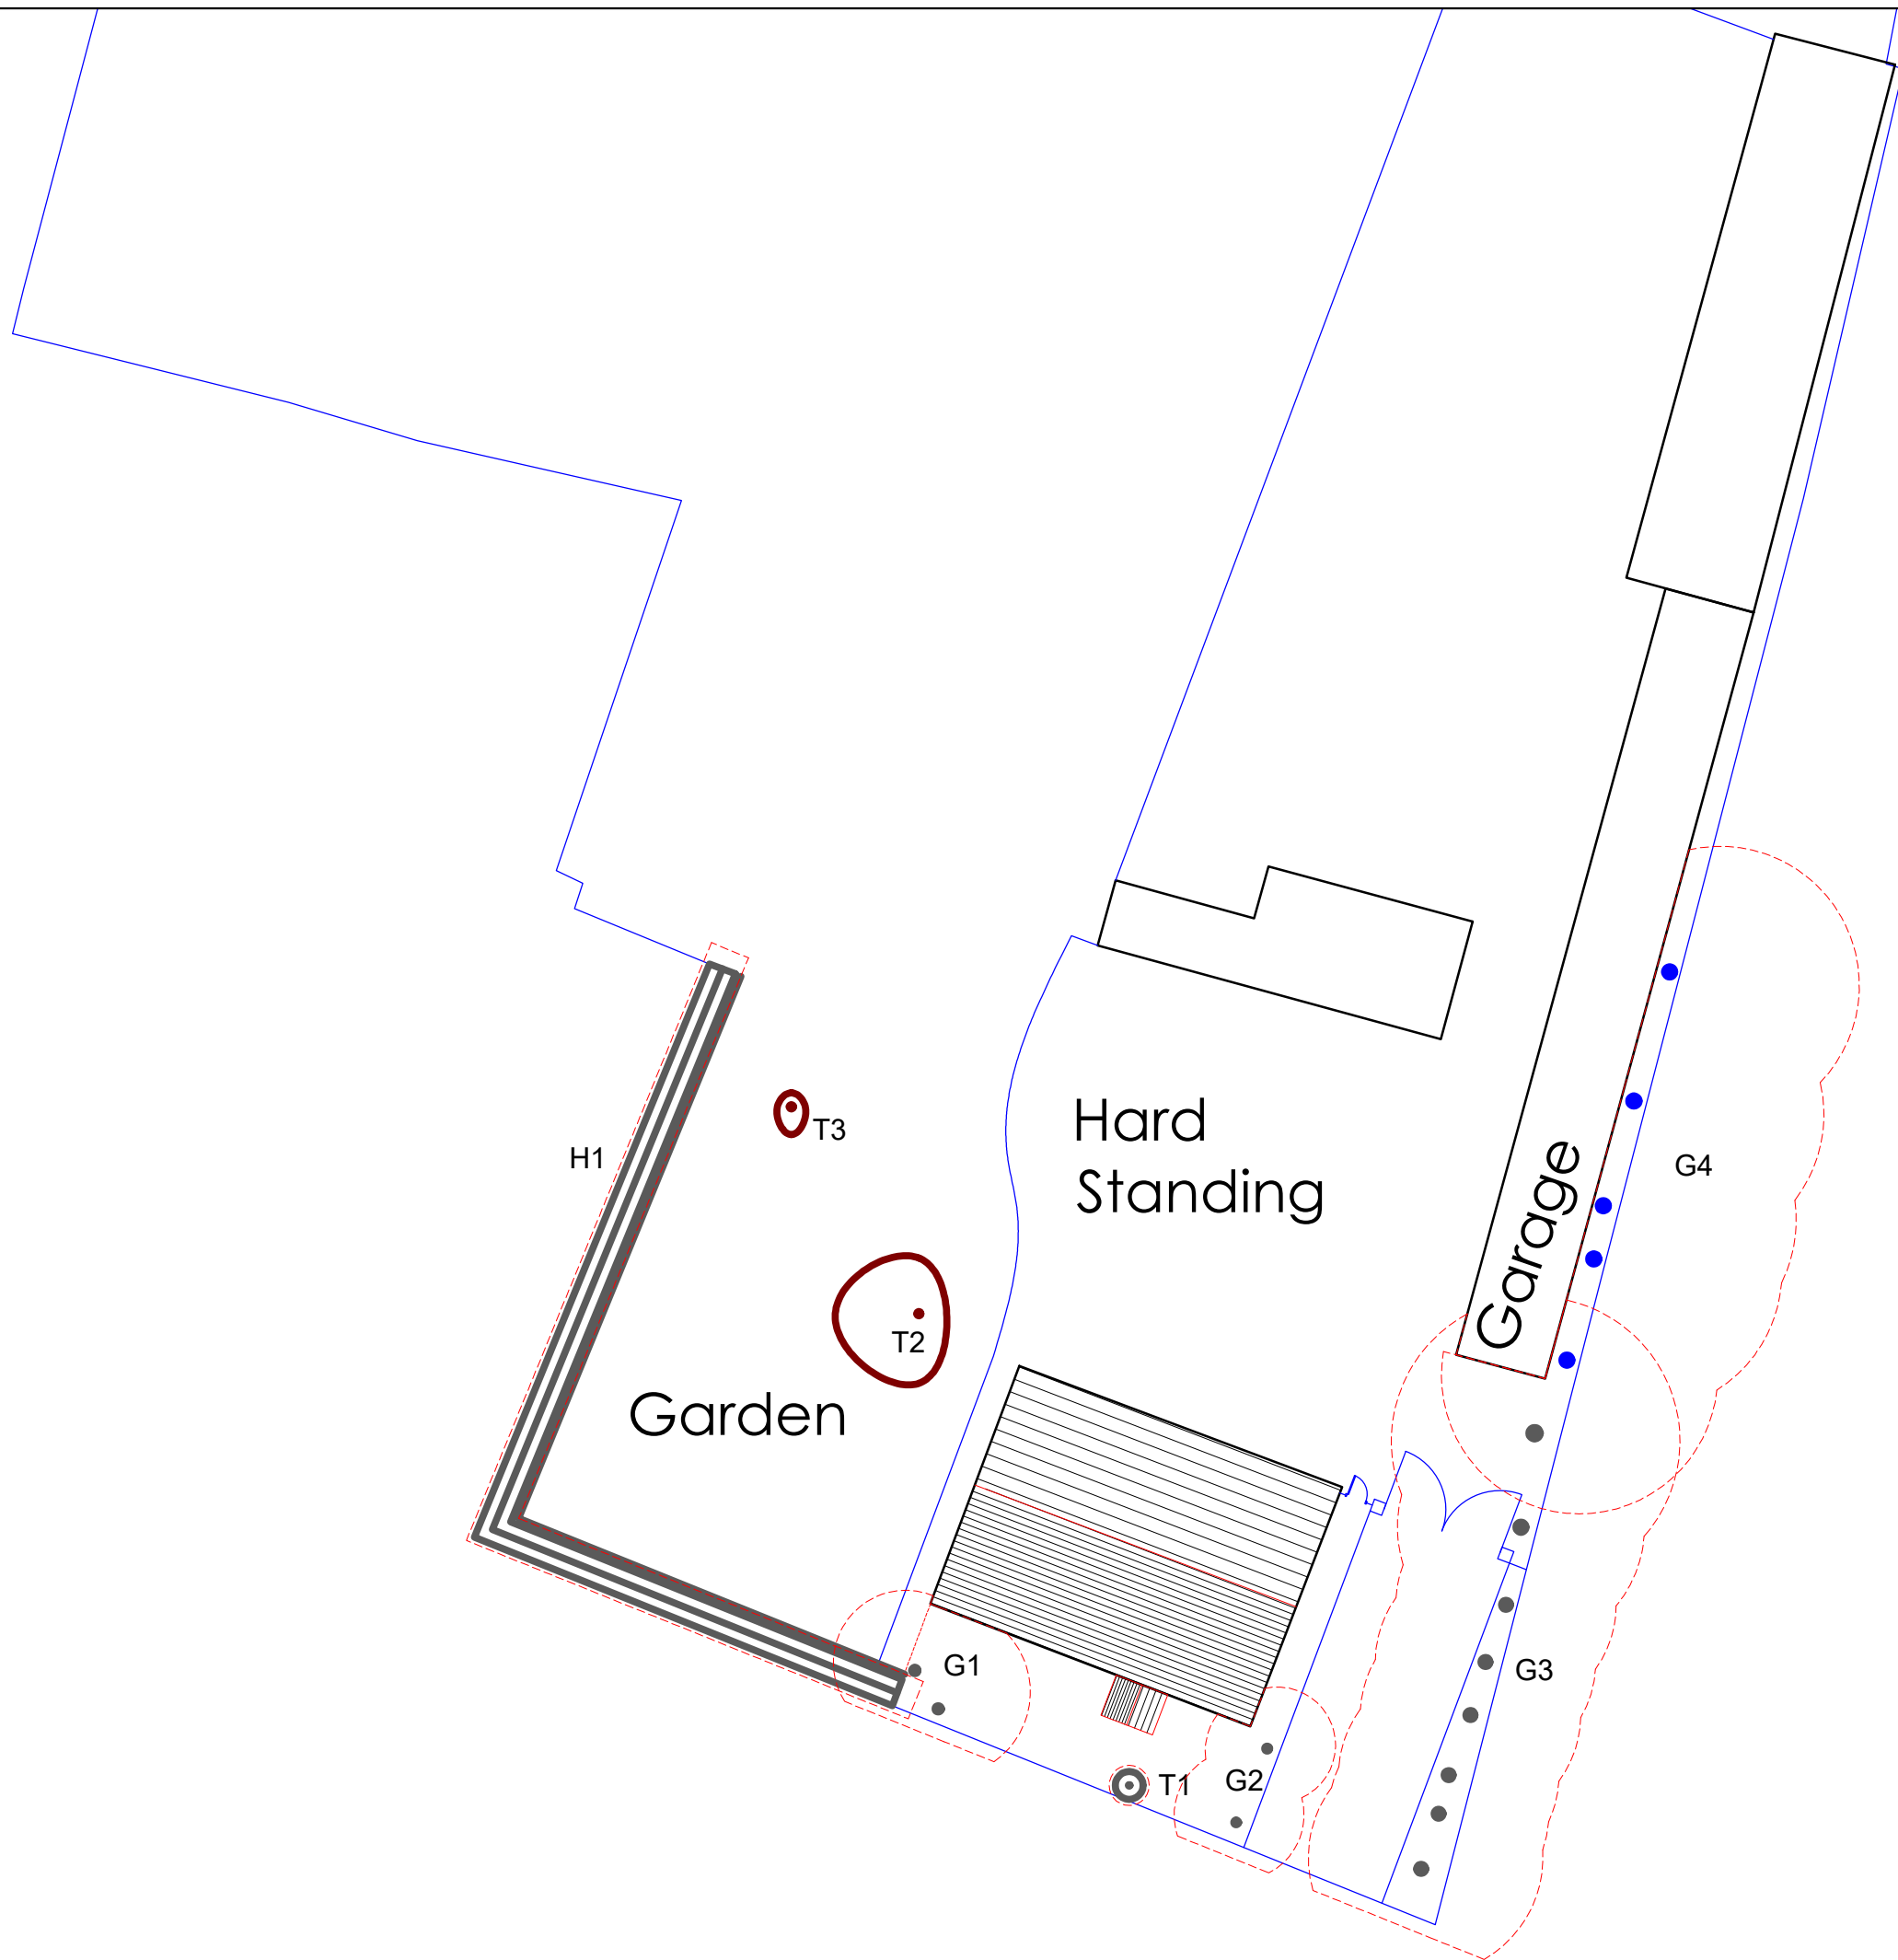
Drawing Title:  
BS5837 Plan

- 2.1 The trees were surveyed (prefixed T, or G for group) and recorded in the tree schedule in appendix one. Where groups are recorded, average height and diameter at breast height (DBH) of the trees in the group are reported. Where access to the base of any trees was limited, stem size was estimated.
- 2.2 All the trees were assessed using: a grading A to C (retention) and U (removal); condition and age class as defined in appendix two.
- 2.3 Where appropriate, canopy spread for each tree was recorded at four cardinal points in order to reproduce an accurate representation of the crown shape of the tree on the tree plan in appendix three.
- 2.4 The survey included all trees within the proposal area and trees near to the proposal.

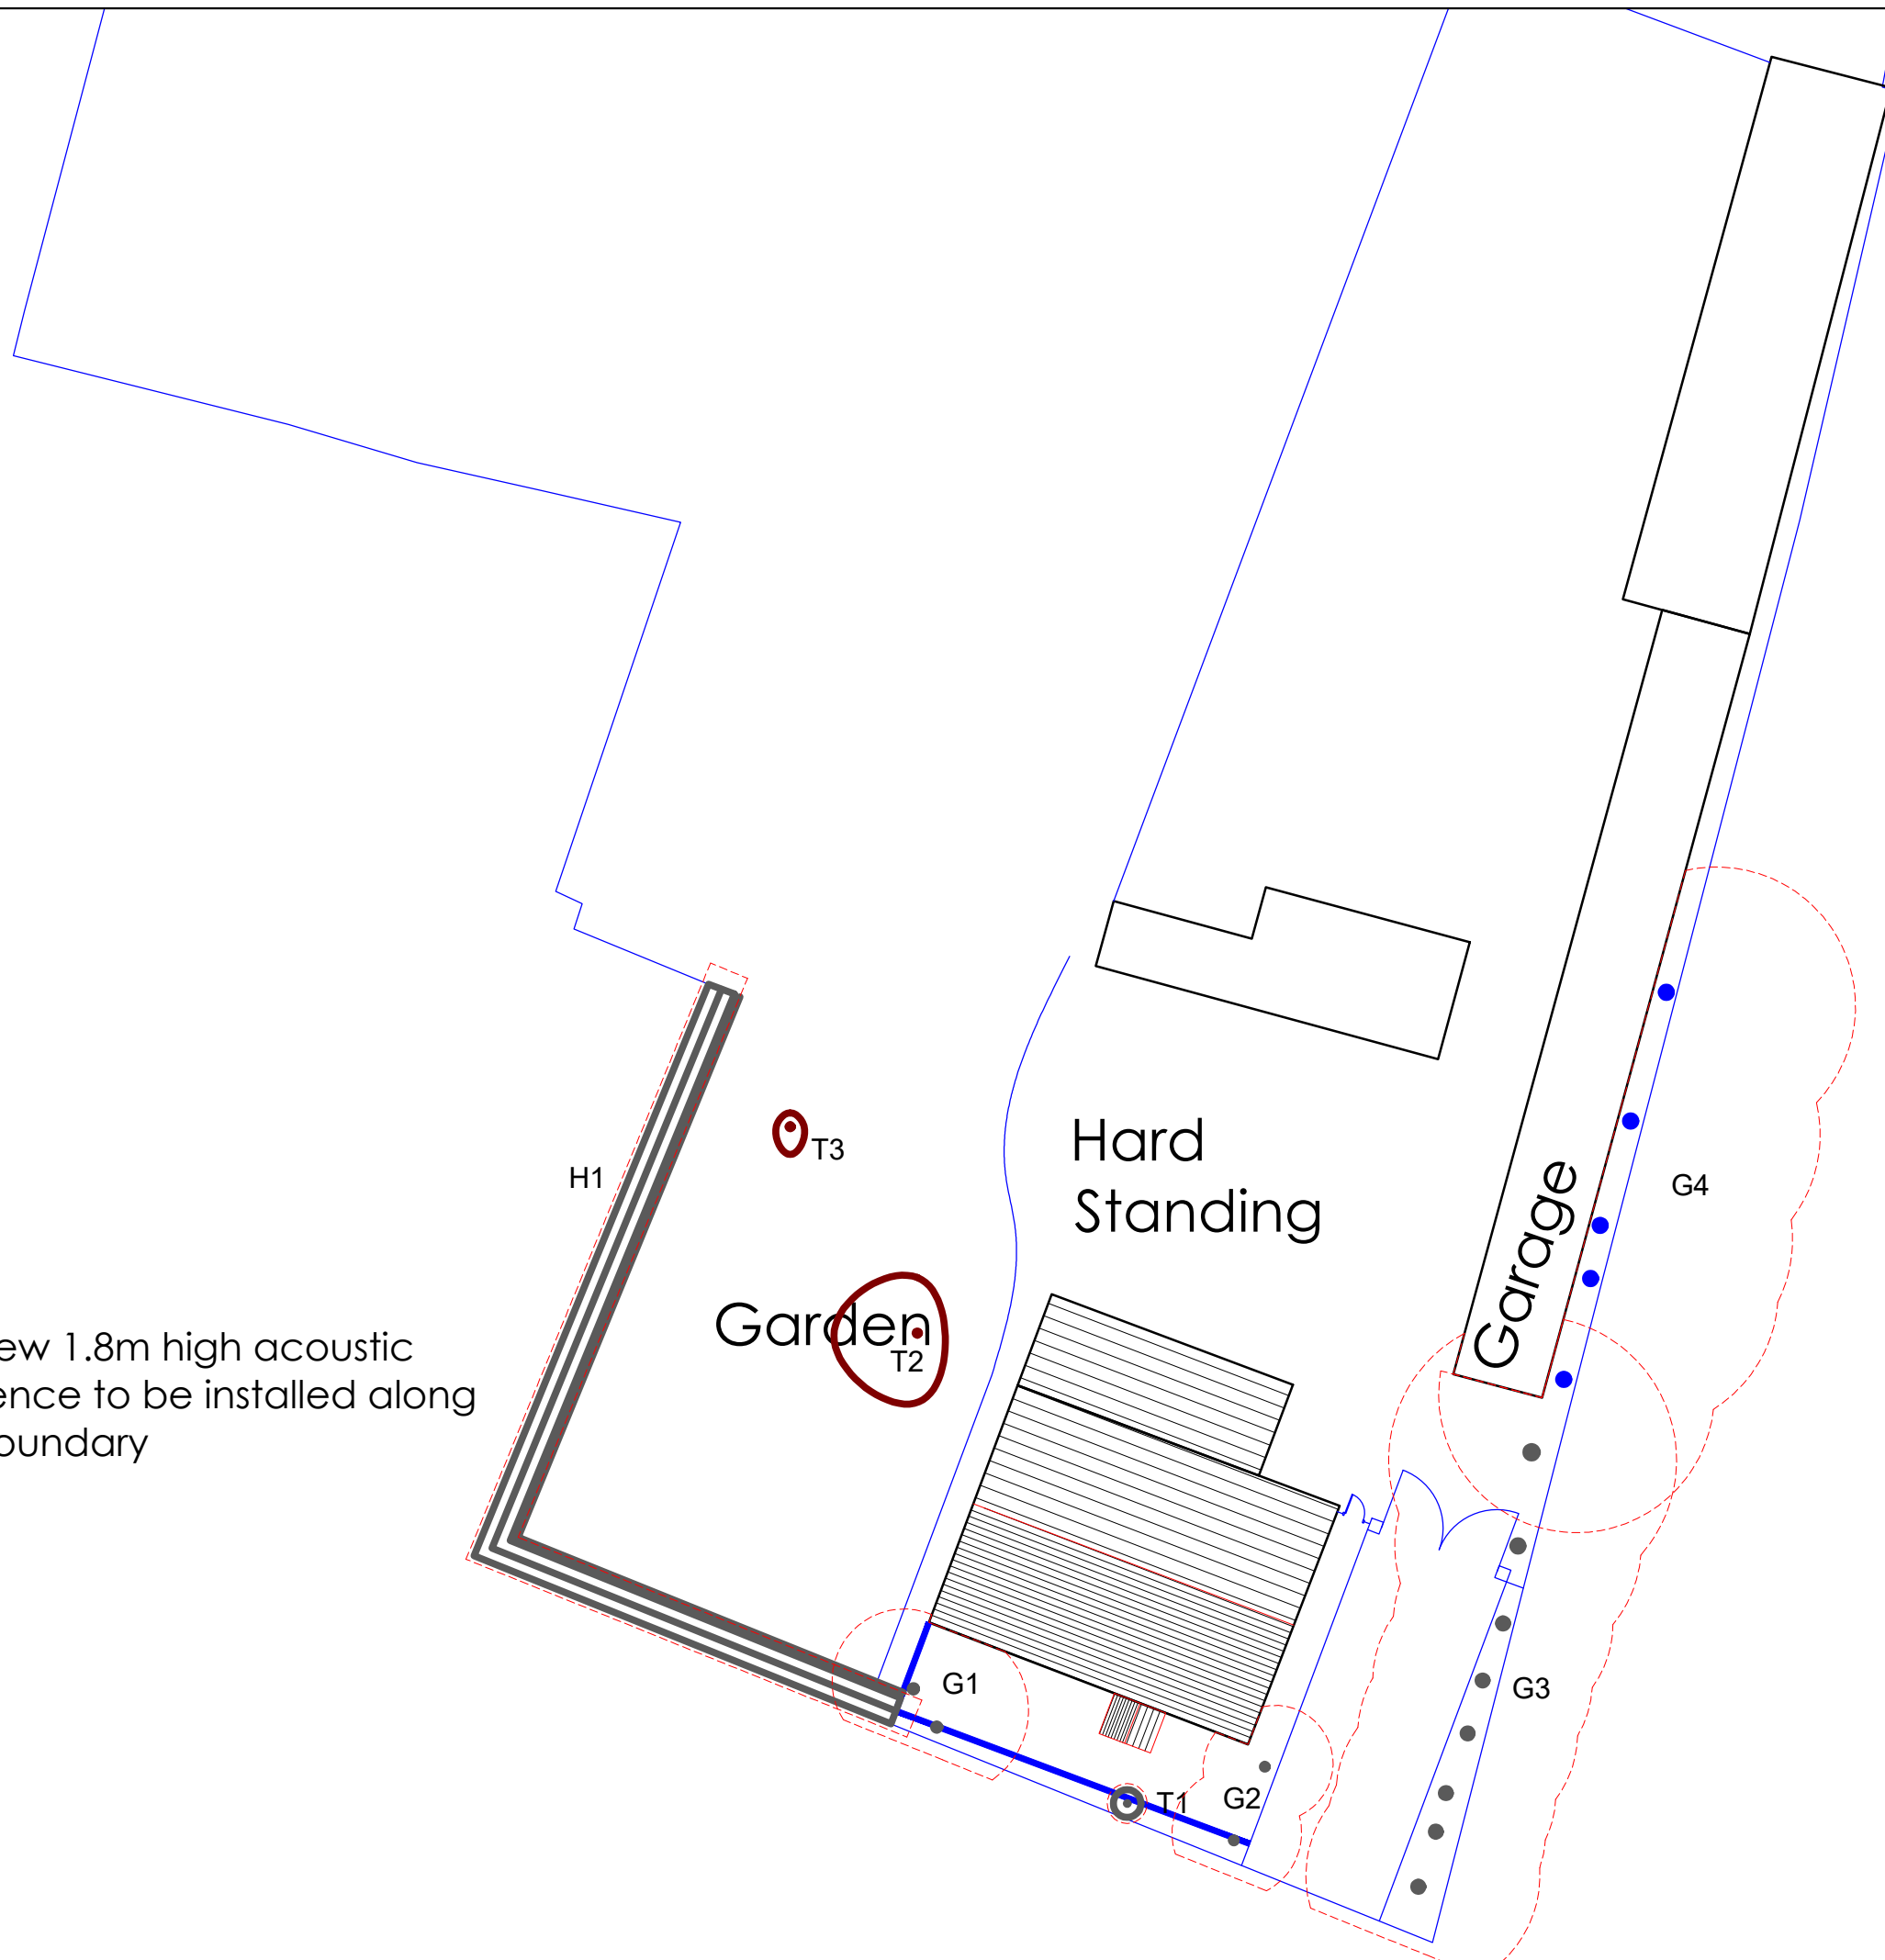
Drawing Title:  
AIS Plan

- 3.1 Due to the proposed development and its associated infrastructure there are a number of locations where the proposals are in close proximity to the trees surveyed. The Site Layout Plan within appendix three identifies the trees in relation to the proposed development.
- 3.2 In order to fully assess the impact of the proposals an Impact Table has been created detailing each tree, which shows the proximity of the associated works to the tree.
- 3.3 This can then be assessed in accordance with BS 5837:2012 to determine whether the development will have a detrimental impact on the health of each tree. Once this has been determined remedial measures can be detailed to reduce the impact the proposals will have on the treescape.

New 1.8m high acoustic  
Fence to be installed along  
boundary

- 5.1.1 The five trees identified for removal as a result of the development are poor-quality specimens and offer little in the way of visual amenity. It is therefore felt that the loss is acceptable.
