261-02

The Hovels,  
Tarbock Hall Lodge  
Ox Lane  
Prescot  
L35 1QA

Design and Heritage statement

Rev C

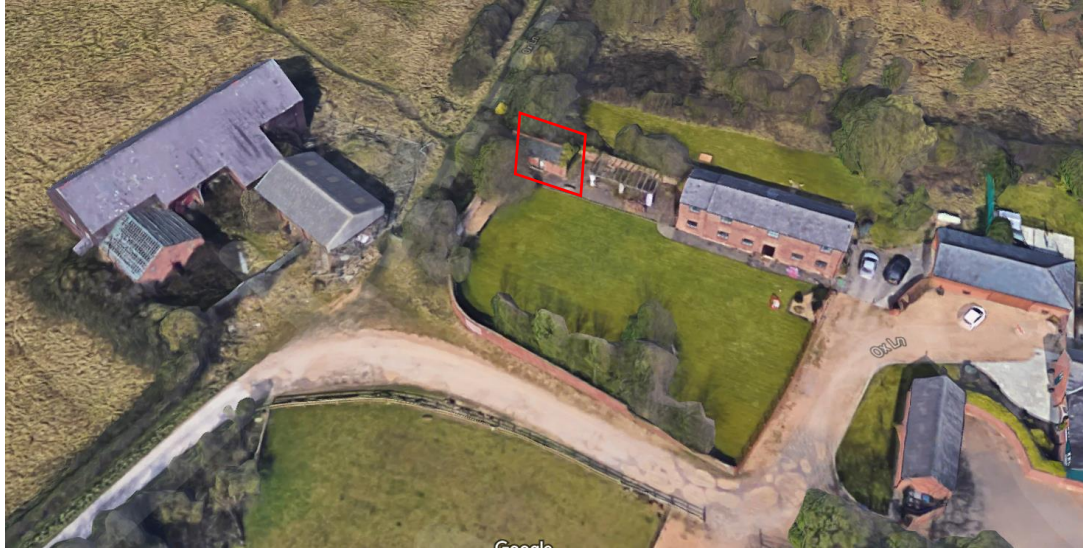
The South and East Walls, and the roof of the Hovels outbuilding have now been demolished.

Only the boundary walls (North and West walls of the Hovels Building), and the connecting easterly part of the North wall (the subject of this application) remains standing.
